Aircraft Accident Digest
Recueil d'accidents d'aviation
Recopilación de accidentes de aviación
No. - N° - Núm. 36

1989

G-OBME left Heathrow Airport for Belfast at 1952 hrs with 8 crew and 118 passengers (including 1 infant) on board. As the aircraft was climbing through 28,300 feet the outer panel of one blade in the fan of the No 1 (left) engine detached. This gave rise to a series of compressor stalls in the No 1 engine, which resulted in airframe shuddering, ingress of smoke and fumes to the flight deck and fluctuations of the No 1 engine parameters. Believing that the No 2 engine had suffered damage, the crew throttled that engine back and subsequently shut it down. The shuddering caused by the surging of the No 1 engine ceased as soon as the No 2 engine was throttled back, which persuaded the crew that they had dealt correctly with the emergency. They then shut down the No 2 engine. The No 1 engine operated apparently normally after the initial period of severe vibration and during the subsequent descent.

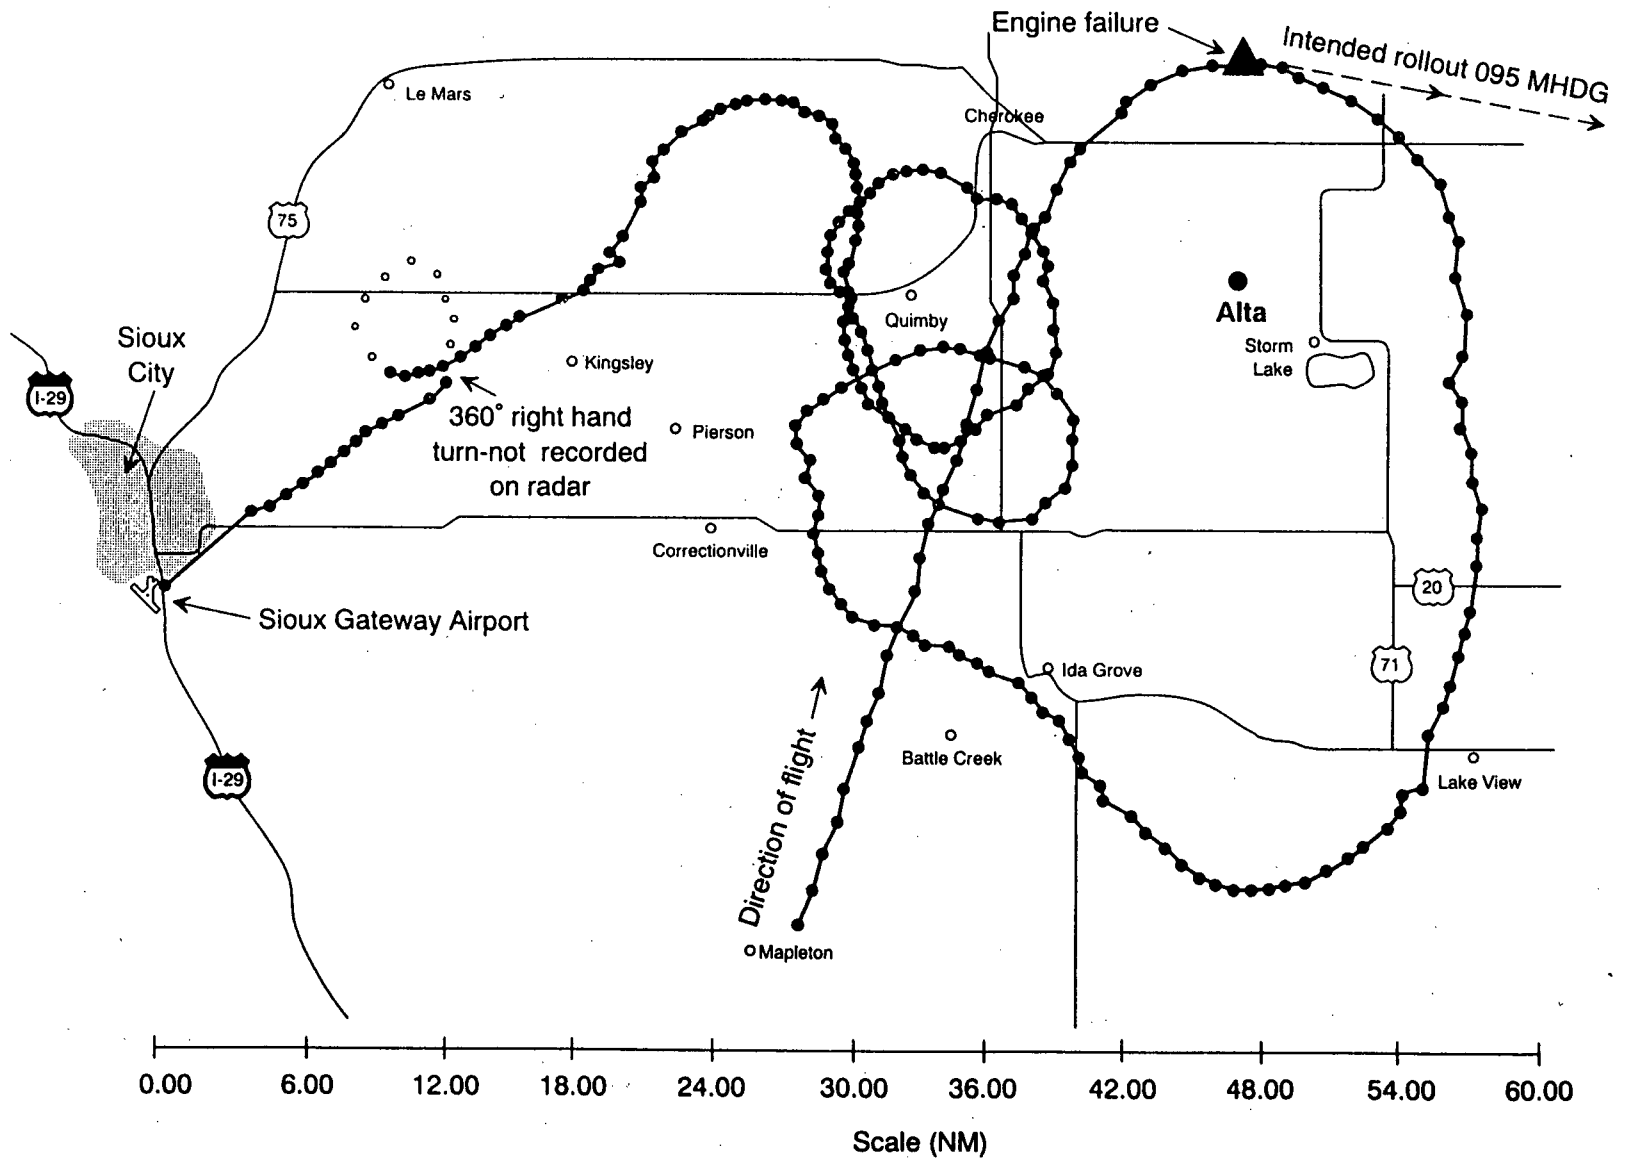
Figure 2.--Ground track from radar plot.

The check airman said that based on experience with no flap/no slat approaches he knew that power would have to be used to control the airplane's descent. He used the first officer's airspeed indicator and visual cues to determine the flightpath and the need for power changes. He thought that the airplane was fairly well aligned with the runway during the latter stages of the approach and that they would reach the runway. Soon thereafter, he observed that the airplane was positioned to the left of the desired landing area and descending at a high rate. He also observed that the right wing began to drop. He continued to manipulate the No. 1 and No. 3 engine

throttles until the airplane contacted the ground. He said that no steady application of power was used on the approach and that the power was constantly changing. He believed that he added power just before contacting the ground.
