Aircraft Accident Digest
Recueil d'accidents d'aviation
Recopilación de accidentes de aviación
No. - N° - Núm. 34

INTERNATIONAL CIVIL AVIATION ORGANIZATION
ORGANISATION DE L'AVIATION CIVILE INTERNATIONALE
ORGANIZACIÓN DE AVIACIÓN CIVIL INTERNACIONAL

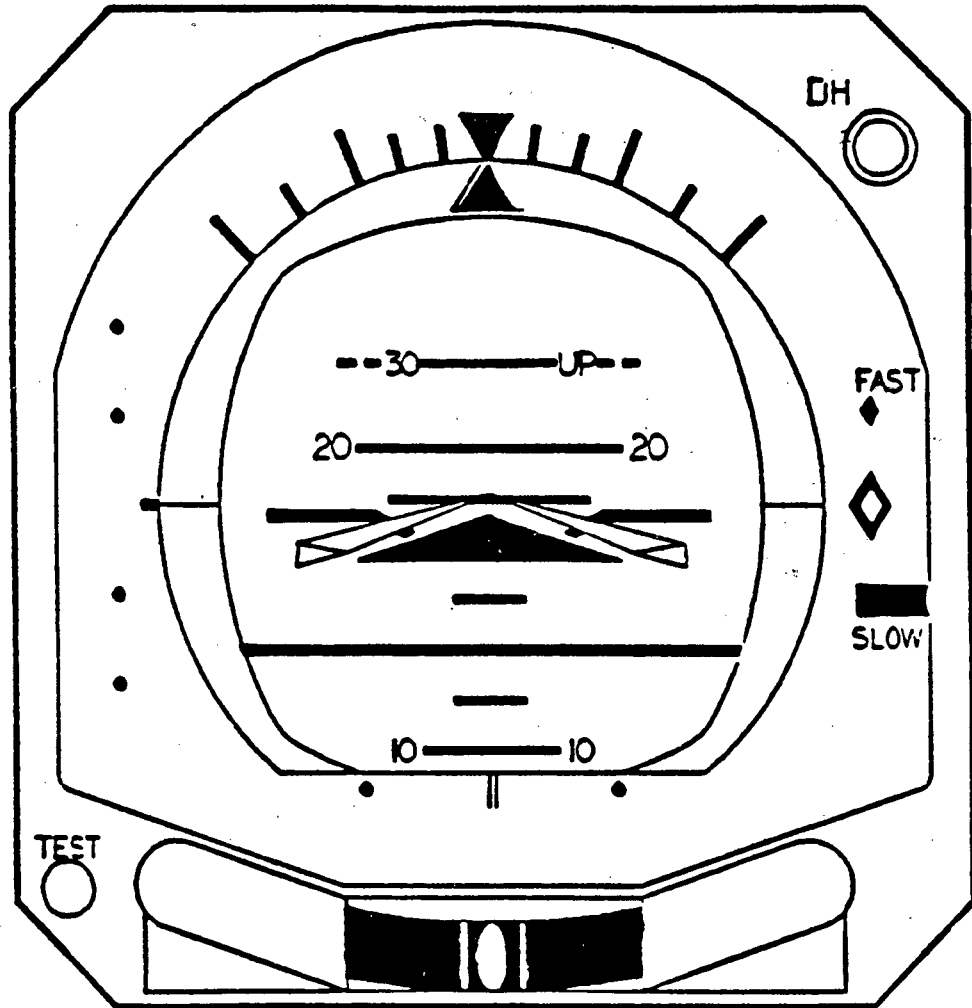
Figure 3.--Displays theoretical pitch attitude information presented by the ADI and the F/D command bar for the conditions existing 65 seconds after the start of the takeoff roll and after the F/D has entered the go-around mode. Roll attitude information and command bar roll guidance information is not displayed.

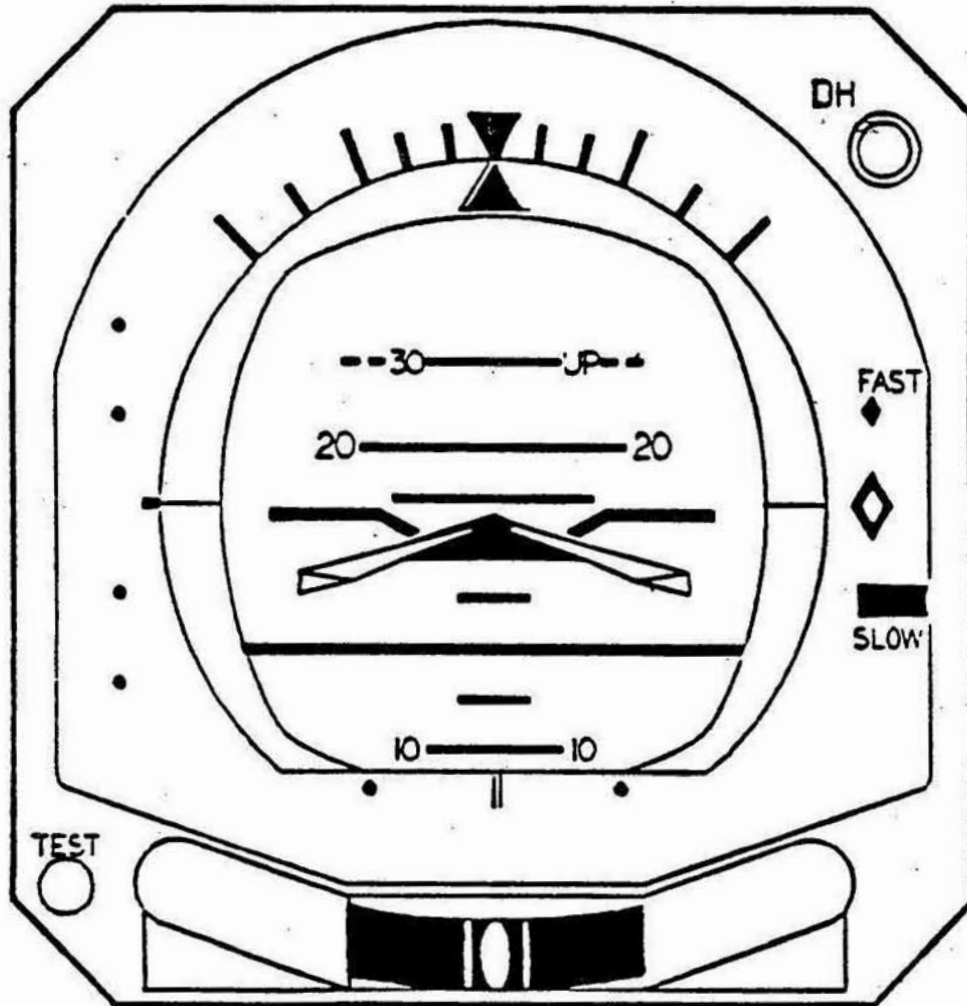
Figure 4.--Displays theoretical pitch attitude information presented by the ADI and the F/D command 65 seconds after the start of the takeoff roll with the F/D in Takeoff mode. Roll attitude information and command bar roll guidance is not displayed.
