ICAO CIRCULAR

CIRCULAR 245-AN/147

AIRCRAFT ACCIDENT DIGEST 1986 (No. 33)

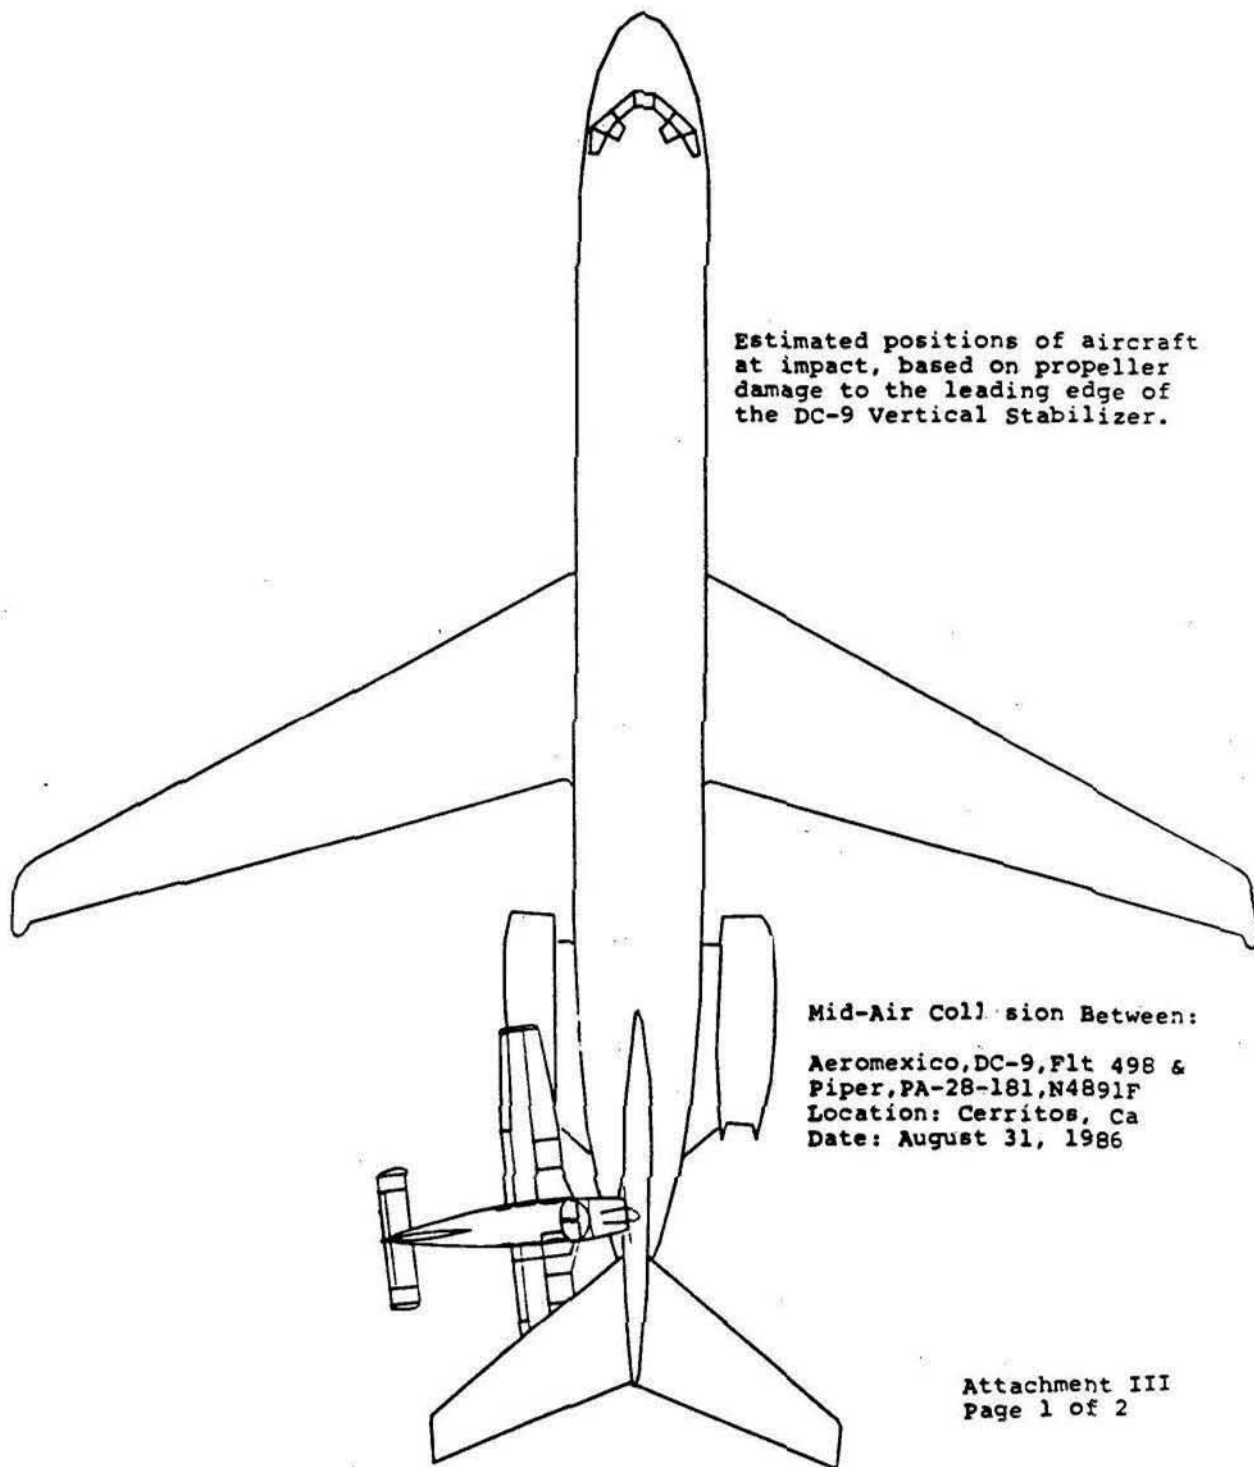
The damaged areas on the DC-9 vertical and horizontal stabilizers contained propeller slice marks, paint transfer marks from the nose wheel area and vertical stabilizer of the Piper, and embedded pieces from the cabin roof area of the Piper. The location and angles of these marks and damage on the DC-9, when matched to their respective locations on an intact Piper PA-28, showed that the front of the Piper had struck the left side of the DC-9 vertical stabilizer and that the impact angle was perpendicular to the longitudinal axis of each airplane. (See figure 6.) The impact angle was generally consistent with the flight tracks of the airplanes shown on the radar data plots.

The absence of any impact marks or damage on those portions of the DC-9 left wing and fuselage forward of the empennage that had not been consumed by fire and the damage to the DC-9 vertical and horizontal stabilizers, showed that the PA-28 airplane was about 8 to 10 feet above the top of the DC-9's fuselage and about 15 to 17 feet above its wings when the collision occurred. The damage also indicated that the longitudinal axis of the Piper was almost level at impact and that the initial impact was with the DC-9 vertical and horizontal stabilizers. The debris from the Piper cabin roof, embedded in the leading edge of the DC-9 horizontal stabilizer, and the fact that the roof of the Piper was sheared off at about the same height on both sides of its fuselage, confirmed the fact that the DC-9's horizontal stabilizer struck the top of the Piper's fuselage and that the Piper was in the almost wings-level attitude at impact.

Figure 6.--Collision geometry as viewed from above the DC-9.

Even though the Piper was a much smaller and lighter airplane, its engine, a relatively massive object, struck the DC-9 horizontal stabilizer's main support structure, causing it to fail and the horizontal stabilizer to separate. Longitudinal control and stability was lost when the horizontal stabilizer separated and further controlled flight was impossible.
