# ICAO CIRCULAR

CIRCULAR 232-AN/139

## AIRCRAFT ACCIDENT DIGEST 1985 (No. 32)

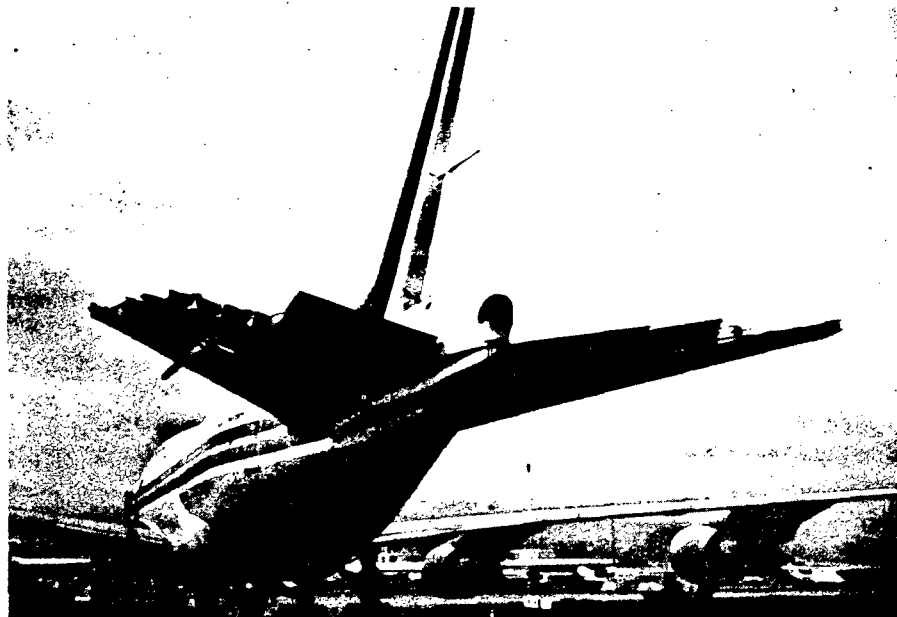
Figure 8.—Photograph of Empennage.

### **1.3 Damage to the Airplane**

The airplane was damaged substantially (see section 1.12).

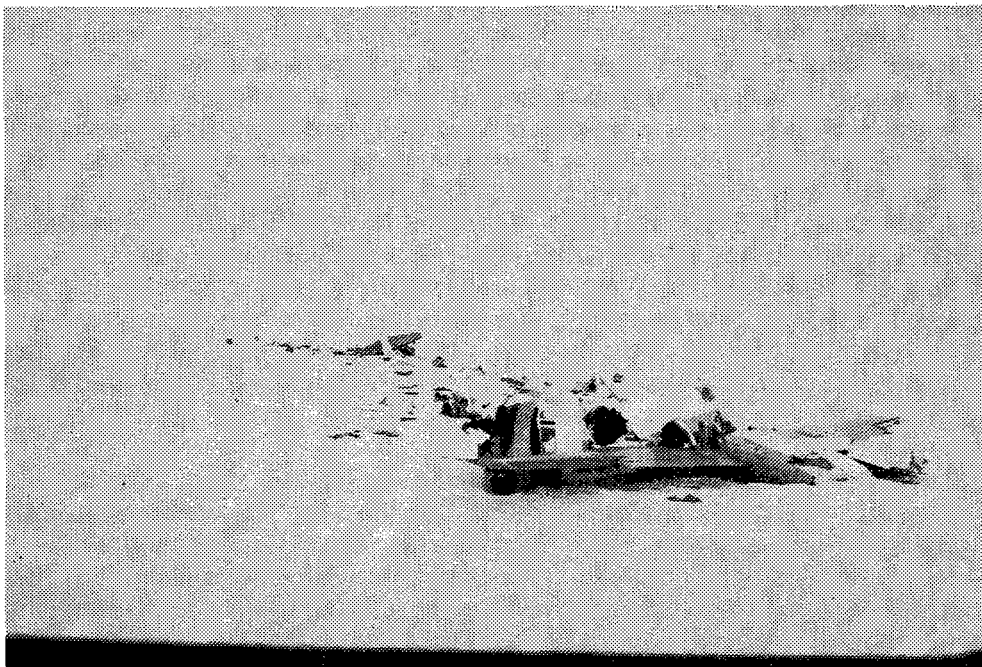
The aircraft fuselage had disintegrated and had been scattered along the wreckage path, which was approximately 190 m long in a fairly straight line on a heading of  $286^{\circ}$  magnetic. In the final impact hole wreckage parts from the lower structure of the fuselage were found. Propeller marks still visible measured about 150 cm with deeper cuts on the left side.

The left hand propeller had detached from the engine, while the right hand propeller was still attached to the engine. The tail section was found 60 m behind the final impact hole in an inverted position. From this position seats, interior material, luggage, and clothing had been spread in a narrow angle of about  $10^{\circ}$

further up to the main wreckage. The aircraft fuselage had disintegrated, and had been scattered along the wreckage path. The entire wing section had catapulted to the left of the fuselage path of travel, and had come to rest in line with the path of debris, with the engines facing inwards at a distance of 130 m, with a 40 ft section of the front fuselage belly section on top. The aircraft nose section had severed from the fuselage 1 metre aft of the flight deck bulkhead, and was resting on its left side at the end of the left wing section at an angle of almost 90°.

The underside of the cockpit section showed signs of heavy compression from impact forces. The left pilot seat had been damaged (buckled), while the right hand seat was intact. Harnesses on all seats were intact. (Appendix D).

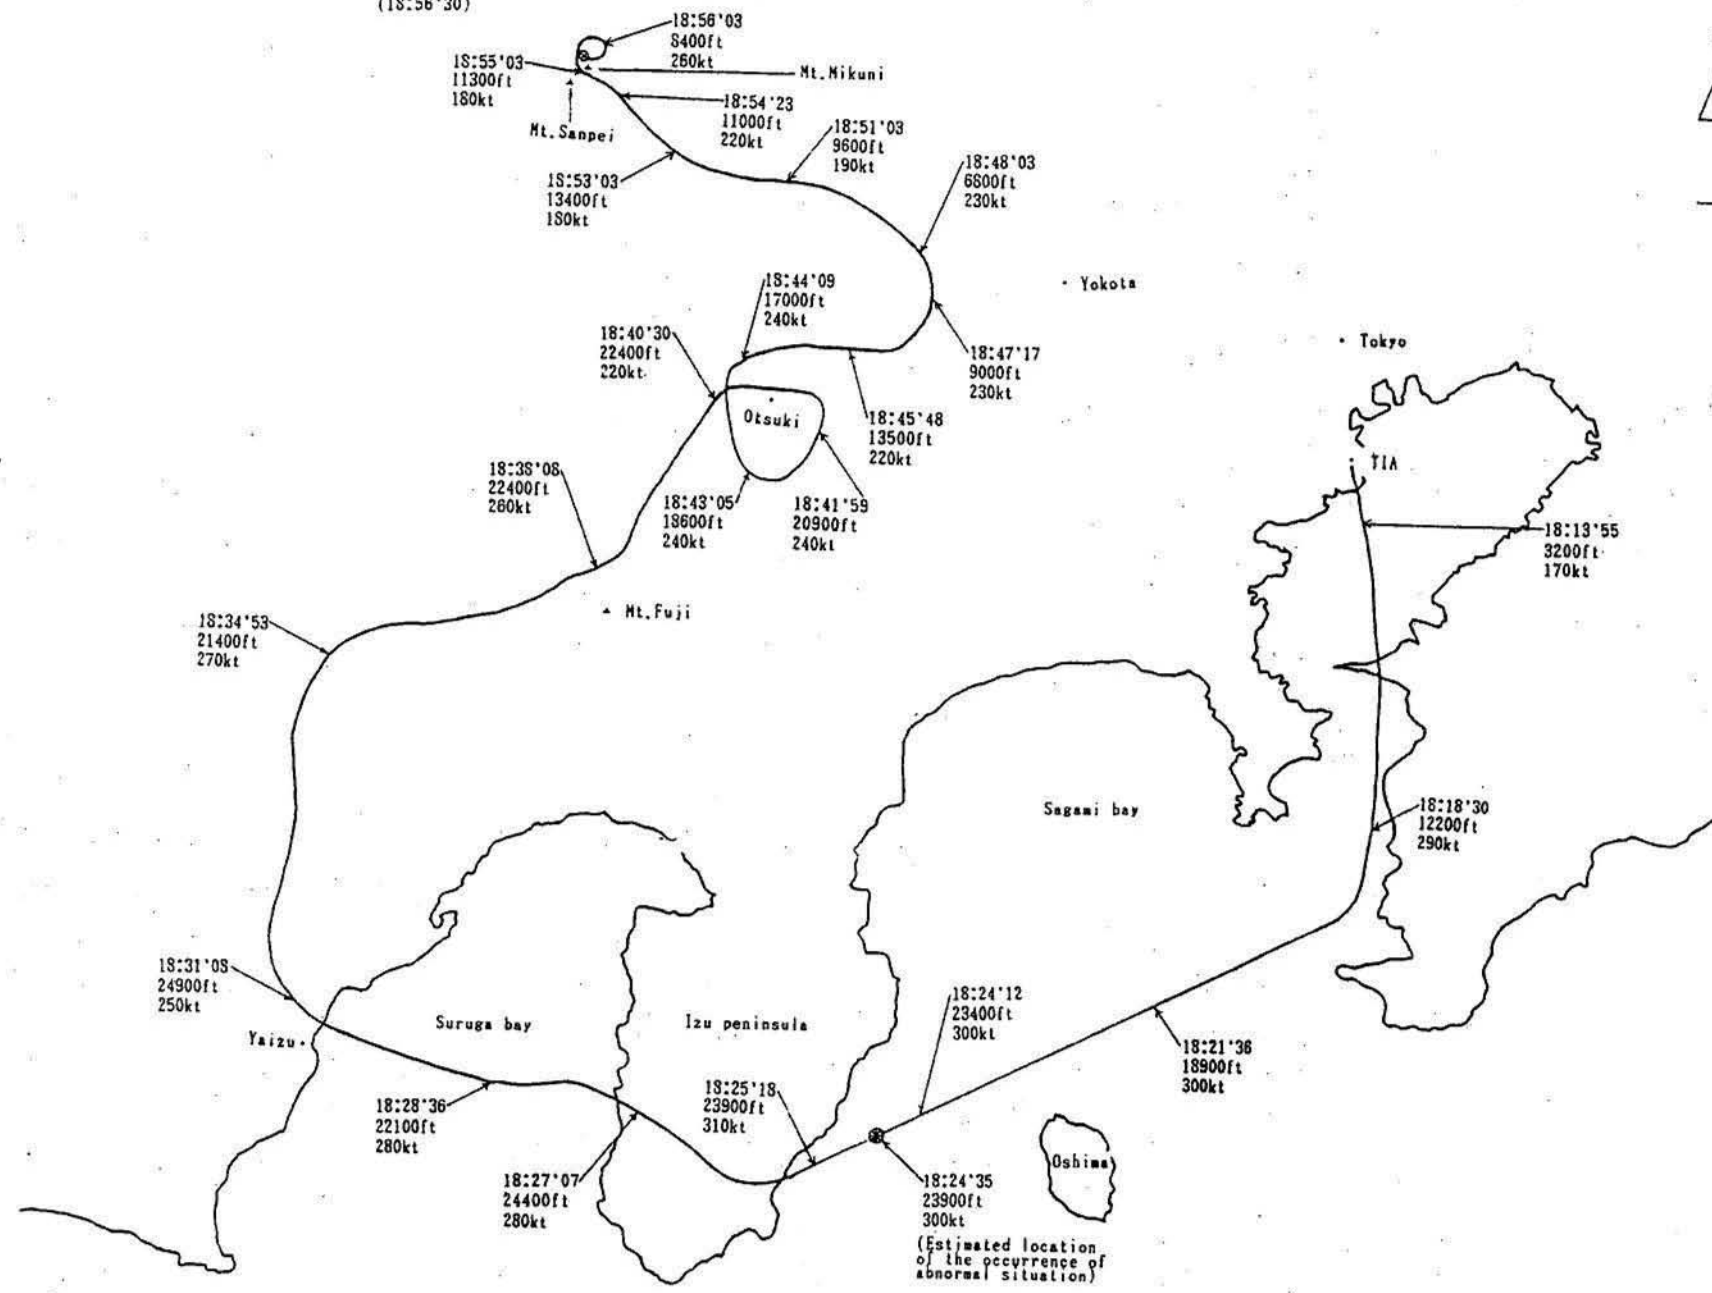
(Estimated location of the occurrence of abnormal situation)

3. In this accident, ruptures of the fuselage tail, vertical fin, and hydraulical flight control systems were caused as a chain reaction by flowout of the pressurized air due to rupture of aft pressure bulkhead. To prevent the recurrence of such situation, a study should be initiated on the addition to the airworthiness standards of the provisions concerning the fail-safe capability of peripheral structures, functional systems etc, against rupture of pressurized structural components such as the aft pressure bulkhead on a large aircraft.

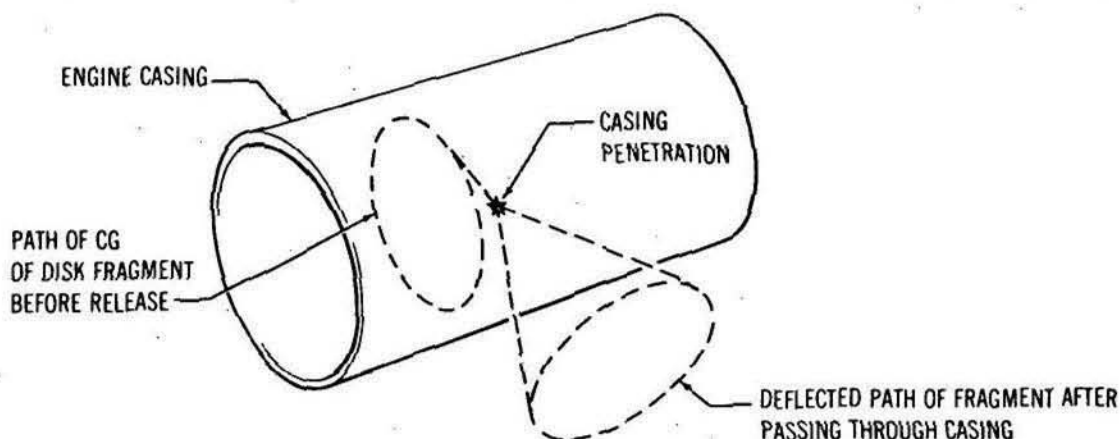
The contention that engines Nos. 1, 2 and 3, did not flame out is further supported by the following:

Using the broomstick method and relying on the Pratt & Whitney service experience, the initial trajectory of the ejected right engine spacer pieces was determined

to be at an angle of about  $20^\circ$  to the right of vertical, away from the fuselage. Based on the calculated climb performance of N100ME (50 feet per second) before the right engine failed, the pitch attitude of the aircraft was determined to be  $12^\circ$  nose-up at the moment of the failure. The engines of the DC-9-14 were mounted to the engine pylons at another  $3^\circ$  nose up. Thus, the ejected engine parts were assumed to have a rearward component, based on the rearward alignment of the engine,  $15^\circ$  nose-up horizontal. A wind factor, based on a wind from  $220^\circ$  at 17 knots, was assumed.

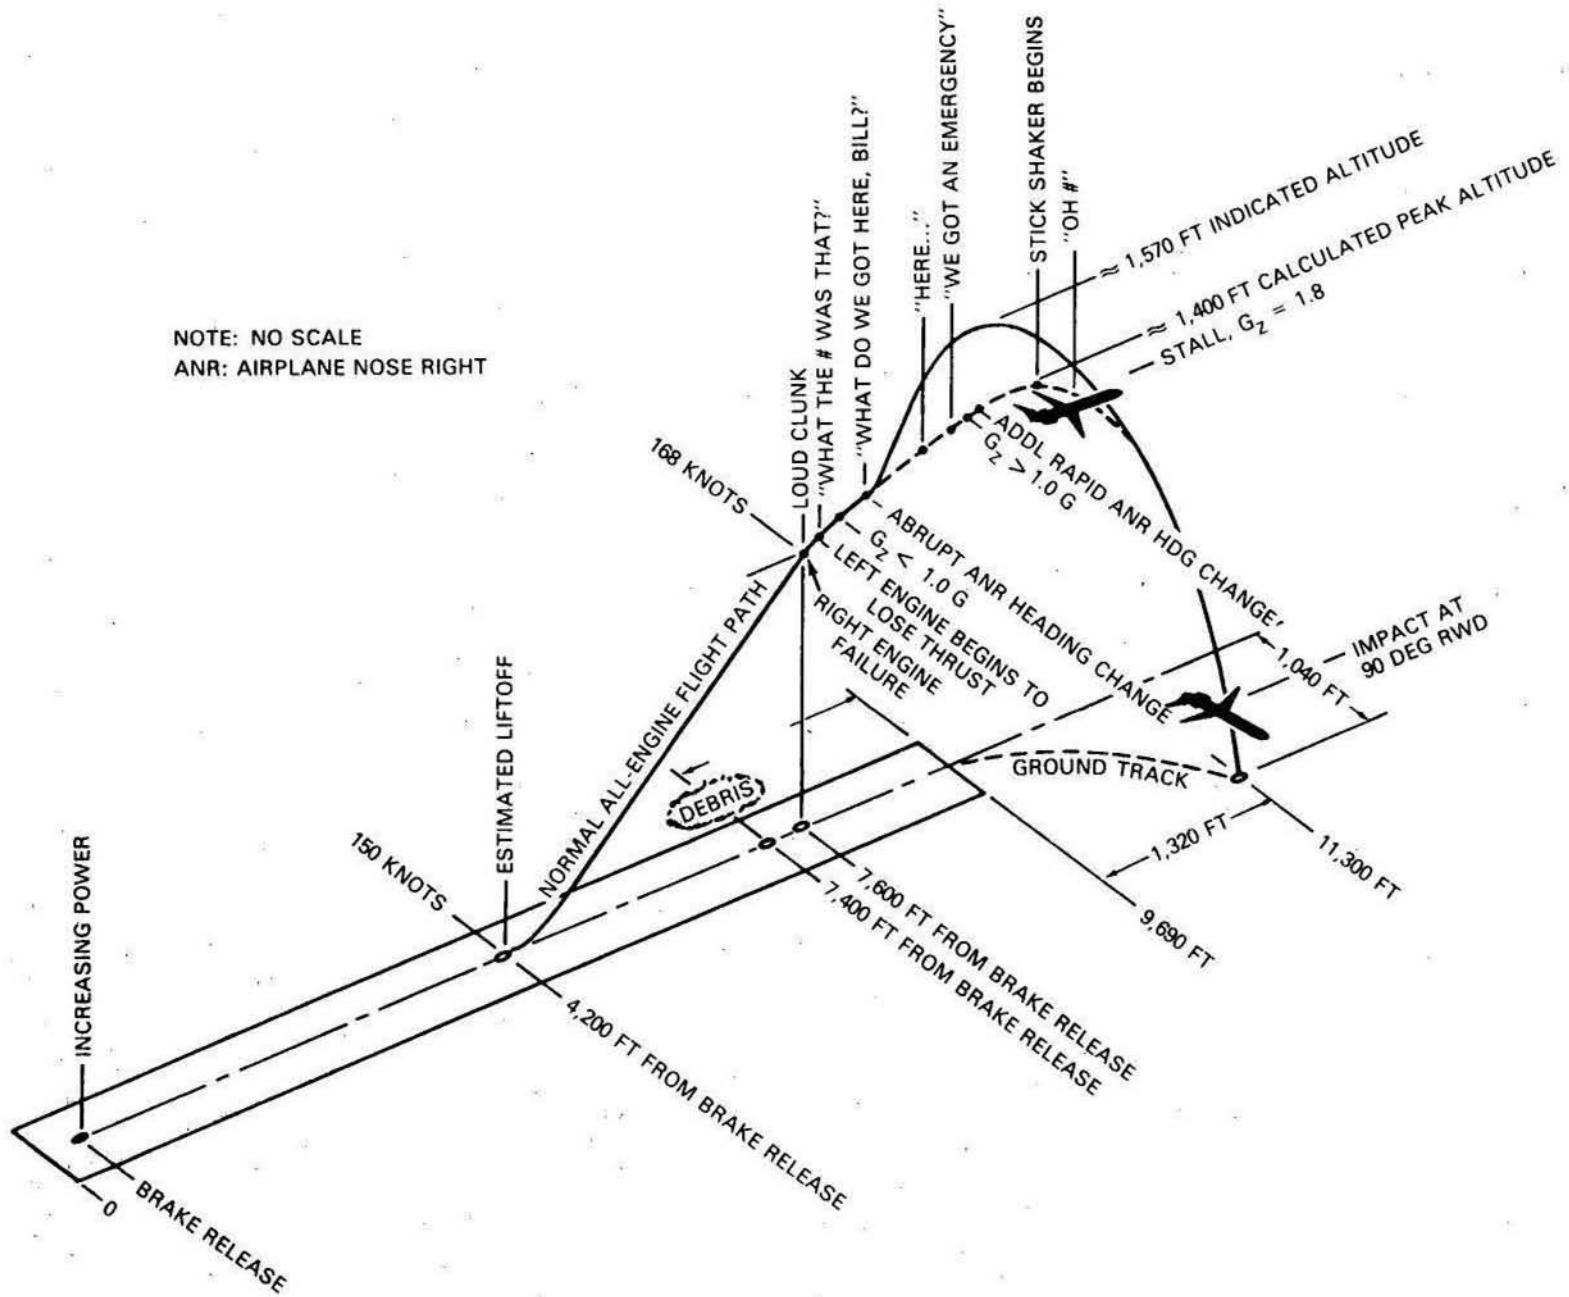
Figure 5.—Representation of the estimated flightpath and sequence of events.

The hole in the high pressure compressor in the plane of rotation of the 9-10 stage removable sleeve spacer and the damage to the compressor and spacer revealed conclusively that the spacer had ruptured in flight and that the spacer parts were not contained by the engine casing. The ejected spacer parts had ruptured the rear skirt intermediate case at the 11 to 1 o'clock position, leaving a 4-by 7-inch opening in the top of the case. The loss of the spacer and consequential damage within the right engine caused a rapid deceleration and a complete loss of thrust from that engine.

The Safety Board based its analysis of the trajectory of ejected engine parts from the right engine on the following: (1) Pratt & Whitney's experience in other incidents which involved rotor and spacer uncontained failures, (2) the research described in the D. McCarthy report, (3) the physical evidence obtained in examination of the right

engine and locations of debris at the accident site, (4) the analysis and data contained within the submissions of the parties to the Safety Board's investigation of this accident, and (5) the Safety Board's engineering analysis of the trajectory of engine parts.
