Circular 202-AN/123

AIRCRAFT ACCIDENT DIGEST 1984 (No. 31)

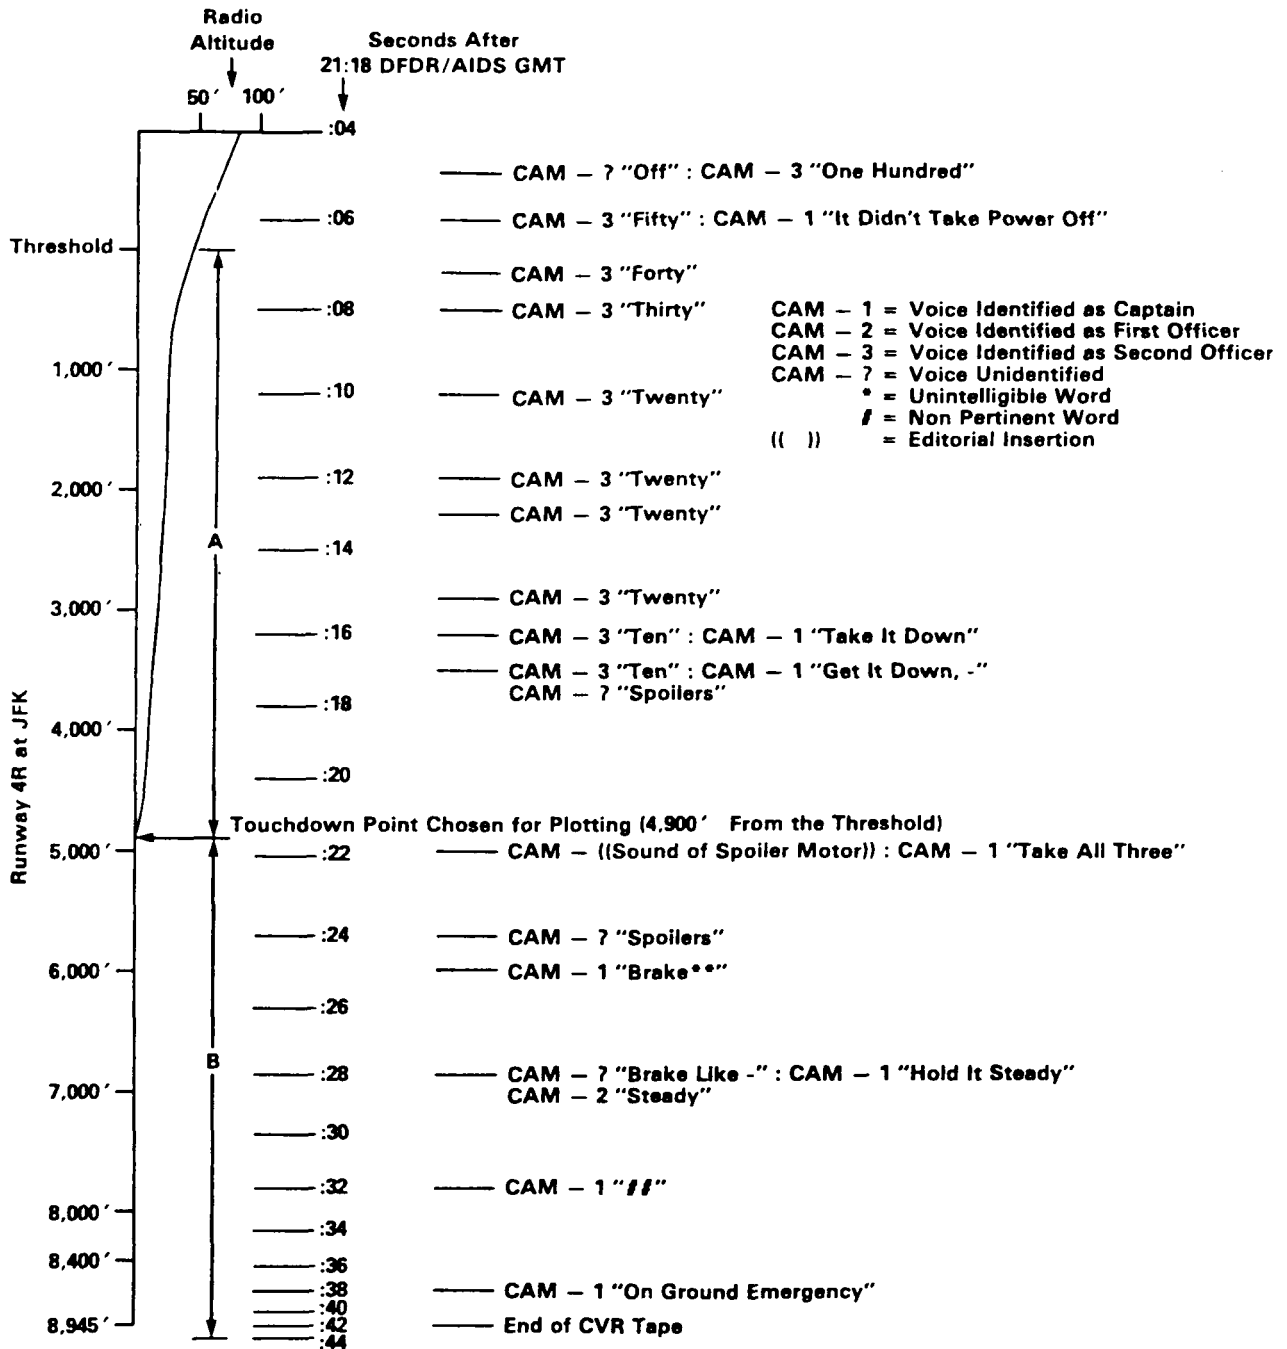
A correlation was made between the CVR cockpit conversation, radio altitude, and position over and on the runway. (See figure 4.) Because CVR times are listed to the nearest second, this correlation is only approximate.

"A" Distance Is Based on AIDS INS Ground Speed Integration From the Middle Marker to Touchdown.

"B" Distance Is Based on the DFDR Longitudinal Acceleration Integration From the Assumed Time of Impact Back to the Time of Touchdown. This Distance Is Anchored at One End to the Approximate Final Position of the Aircraft.

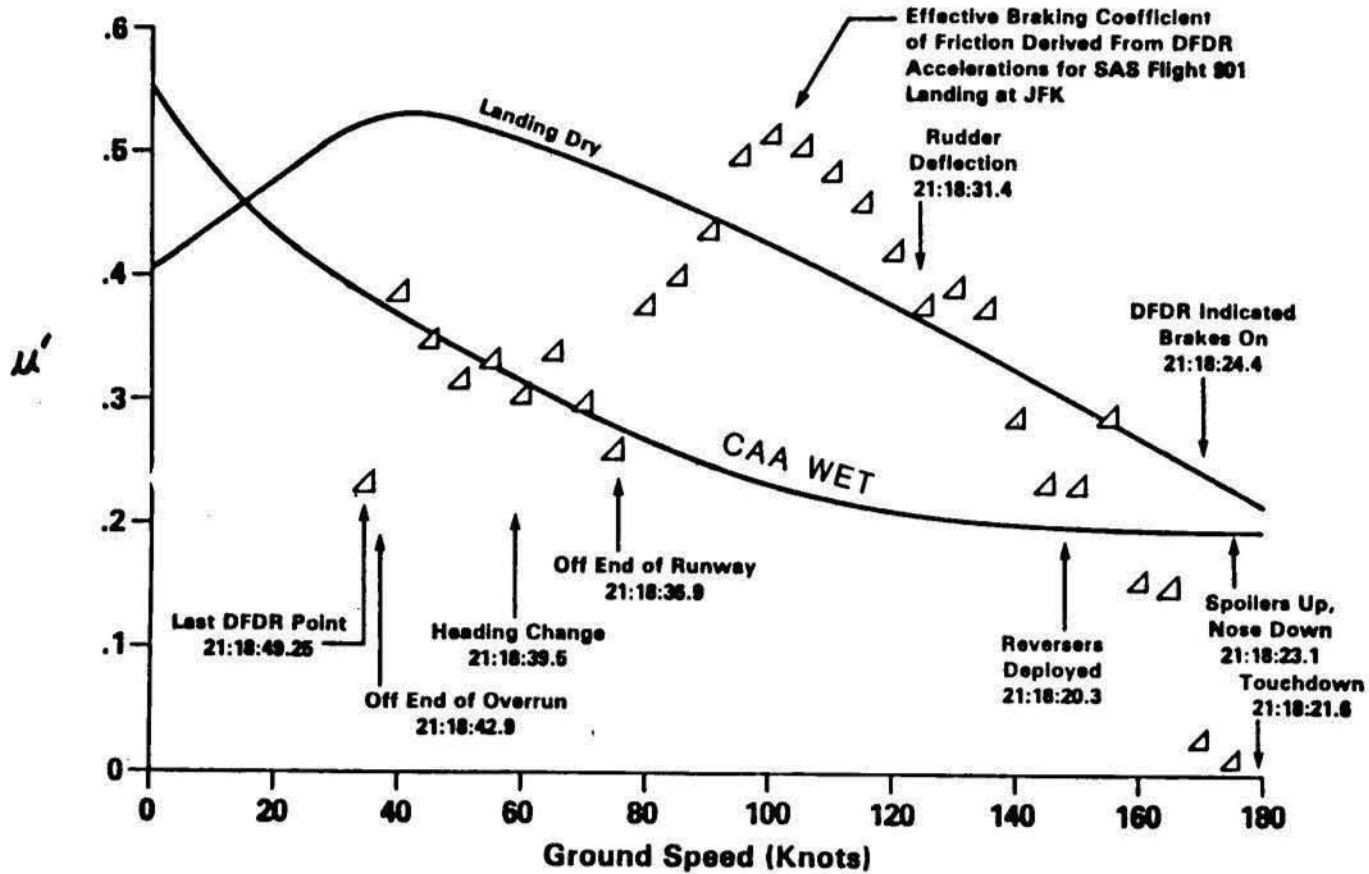
Figure 5.—Effective Braking Coefficient Derived from DFDR.

Effective Braking Coefficient Derived From
DFDR Decelerations – CF6-50 Engine
Turbine Reversers Inoperative
