CIRCULAR 24-AN/21

AIRCRAFT ACCIDENT DIGEST NO. 2

*Prepared in the Air Navigation Bureau
and published by authority of the Secretary General*

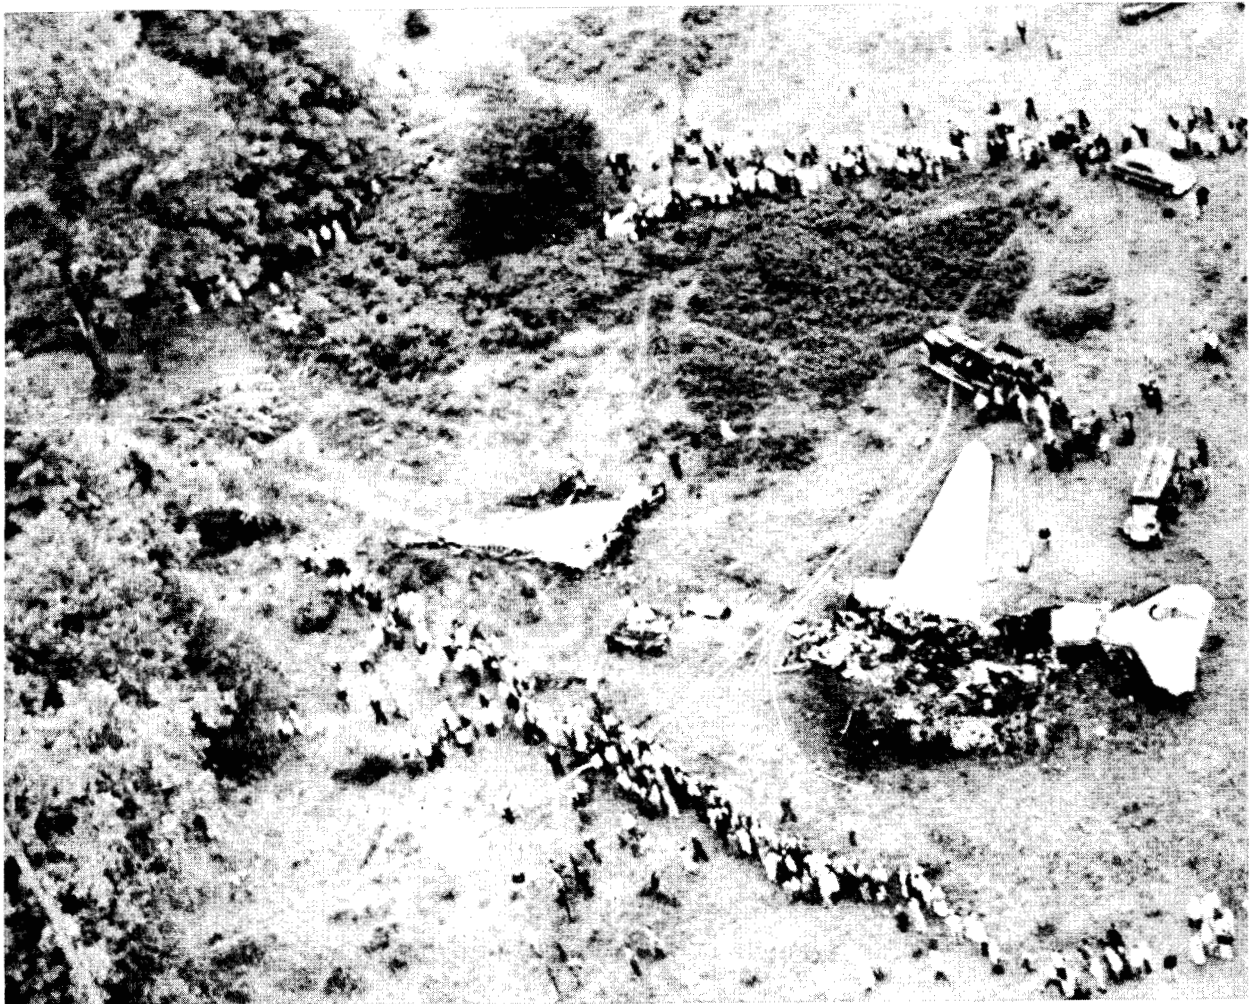
3,000 feet from take-off, parts were observed to fall from the left engine and the aircraft was seen to make a shallow turn to the left, slowly losing altitude until it struck a grove of trees 1.5 miles S.E. of the airport. Sixteen of the occupants were fatally injured and seven seriously injured. The aircraft was completely destroyed.

During the descent through the trees, the left wing separated from the fuselage, and the left engine broke free from its engine mount. The right wing and engine remained attached to the fuselage. The tail section separated at impact. Fuel from the ruptured centre section tanks spilled over the forward part of the fuselage and was probably ignited by severed electrical wiring in the radio compartment. Examination of the cockpit control quadrant revealed the left engine propeller control in the full high pitch position, and the right engine propeller control in the full high pitch position, both throttles fully forward, and both mixture controls in automatic rich. With the exception of the left engine and left engine cowling, there was no evidence of structural failure of any components of the aircraft's structure or remaining engine.

Examination of the left engine and propeller disclosed that the propeller was in the full feathered position, and that the entire engine cowling and No. 9 cylinder had separated and fallen from the engine during flight approximately 3,200 feet from the point of take-off. When disassembled it was found that the inside of the crank case main section was badly mutilated as a result of the movement of broken parts. The primary cause of the loss of power of the left engine was due to the cracking of the No. 1 piston pin. The failure occurred in the inside diameter and approximately mid-way longitudinally of the piston pin. The inside diameter of the pin was not case hardened or carburized and was, therefore, more susceptible to fatigue.¹⁾ When the piston pin cracked, it began a rocking motion which imposed excessive loads on the master rod and piston pin bushing. The pin then separated from the master rod and broke into several pieces.

1) Since the accident, Robinson Airlines has installed carburized piston pins in all of its aircraft which will tend to prevent this type of failure.

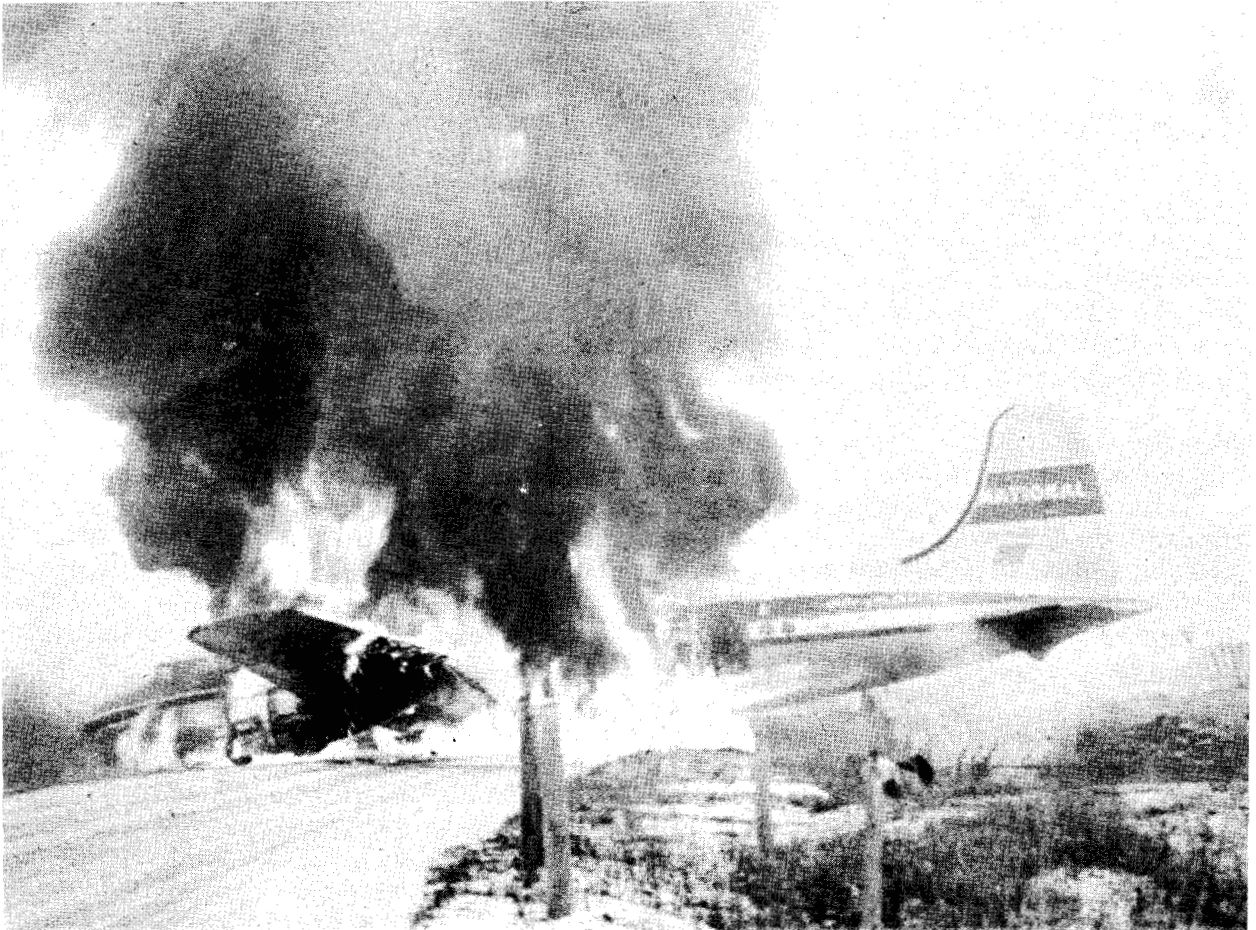
A survivor of a National Airlines plane wreck, at International Airport, Philadelphia, Pa., Jan. 14, clammers from the ditch seconds after the blazing plane came to a stop on a road adjoining the airport. Another person is dimly visible in the doorway of the plane's cabin as fire, fed by high-octane gasoline, spreads from the front of the ship. This picture was taken by an amateur photographer near the spot as the plane crashed. (Wide World Photo).
