ICAO

CIRCULAR 31-AN/26

AIRCRAFT ACCIDENT DIGEST NO. 3

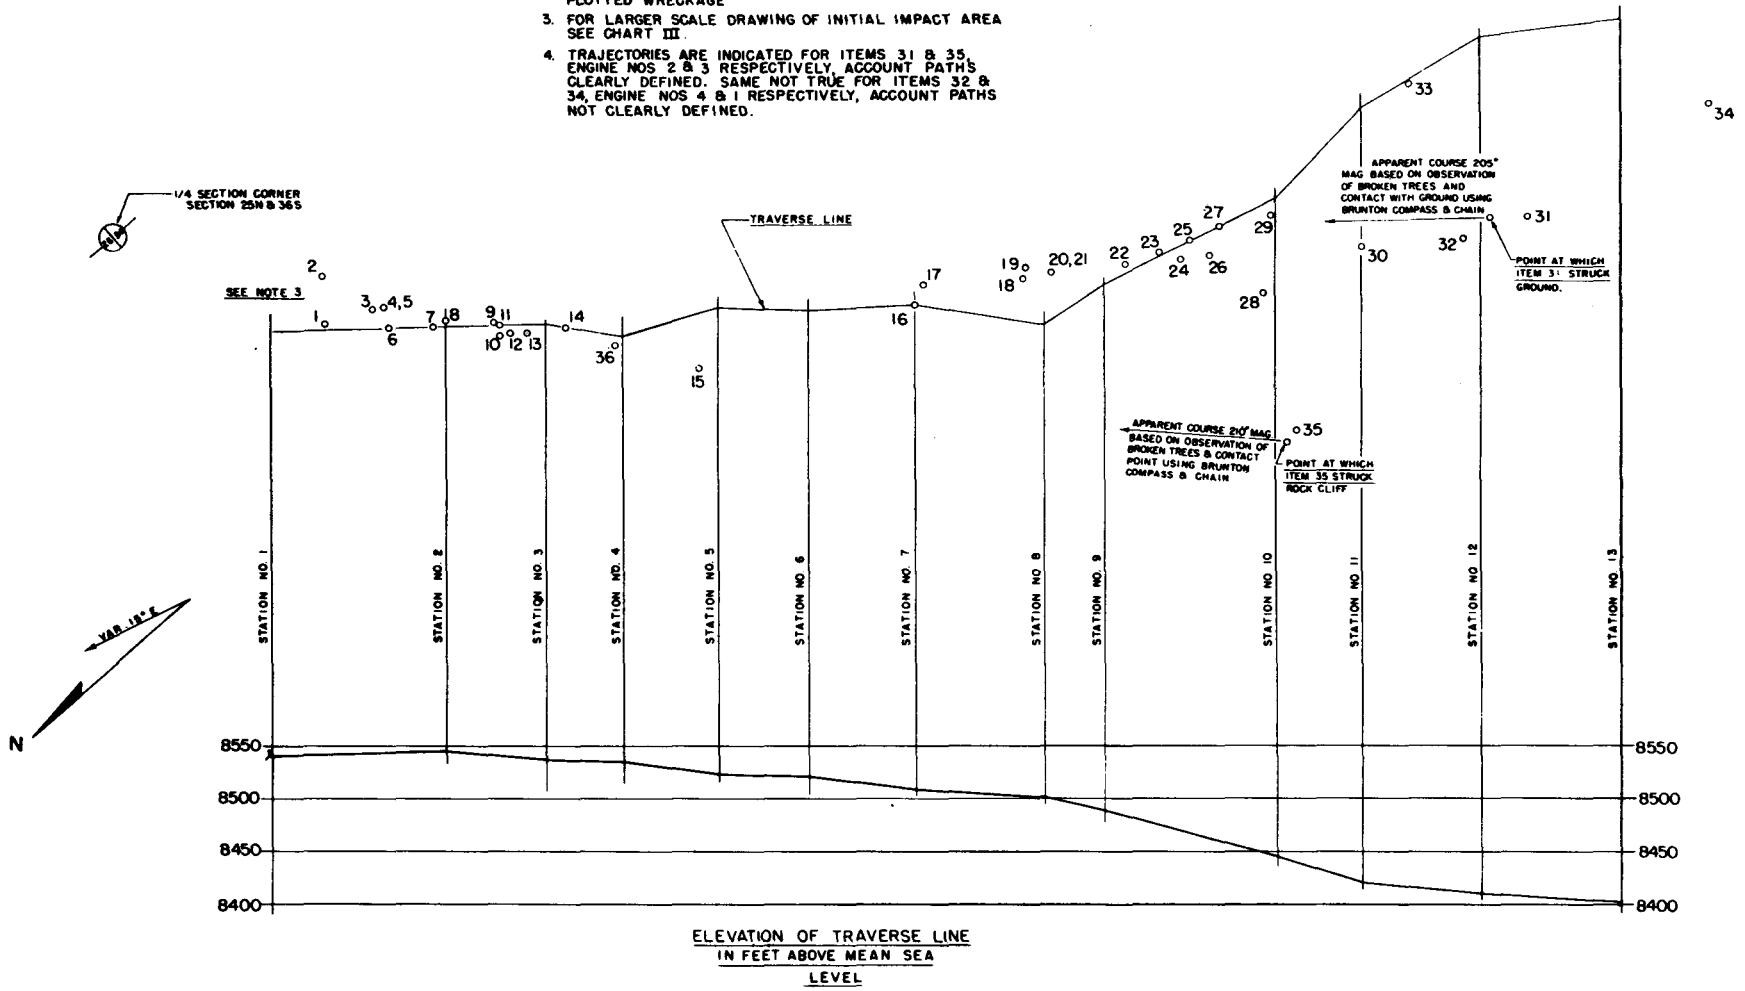
CHART III-INITIAL IMPACT AREA
 UNITED AIR LINES ACCIDENT
 DC-6 N37543 AT CRYSTAL MOUNTAIN
 NEAR FORT COLLINS, COLORADO, JUNE 30, 1951

SECT. A-A
 ROTATED APPROX 70° C
 SECTION REPRESENTS LOWER SURFACE
 OF DC-6 AIRPLANE FROM WING TIP TO
 WING TIP AND ITS DISPLACEMENT FROM
 A LINE PARALLEL TO HORIZON AS
 DETERMINED FROM BROKEN TREE TOPS.

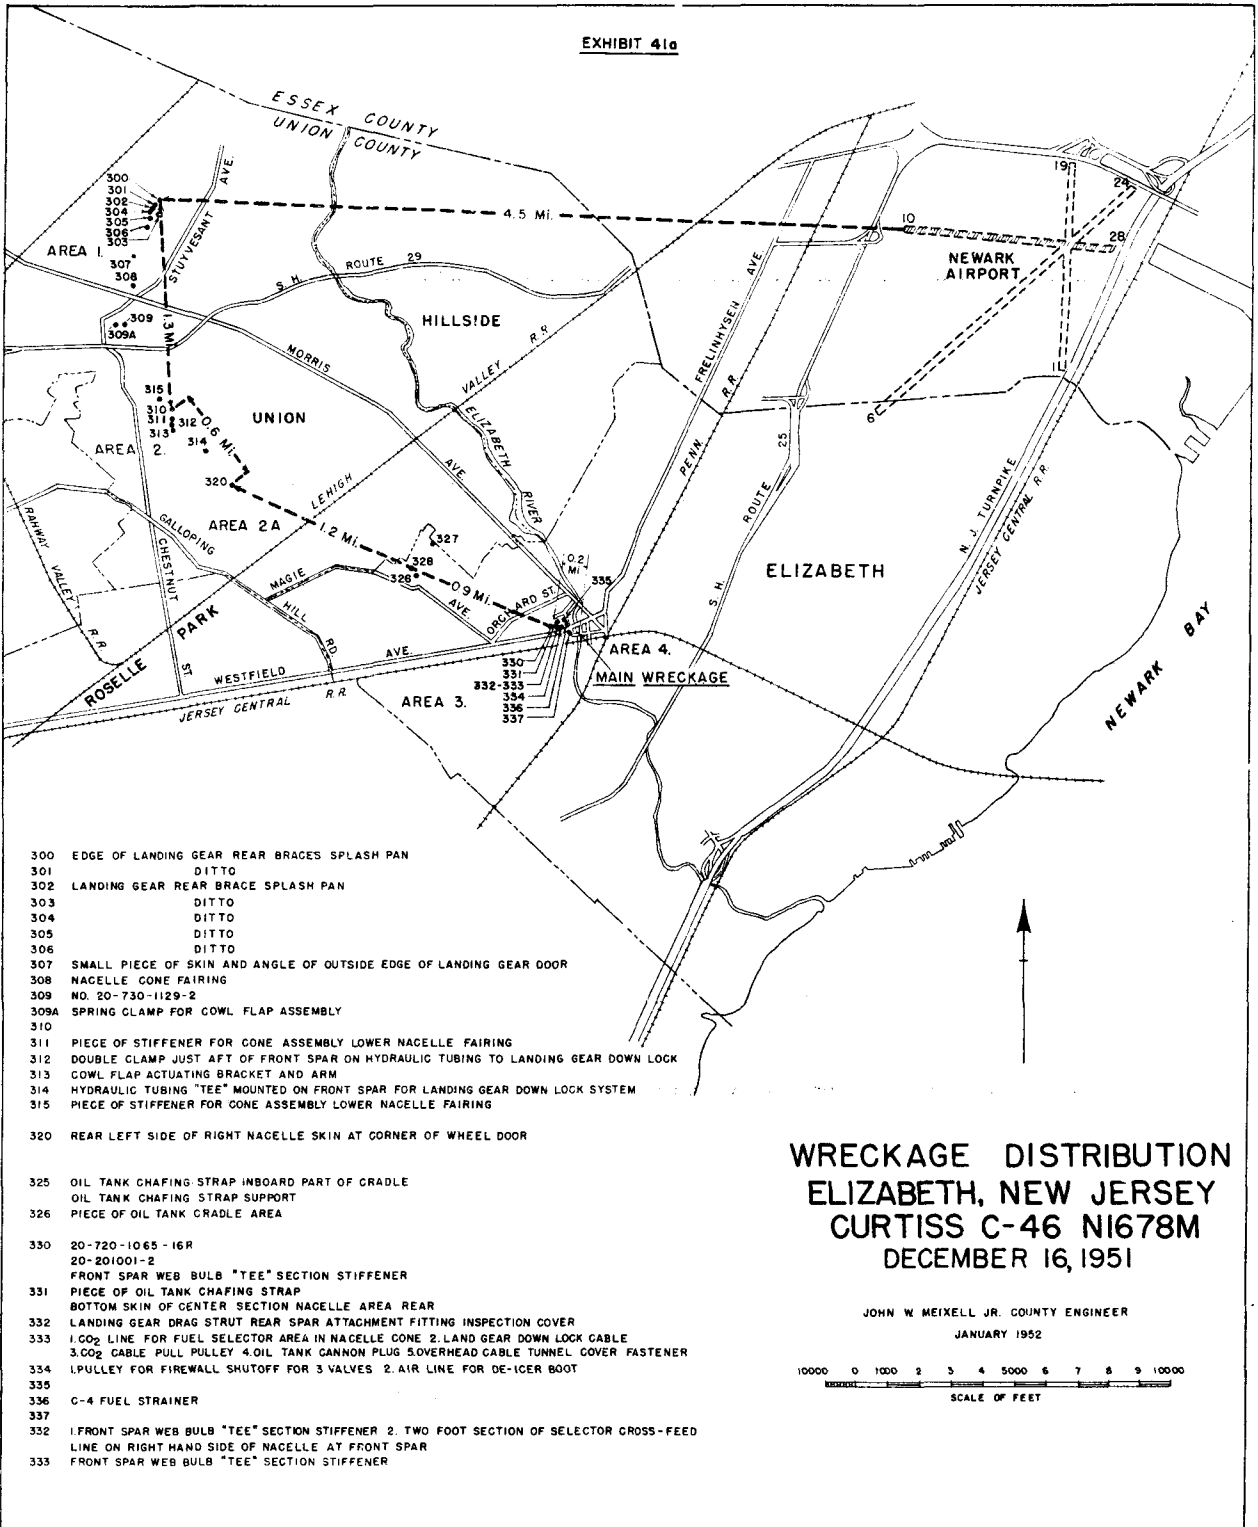
EXHIBIT 401
AIRCRAFT ACCIDENT - ELIZABETH, N. J., 12-16-51
MIAMI AIRLINE, INC. - C46-F NI678M
FIRE PROPAGATION (RIGHT ENGINE)
PROBABLE FLIGHT PATH BASED ON DISTRIBUTION OF WRECKAGE
AND OBSERVATIONS OF WITNESSES

The Board determines that the probable cause of this accident was a stall with the landing gear extended following a serious loss of power from the right engine. This power loss was caused by the failure of the hold-down studs of the No. 10 cylinder, precipitating a fire in flight which became uncontrollable.

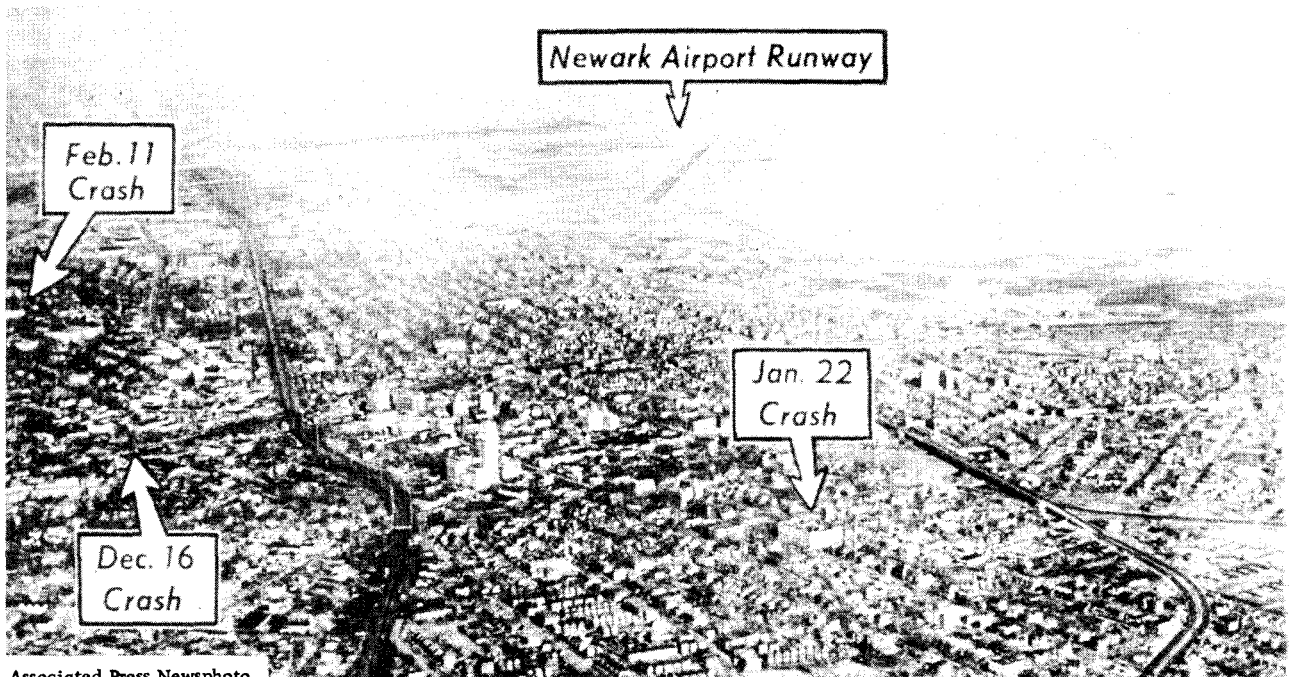
No. 1, 2 and 3 Crashes. Air view of Elizabeth showing Newark Airport in the background. For 23 years aircraft operated from this airport without an accident in Elizabeth until these three occurred within two months. The Jan. 22 accident was 1-1/2 miles from the site of the Feb. 11 crash.

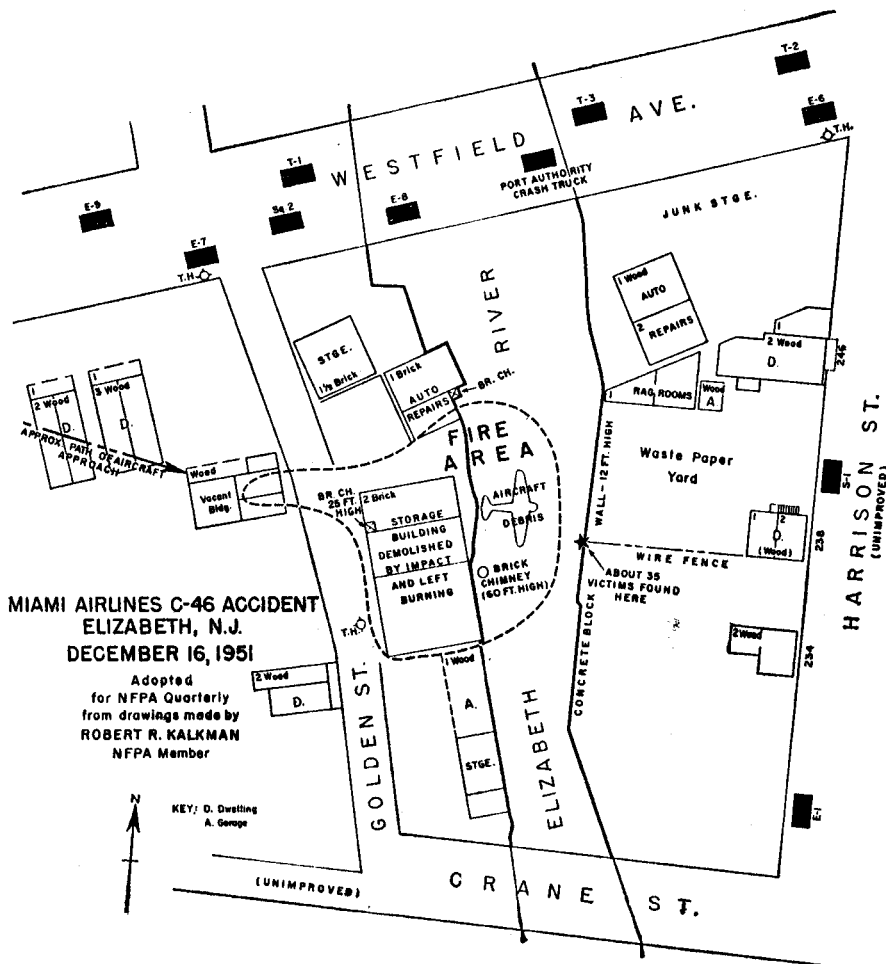
Figure 1

The C-46 was out-of-control when it began its sharp descent, a wing having failed in flight. The aircraft struck a corner of an unoccupied frame building, demolished a two-story brick storehouse, overturned and landed on its back in two feet of water near the east bank of the Elizabeth River. (See Figure 1)

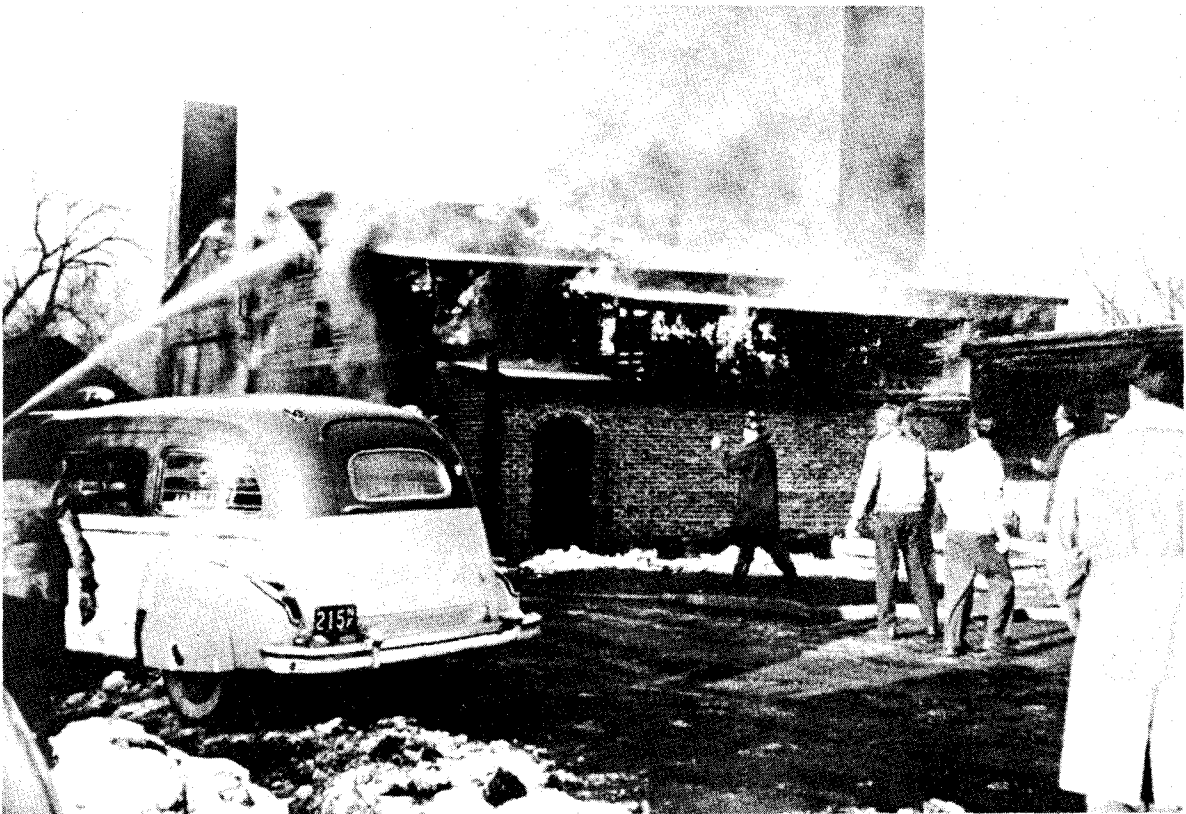
No. 1 Crash. The C-46 crashed into this storehouse (a former Pumping Station) causing a severe fire and its almost total destruction. The fuselage main section came to rest a few feet beyond on the edge of the Elizabeth River.

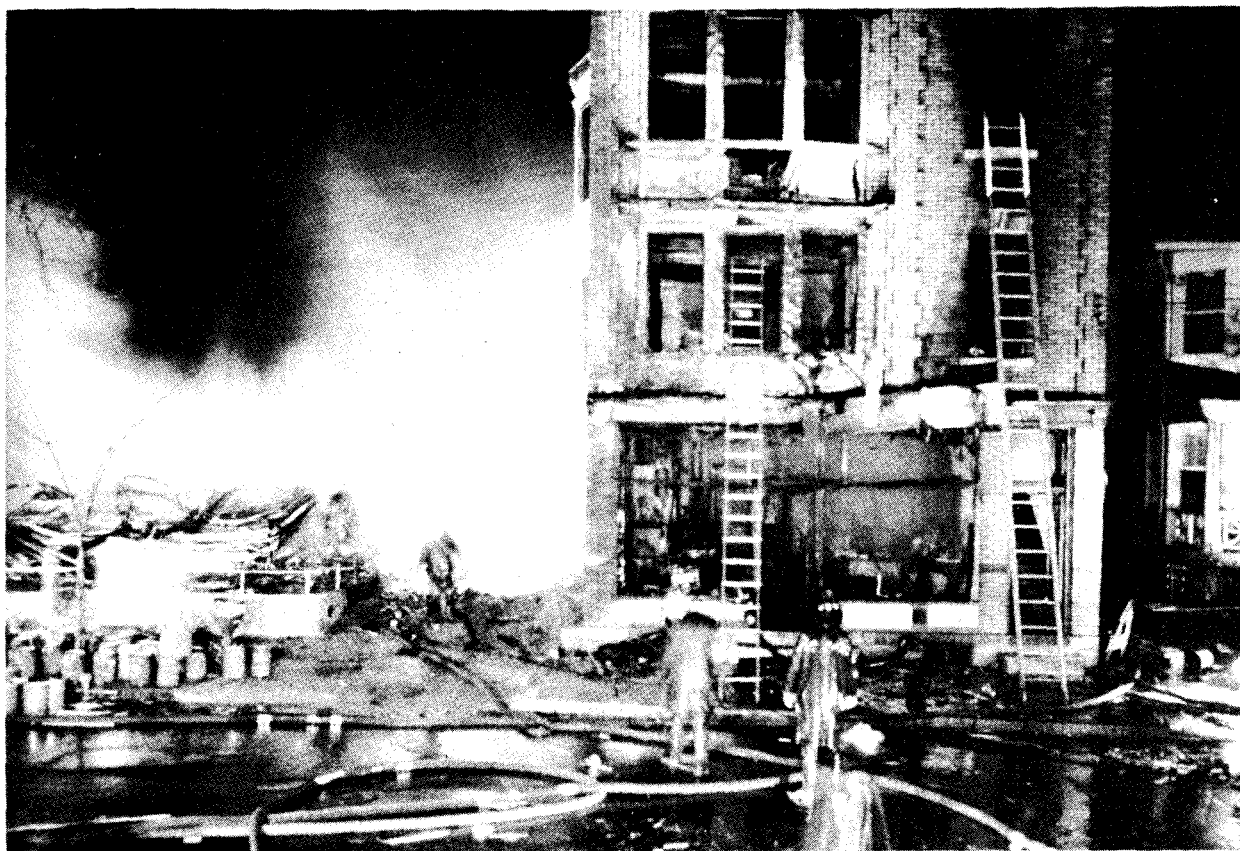
No. 2 Crash. Close up of the main fire area shows how the brick store was gutted and the dwelling initially struck flattened. To the extreme right, it will be observed that this seriously exposed dwelling was protected from fire damage on the ground floor level. The attic floor to the rear was brushed by the aircraft and set afire but the Fire Department succeeded in preventing spread.

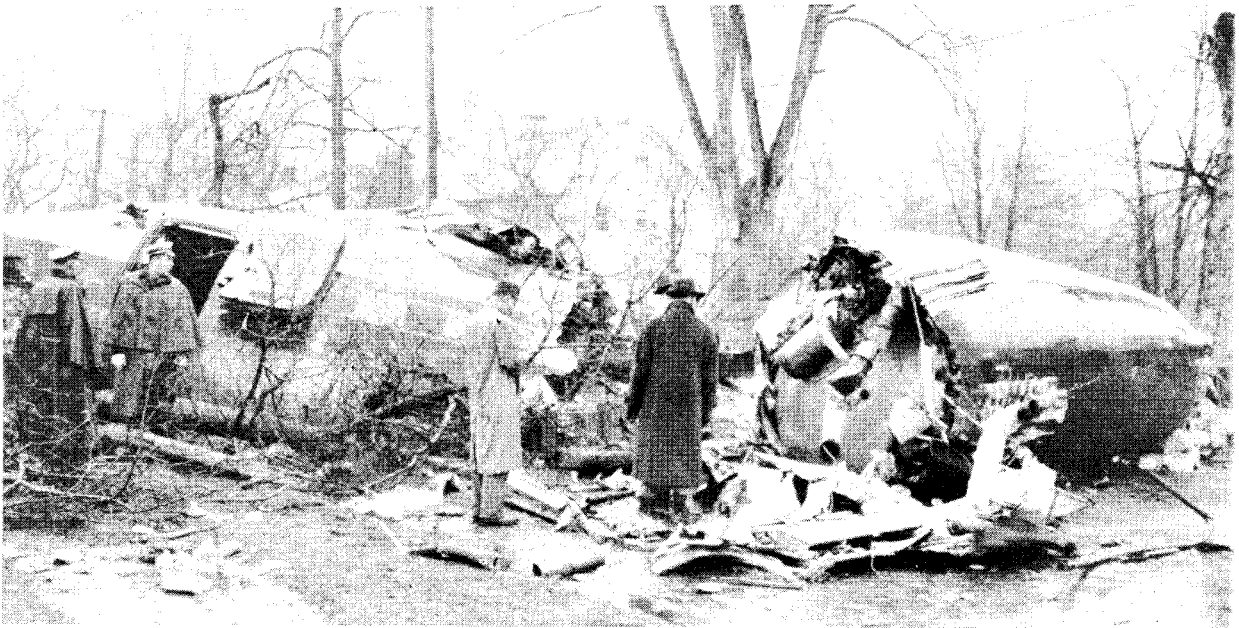
No. 3 Crash. The unburned portion of the fuselage where the survivors were located. This section came to rest after breaking the trunk of a three-foot diameter tree. Those who escaped apparently had their seat belts attached.

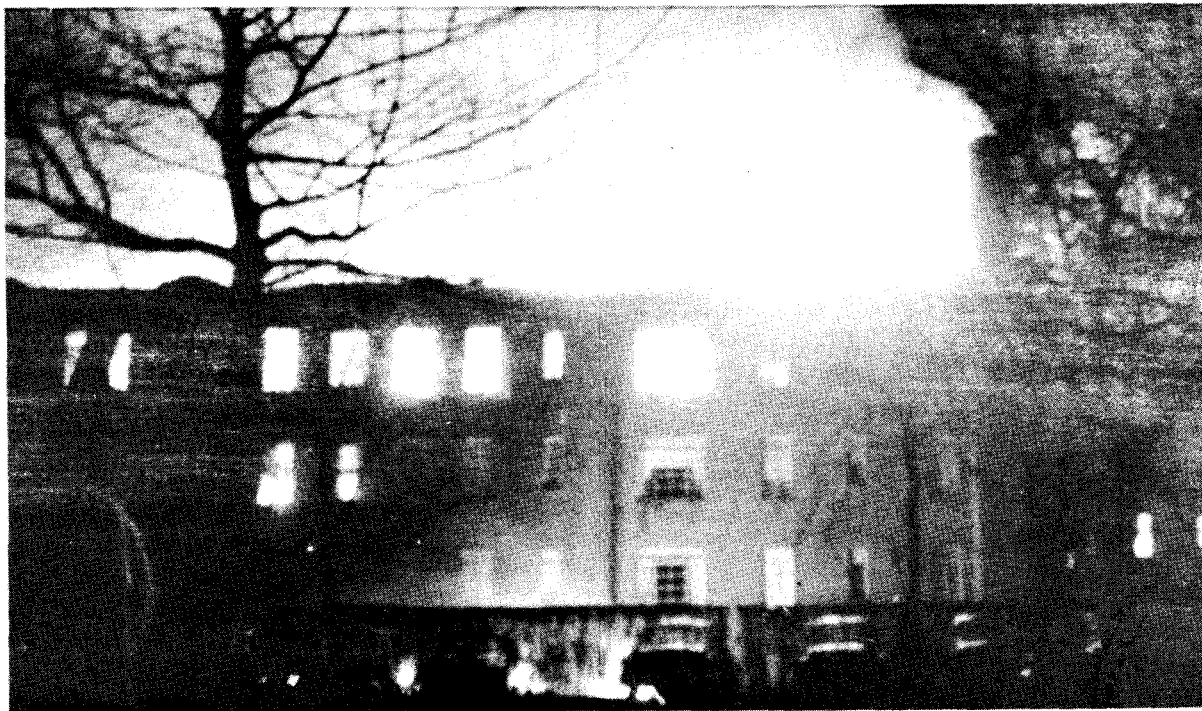
No. 3 Crash. The burning apartment house which the DC-6 struck looks totally involved but actually only six apartments were severely damaged. The dropping of a wing in the apartment courtyard containing over 2 000 gallons of gasoline complicated fire fighting activity. Four occupants of the apartment lost their lives.

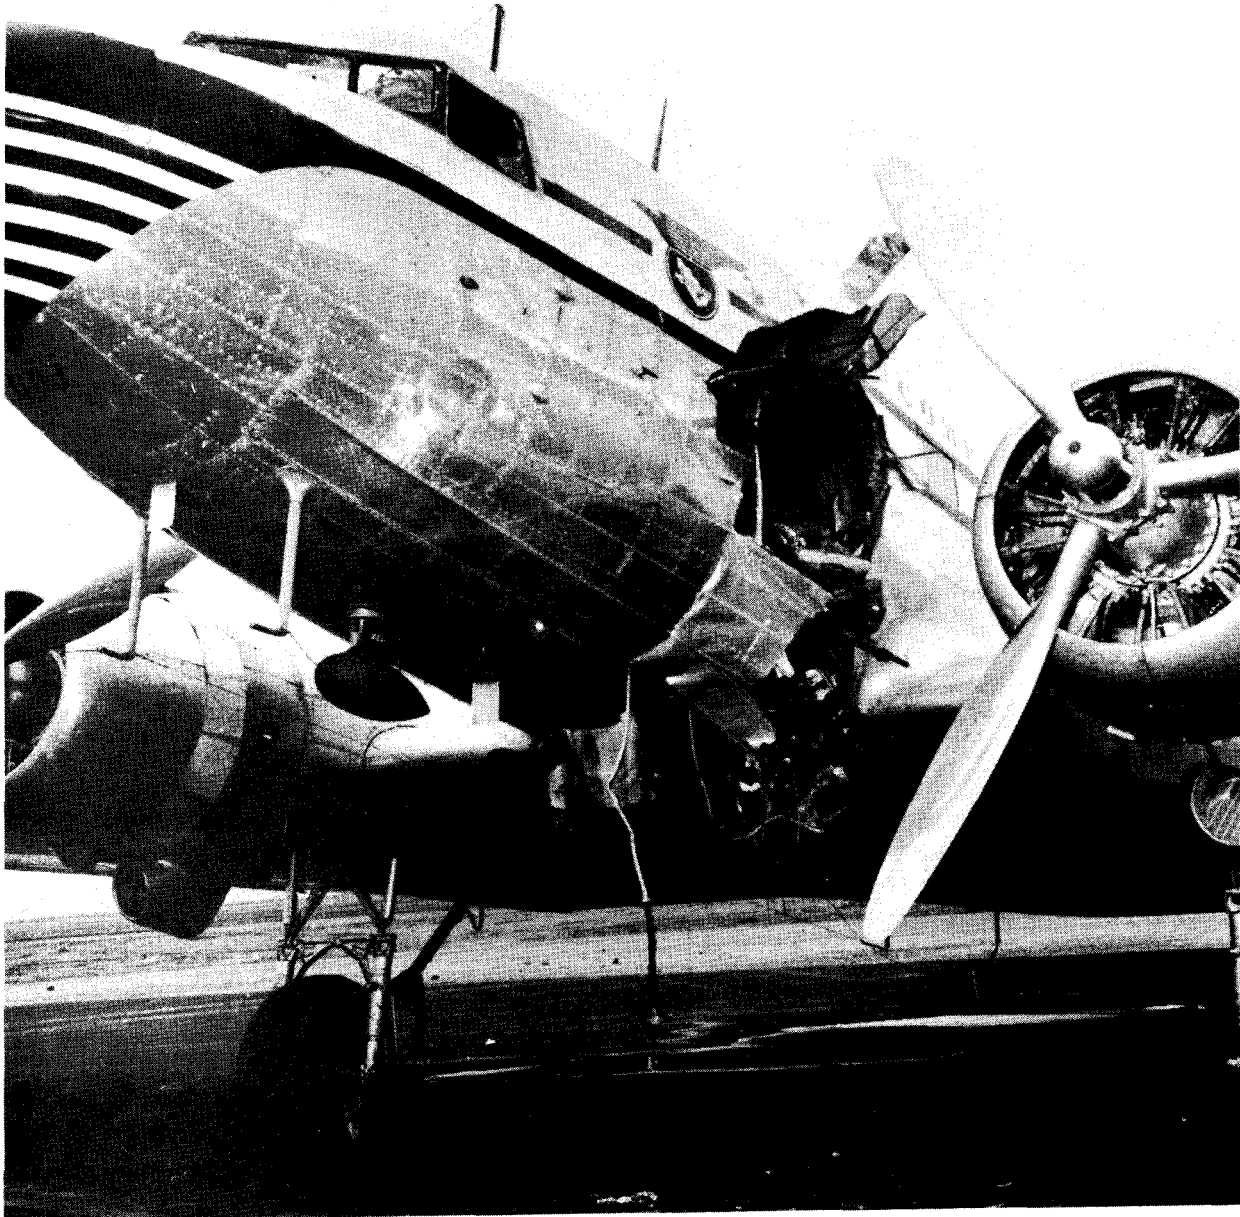
Dangerous Practice

Mexico City: A DC-3 of Compañía Mexicana de Aviación, with seventeen passengers aboard, forced landed at a military aerodrome shortly after the explosion of a time-bomb in a suitcase placed in the forward luggage compartment of the aircraft. The pilot, luckily delayed fifteen minutes in take-off, was over the military field when the explosion occurred and was able to land the crippled ship safely. Note the damaged windshield in the pilot's compartment in the photograph.
