ICAO

CIRCULAR 38-AN/33

AIRCRAFT ACCIDENT DIGEST NO. 4

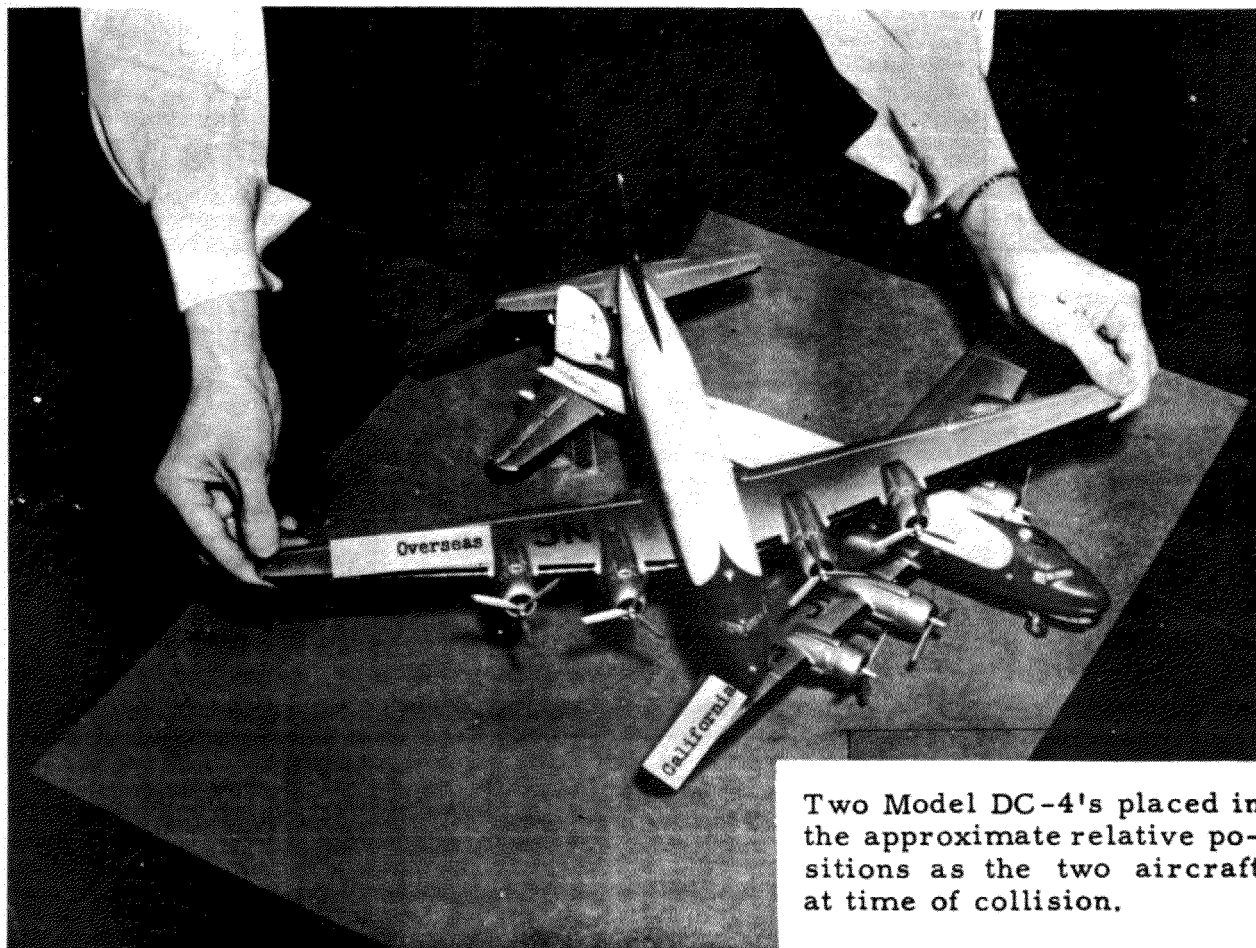
Two Model DC-4's placed in the approximate relative positions as the two aircraft at time of collision.

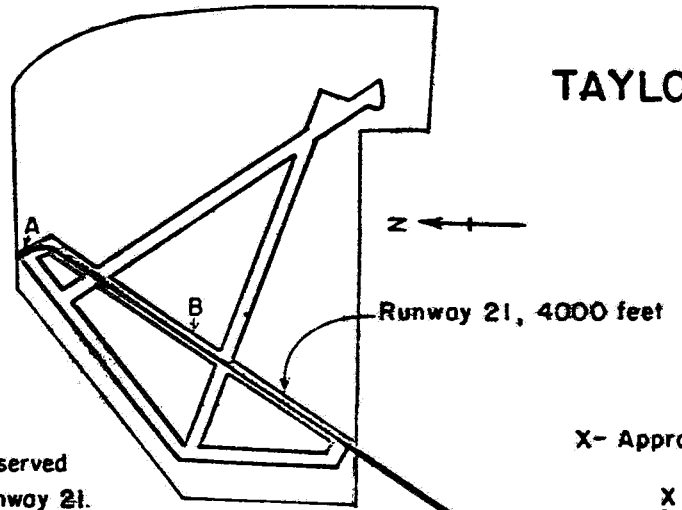
TAYLOR FIELD, OCALA, FLA.

A - Point where L4-J was observed to turn into Runway 21.

B - Point where L4-J was observed passing southwest down Runway 21.

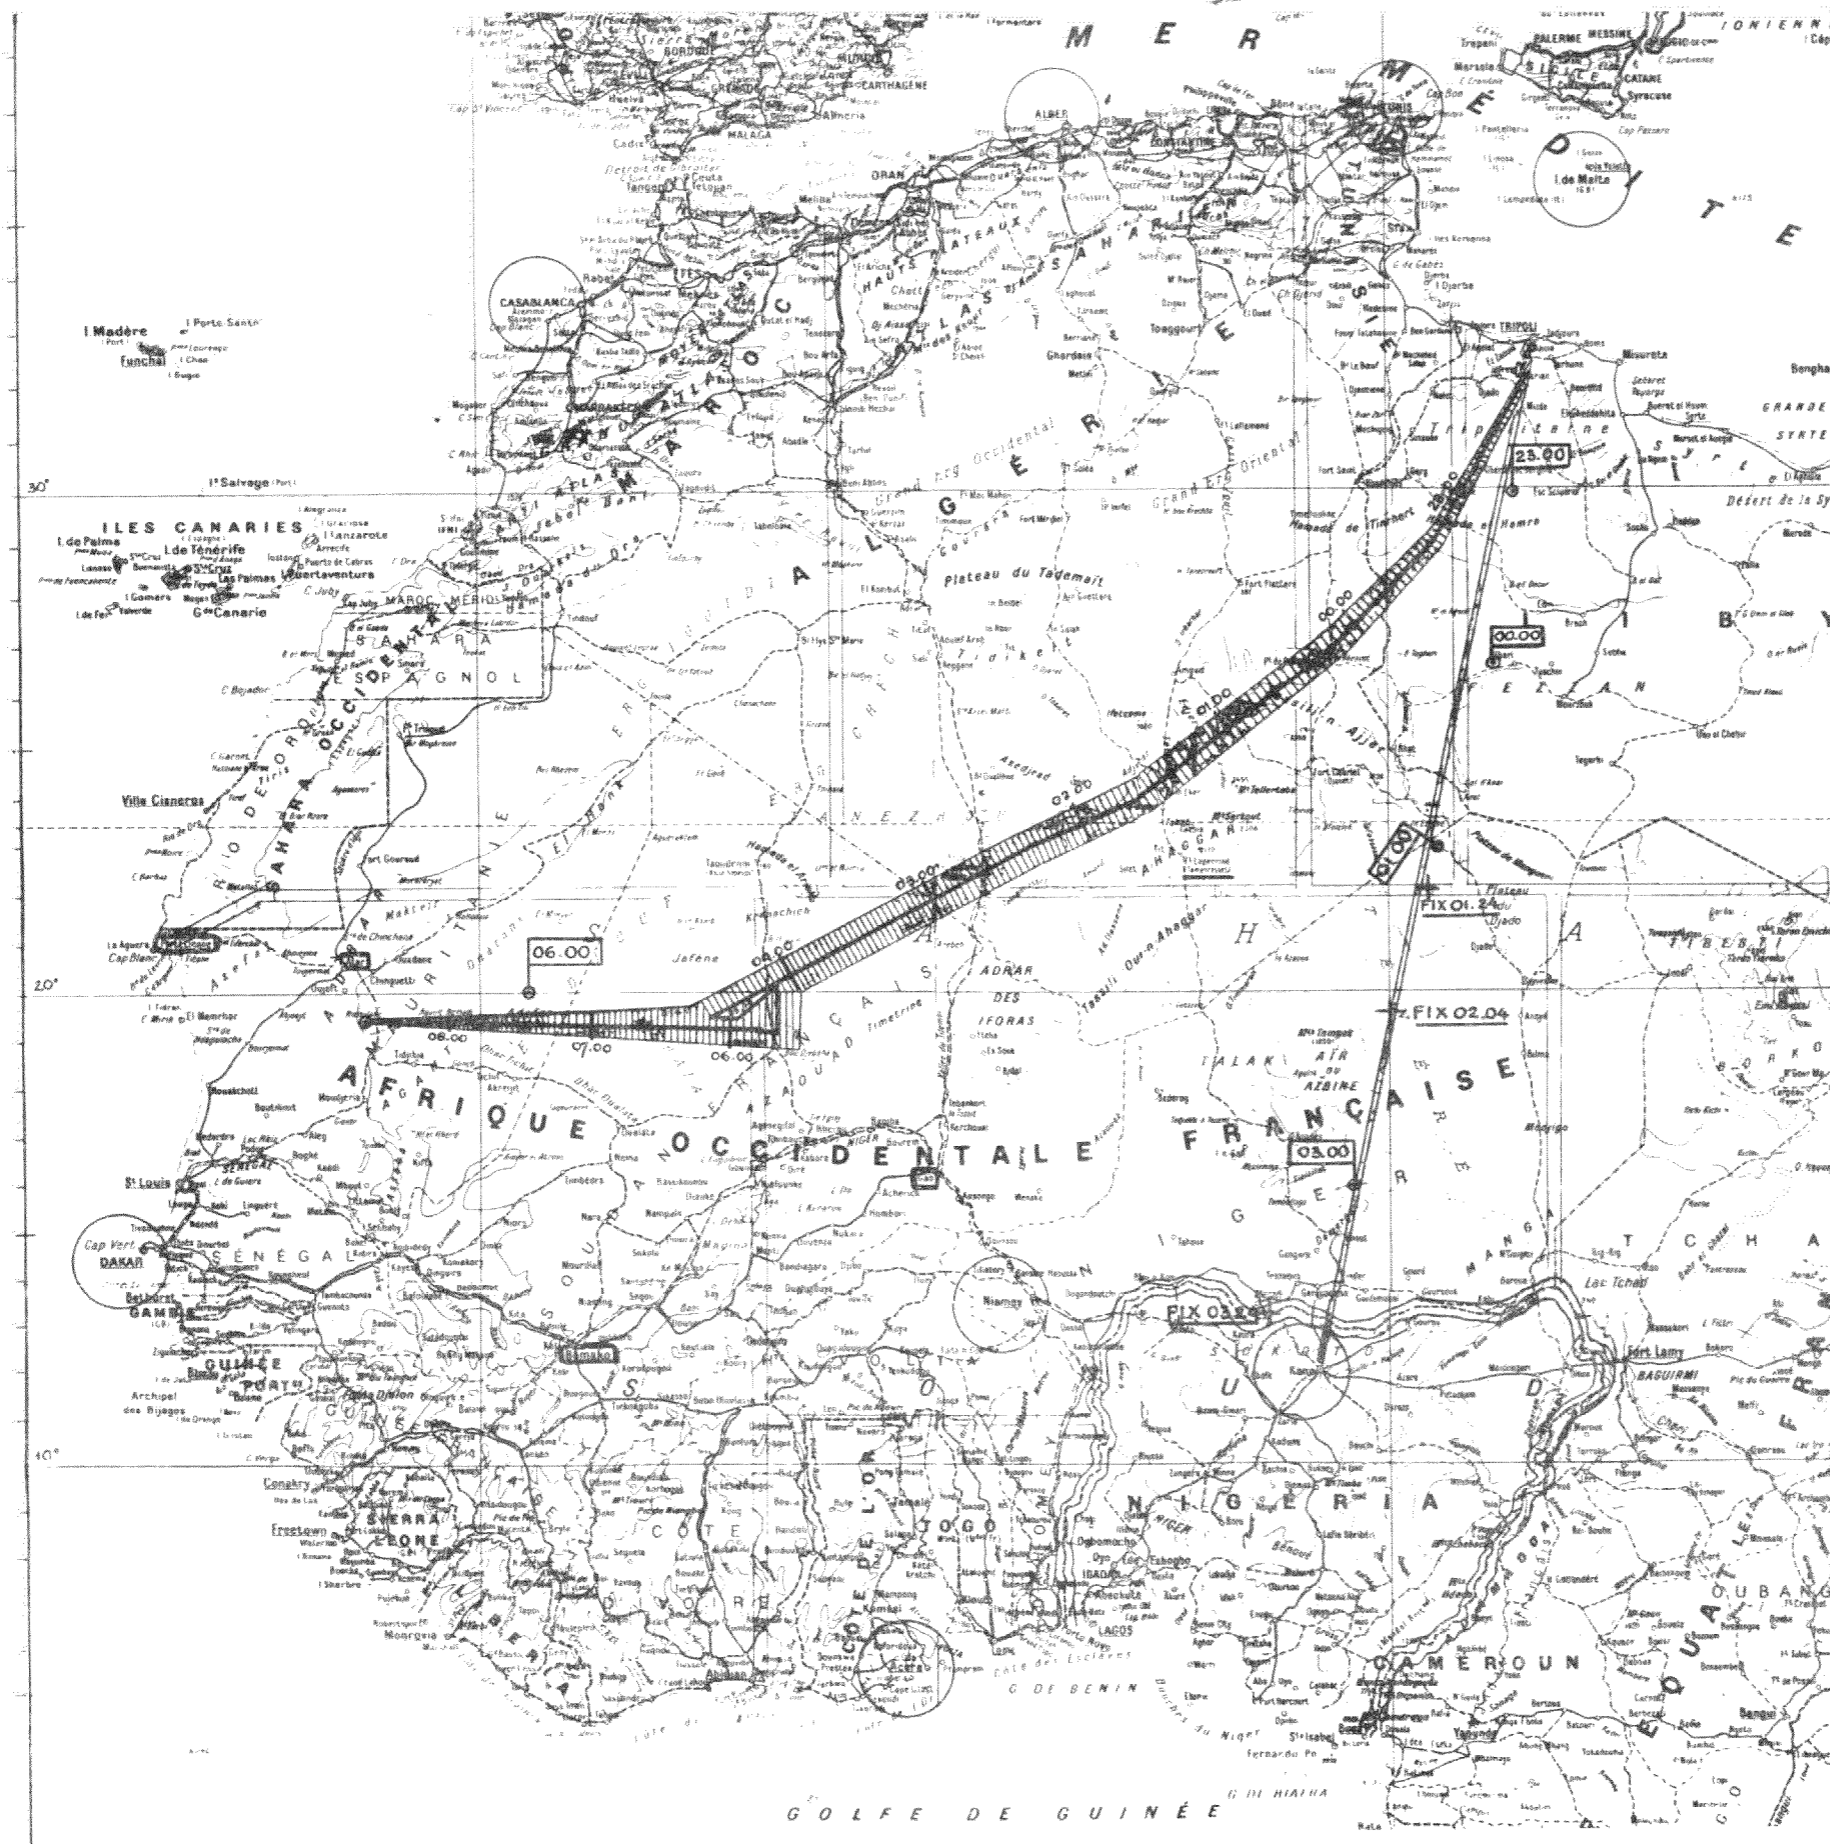
18. CHART SHOWING ROUTE FLOWN

Flight by the Hermes aircraft G-ALDN which was involved in an accident on 26th May, 1952.

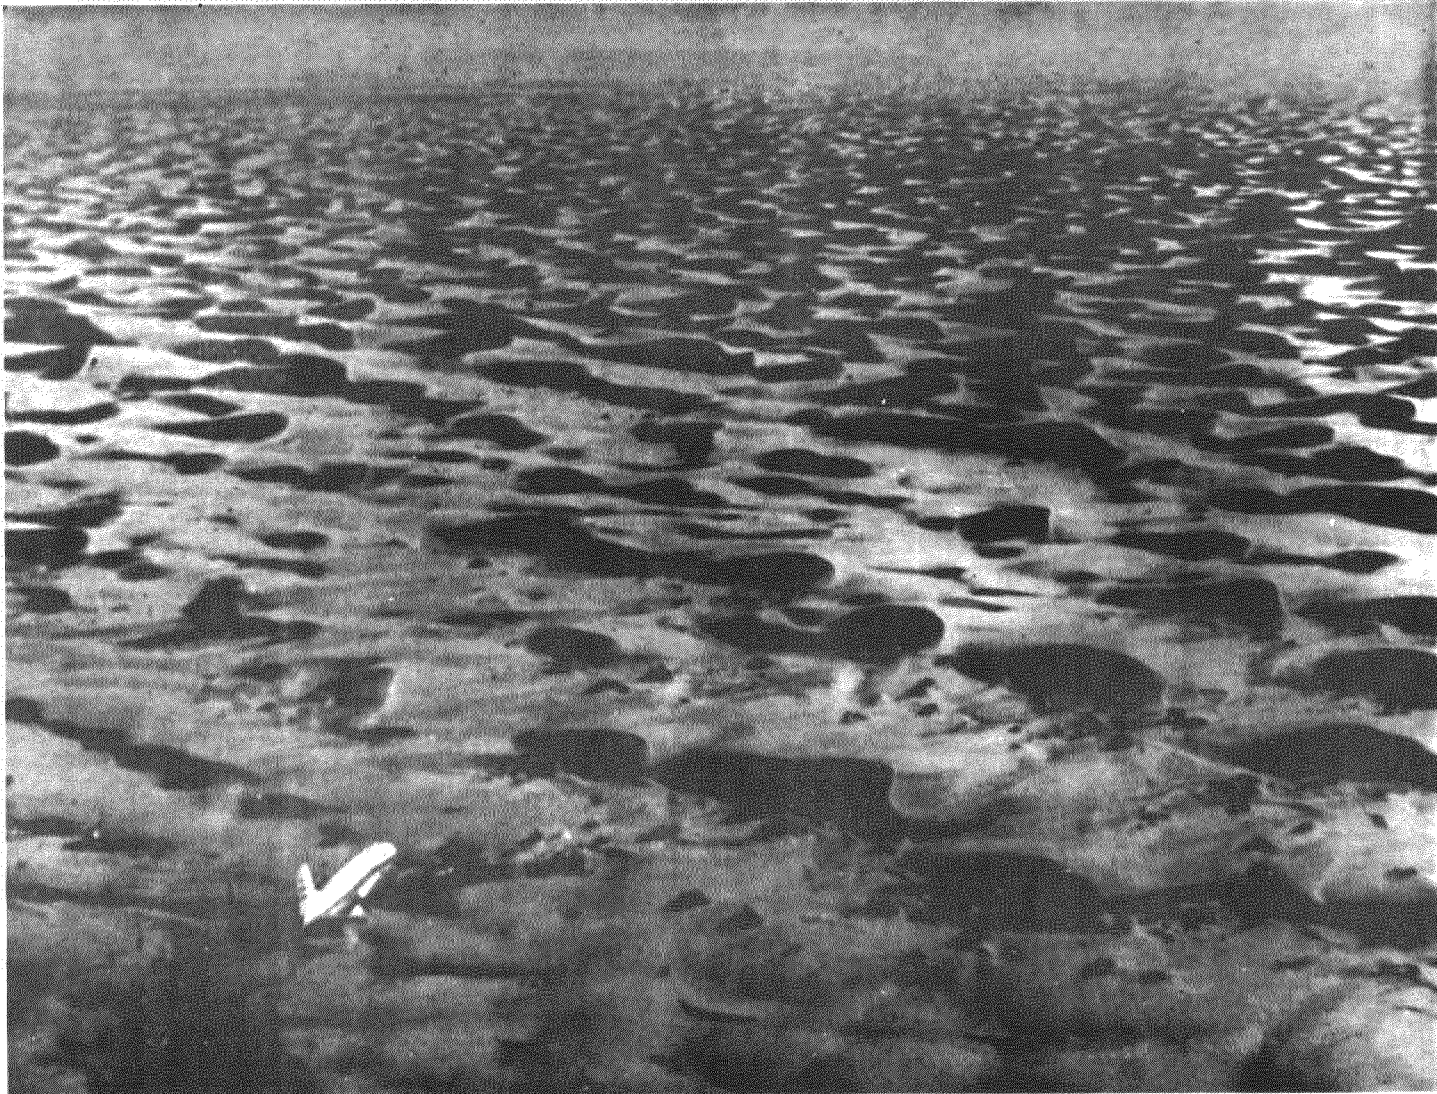
SCENE OF ACCIDENT TO HERMES AIRCRAFT G-ALDN.
DESERT OF MAURITANIA (FRENCH WEST AFRICA).

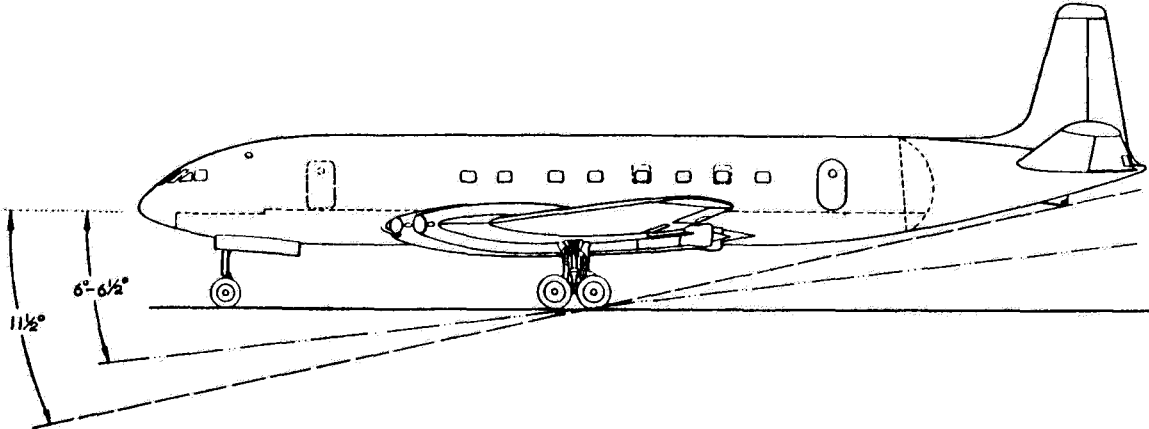
The accident was due to an error of judgment by the Captain in not appreciating the excessive nose-up attitude of the aircraft during the take-off.

- REPRESENTS GROUND LINE WITH NOSE WHEEL ON GROUND. _____
- REPRESENTS GROUND LINE WITH AIRCRAFT AT CORRECT "UNSTICK" ATTITUDE $6^\circ-6\frac{1}{2}^\circ$ NOSE-UP _____
- REPRESENTS GROUND LINE WITH TAIL BUMPER TOUCHING GROUND $11\frac{1}{2}^\circ$ NOSE-UP. _____

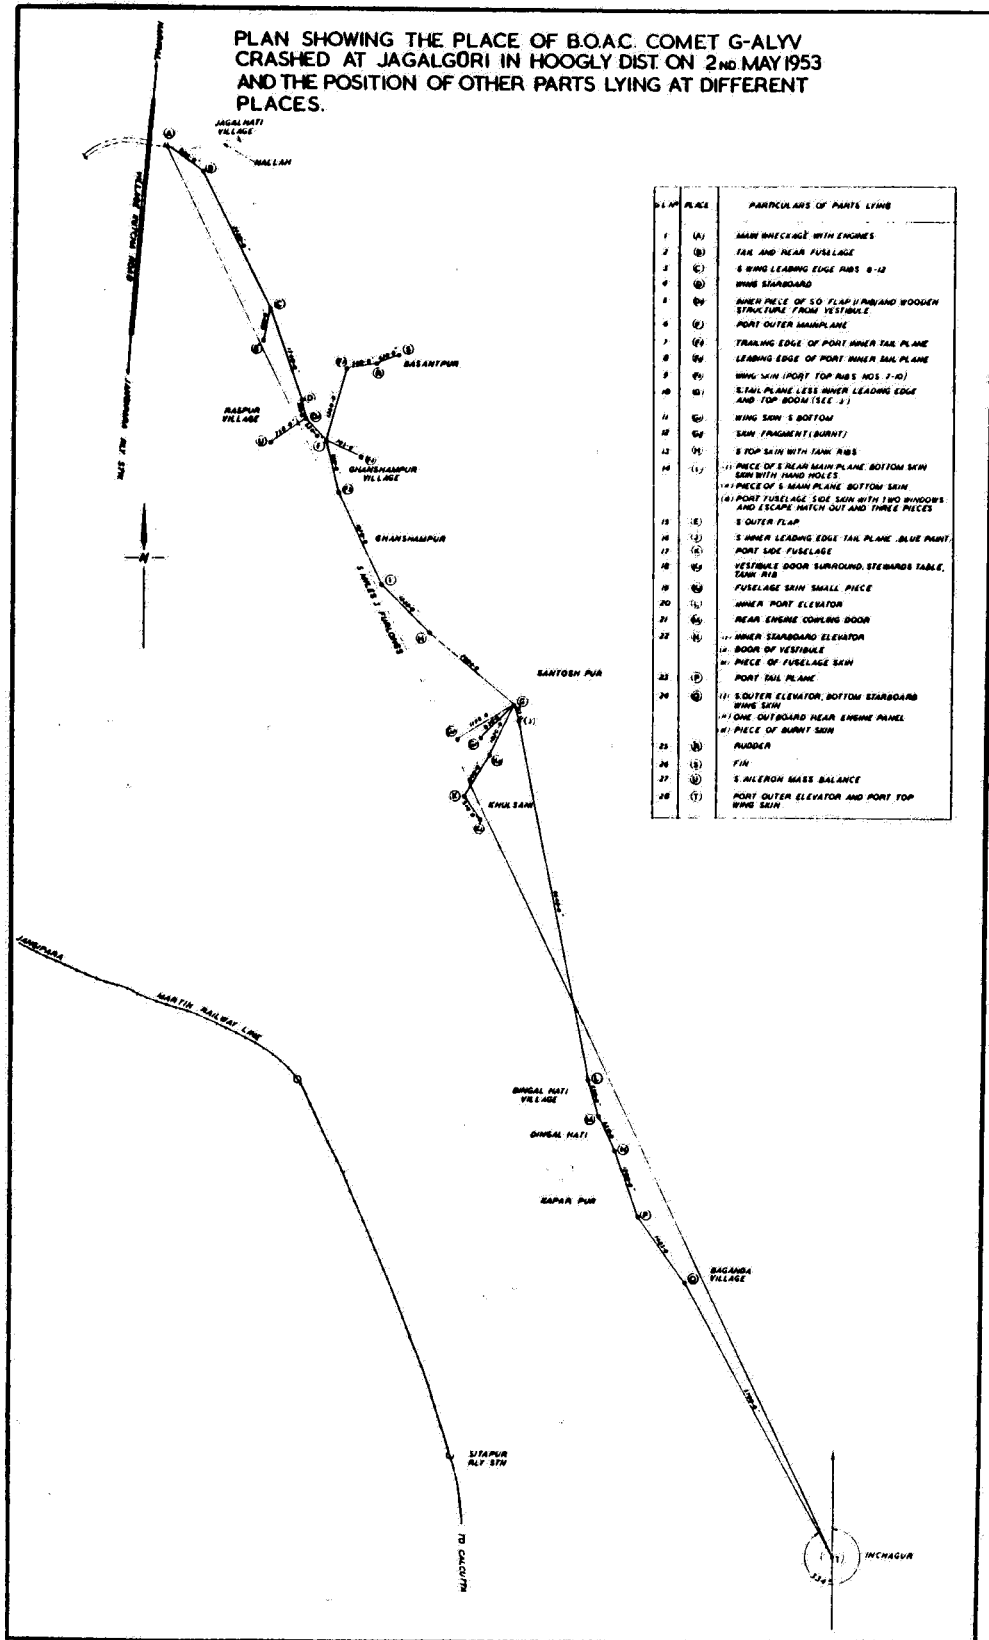
PLAN SHOWING THE PLACE OF BOAC COMET G-ALYV
 CRASHED AT JAGALGORI IN HOOGLY DIST ON 2ND MAY 1953
 AND THE POSITION OF OTHER PARTS LYING AT DIFFERENT
 PLACES.
