CIRCULAR 39-AN/34

AIRCRAFT ACCIDENT DIGEST

No. 5

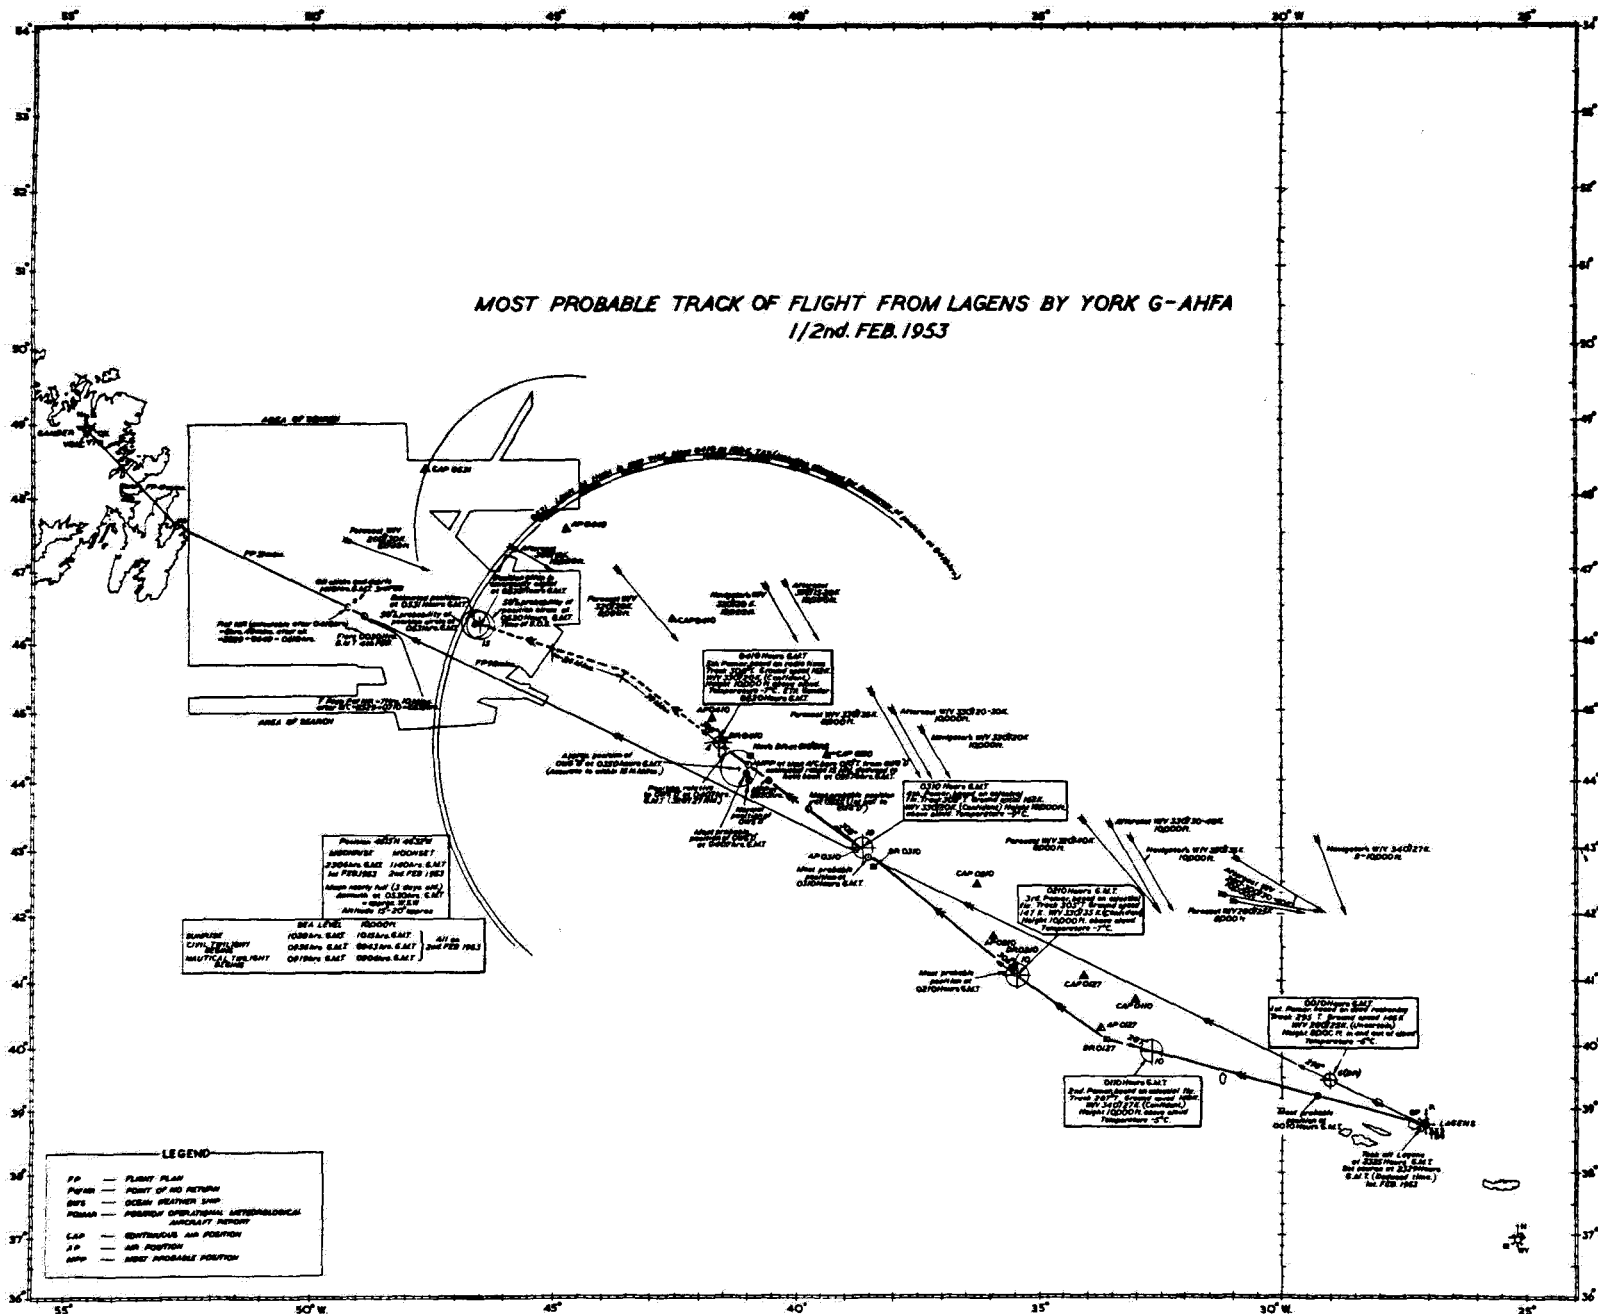
**MOST PROBABLE TRACK OF FLIGHT FROM LAGENS BY YORK G-AHFA
1/2nd. FEB. 1953**

Ditching: The York aircraft is a high-wing monoplane the whole of the fuselage of which is below the level of the main planes. In "ditching" it is unlikely that the aircraft could remain afloat for more than a few seconds after even a fully controlled descent on to smooth water. In a rough sea the aircraft would almost certainly break up almost immediately and it is extremely unlikely that any of the occupants who were alive when it touched the water would have any chance of using the escape hatches or of launching any of the six internally stowed dinghies provided for such emergencies.

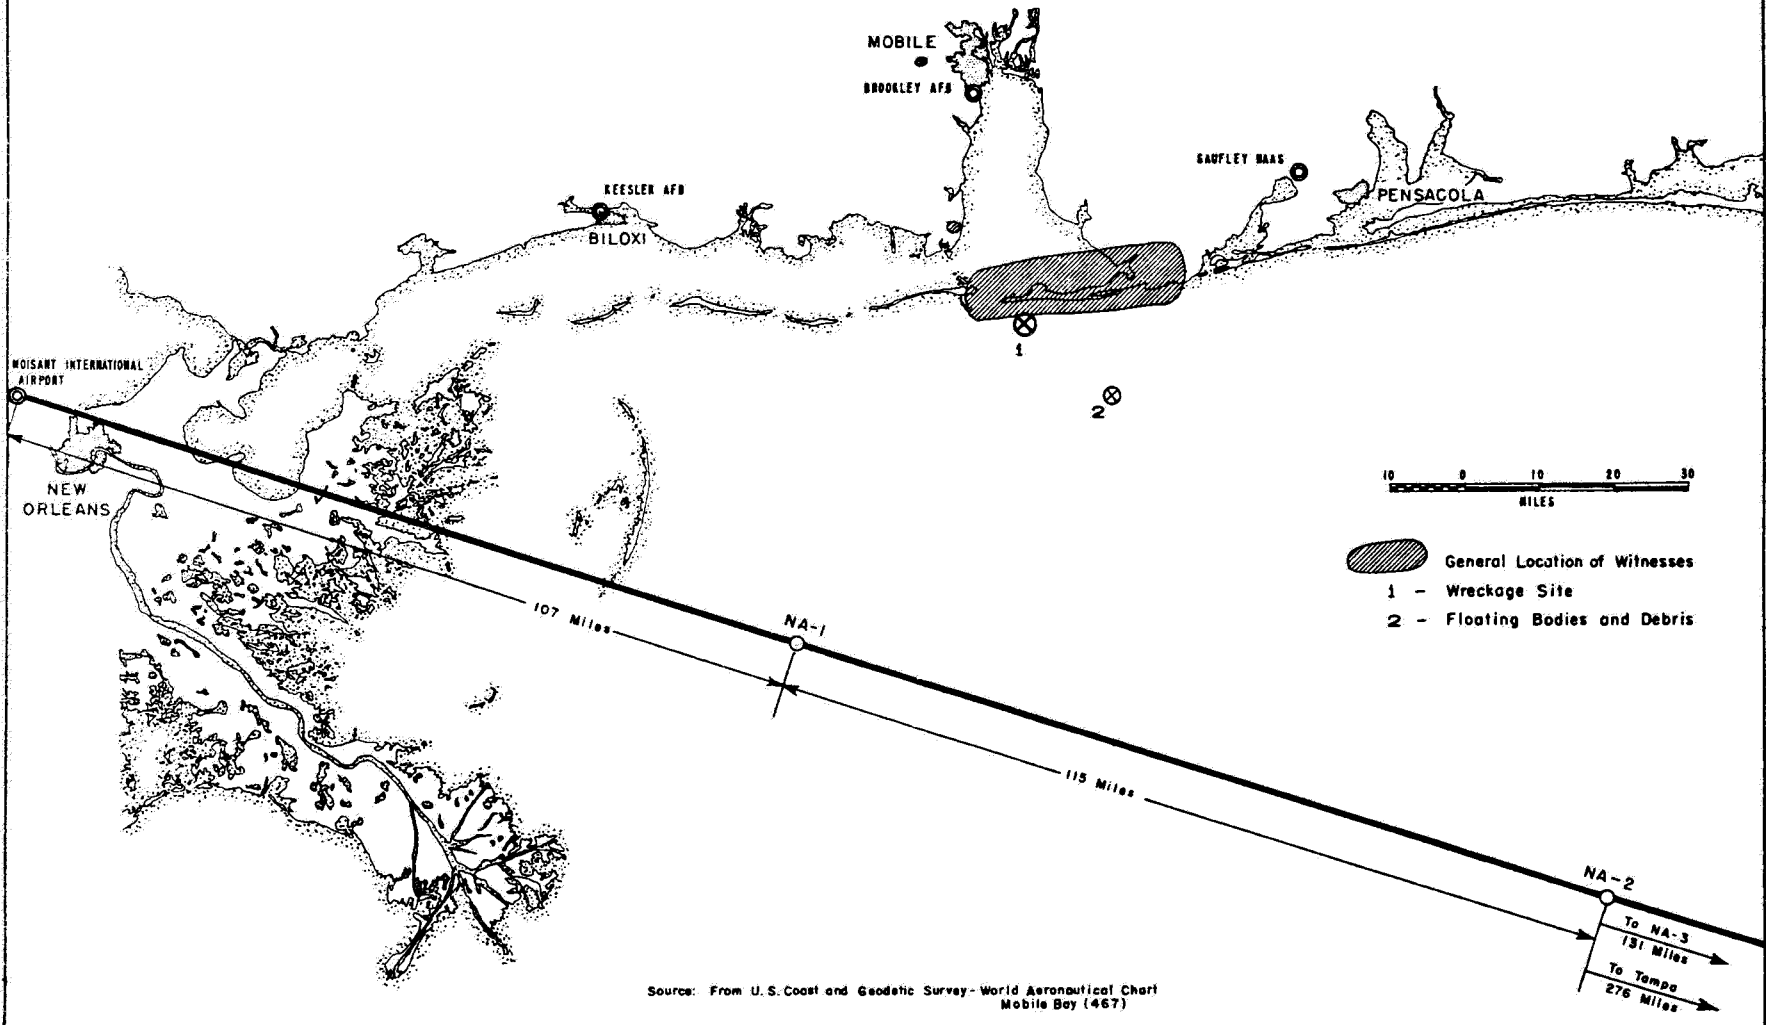
ACCIDENT TO NAL DC-6, FEBRUARY 14, 1953 IN GULF OF MEXICO

When it became apparent that the actual wreckage site was not in the immediate vicinity of the recovered floating debris, an intensive organized search of the surrounding area in the Gulf was instituted. Aircraft of the company, the United States Coast Guard and surface craft of the Navy and Coast Guard as well as pleasure and fishing boats participated. The Navy did considerable diving at suspected locations. This search proved futile and was discontinued officially on 20 March 1953, after it appeared improbable that the wreckage could ever be located. But a group of the passengers' relatives elected to continue an unofficial search, and on 20 May commercial fishermen in their employ located a piece of wreckage. At the request of the Board, the Navy and the Coast Guard once more renewed their search and diving activities and in the subsequent days two separate wreckage areas were located. The main wreckage area was located at Latitude 30°10'25" North and Longitude 87°57'10" West, and contained fuselage parts, right wing parts and the Nos. 3 and 4 power-plants. The second area was located 2,100 feet to the northwest of the main wreckage on a bearing of 331°, and left wing parts and the No. 1 power plant were found in this area. Water depth at both places is about 50 feet and the distance from the Gulf shore is about 3.8 miles.

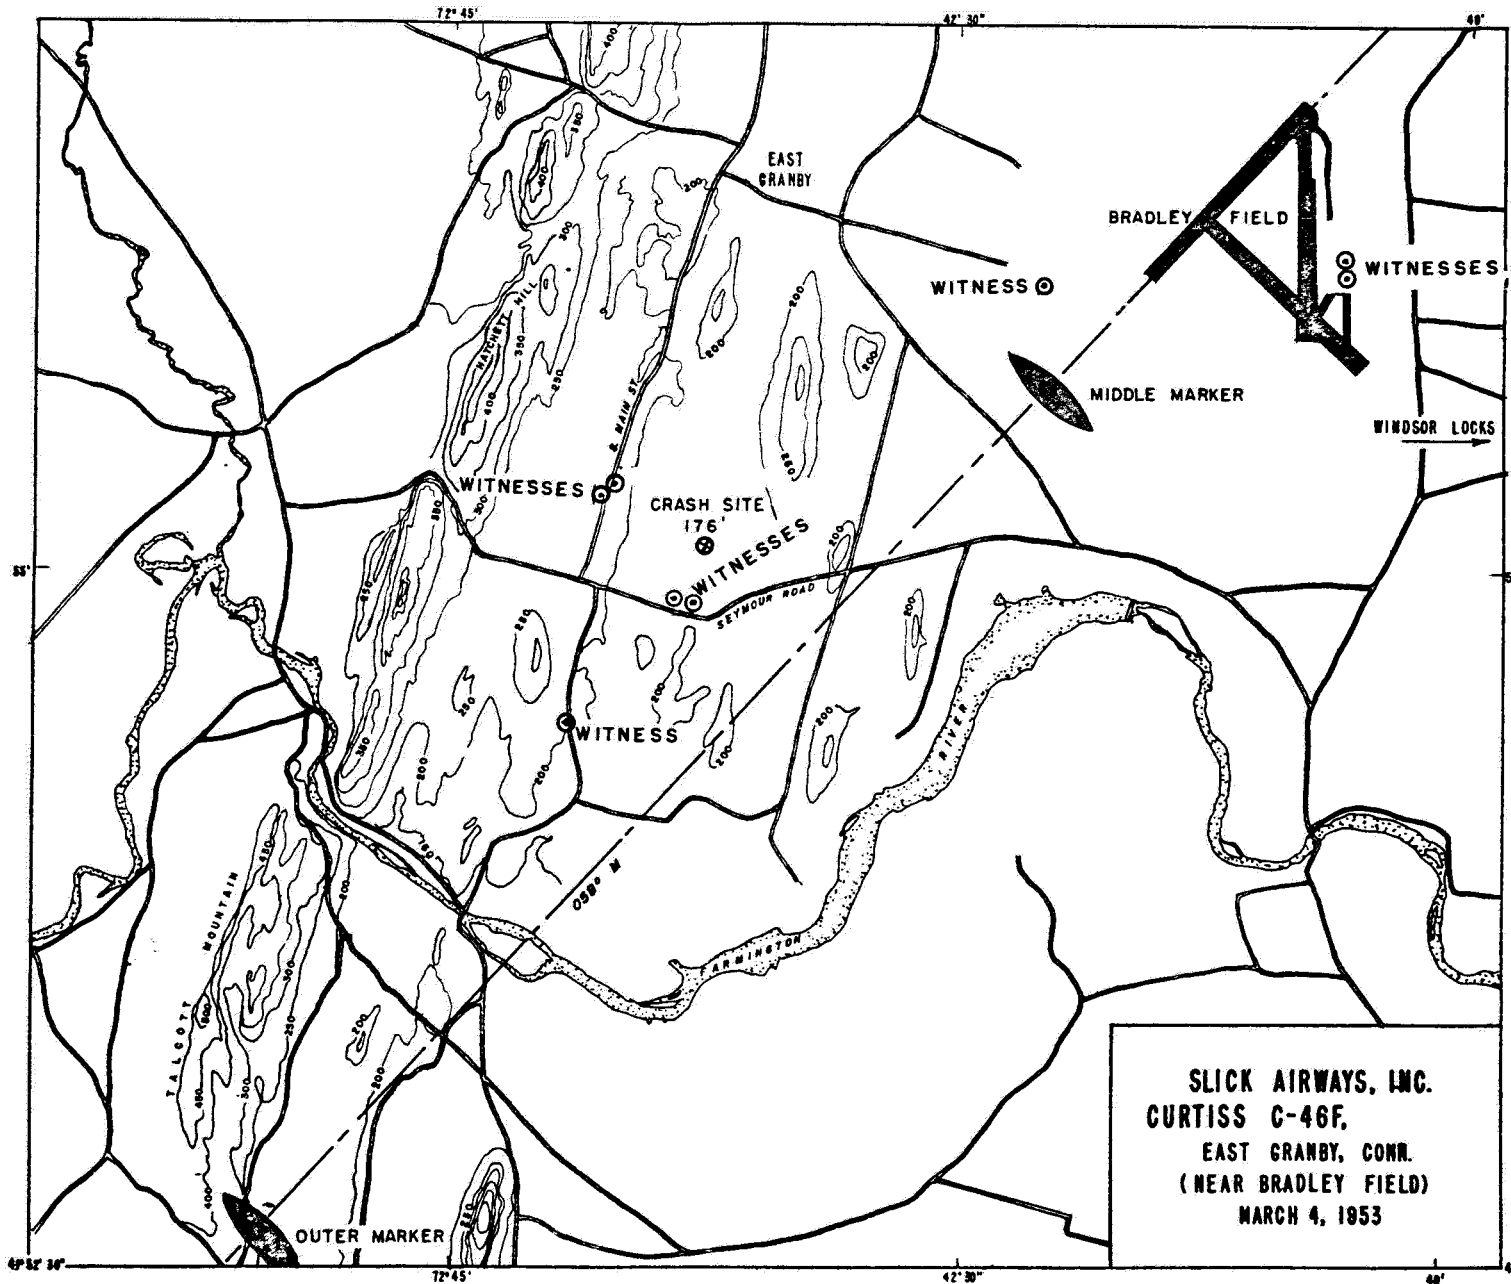
SLICK AIRWAYS, INC.
CURTISS C-46F,
EAST GRANBY, CONN.
(NEAR BRADLEY FIELD)
MARCH 4, 1953

It was deduced, from the fact that the aircraft passed very low over a house near the approach end of Runway 6 and the noted visibility was one mile or more, that the aircraft was low enough for the pilot to have had visual reference to the ground. Since reported weather conditions were equal to his circling minima, it was not improper for him to circle under the overcast in a second attempt to land. However, the more desirable method of making a second approach would have been to conduct a missed approach procedure and a new ADF instrument approach. A properly performed ADF procedure would probably have prevented the accident, even recognizing that the final approach would require precise control of the

rate of descent, for its procedures are designed to prevent collision with ground hazards. The Board therefore questioned the pilot's judgment in this instance.

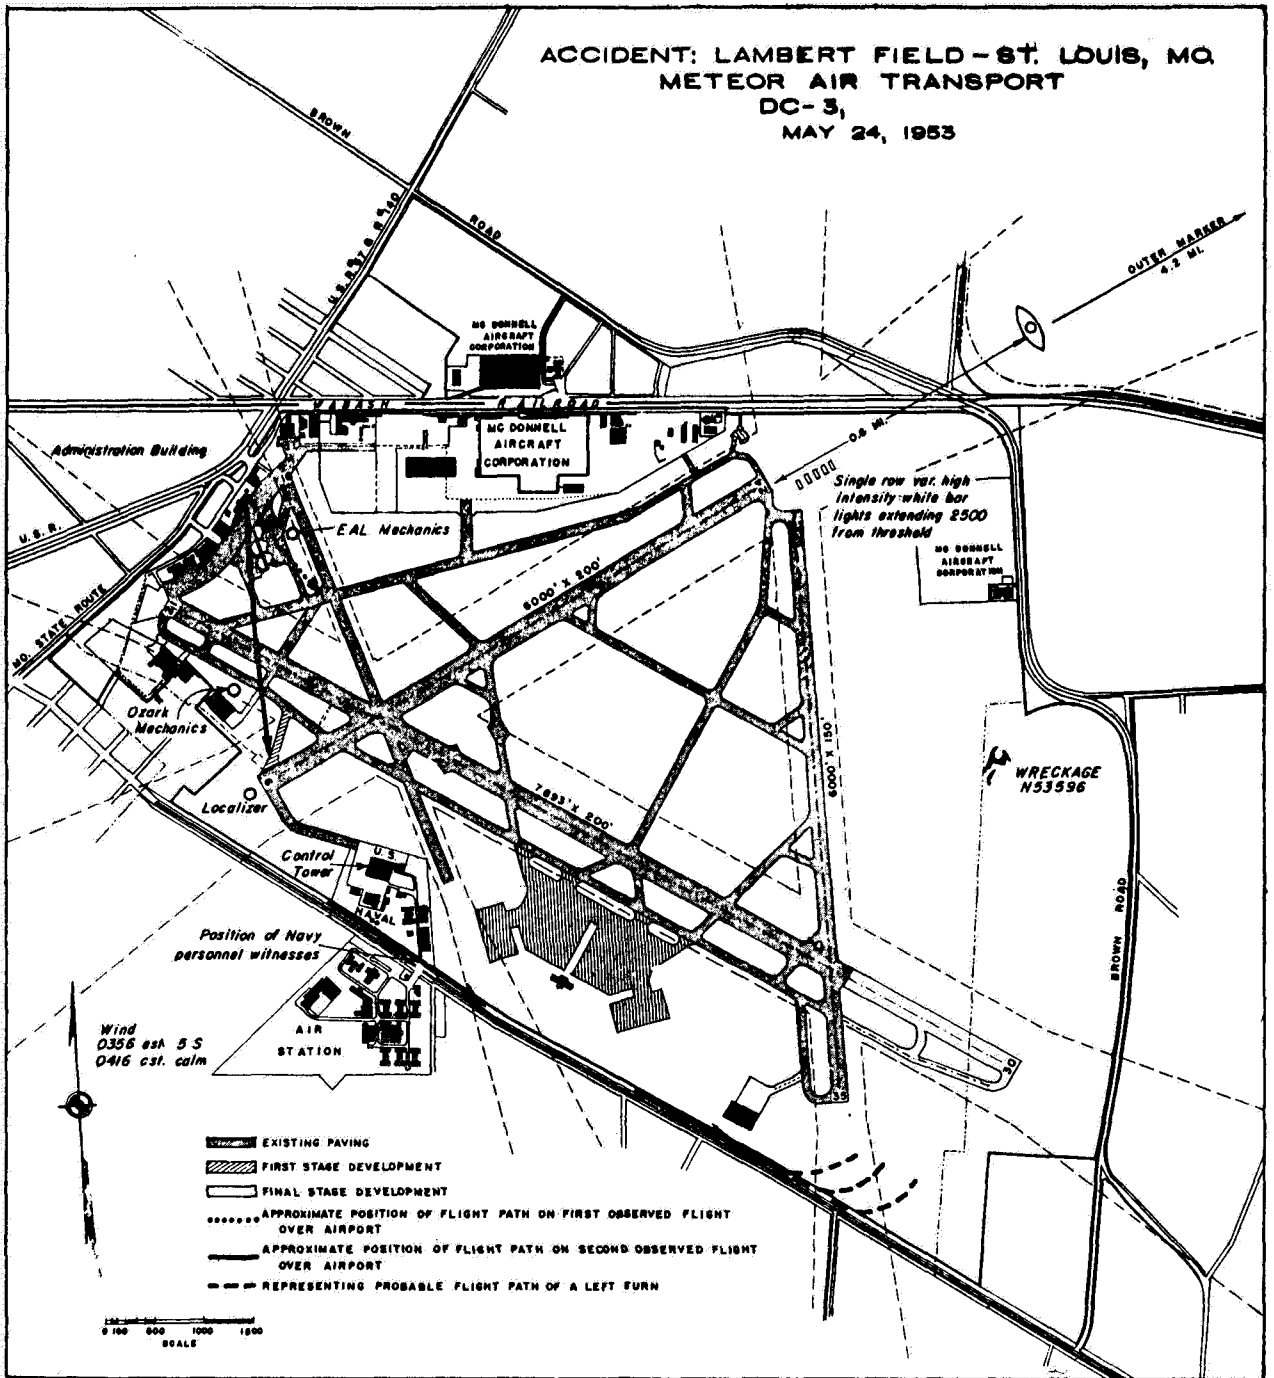
ACCIDENT: LAMBERT FIELD - ST. LOUIS, MO.
METEOR AIR TRANSPORT
DC-3,
MAY 24, 1953

The aircraft was observed by competent witnesses to twice approach the airport below the overcast from the north and disappear, headed in a southerly direction. These witnesses were all located in the vicinity of the Administration Building at the northwest corner of the airport. All stated the engines appeared to be functioning normally. The aircraft was also observed by three Navy guards located at the Navy entrance on Natural Bridge Highway just south of the tower on the south side of the airport who stated they got a fleeting glimpse of the aeroplane as it passed overhead in a southeasterly direction. They stated that during this period they noticed that the left engine was either windmilling or feathered. It must have been shortly thereafter that the tower controller observed the aircraft at a position south of the field flying on a southeasterly heading above Natural Bridge Highway. Whether or not the message from the pilot to the controller, that he was over the field and had an engine out, was received before or after the aircraft was first observed over the field in the vicinity of the Administration Building could not be determined.

The survivor of the accident testified that, from his seat in the rear of the cabin, he saw the lighted sign on the McDonnell Aircraft Factory located on the north side of the field, both times they passed across the airport. He further stated he believed both engines functioned normally throughout the circuits of the field and that the only change in power that he recognized was when the aircraft climbed slightly when crossing the field the first time. He stated also that, a short time before the crash, the aircraft "trembled" twice in rapid succession, there was no recognizable change in power at that time, and the aircraft continued flying in level flight. He said, "I made a statement to my mechanic friend that it felt like it was going to stall." A few seconds later the aircraft again "trembled" and the right wing dropped. The crash followed immediately. The aircraft struck the ground on an undeveloped portion of the airport approximately 1,950 feet east of the mid-point of the north-south runway which is itself located on the eastern side of the airport proper.

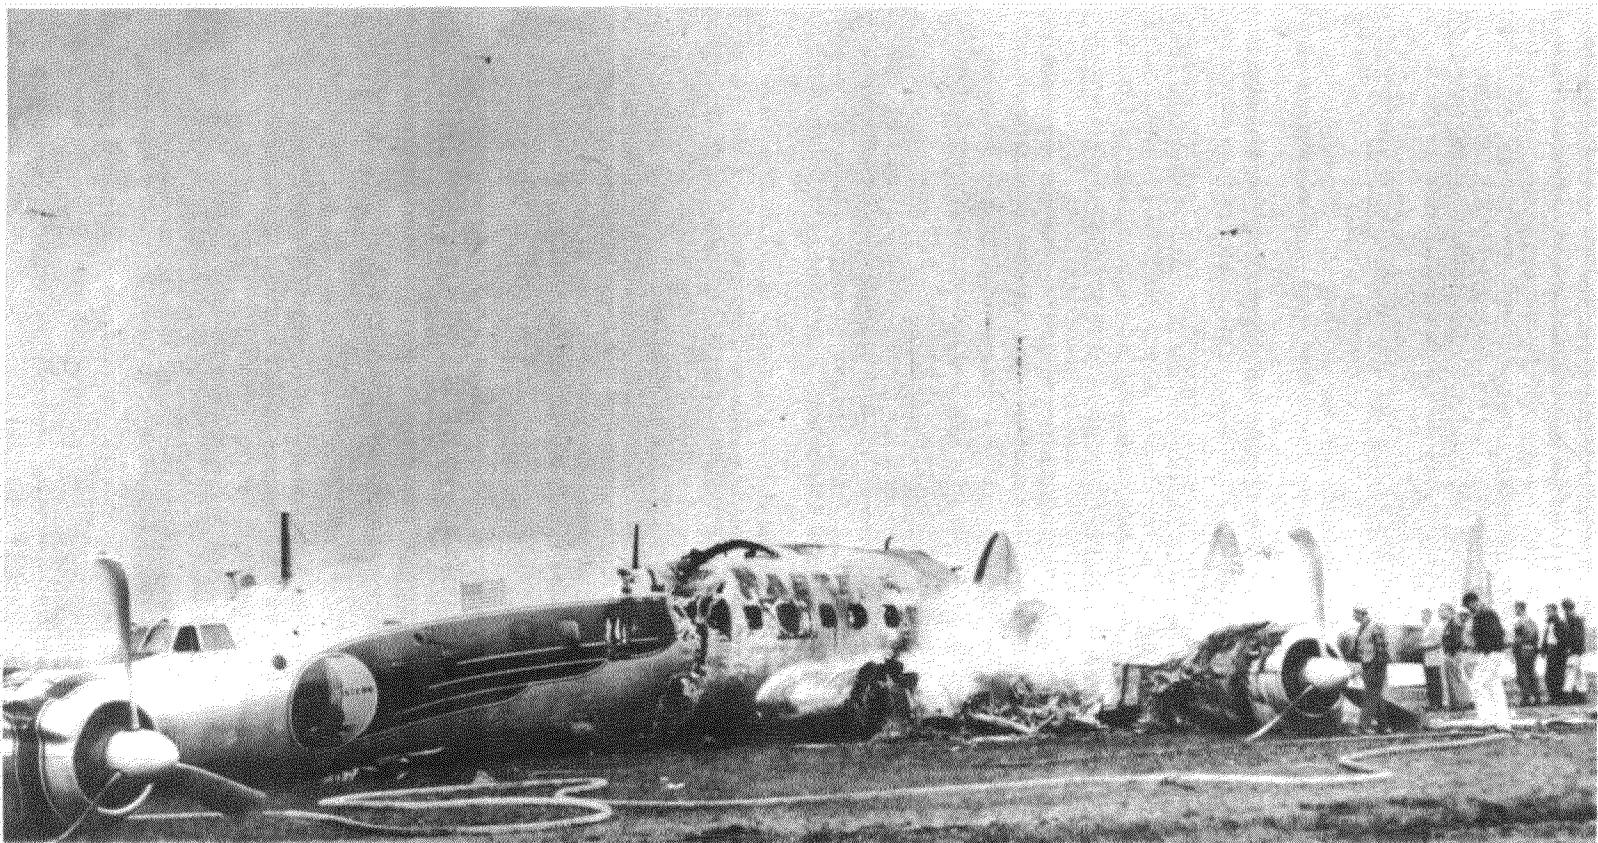
For better understanding of the operation of the wing flaps and landing gear, it is desirable at this time to describe briefly the hydraulic system of the aircraft in question. Each of the four engines drives a hydraulic pump. Those on Nos. 1 and 2 engines furnish jointly (or individually in the event of failure of either No. 1 or No. 2 engine) hydraulic pressure to supply boost for the aircraft's flight controls, and for certain other purposes. This is known as the primary hydraulic system.

Pumps on Nos. 3 and 4 engines furnish jointly (or individually in the event of failure of either No. 3 or No. 4 engine) hydraulic pressure to effect wheel braking, nose-wheel steering, wing flap motion, landing gear extension or retraction, and for certain other purposes. This is known as the secondary hydraulic system. It can supplement the primary hydraulic system, but the reverse is not possible. If Nos. 3 and 4 engines are inoperative, there is no means of obtaining nose-wheel steering; wing flaps must be cranked down manually, and the landing gear must be lowered with the hydraulic hand pump. It is therefore apparent that the only source of pressure available in the secondary system of the aircraft during its emergency was the hydraulic pump driven by the windmilling No. 3 engine. The result was an abnormally low volumetric output.

A small internal leak was found in the landing gear selector valve when in the "neutral" position. The leak was caused by an improperly seated poppet valve which permitted flow from "pressure" port to "down" port. Since the "down" port is connected internally to "return" port when selector valve is in "neutral" a leakage path was provided between pressure and return lines. This leakage at the landing gear selector valve prevented normal flap extension, due to insufficient hydraulic pressure.
