CIRCULAR 47-AN/42

AIRCRAFT ACCIDENT DIGEST NO. 6

Prepared by the Secretariat and published
by authority of the Secretary General

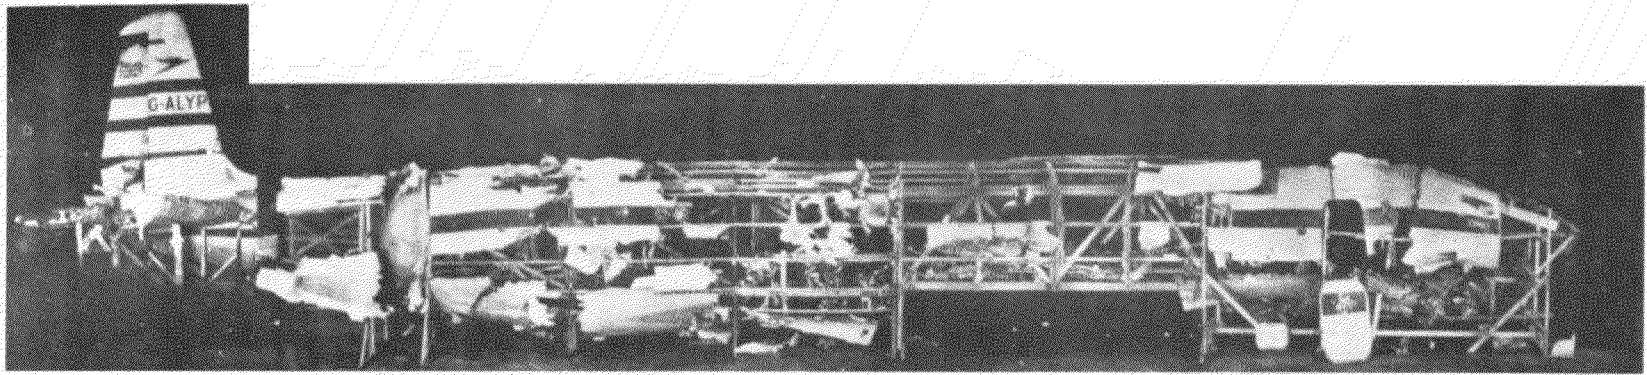
Fig. 3. RECONSTRUCTION OF FUSELAGE AND TAIL UNIT WRECKAGE—G-ALYP.

THIS PANEL (INCLUDING CREW ENTRY DOOR) RECOVERED SEPARATELY AND SHOWS WATER IMPACT DAMAGE ON OUTER FACE.

FORWARD EQUIPMENT BAY REAR BULKHEAD TORN FROM FRONT FUSELAGE AND REMAINED ATTACHED TO WING.

NOSE DOWN BENDING FAILURE OF PICK UP POINTS ON WING WITH FINALLY SOME BENDING TO STARBOARD.

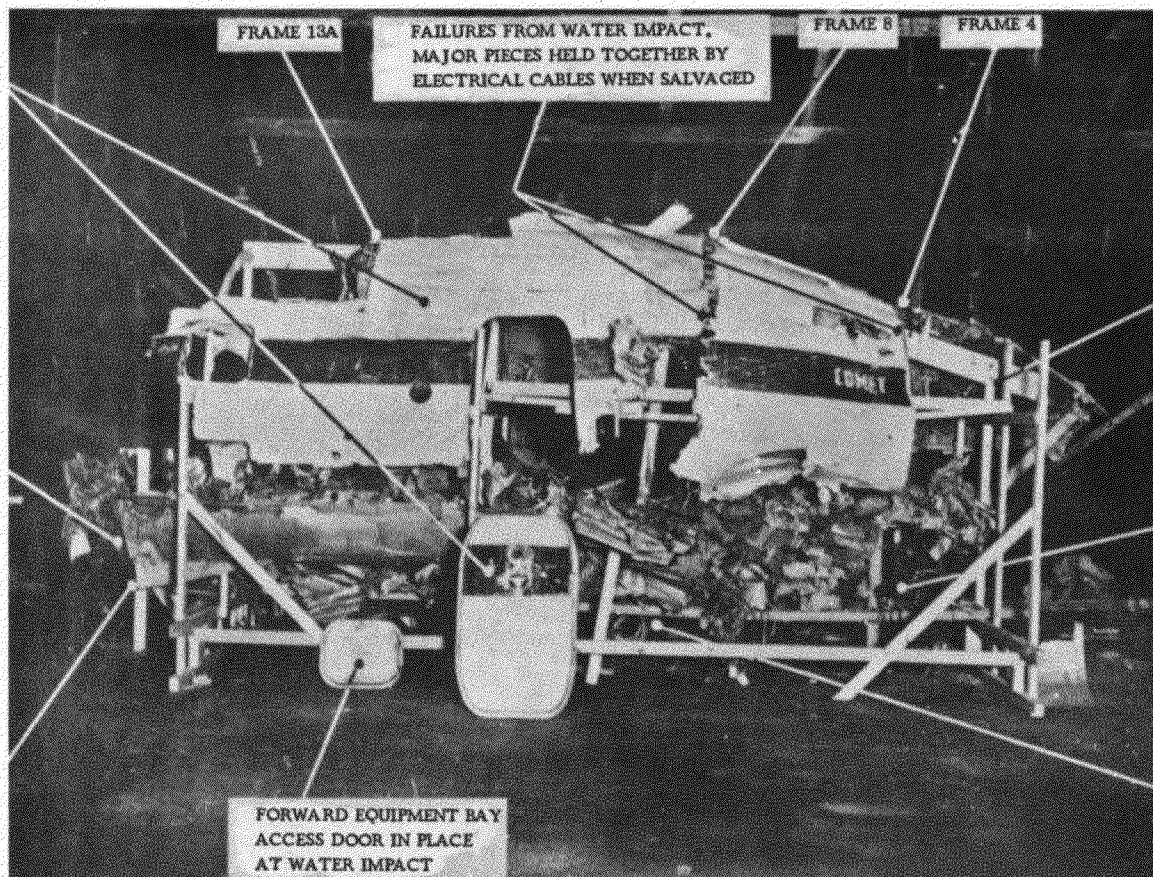
FIG. 4. FRONT FUSELAGE—VIEW ON STARBOARD SIDE—G-ALYP.

STARBOARD WINDSCREEN MISSING.

EXTENSIVE CRUSHING OF WHOLE UNDERSIDE OF FRONT FUSELAGE BY WATER.

NOSE WHEEL RETRACTED WHEN SALVAGED.

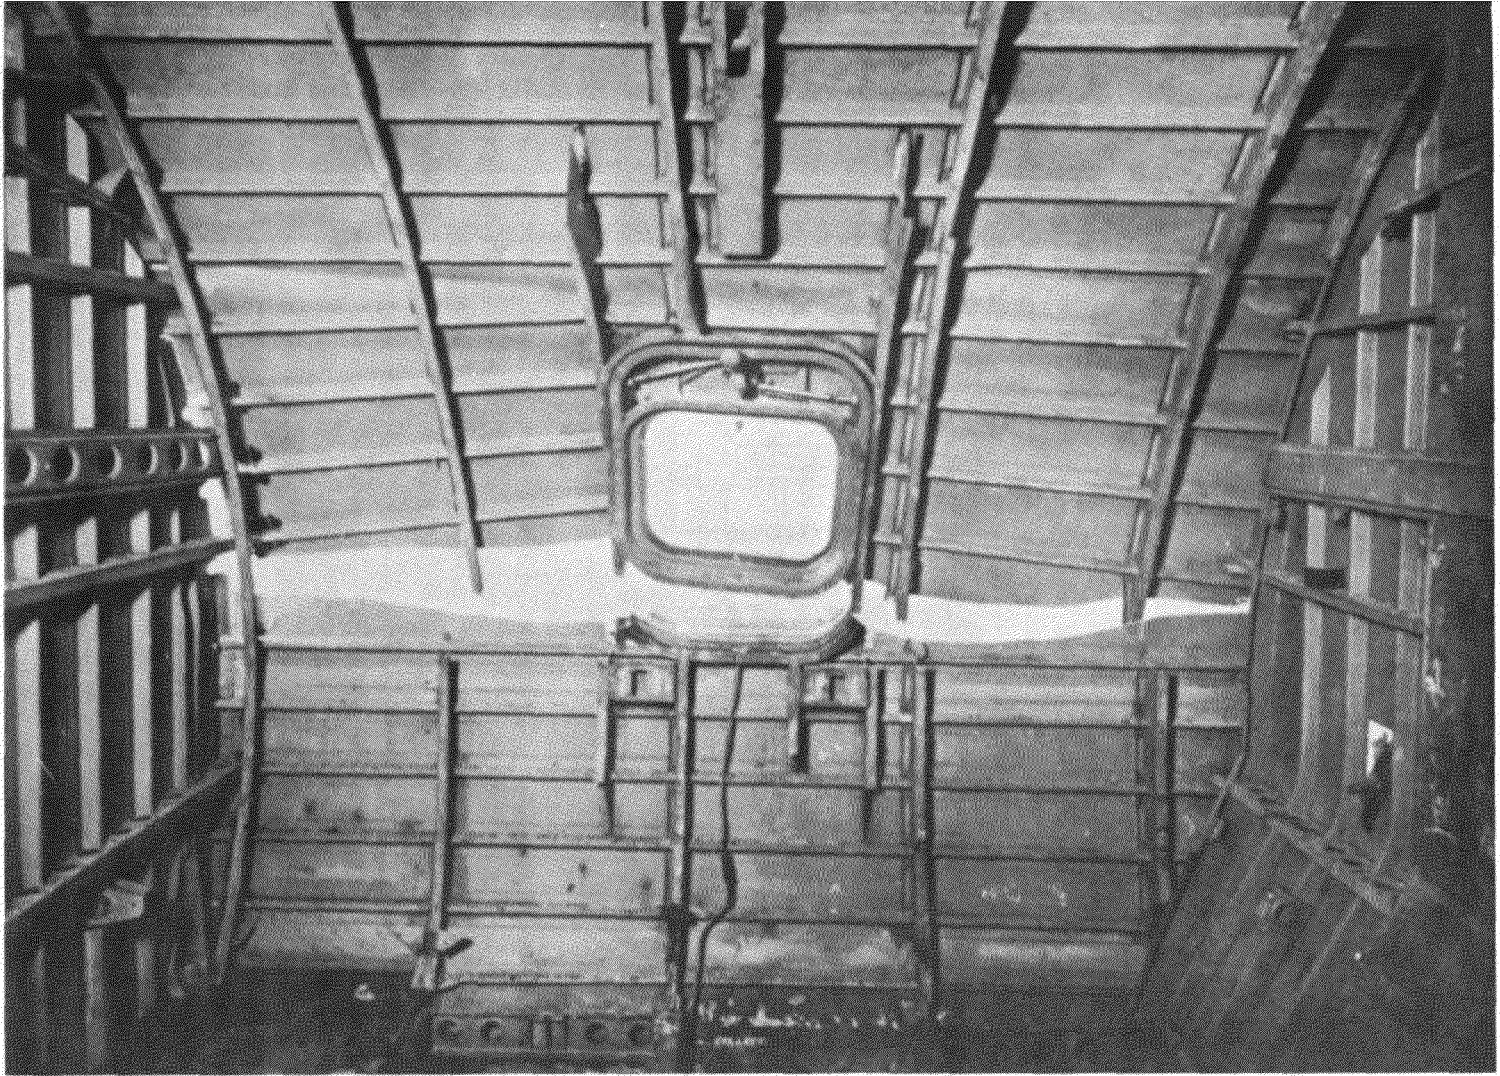
FIG. 6. VIEW FROM INSIDE OF FAILURE AT THE FORWARD ESCAPE HATCH ON THE PORT SIDE—COMET G-ALYU

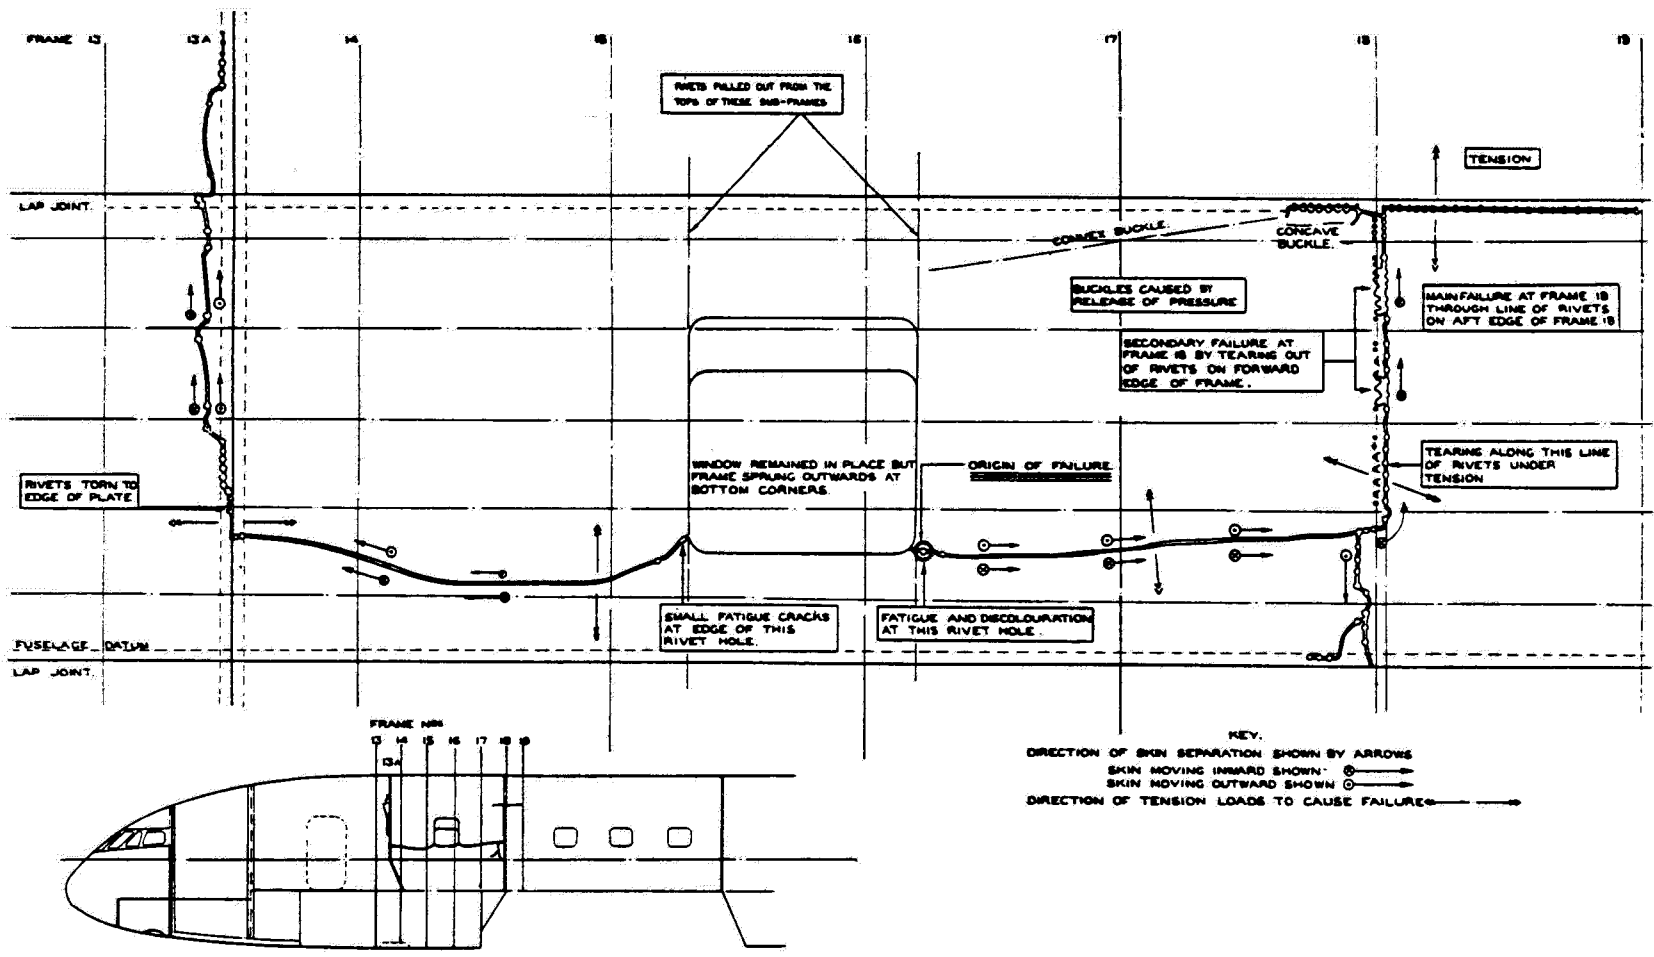
FIG. 7. THE PROGRESS OF THE FAILURE OF THE FORWARD ESCAPE HATCH ON THE PORT SIDE—COMET G-ALYU.

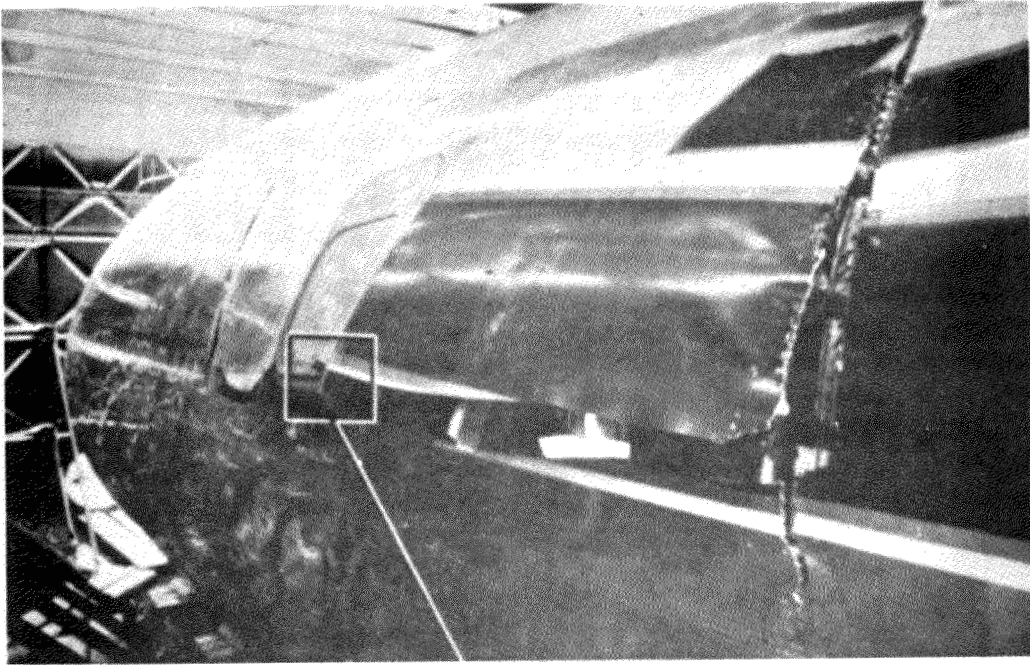
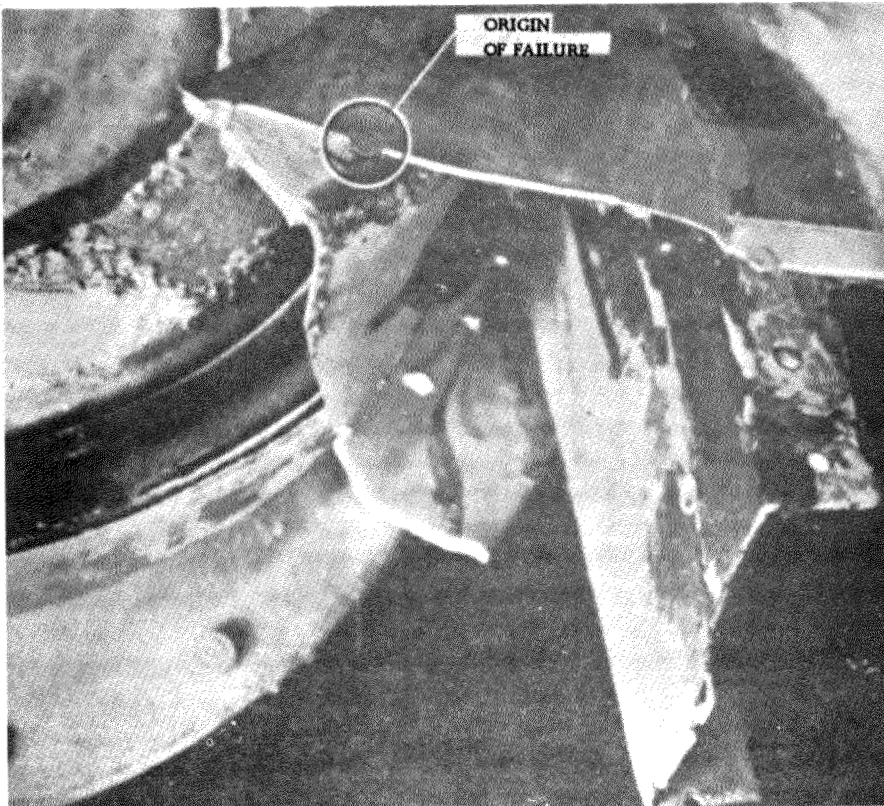
a. GENERAL VIEW LOOKING FORWARD.

b. CLOSE-UP OF SKIN AT BOTTOM REAR CORNER OF ESCAPE HATCH.

FIG. 8. FAILURE OF FRONT FUSELAGE AT 10.4 lb./in² (3057 TOTAL FLIGHT5)—G-ALYU.

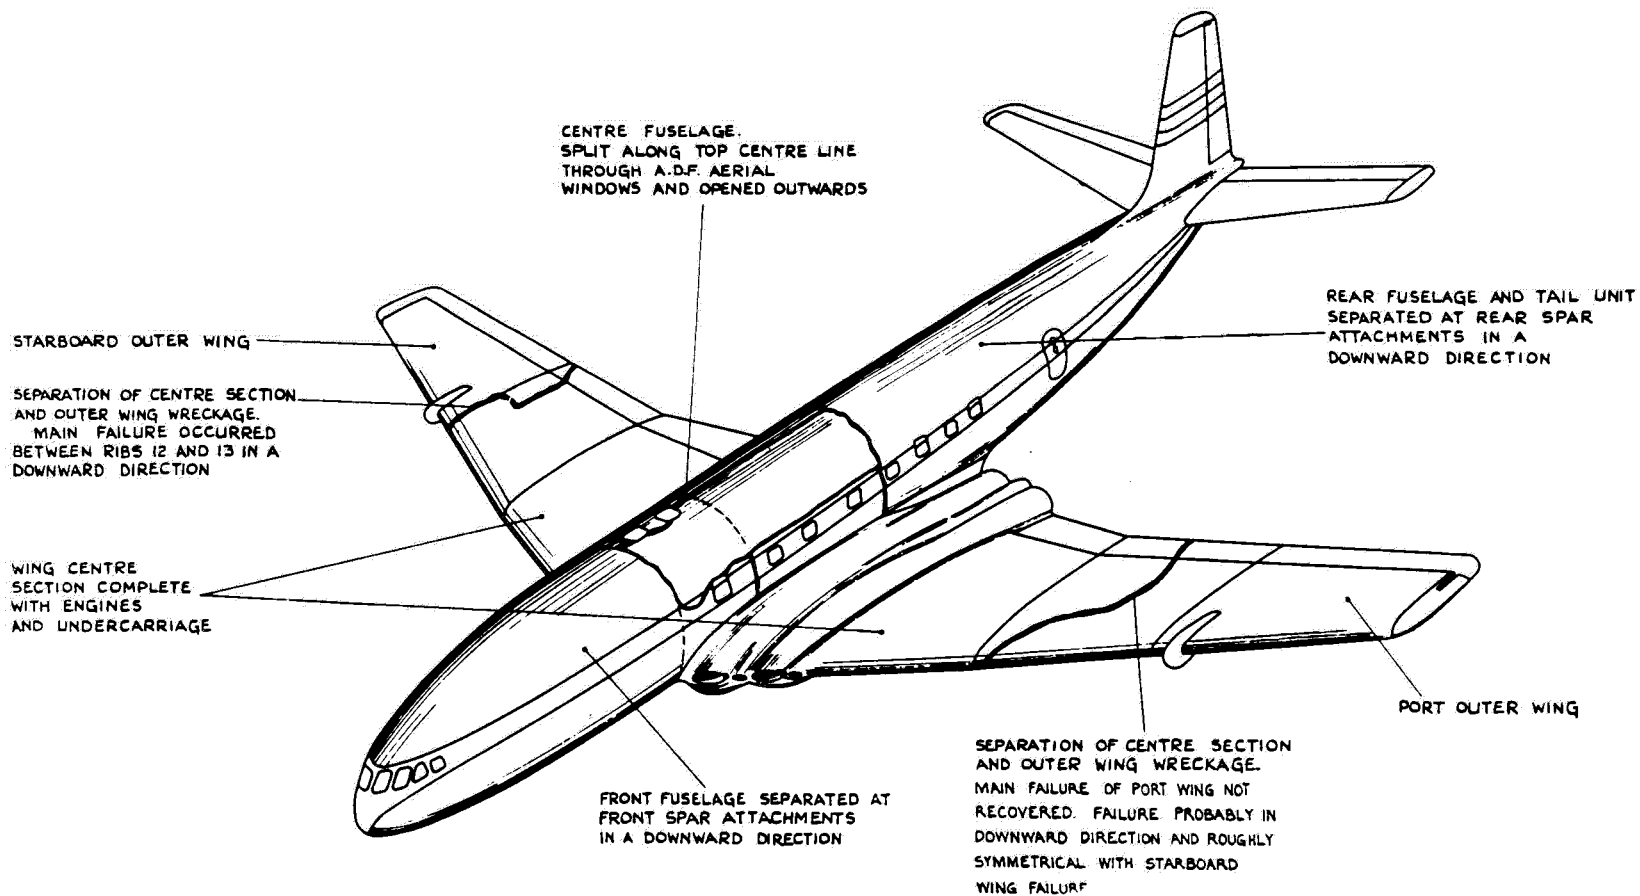
FIG. 9. LOCATION AND DIRECTION OF MAIN FAILURES—G-ALYP.

DIRECTION OF
PROPAGATION
OF MAIN
FAILURES

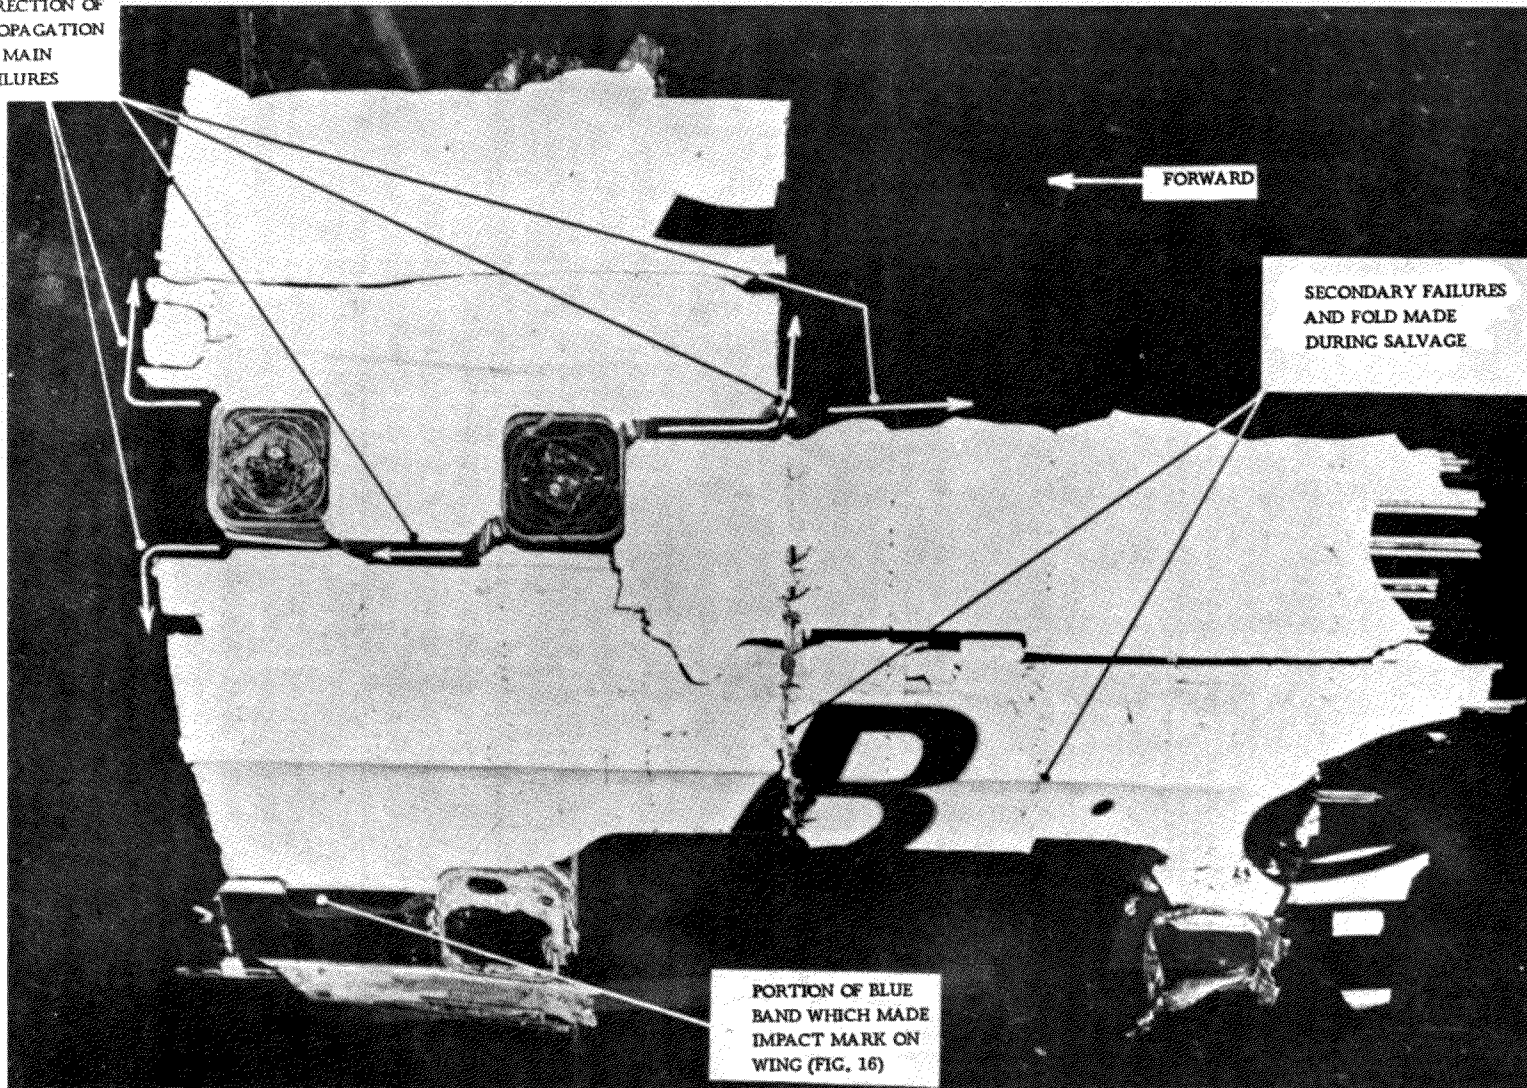
FIG. 10. PHOTOGRAPH OF WRECKAGE AROUND ADF AERIAL WINDOWS—G-ALYP.

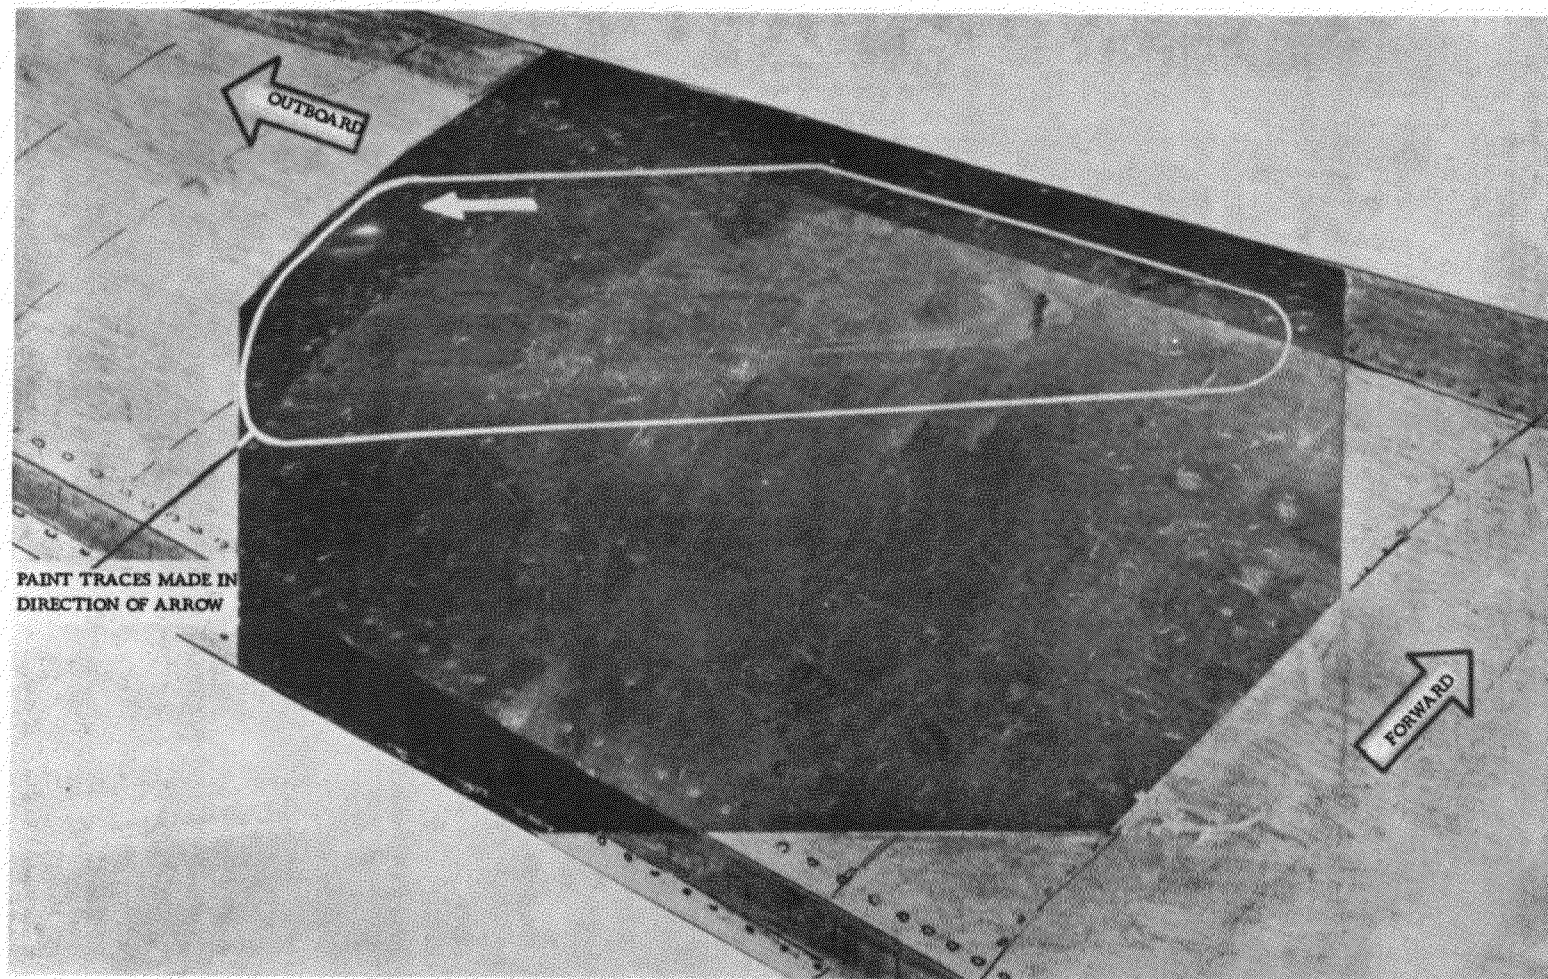
FIG. 11. PAINT TRACES OVER PORT AILERON UPPER SURFACE—G-ALYP.

PARTICLES OF FIBREGLASS AND WOOD JAMMED INTO SKIN AND UNDER LAP JOINT PROBABLY FROM FUSELAGE CABIN FLOORING

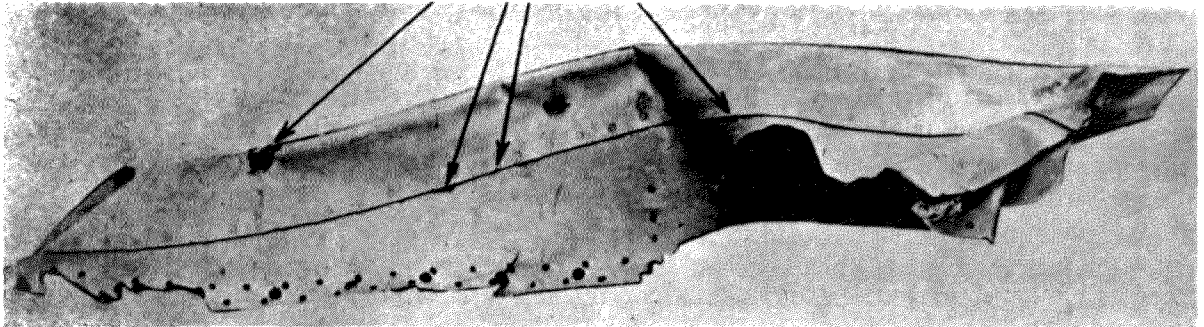
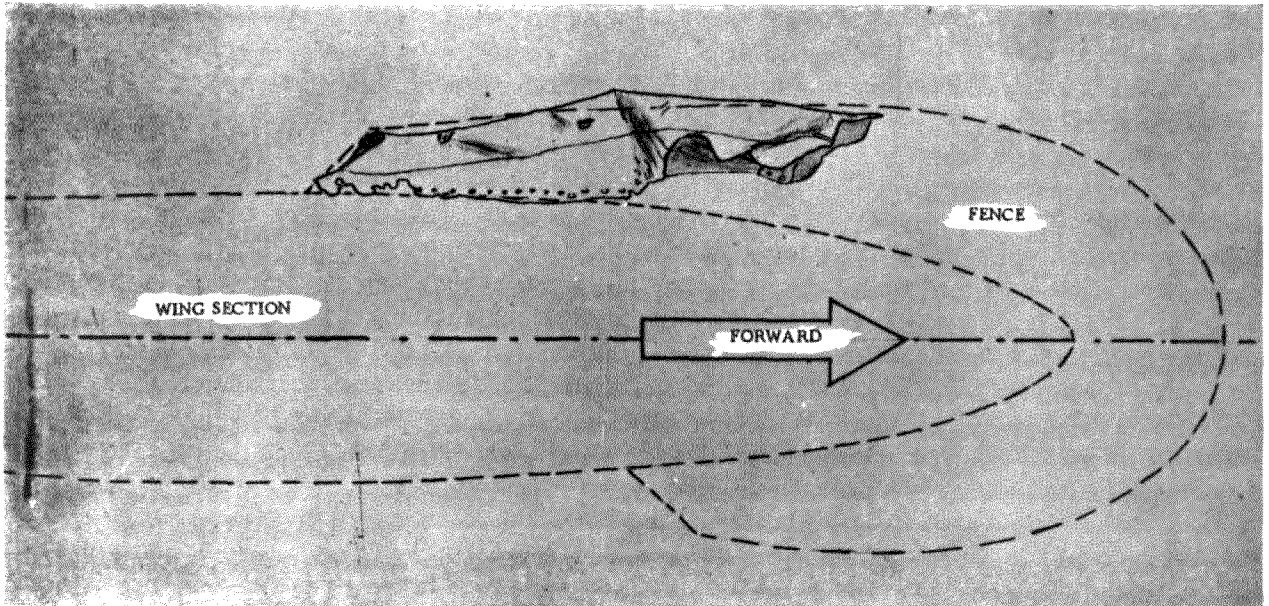
FIG. 12. PORT BOUNDRY LAYER FENCE, IMPACT DAMAGE TO INBOARD FACE—G-ALYP.

GENERAL PATTERN OF METALLIC SCORES AND PAINT TRACES OVER INBOARD FACE PROGRESSING FROM WING SKIN TO UPPER EDGE OF FENCE

NO COMPARABLE DAMAGE ON OUTBOARD FACE OF FENCE

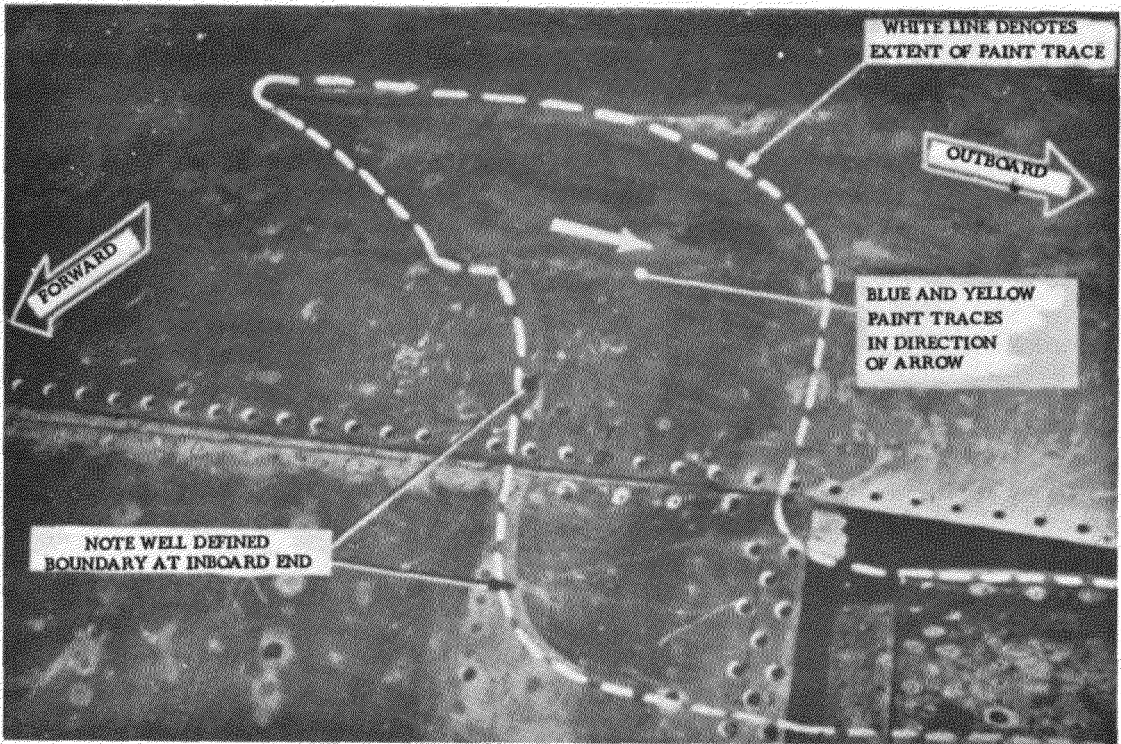
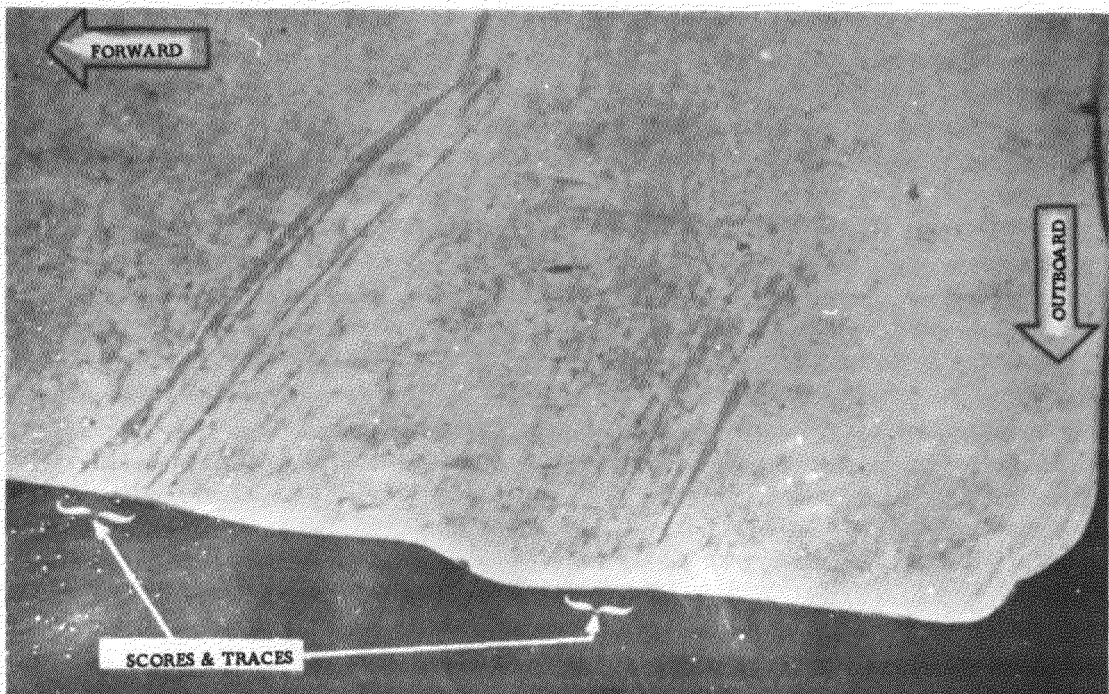
FIG. 13. PAINT TRACES ON PORT WING UPPER SURFACE—G-ALYP.

PAINT TRACES MADE BY PORTION OF CABIN WALL
(FOR LOCATION SEE FIG. 16).

HEAVY METALLIC SCORING WITH BLUE PAINT TRACES CONTINUOUS OVER FRACTURE EDGE
(FOR LOCATION SEE FIG. 16).

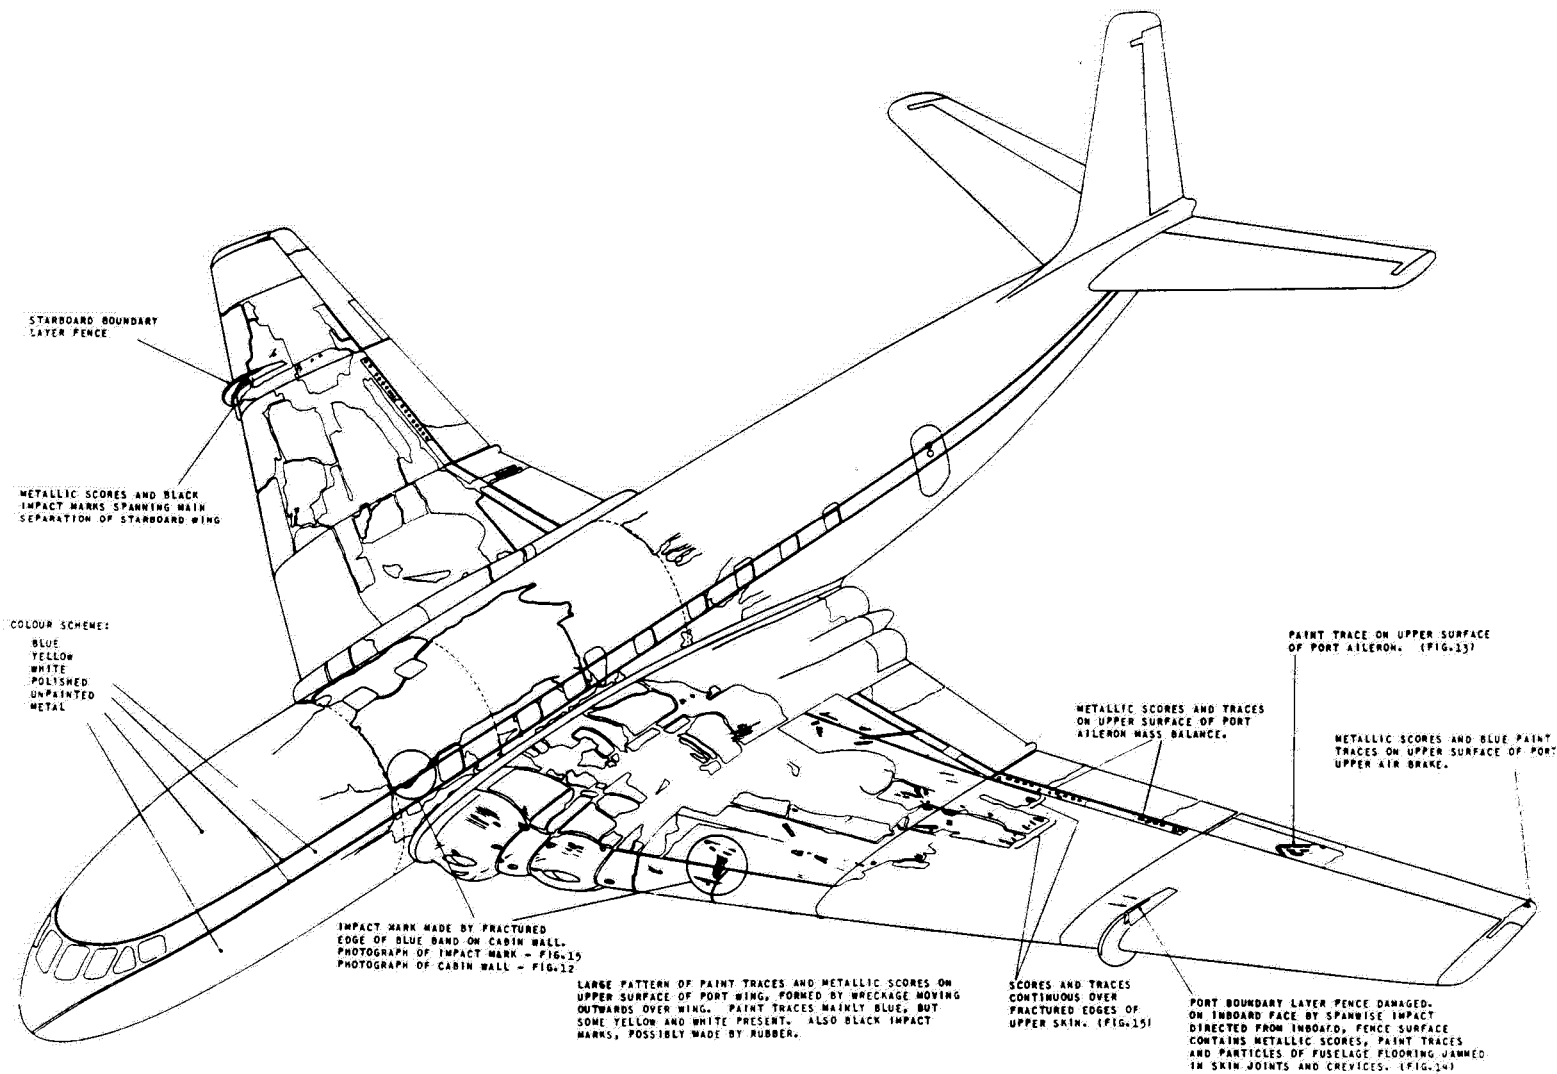
FIG. 14. IMPACT DAMAGE TO UPPER SURFACES OF WINGS—G-ALYP.

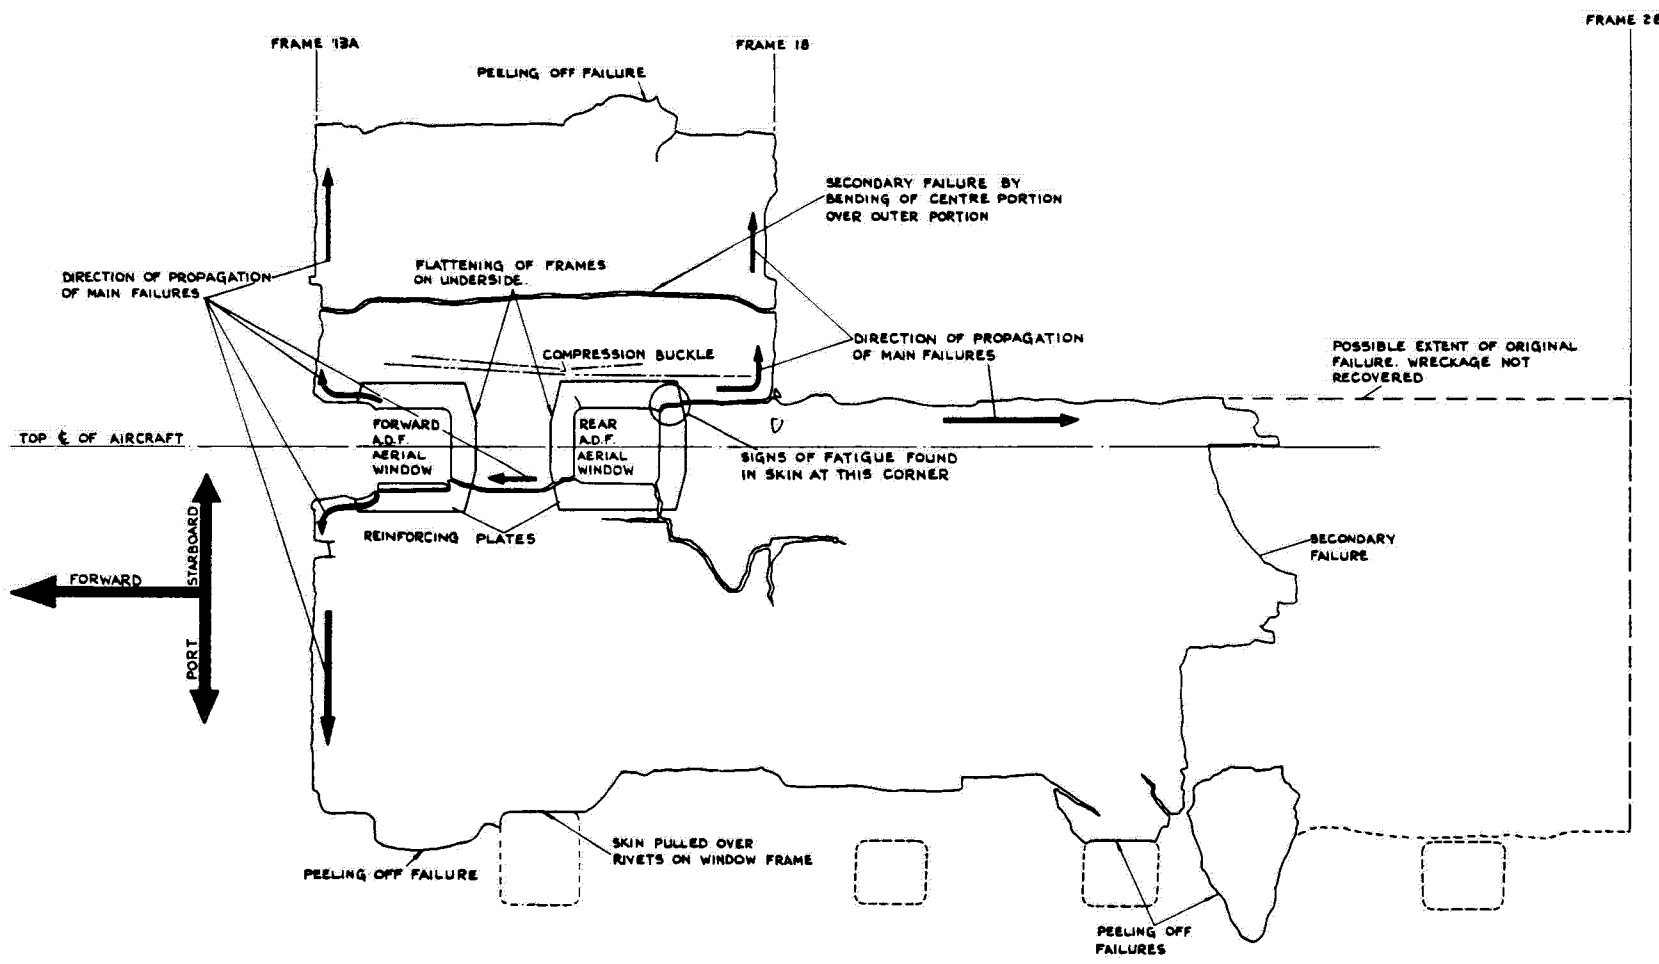
FIG. 15. SALIENT FEATURES OF DISRUPTION OF PRESSURE CABIN—G-ALYP.

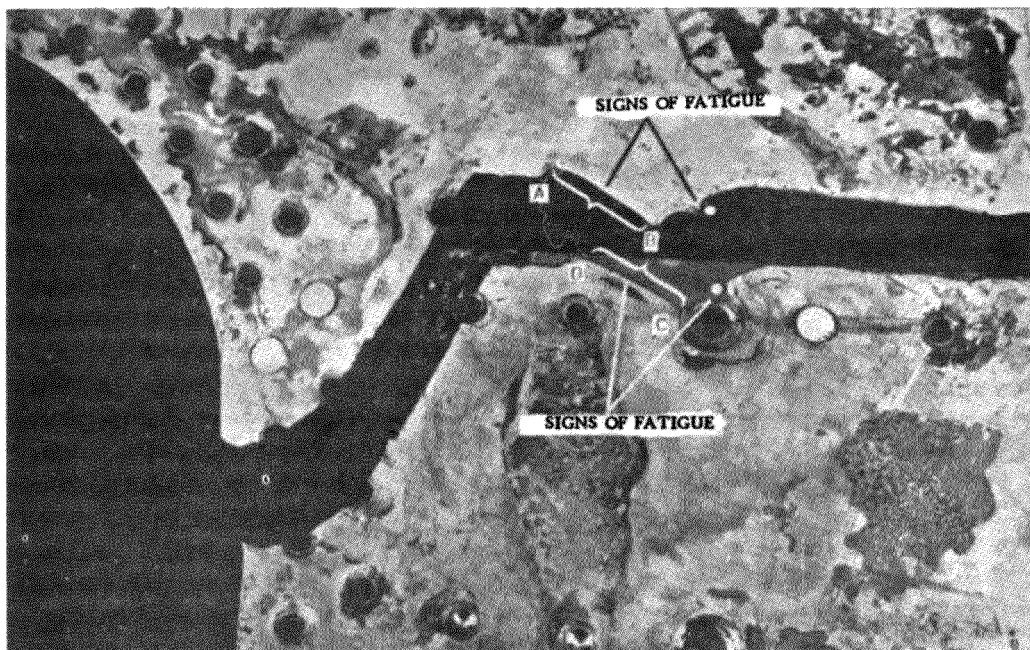
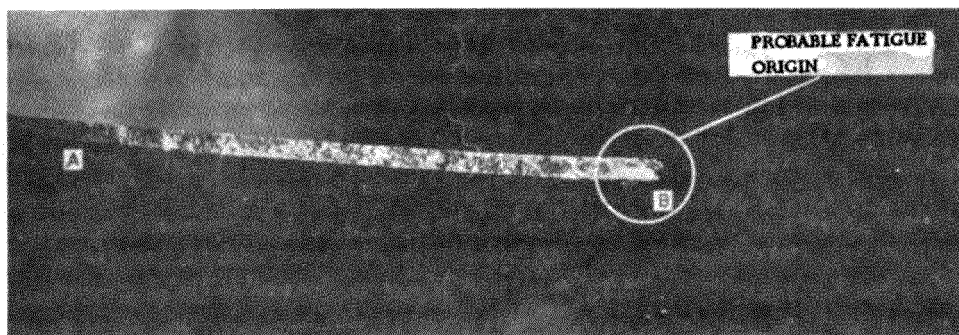
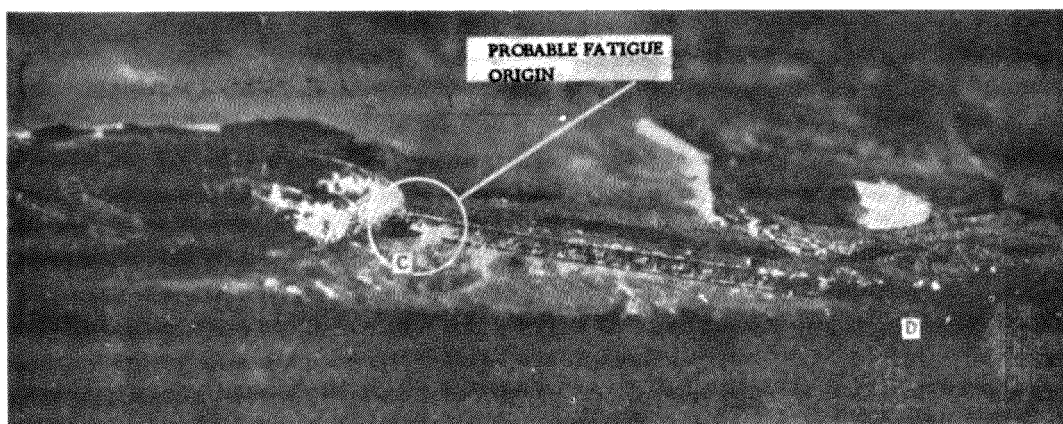
"We have formed the opinion that the accident at Elba was caused by structural failure of the pressure cabin brought about by fatigue. We reach this opinion for the following reasons:

FIG. 16. SIGNS OF FATIGUE IN SKIN AT STARBOARD REAR CORNER OF REAR ADF AERIAL WINDOW—G-ALYP.

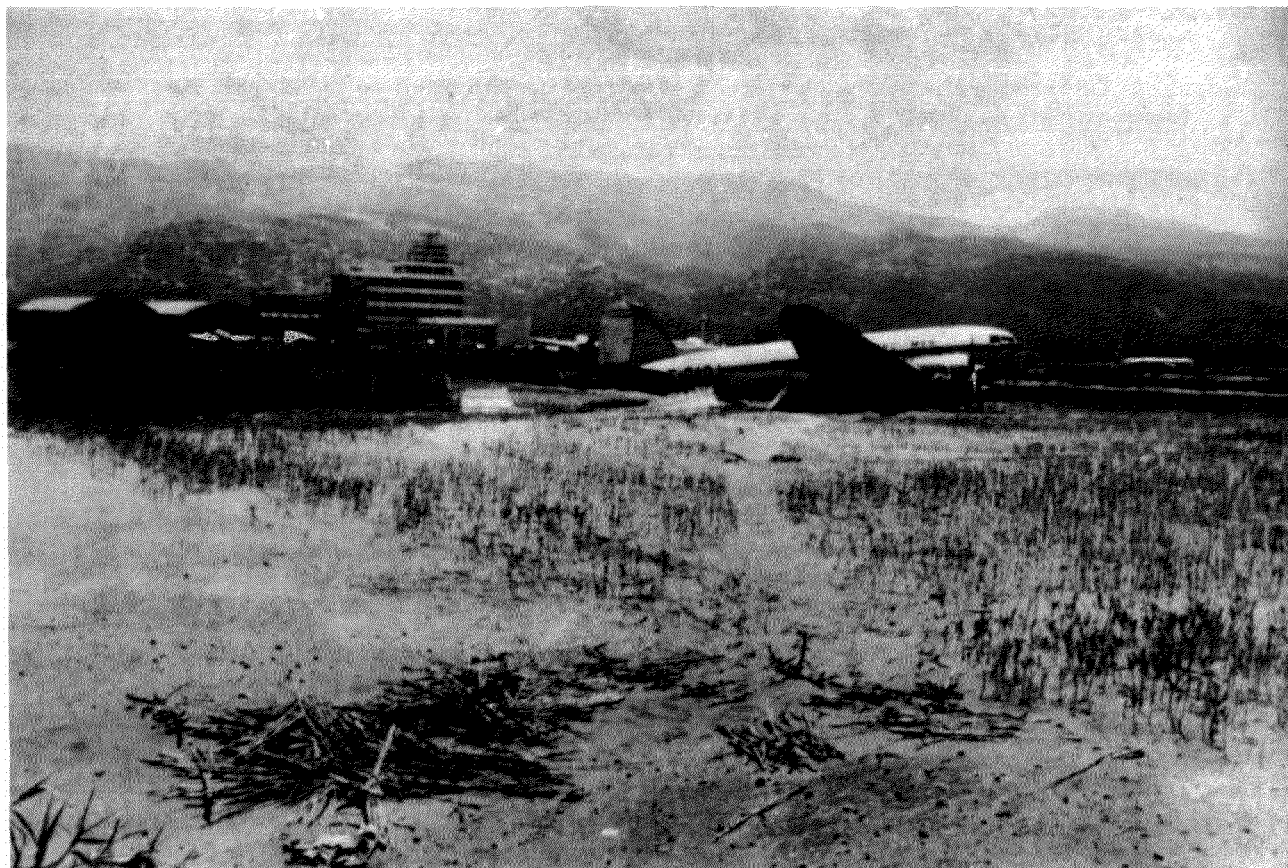
Figure 25

Failure of the port undercarriage back stay attachment fitting, causing the undercarriage to collapse and the aircraft to swing off the runway.
