CIRCULAR 50-AN/45

AIRCRAFT ACCIDENT DIGEST No. 7

Prepared by the Secretariat and published
by authority of the Secretary General

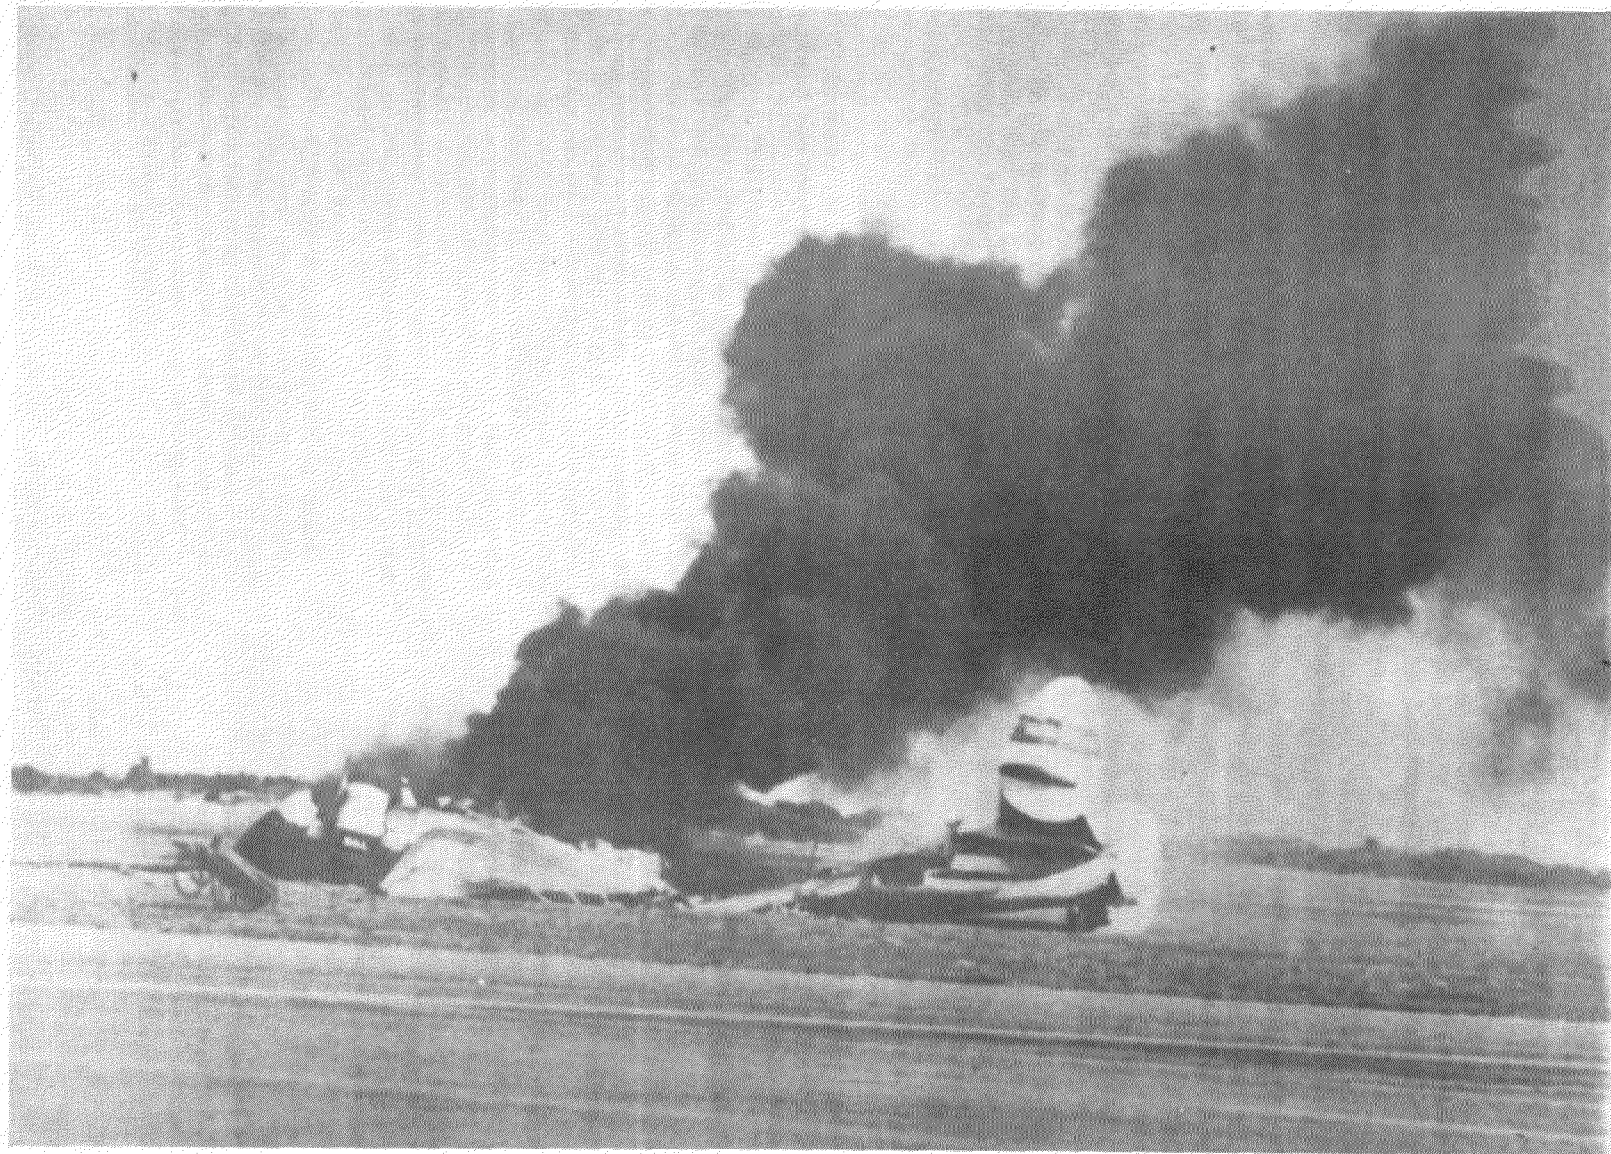
Figure 3

- 9:38 Aircraft groundlooped, gear collapsed and fire started in area of right engine nacelle.
- 9:38+ Under supervision of stewardess, all passengers left the aircraft in a rapid orderly manner through the main cabin door (left side). The pilots made egress through cockpit windows. Alarm given to Airport Fire Department by Tower Controller.
- 9:40 Airport Fire Department reached the scene with a crash truck (capacity 250 gallons of premixed foam) and two 30 lb. dry chemical extinguishers. Fire control could not be achieved with this equipment.
- 9:46 Telephone call received by St. Petersburg Fire Department.
- 9:46+ St. Petersburg Fire Department answered call with three tank wagons and one pumper. On arrival, they were told "to let the plane burn" as all passengers had been removed and the plane was

- "fairly well consumed by fire".
No attempt was made by the
St. Petersburg Fire Department
to extinguish the fire and all equip-
ment was returned to the station.
- 10:05 U.S. Coast Guard Air Station at
St. Petersburg received telephone
call from St. Petersburg Fire
Department that the aircraft had
crashed. Fire truck with crew
was dispatched immediately.
- 10:10 U.S. Coast Guard Duty Officer
advised by Pinellas Tower that
fire was out and truck would not
be needed. Police Department
called and fire truck was stopped
by them and told to return to base.
- 10:25 Pinellas Tower advised U.S.
Coast Guard that fire had started
again. Fire truck and crew were
again dispatched.
- 10:45 U.S. Coast Guard foam truck ar-
rived at scene of crash with 10
men (distance: 18 miles).
- 10:50 Fire extinguished by foam (100
gallons of foam liquid and 1 000
gallons of water).
-

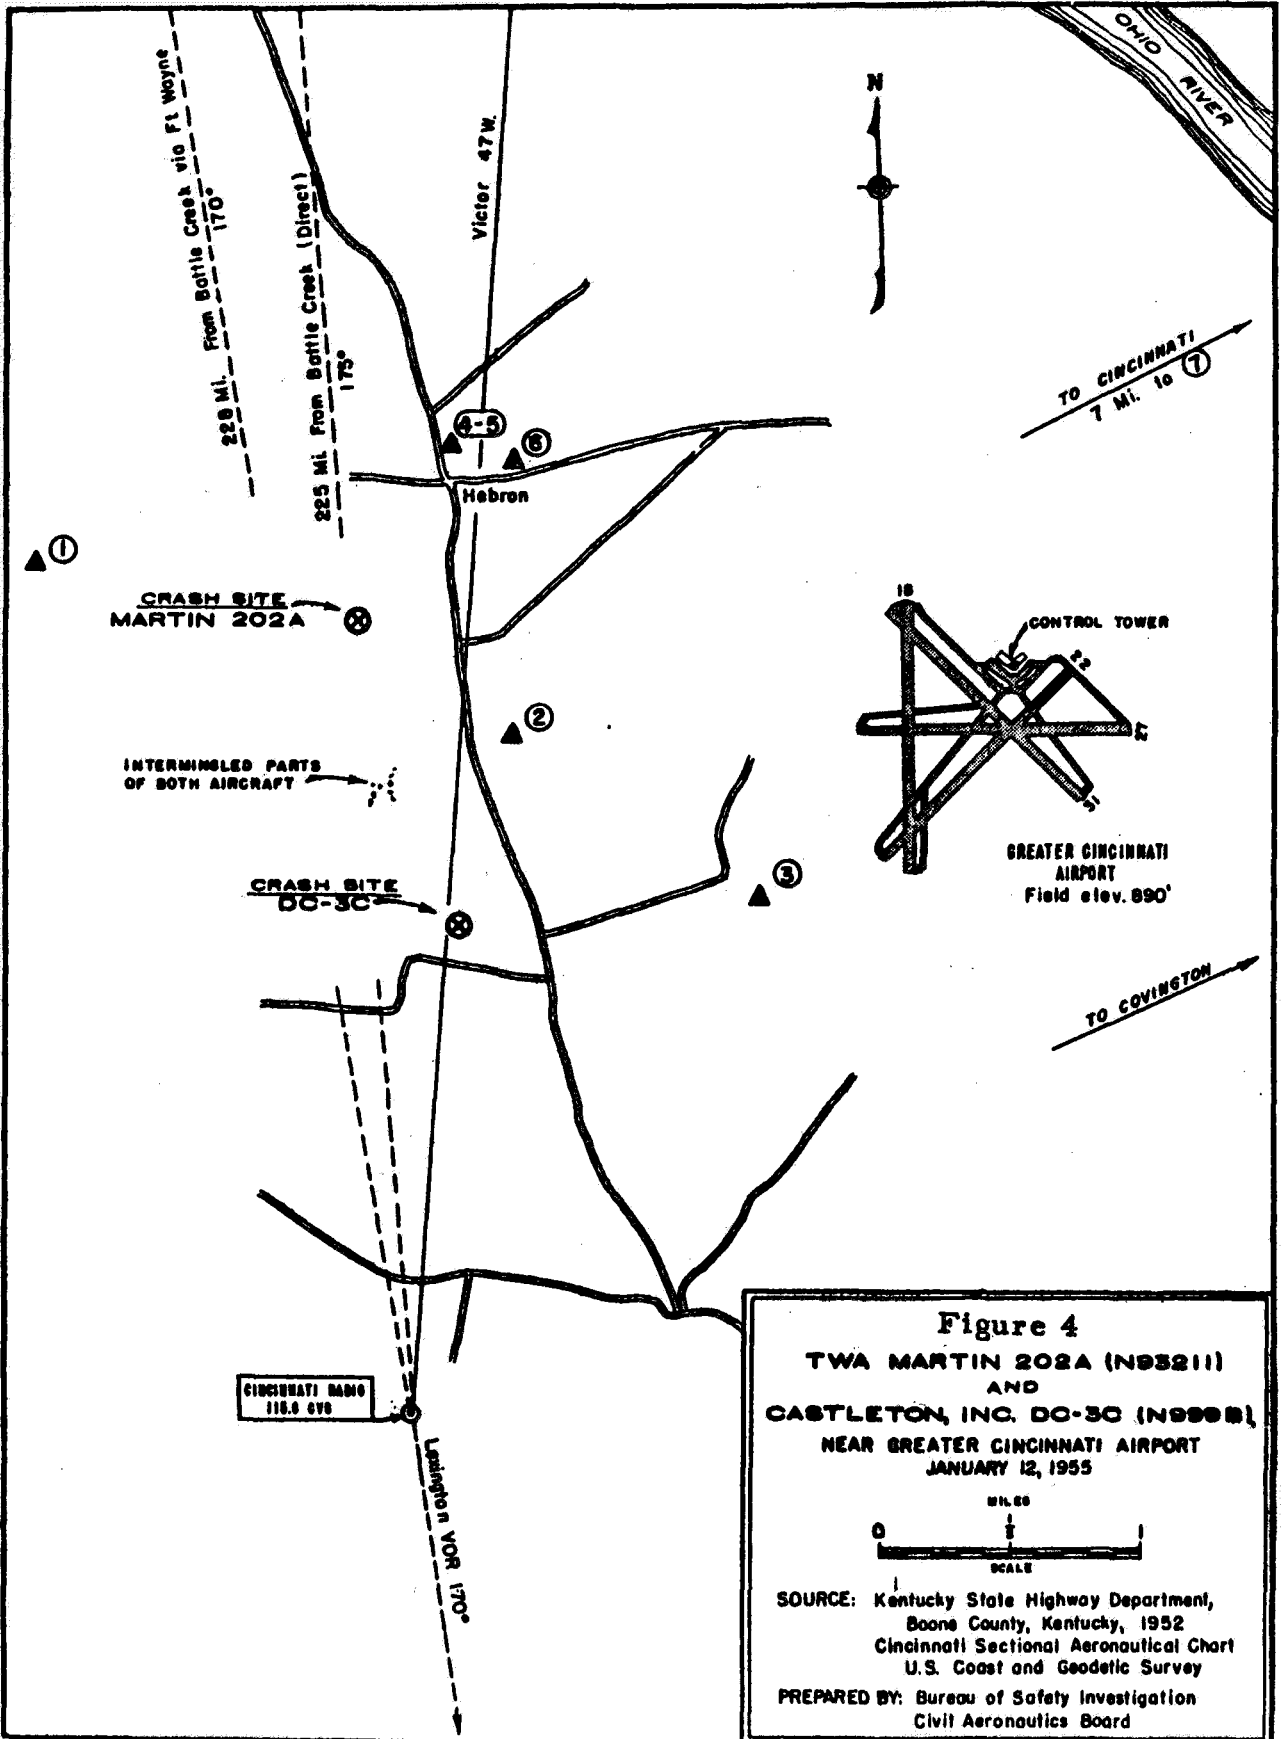
Figure 4
TWA MARTIN 202A (N95211)
AND
CASTLETON, INC. DC-3C (N9998)
NEAR GREATER CINCINNATI AIRPORT
JANUARY 12, 1955

The probable cause of this accident was operation of the DC-3 in the control zone as unknown traffic, without clearance, very close to the base of, or in, the overcast.

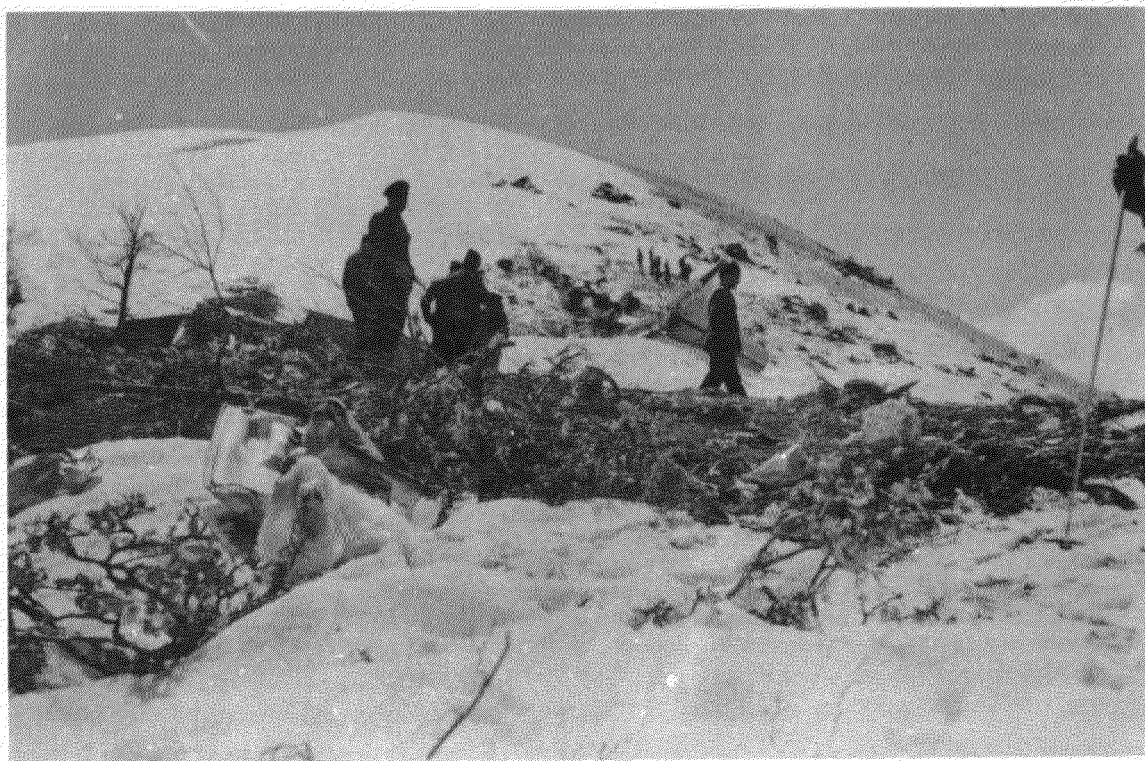
Figure 8

General view of crash area.
Costone dell'Acquasanta, Reatini Mountains.

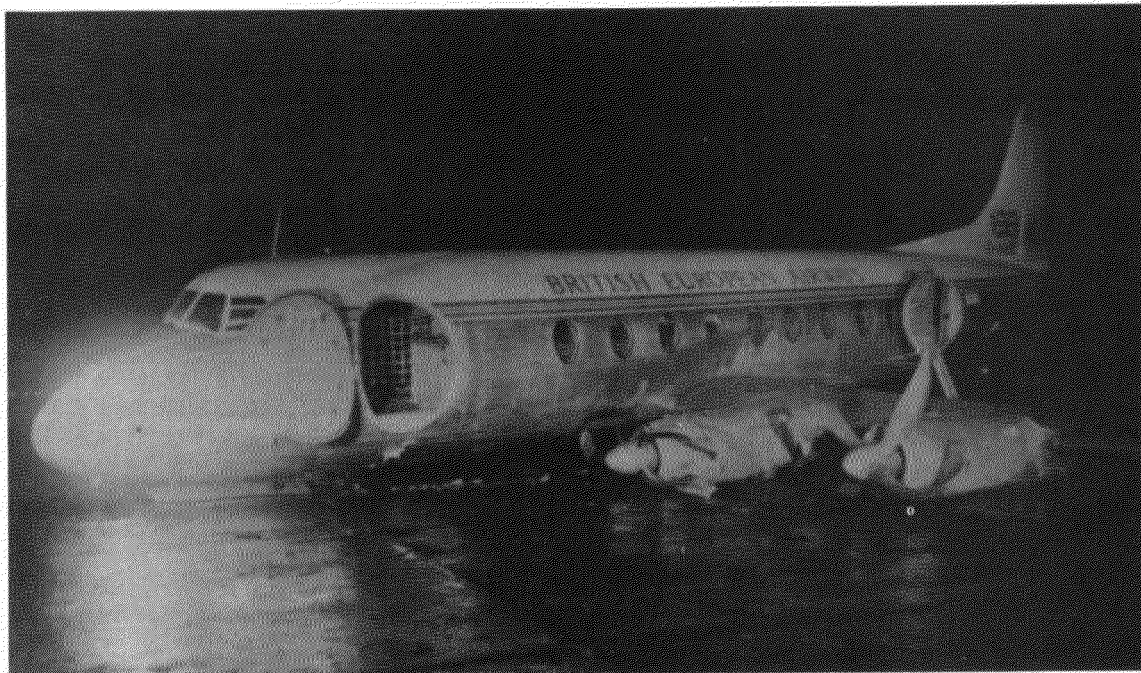
Figure 10

The pilot deviated from the normal procedure and failed to bring the aircraft into alignment with the runway from its position at the time when he obtained visual reference to the runway.

Vickers Viscount G-AMOL at rest on Runway 22 after crash on landing at Copenhagen Airport, Denmark - 25 March 1955.

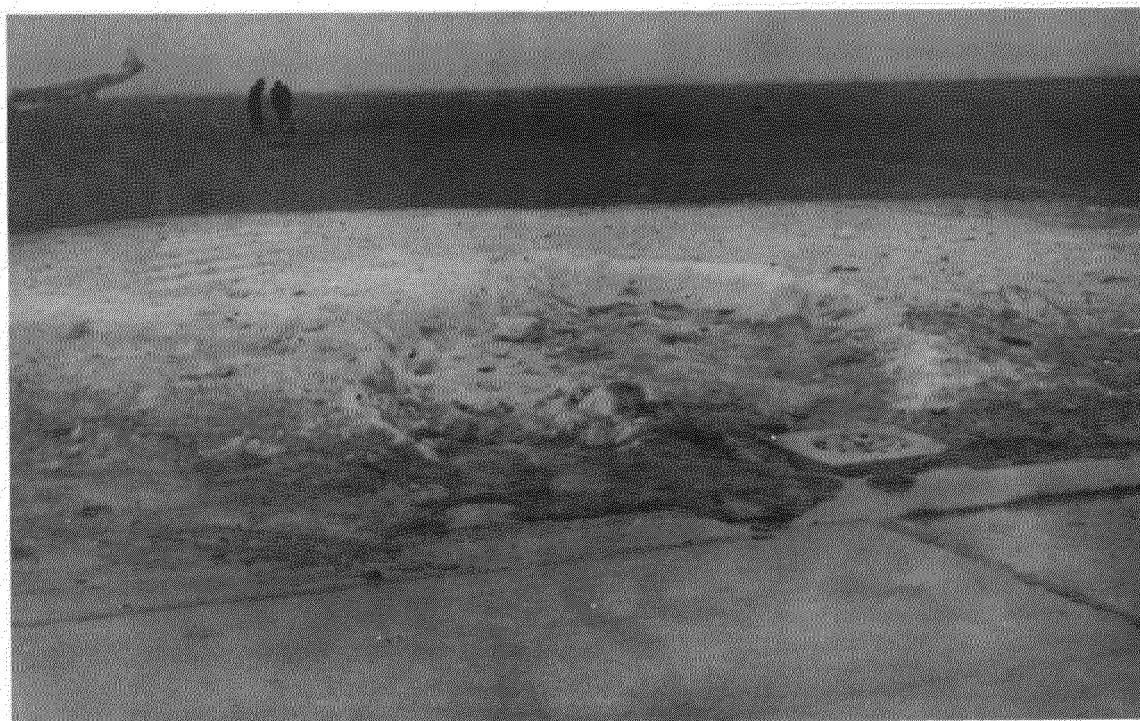
Figure 11

Impression in snow bank made by nose gear and left main gear wheels.

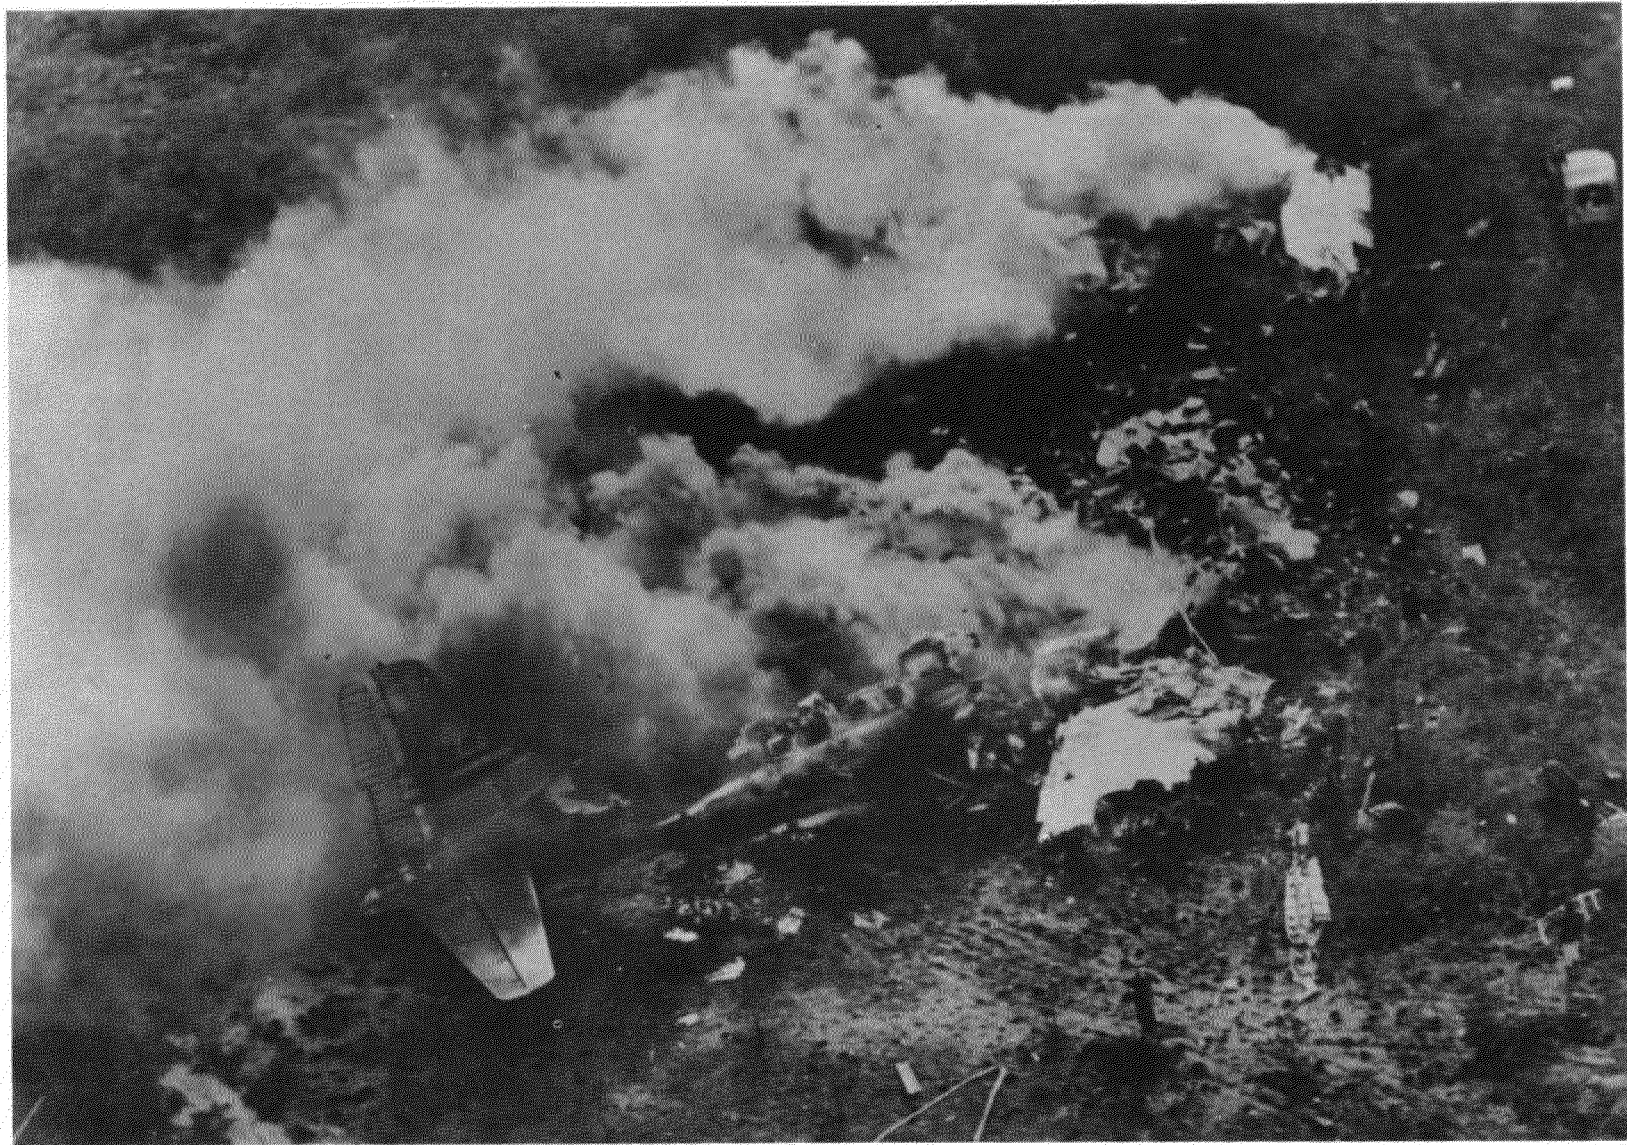
Figure 12

United Air Lines DC-6 which crashed while on a pilot qualification check flight at MacArthur Field, Islip, New York - 4 April 1955. Intense fire consumed a large portion of the wreckage in spite of prompt arrival of fire fighting equipment.

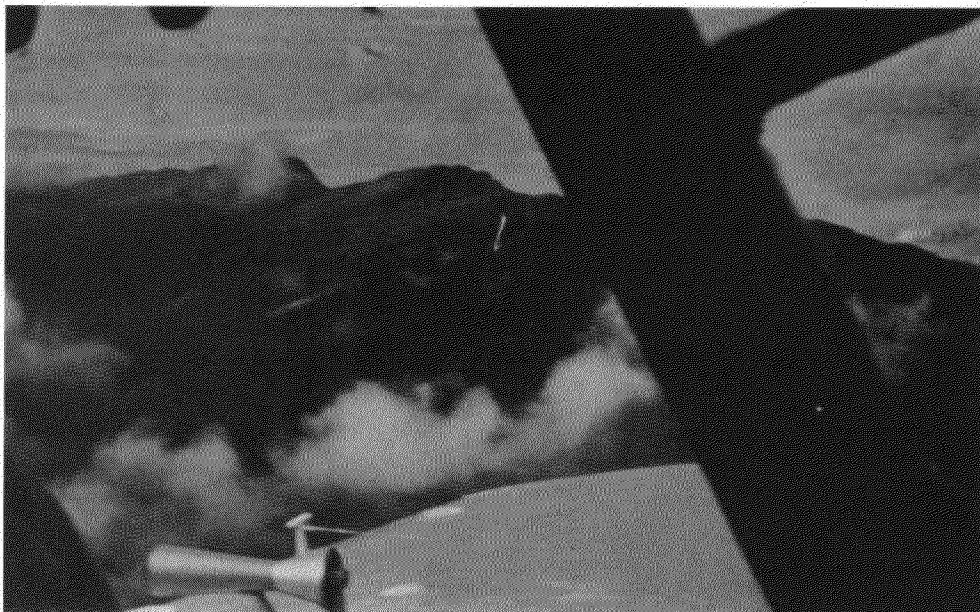
Figure 14

Arrow indicates location of wreckage of Short Sealand, JZ-PTA, which crashed in highlands of Netherlands New Guinea on 28 April 1955.

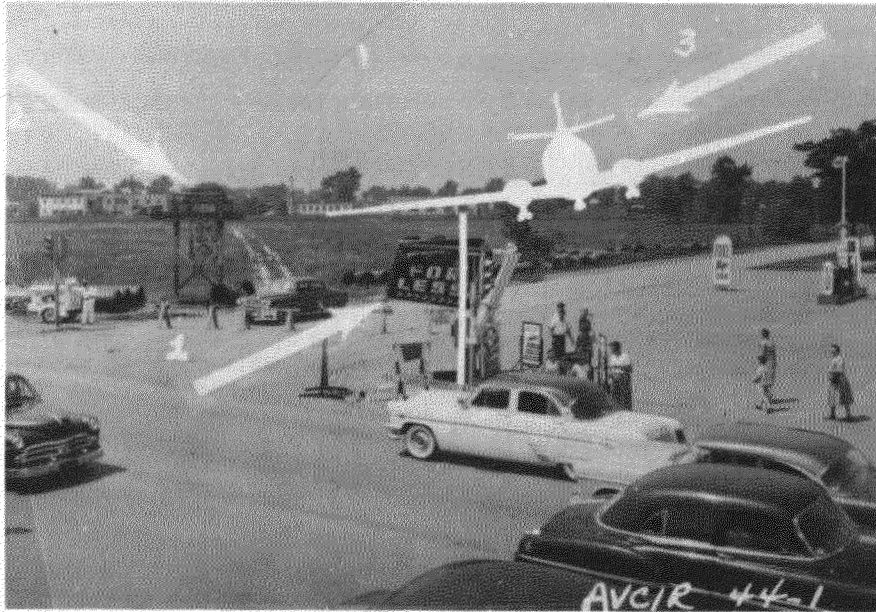
Figure 18

The probable cause of this accident was momentary disorientation caused by the loss of visual reference during the final visual phase of the approach resulting in an increased rate of descent at an altitude too low to effect recovery.

Braniff Airways, Inc., Convair 340 crash at Midway Airport, Chicago - 17 July 1955. View looking back along the approach path; the aircraft initially struck the 18 ft. high electric sign (1), which was approximately 90 ft. from the airport boundary fence. A portion of the line of approach lights (outside of the airport boundary) are shown at (2). The Convair was to the left, and below, the normal approach path - as indicated by the aircraft silhouette (3).

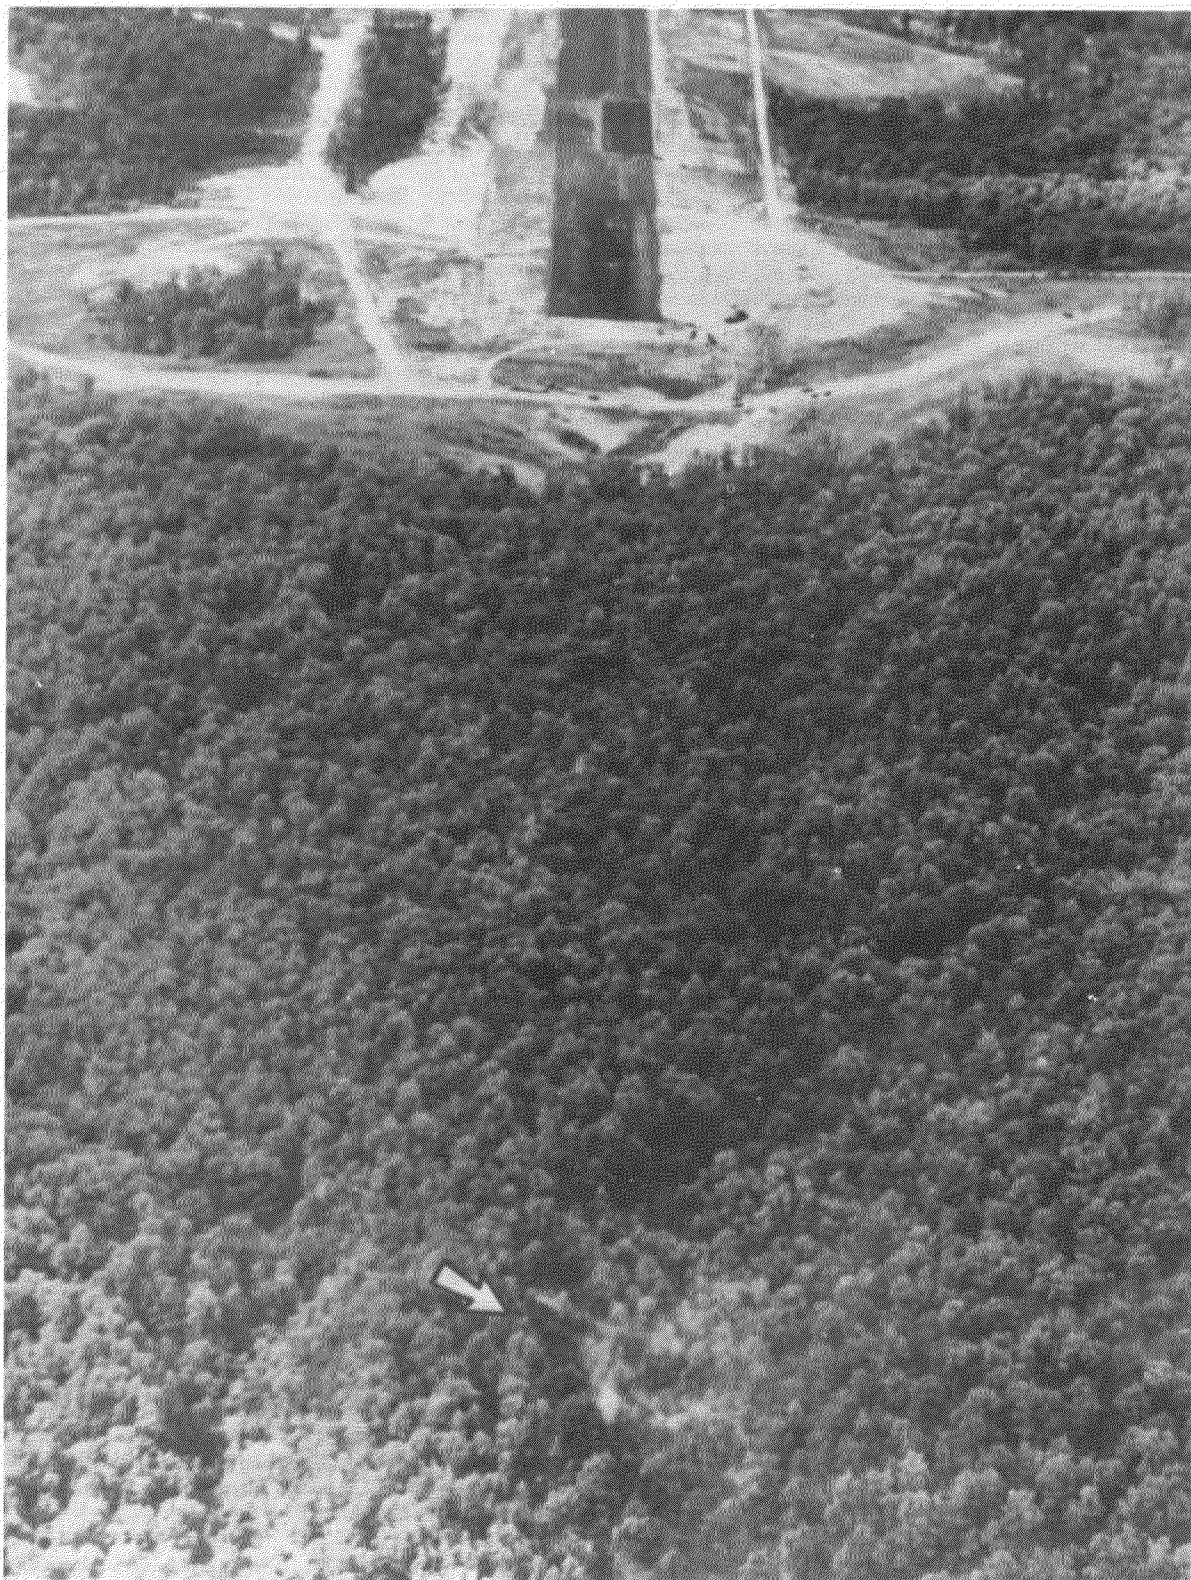
Figure 22

The probable cause of this accident was installation of an unairworthy cylinder, the failure of which resulted in an uncontrollable fire and subsequent loss of a wing in flight.

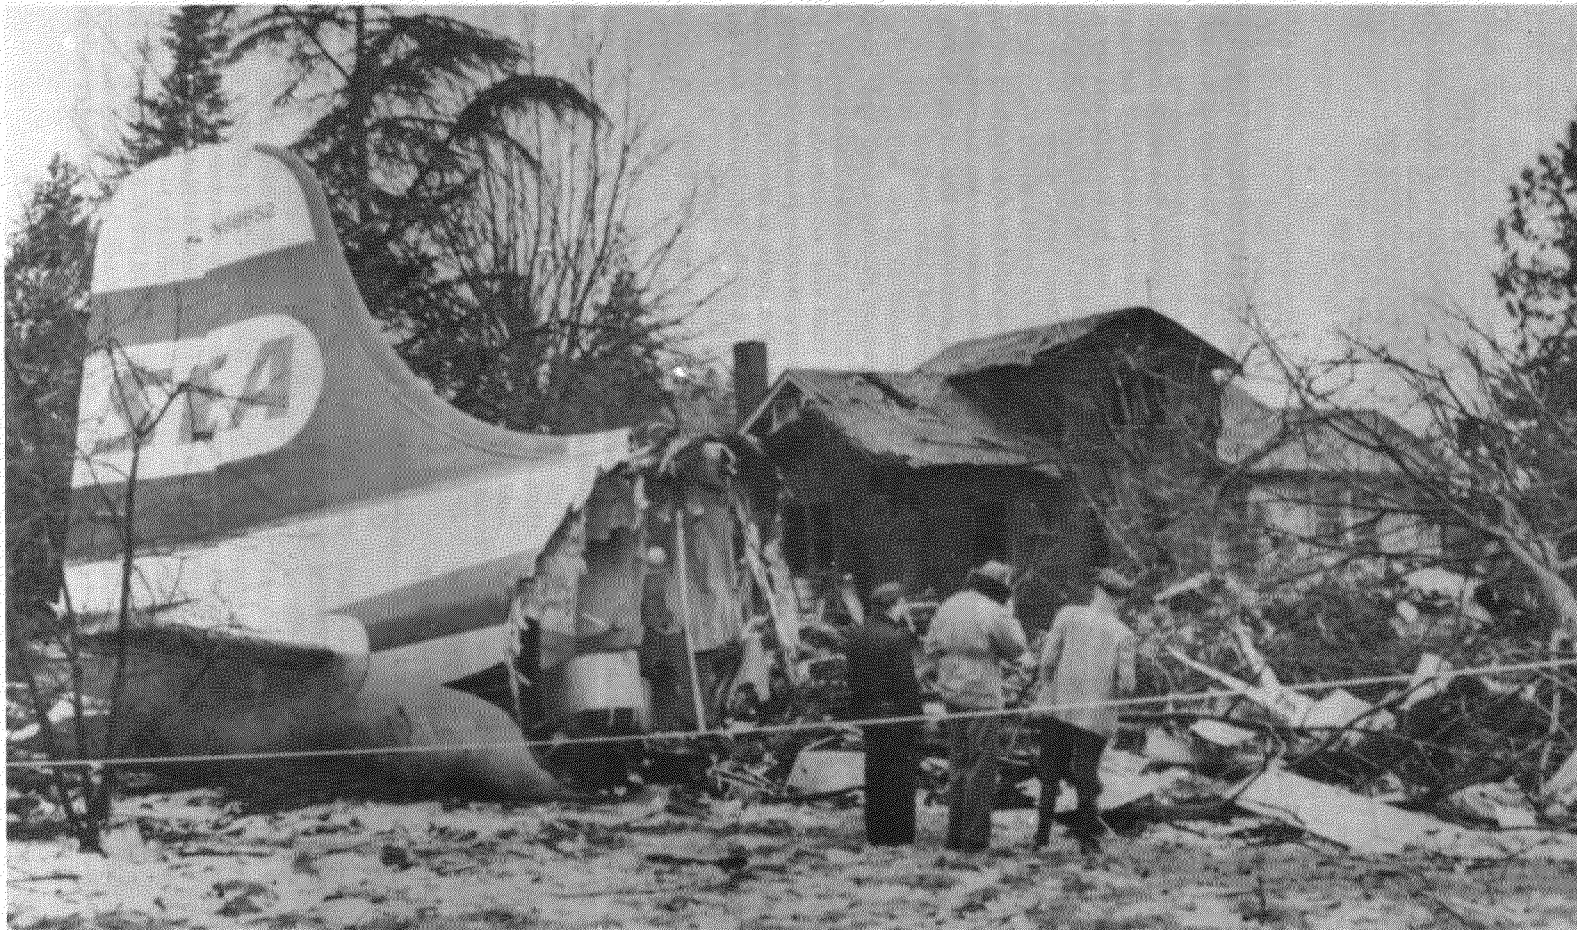
Figure 26

The probable cause of this accident was the excessively high drag resulting from the improperly indexed propeller blades and inability to feather. These conditions were the result of a series of maintenance errors and omissions.
