ICAO

CIRCULAR 54-AN/49

AIRCRAFT ACCIDENT DIGEST

No. 8

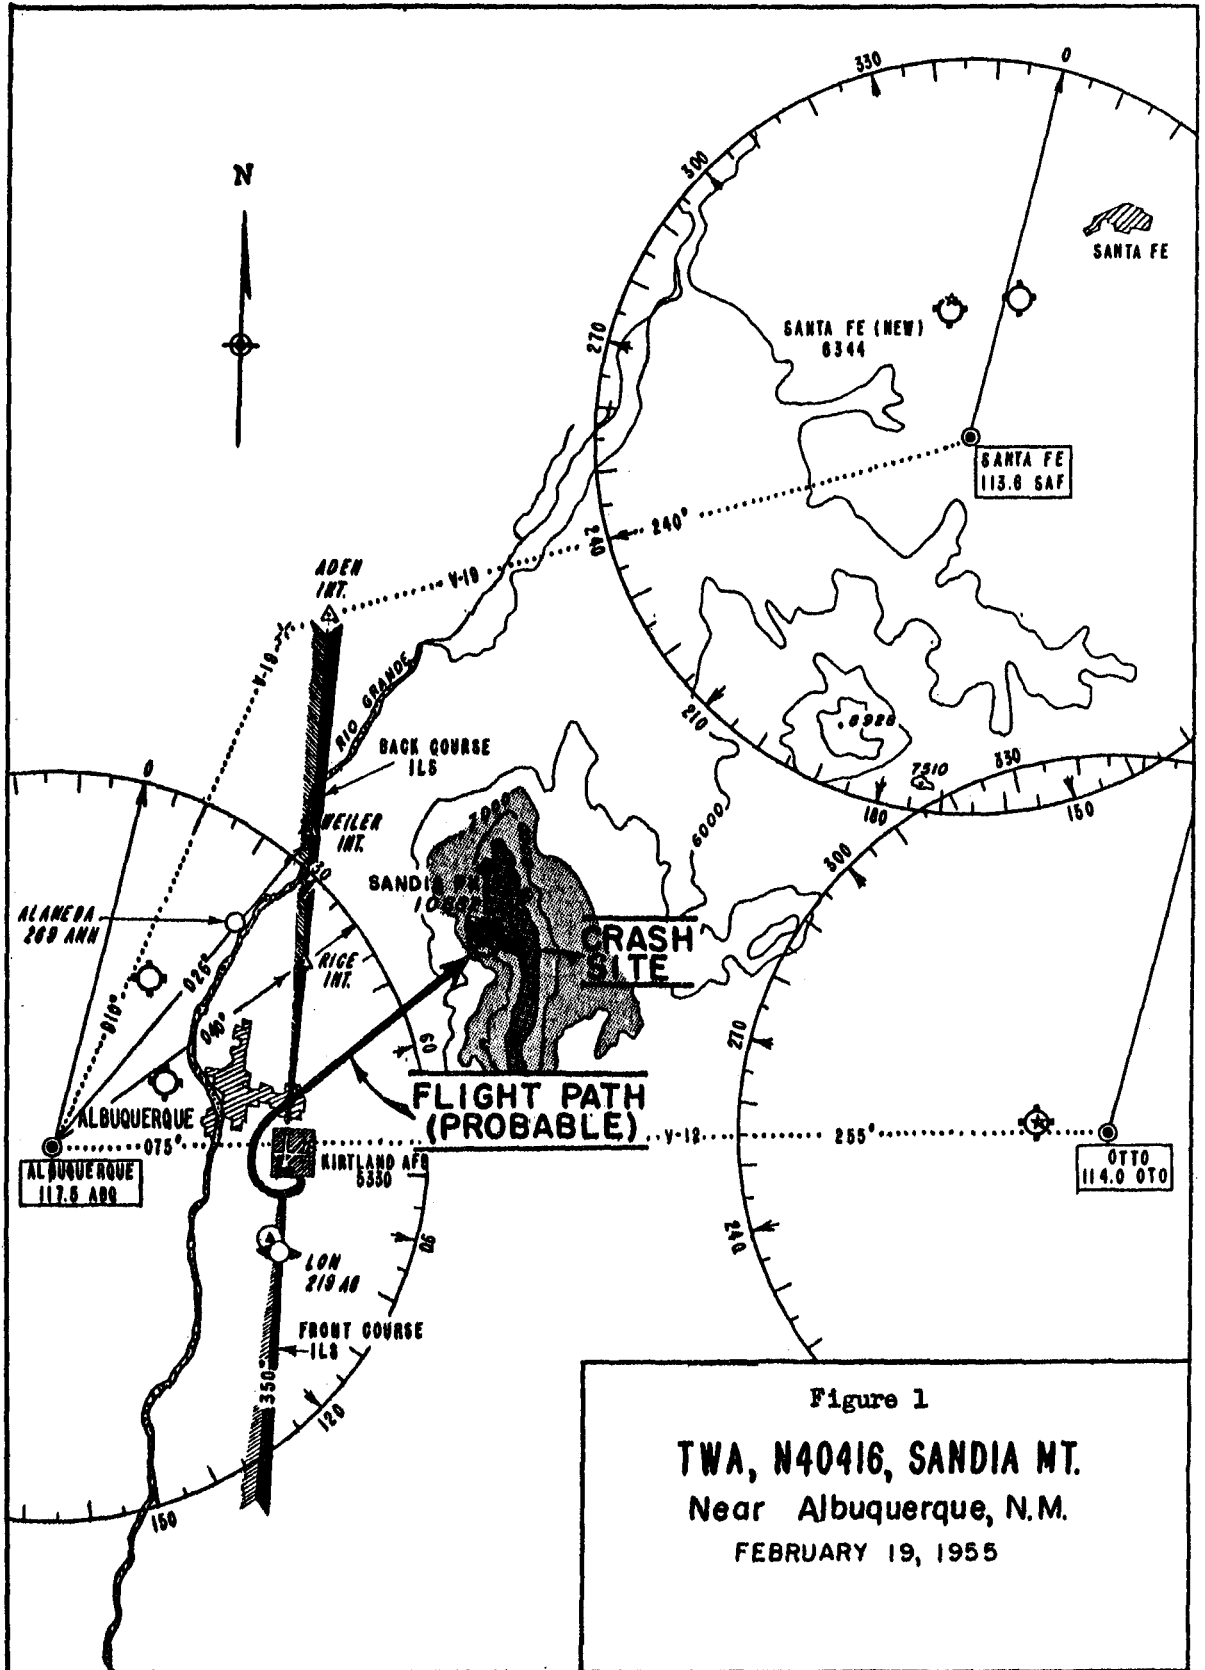
Figure 1
TWA, N40416, SANDIA MT.
Near Albuquerque, N.M.
FEBRUARY 19, 1955

The probable cause of this accident was a lack of conformity with prescribed en route procedures and the deviation from airways at an altitude too low to clear obstructions ahead.

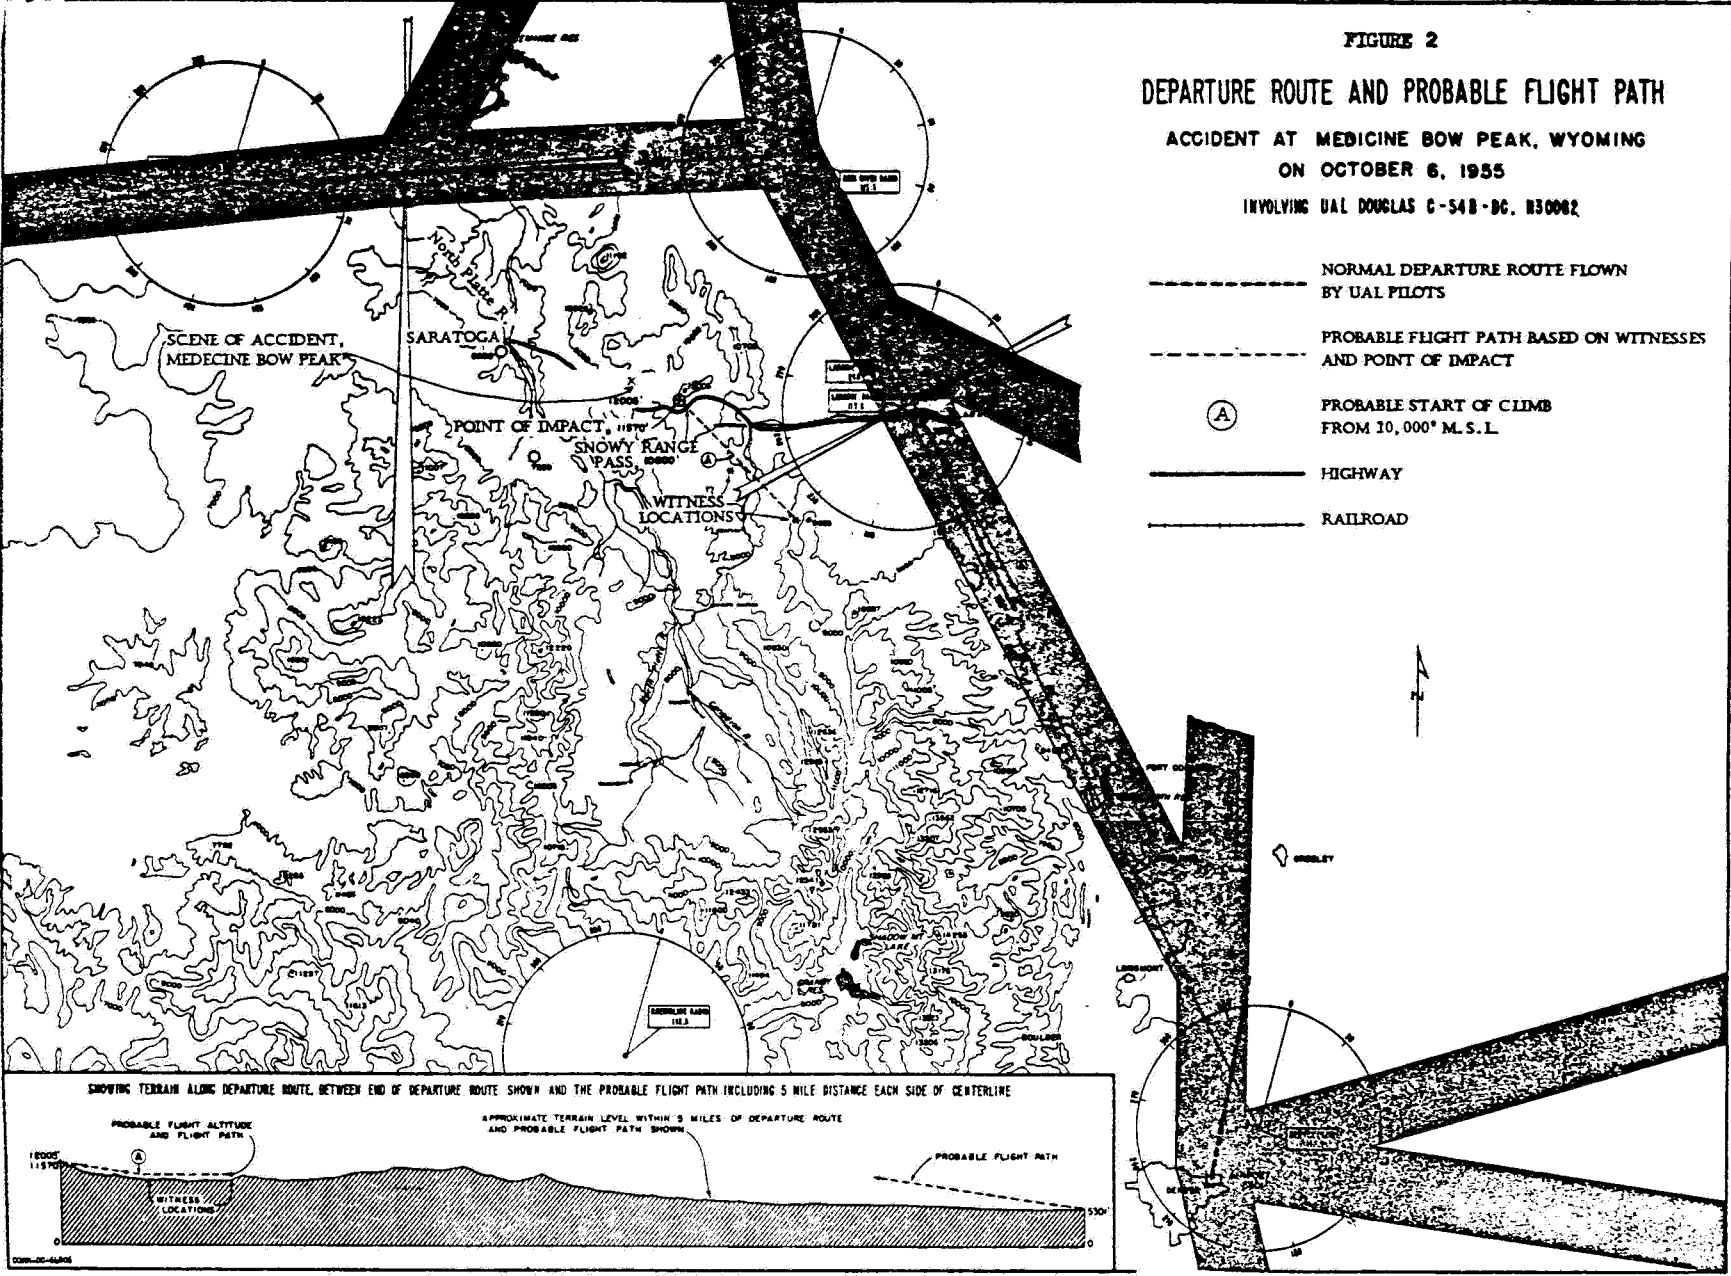
ACCIDENT AT MEDICINE BOW PEAK, WYOMING
ON OCTOBER 6, 1955

The probable cause of this accident was the action of the pilot in deviating from the planned route for reasons unknown.

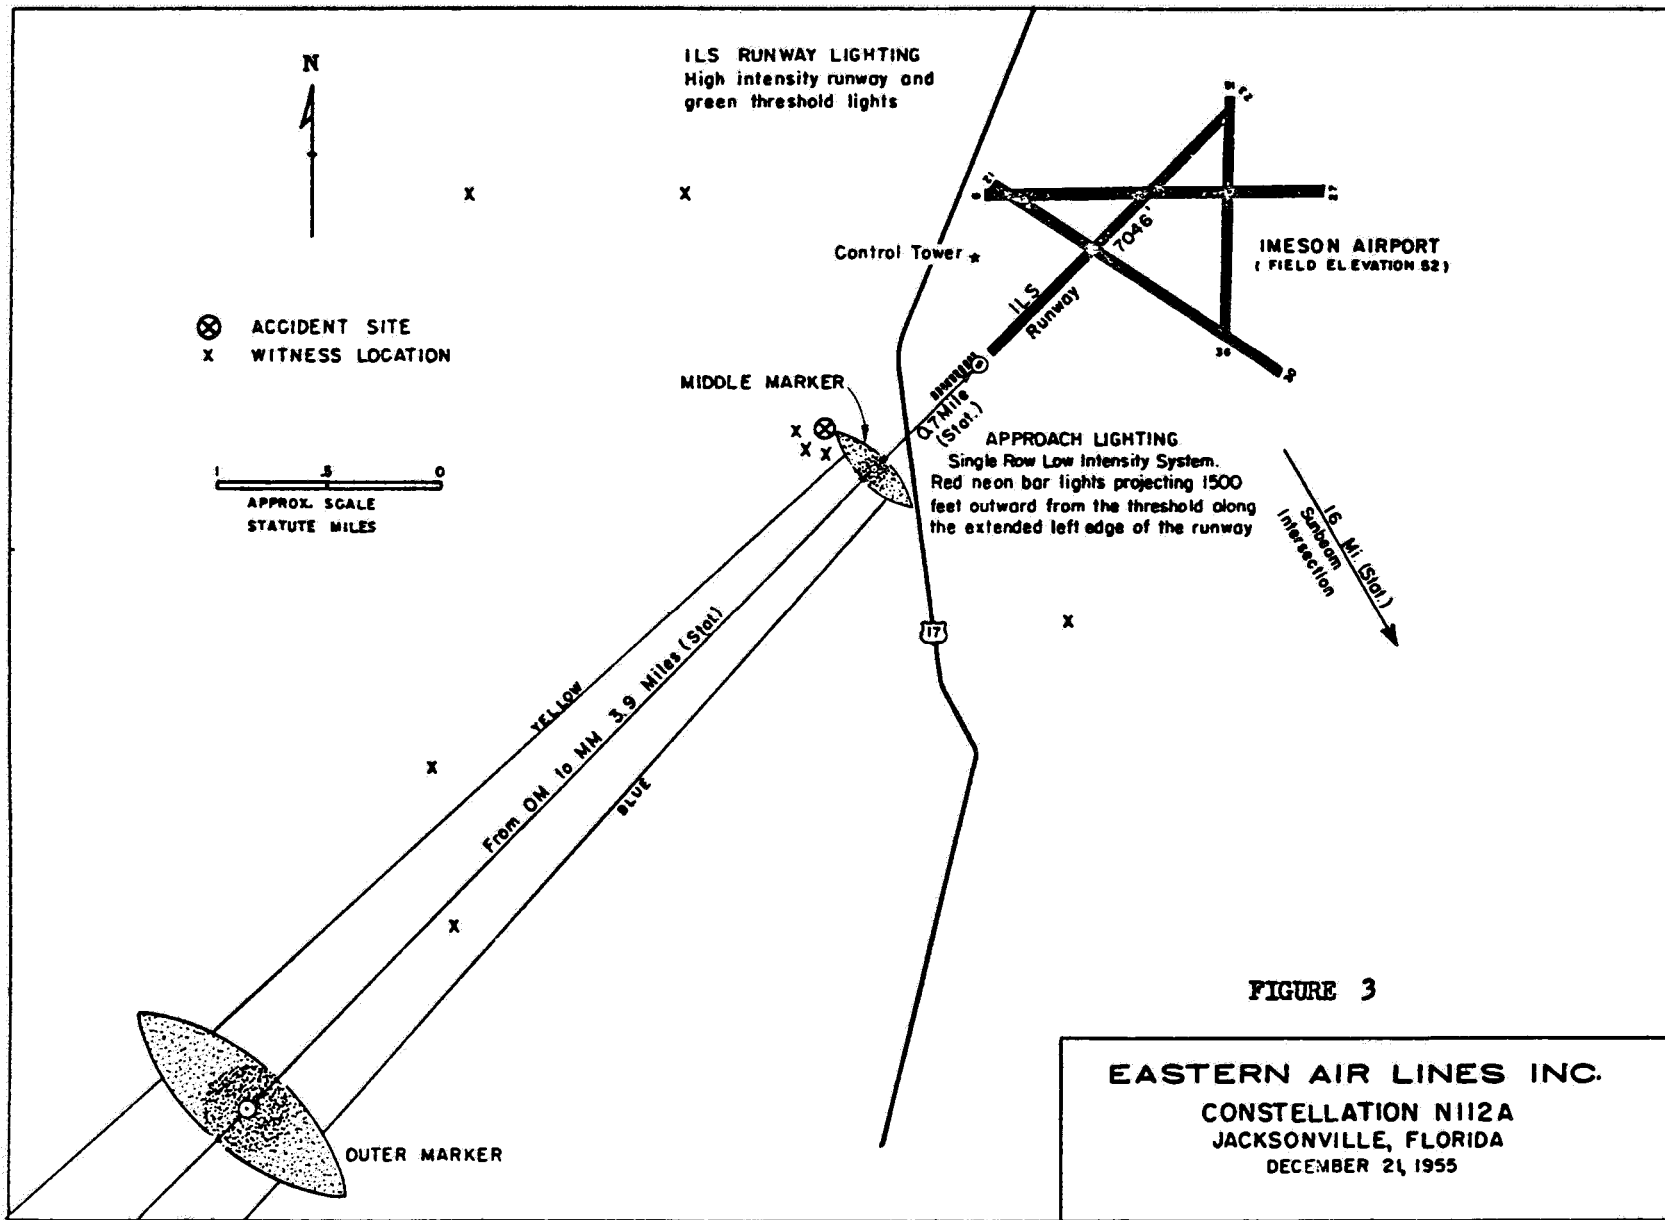
FIGURE 3

The Board determines that the probable cause of this accident was that during the final portion of an ILS approach the pilot, for reasons not determinable, either permitted or caused the aircraft to deviate to the left of course and descend below the glide path to an altitude too low to clear ground obstructions.

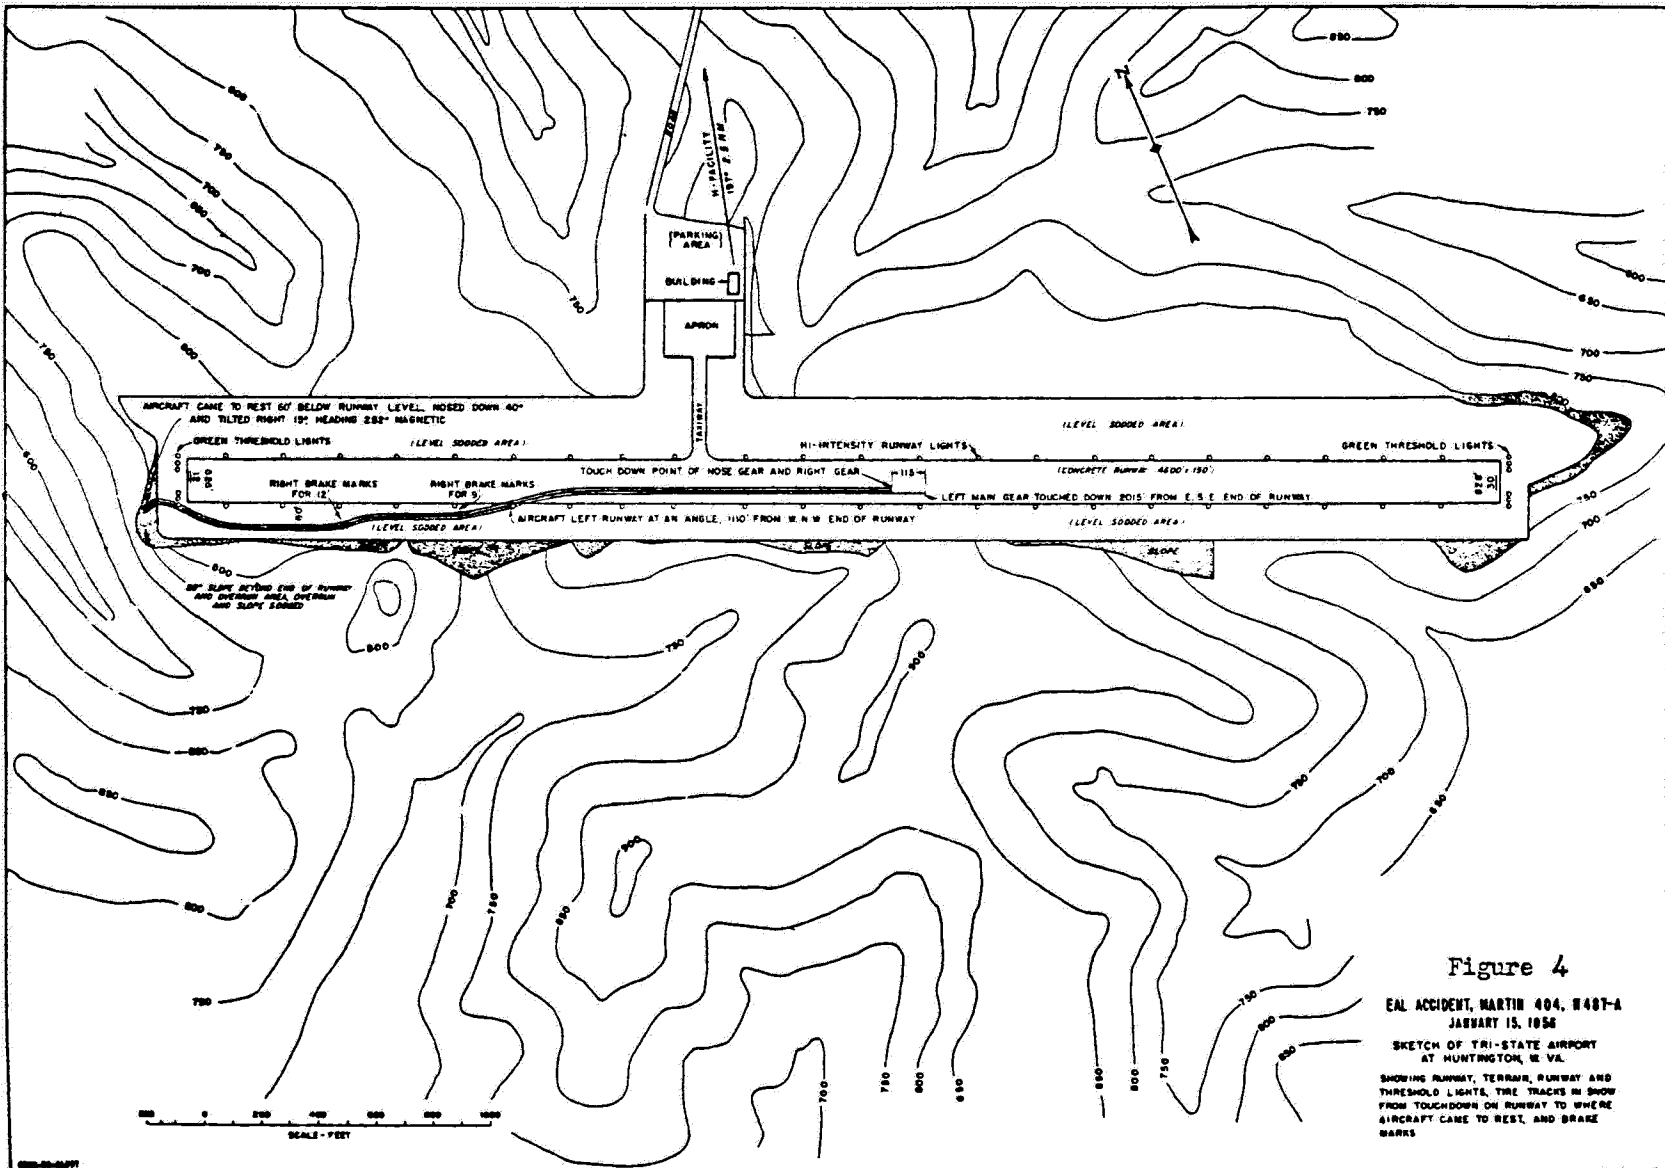
Figure 4
EAL ACCIDENT, MARTIN 404, N487-A
JANUARY 15, 1954
SKETCH OF TRI-STATE AIRPORT
AT HUNTINGTON, W. VA.
 SHOWING RUNWAY, TERRAIN, RUNWAY AND
 THRESHOLD LIGHTS, FIRE TRACKS IN SNOW
 FROM TOUCHDOWN ON RUNWAY TO WHERE
 AIRCRAFT CAME TO REST, AND BRAKE
 MARKS

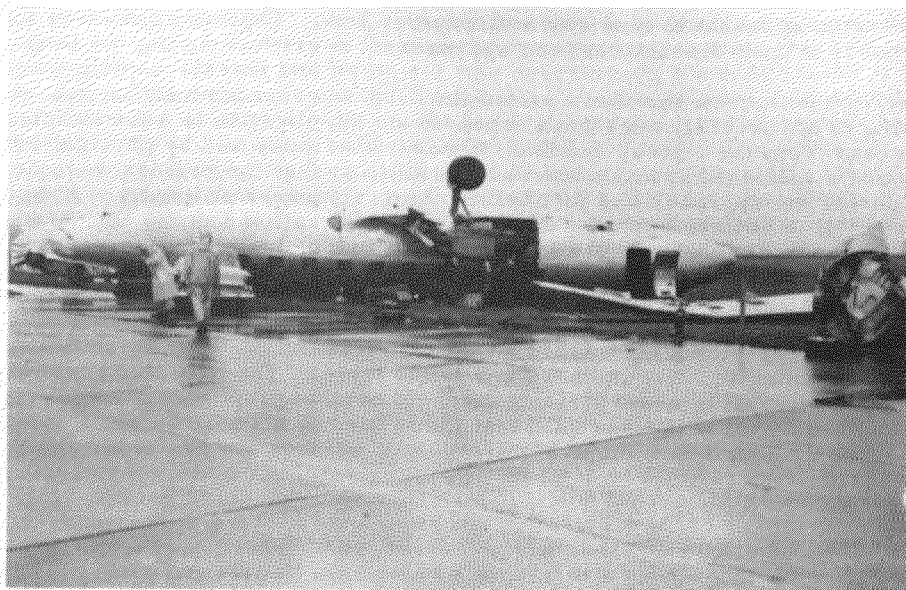
Figure 5 Aviation Crash Injury
Research Photo

The probable cause of this accident was an improperly executed final approach, resulting in a stall, during a steep left turn at an altitude too low to permit recovery.

Eastern Air Lines crash at Owensboro, Kentucky. Left side of aircraft showing final resting attitude (inverted). Photo was made after the left wing was removed by salvage crew.

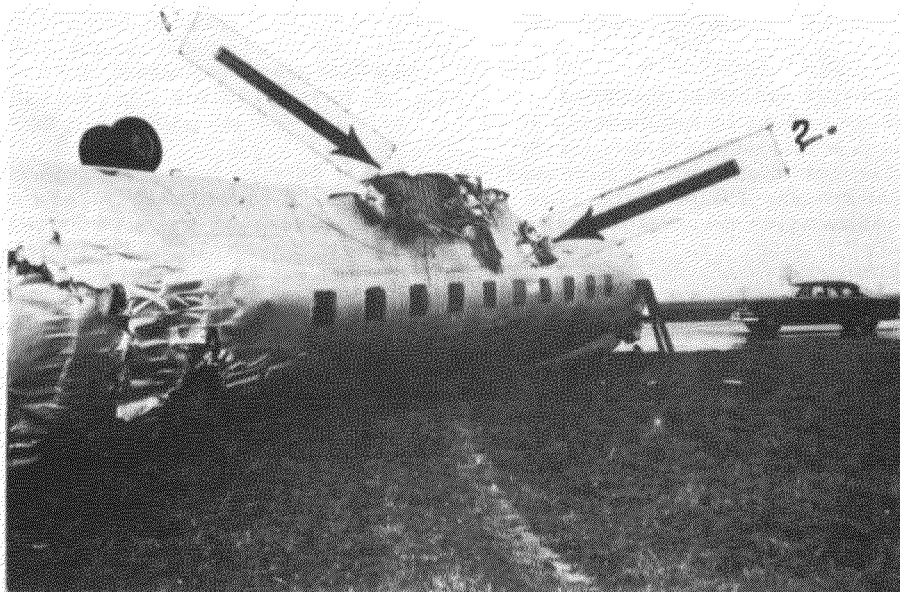
Figure 6 Aviation Crash Injury
Research Photo

Right side of the aircraft - the right wing was torn completely free at the fuselage (1) during the latter part of the initial impact. Penetration of the fuselage at (2) by the inboard trailing edge of the wing forced one passenger seat free from its anchorages.

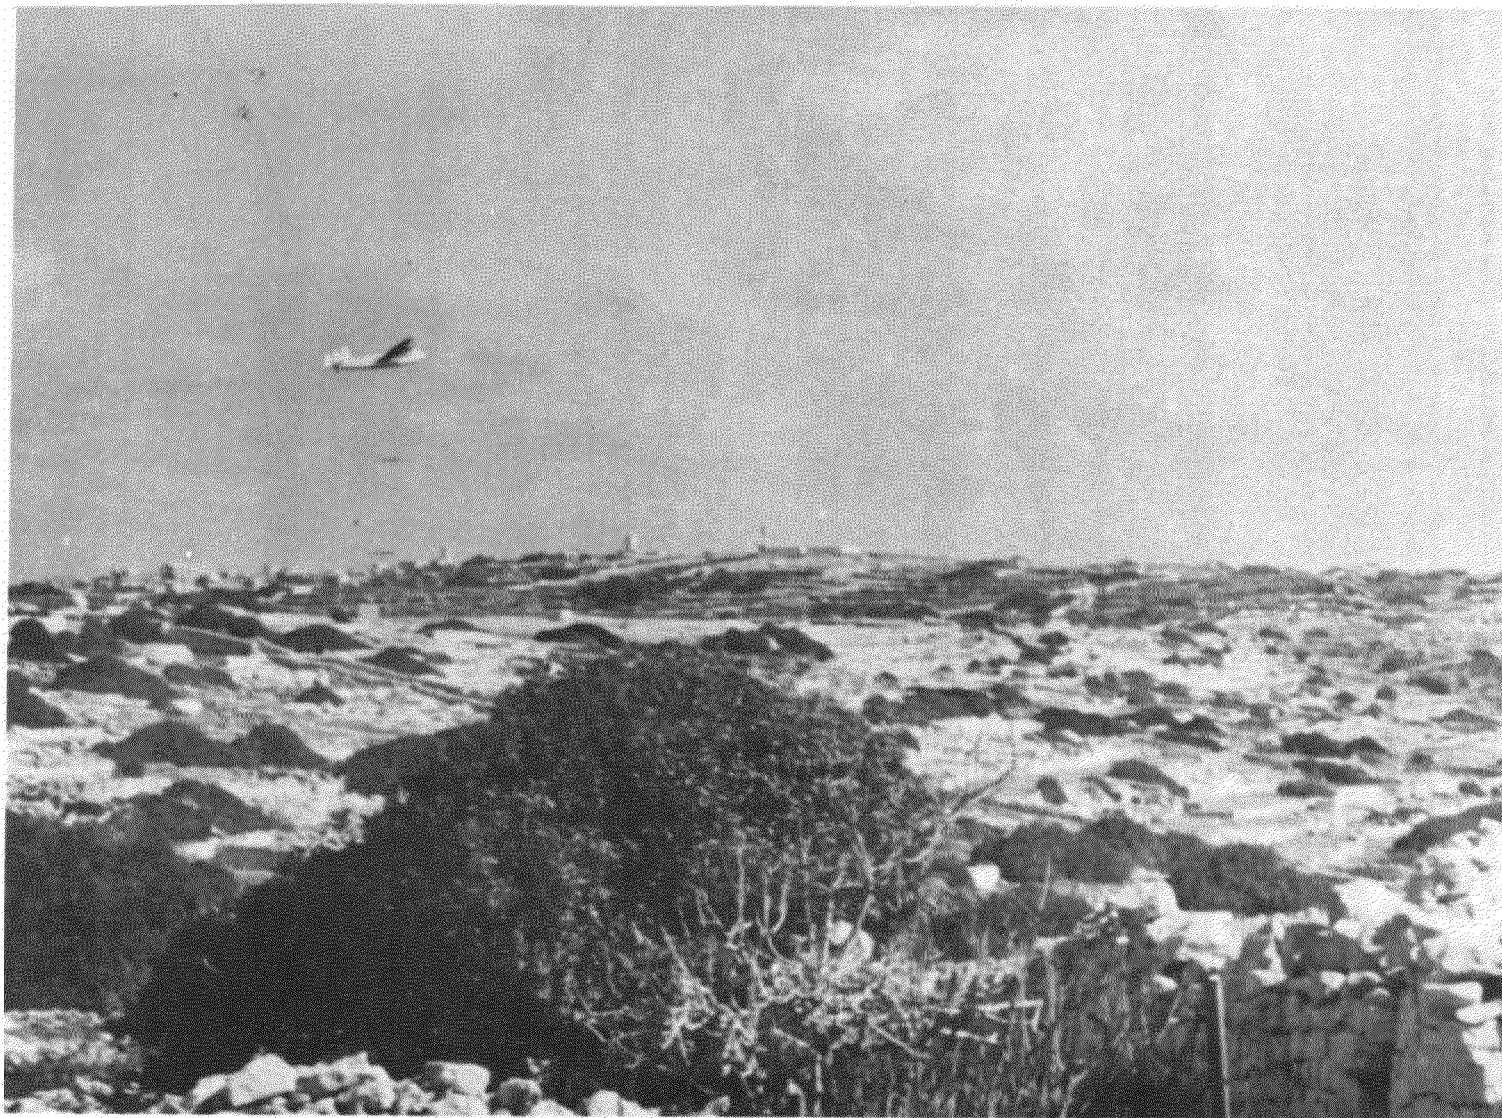
Figure 8

BEFORE - This photo was taken just a few moments before Avro-York, G-ANSY, crashed into the ground on the cliffs near Zurrieq, Malta, on 18 February 1956.

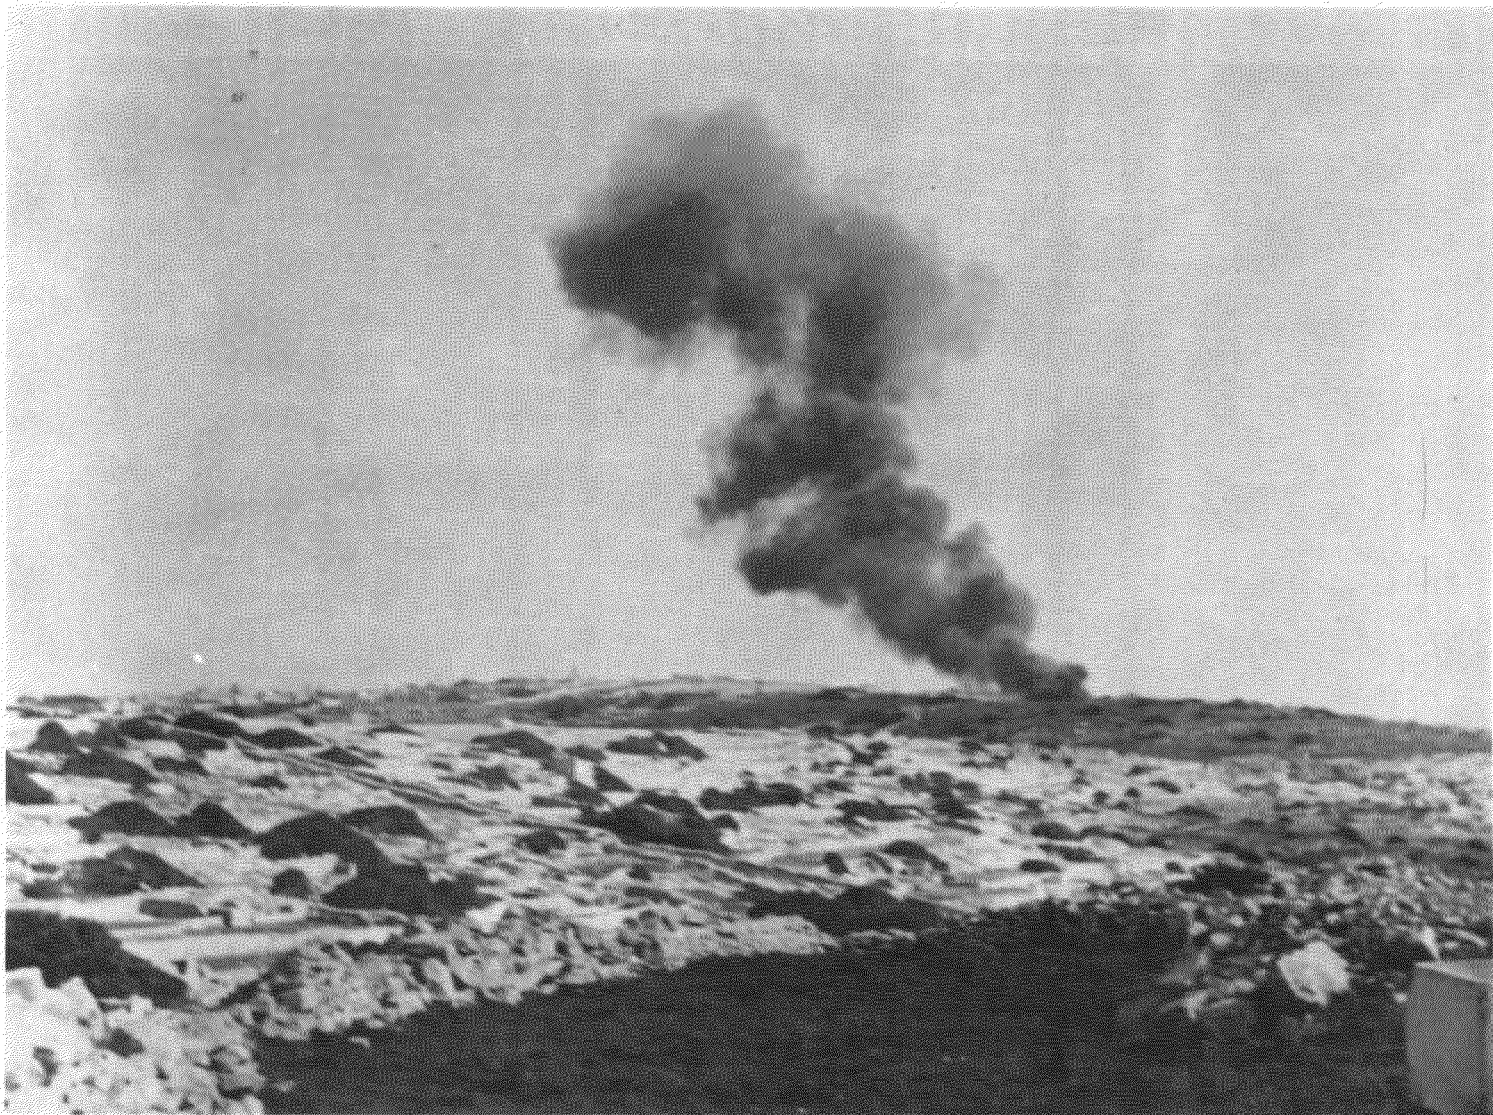
Figure 9

AFTER - The same Avro-York a few minutes later.
It nose-dived into the ground and blew up
on impact killing all 50 persons aboard.

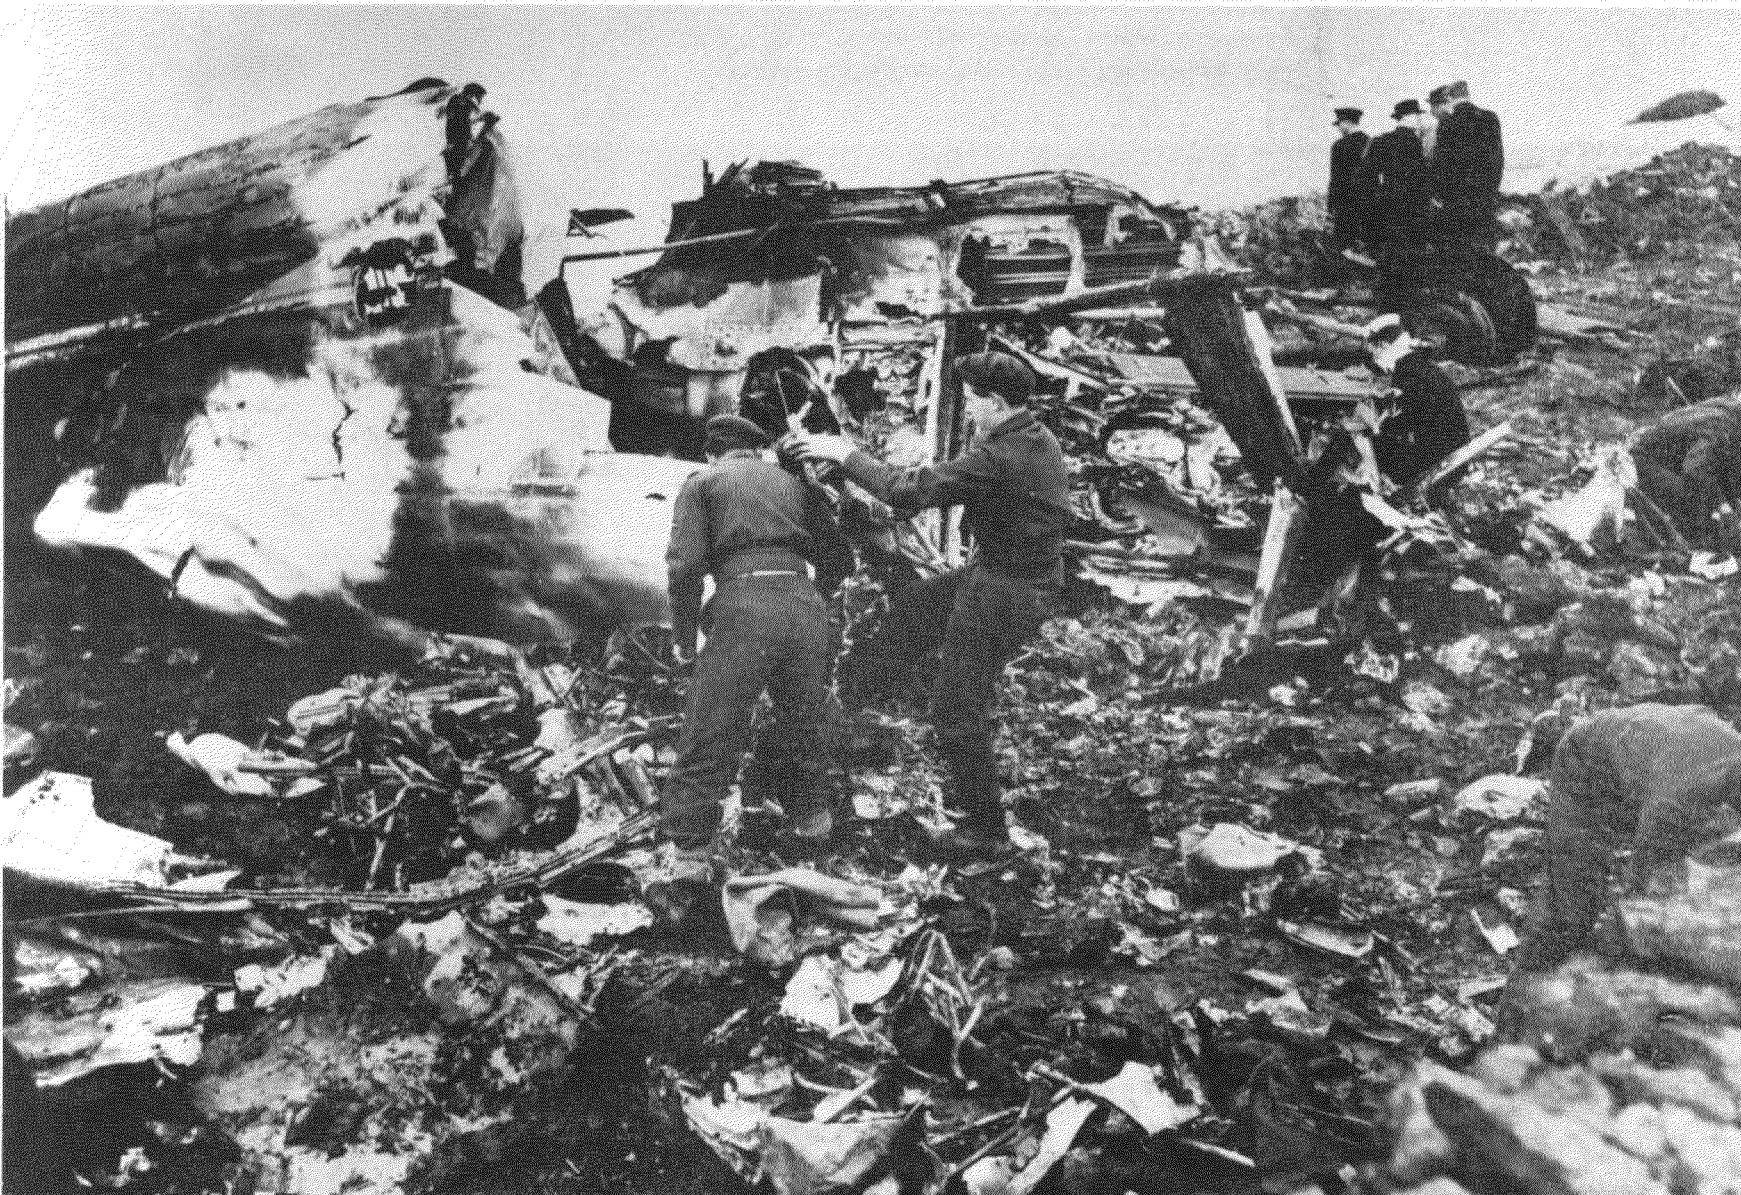
Figure 10

General view of wreckage area of Avro-York, G-ANSY

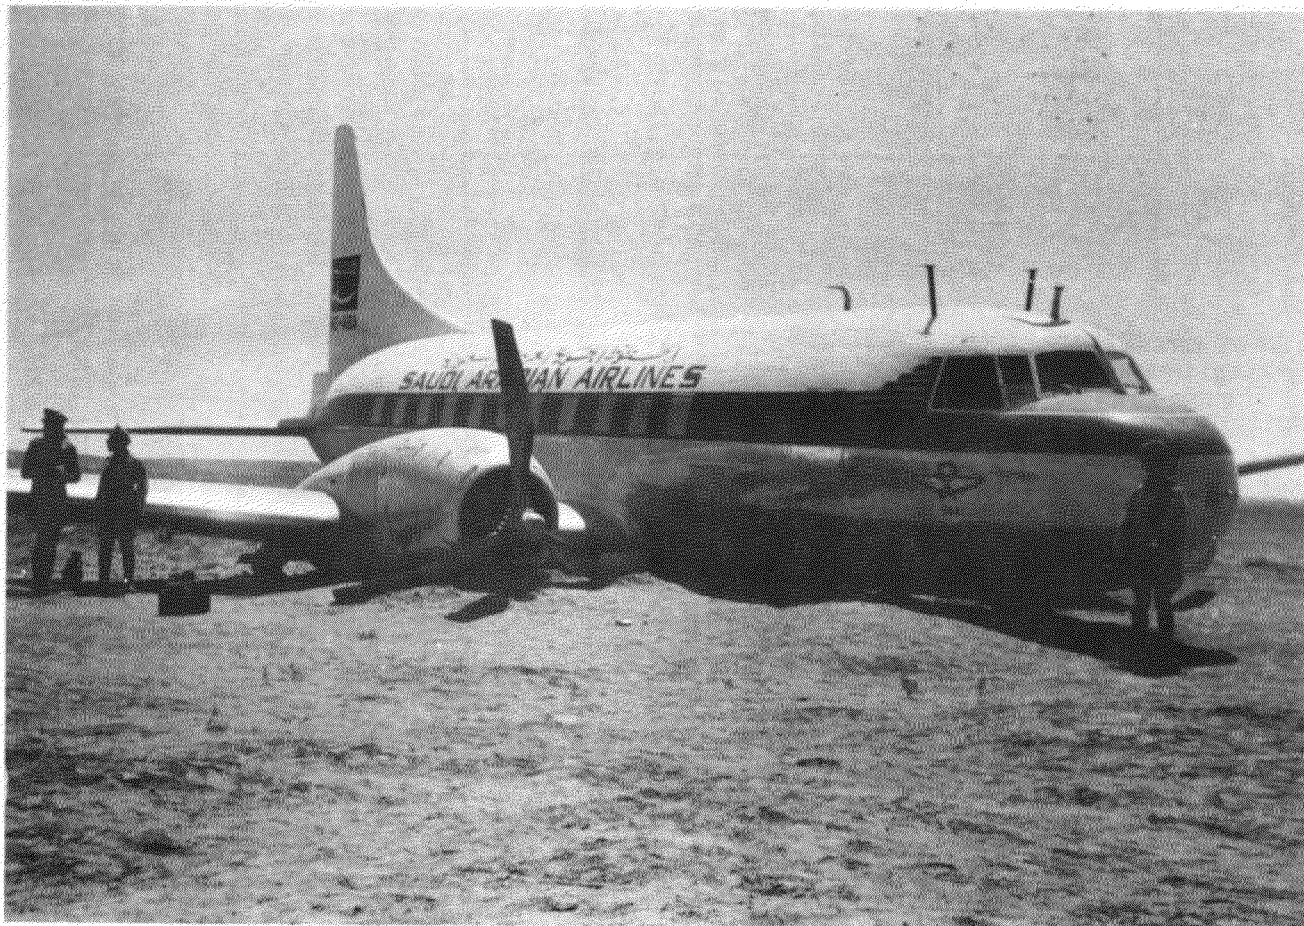
Figure 18

General view of Saudi Arabian aircraft, HZ-ABA which made a forced landing
at Deir-ez-Zor on 27 July 1956

It is recommended that the airline concerned ensure that its aircrews follow adequate flight procedures when navigating extensive areas not equipped with suitable navigational ground aids.

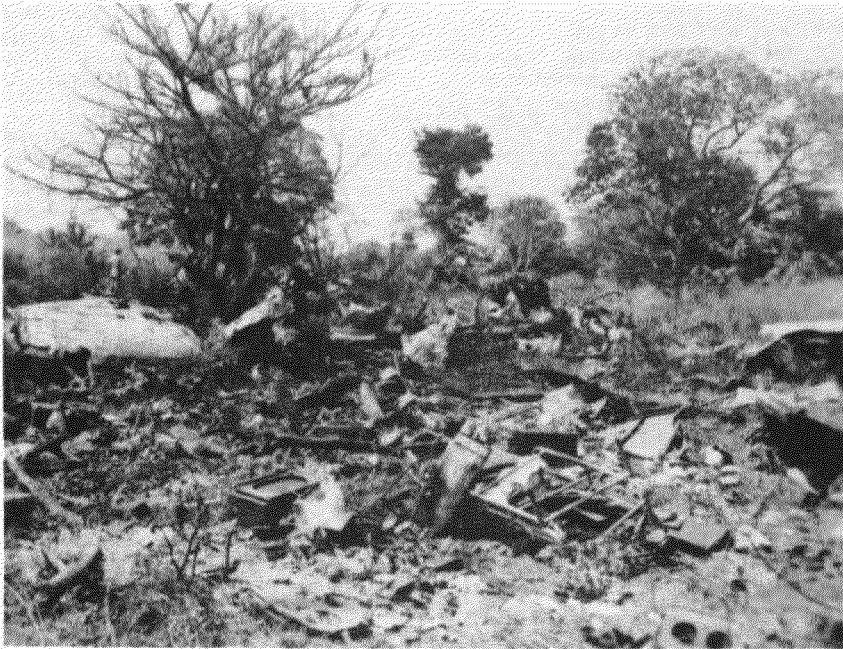
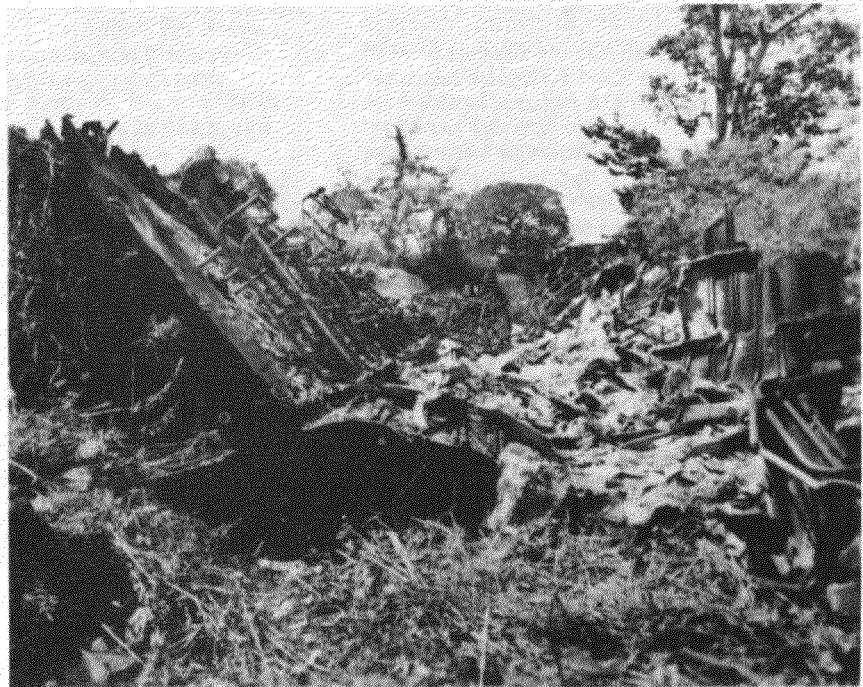
It was not possible to determine the origin of the fire in the main section of the hydraulic and fuel distribution systems; this determination will depend upon the results of laboratory tests and maintenance reports; when these are in, a reasonable conclusion can be reached regarding the probable cause of fire in flight. This may have been occasioned by a number of causes, for example, breaking of a hydraulic pressure line, short circuits in the electrical wiring or leakage of fuel lines or tanks, etc.

General views of wreckage area - DC-4 aircraft of
Líneas Aéreas Aerovías Guest which crashed near
Puerto Somoza, Nicaragua on 15 November 1956.
All 25 persons aboard were killed.

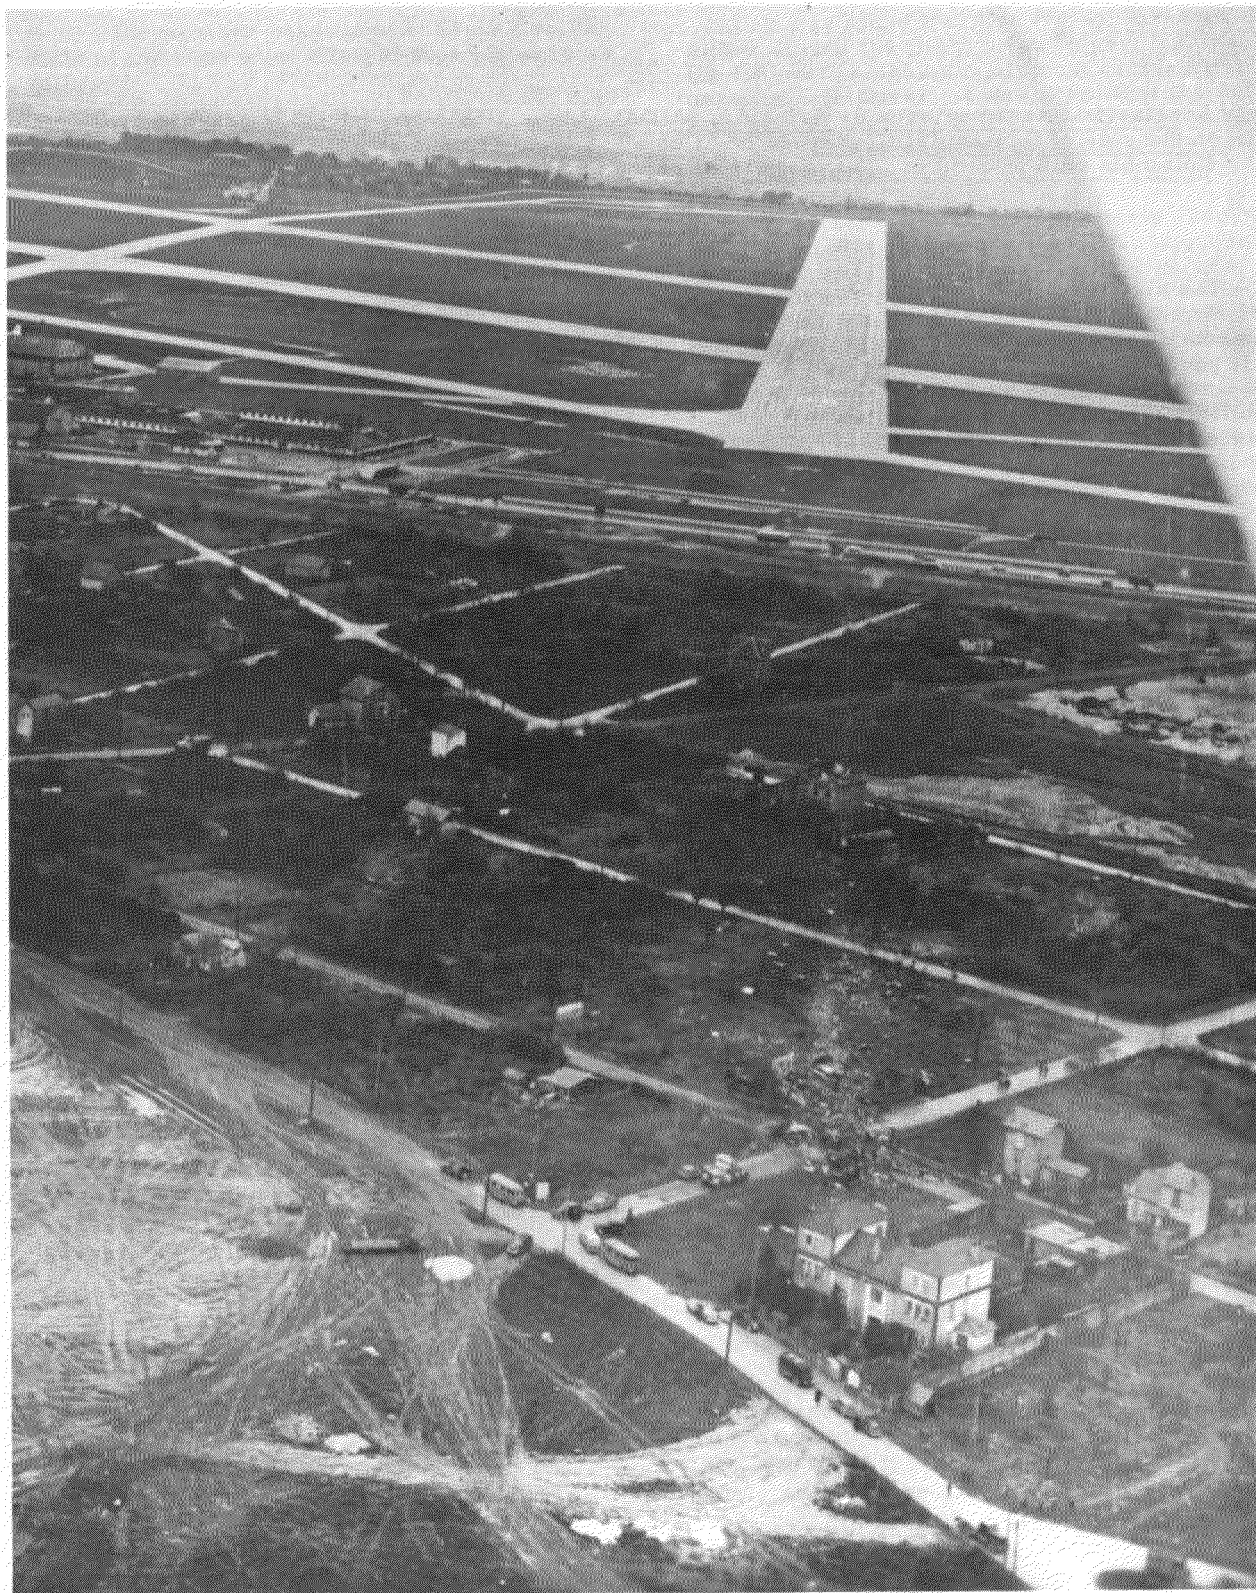
Figure 26

- the aircraft's slight loss of altitude soon after take-off was the main cause of the accident. There is no explanation for this loss of altitude.
- although the regulations in force were observed, the presence of unmarked obstructions in the take-off path constituted an aggravating factor;
- the initial and direct cause of the accident remains unknown.

Wreckage area of Linee Aeree Italiane DC-6B, I-LEAD, which crashed following take-off from Orly Airport, Paris, on 23 November 1956.

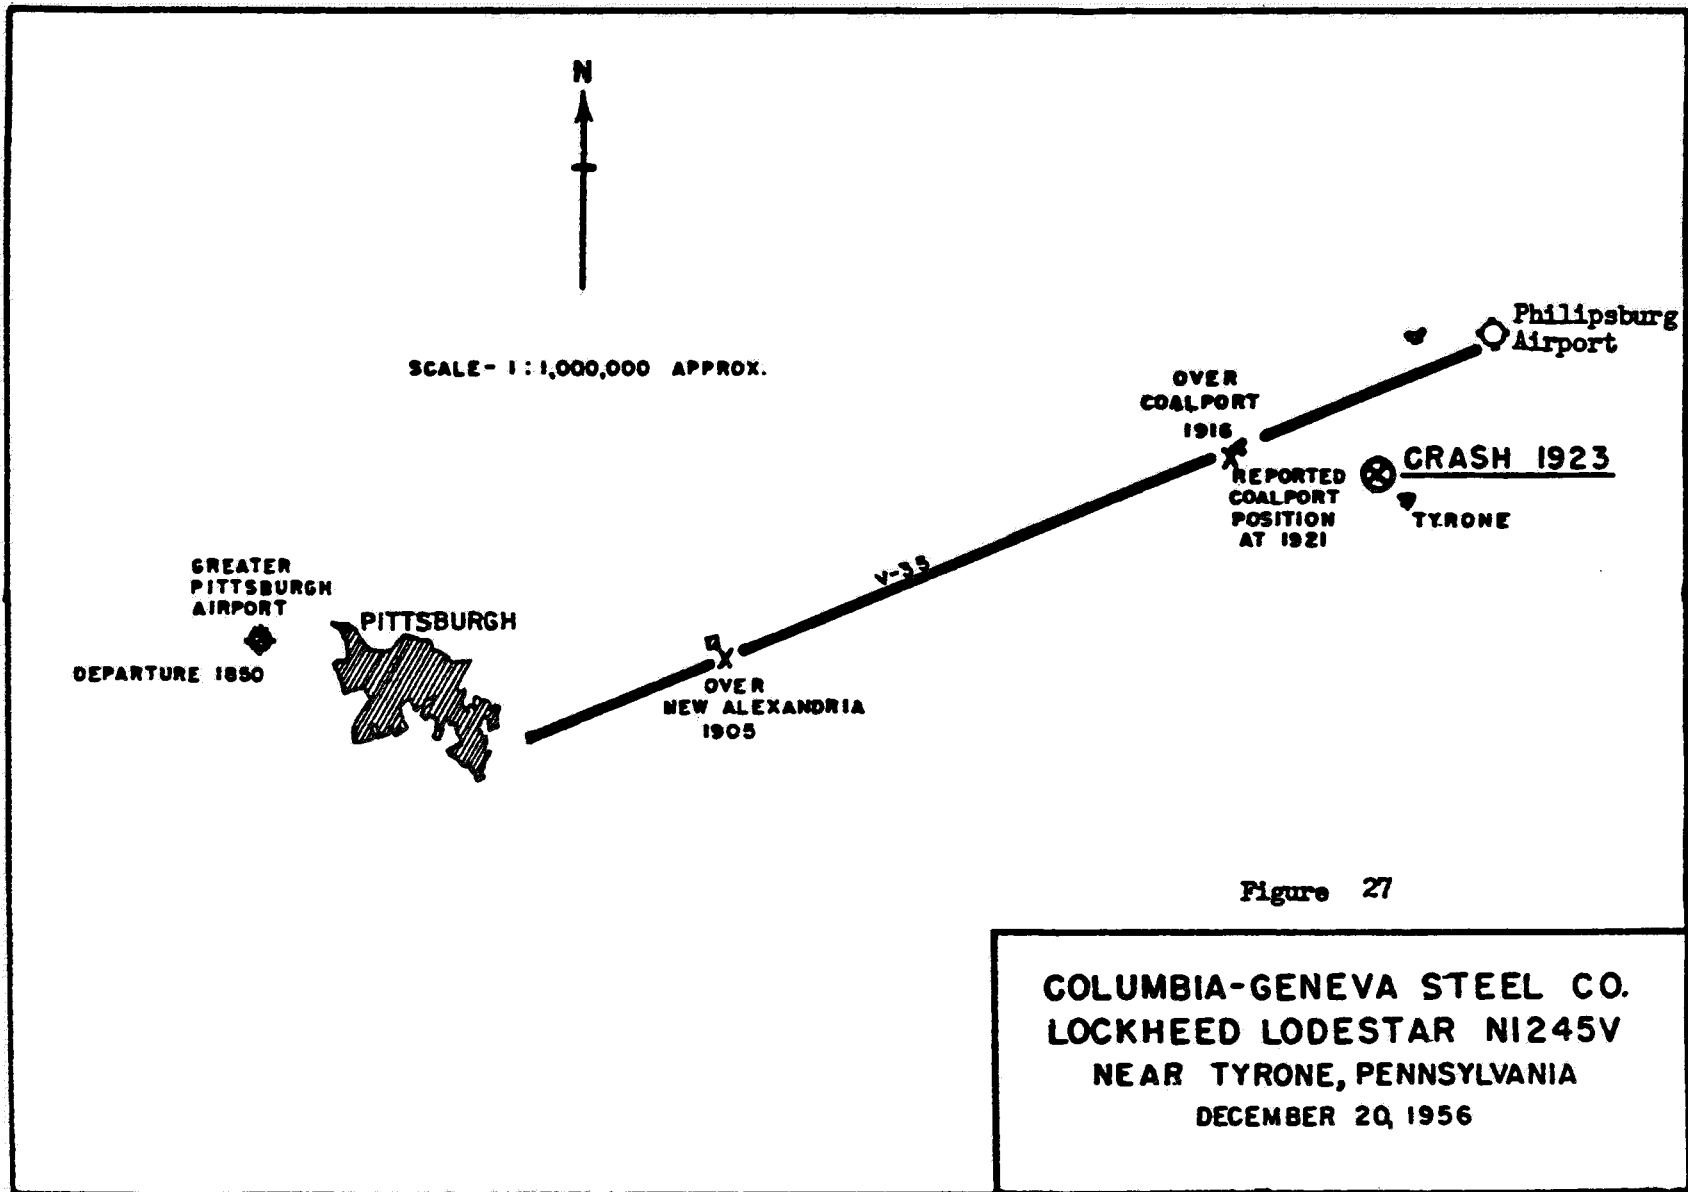
The probable cause of the accident was the loss of control for reasons unknown resulting in a rapid descent during which structural failure occurred.

COLUMBIA-GENEVA STEEL CO.
 LOCKHEED LODESTAR N1245V
 NEAR TYRONE, PENNSYLVANIA
 DECEMBER 20, 1956
