ICAO

CIRCULAR 54-AN/49

AIRCRAFT ACCIDENT DIGEST

No. 8

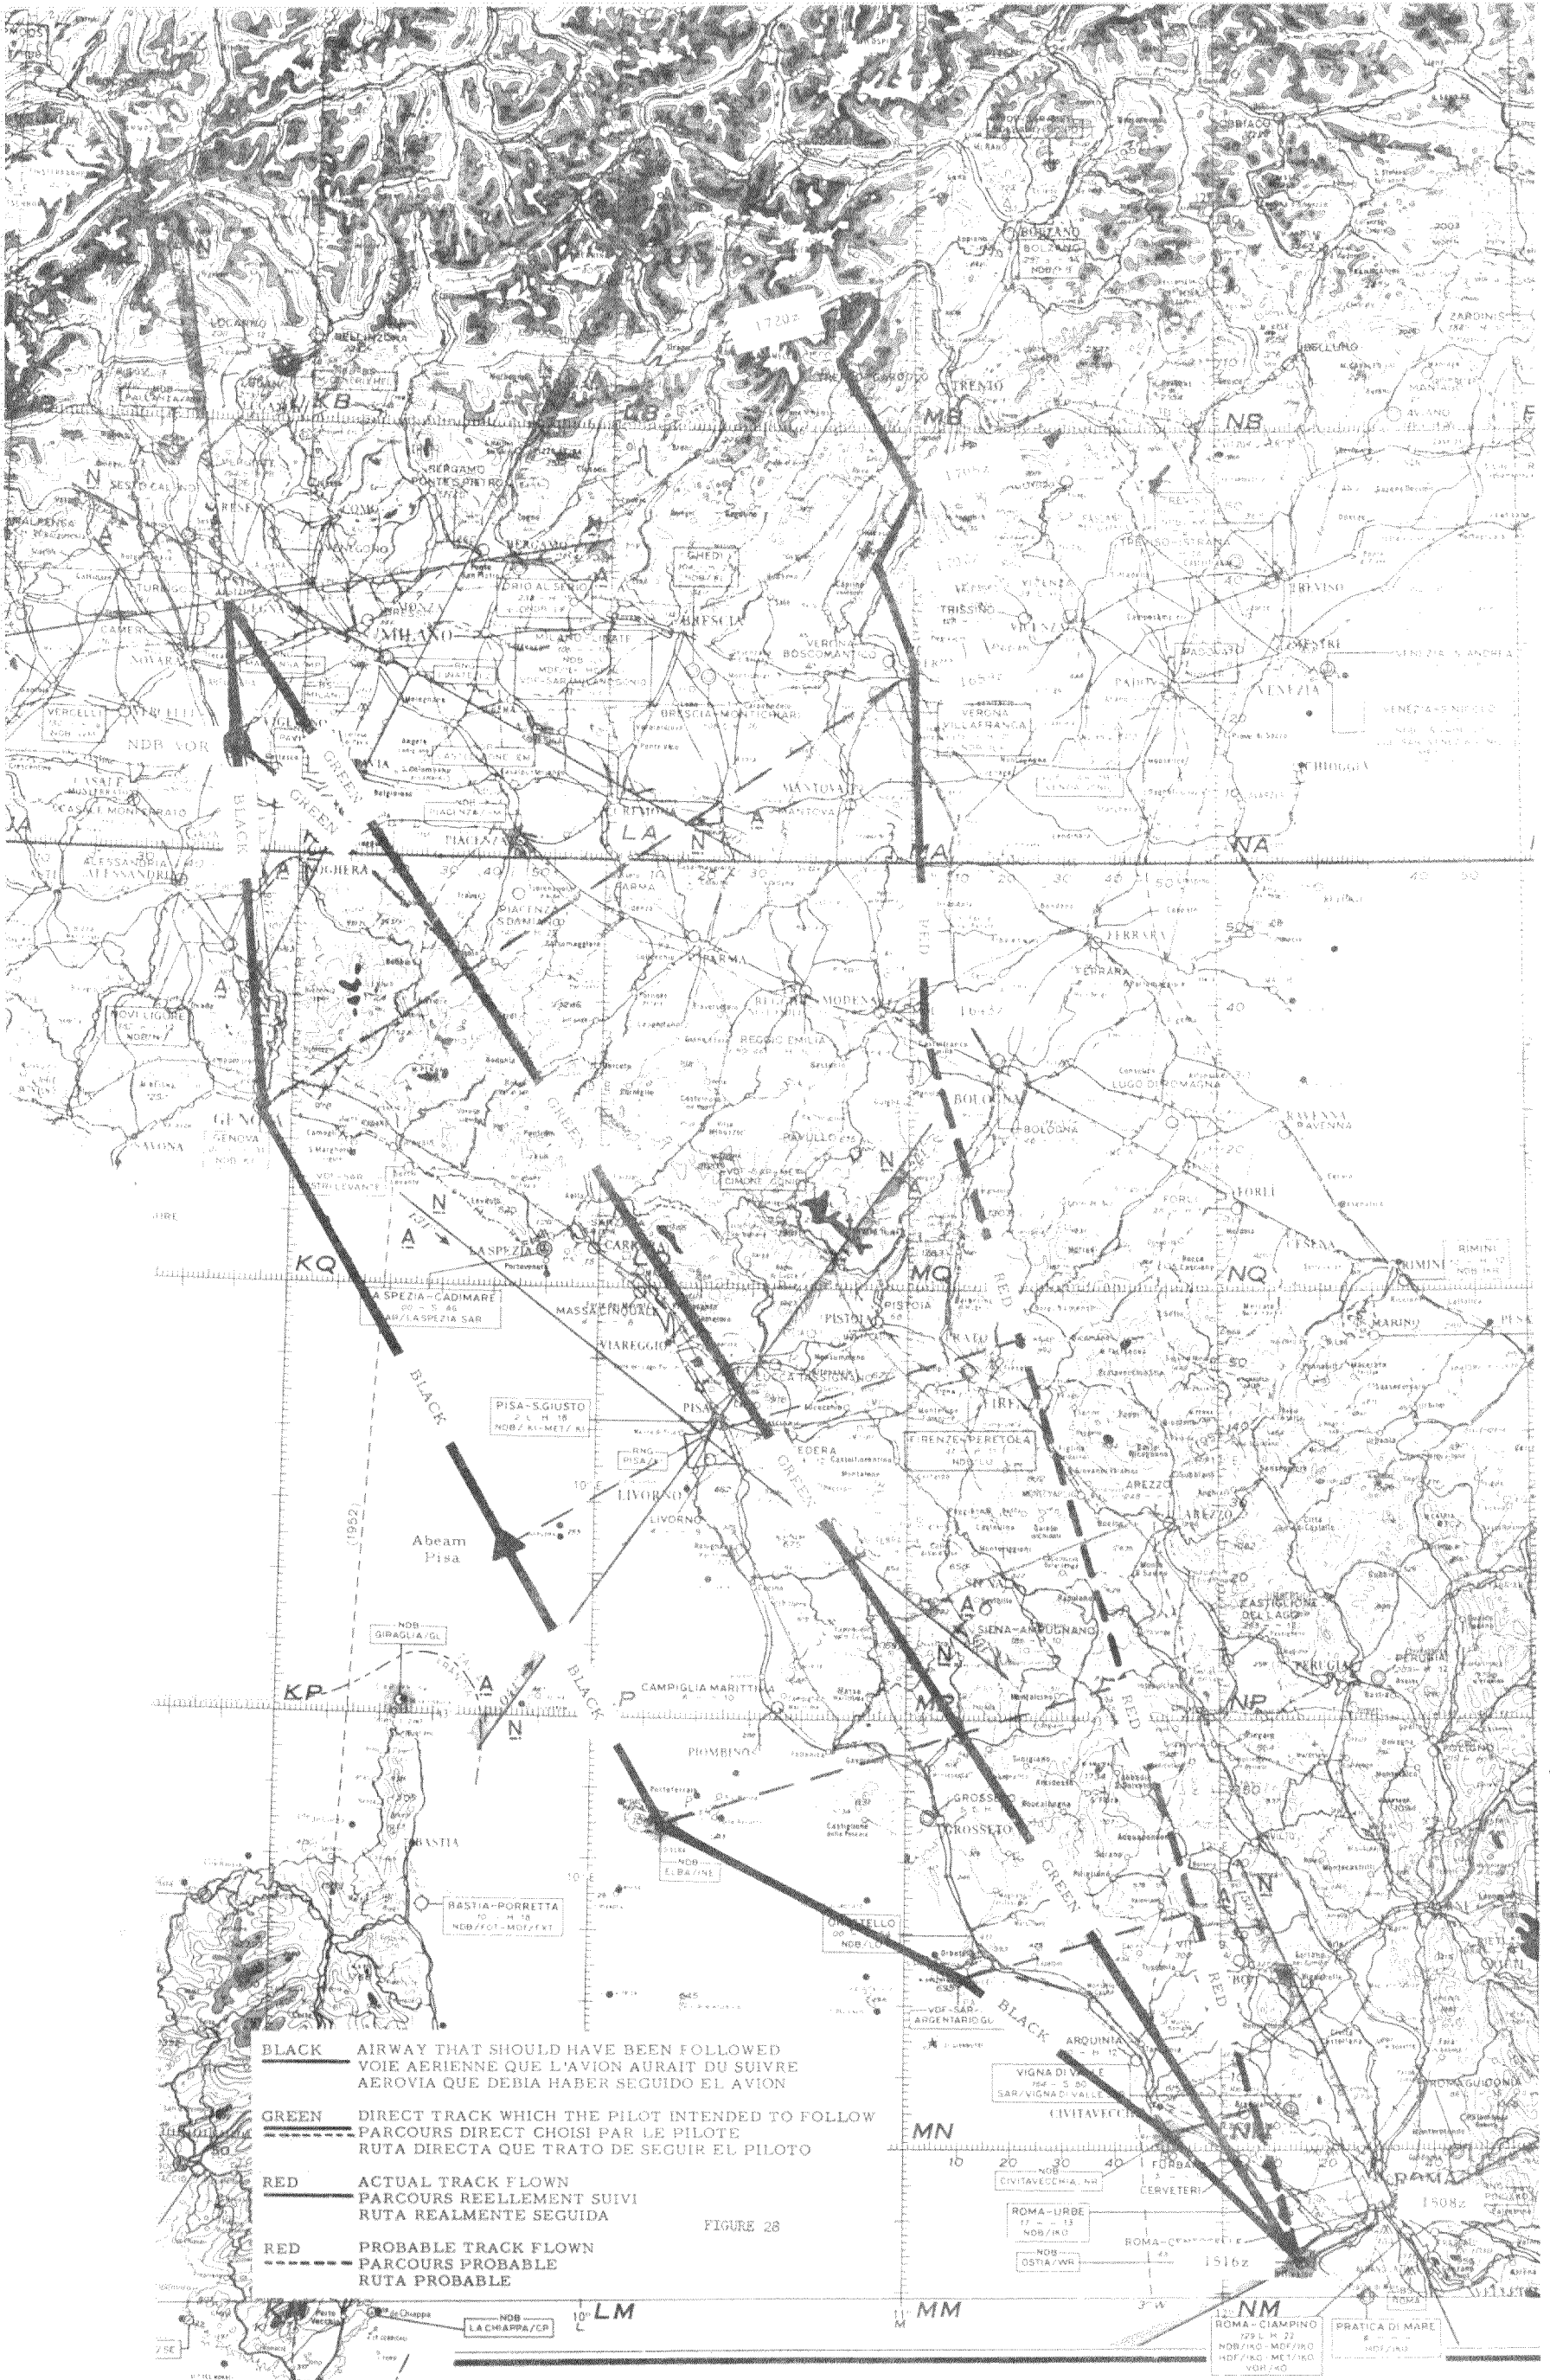
FIGURE 28

- BLACK** AIRWAY THAT SHOULD HAVE BEEN FOLLOWED
VOIE AERIENNE QUE L'AVION AURAIT DU SUIVRE
AEROVIA QUE DEBIA HABER SEGUIDO EL AVION
- GREEN** DIRECT TRACK WHICH THE PILOT INTENDED TO FOLLOW
PARCOURS DIRECT CHOISI PAR LE PILOTE
RUTA DIRECTA QUE TRATO DE SEGUIR EL PILOTO
- RED** ACTUAL TRACK FLOWN
PARCOURS REELLEMENT SUIVI
RUTA REALMENTE SEGUIDA
- RED** PROBABLE TRACK FLOWN
PARCOURS PROBABLE
RUTA PROBABLE

- 1) the instruction to all pilots to follow the airways assigned and entered in the flight plan should be enforced and pilots should be instructed to follow clearly the rules governing instrument flight;
- 2) that in all cases flight crews should avail themselves more fully of existing radio facilities and in particular the HF and VHF D/F aids available.
