ICAO

CIRCULAR 59-AN/54

AIRCRAFT ACCIDENT DIGEST

No. 10

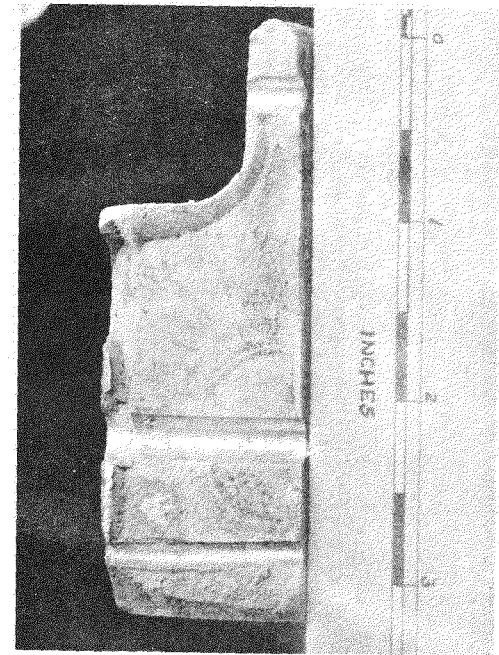
FIGURE 6

EFFECTIVE CROSS-SECTIONAL AREA
OF BOOM AT THIS POINT — 2.8 sq. ins.
EFFECTIVE CROSS-SECTIONAL AREA
PRIOR TO FINAL FRACTURE — 2.1 sq. ins.

VIEW OF FRACTURE SURFACE
SHOWING FATIGUE CRACK

1. that the failure of ZK-AYH at 4 880 hours and/or 8 121 landings be used as a basis for amending the current maker's assessment of safe lives;

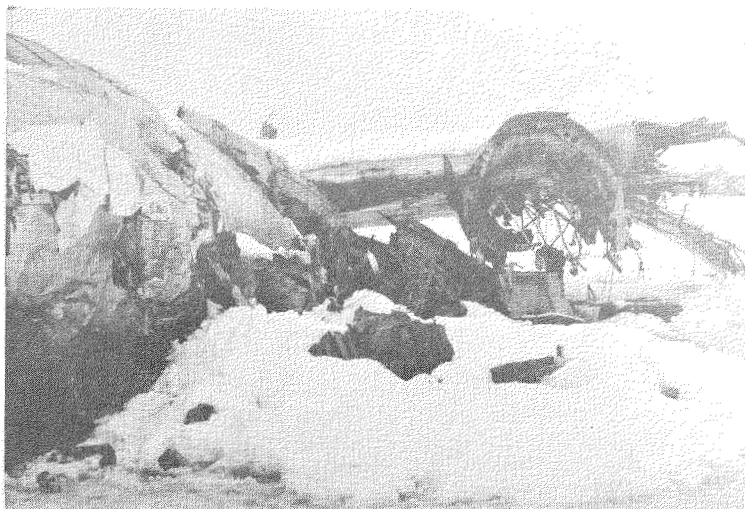
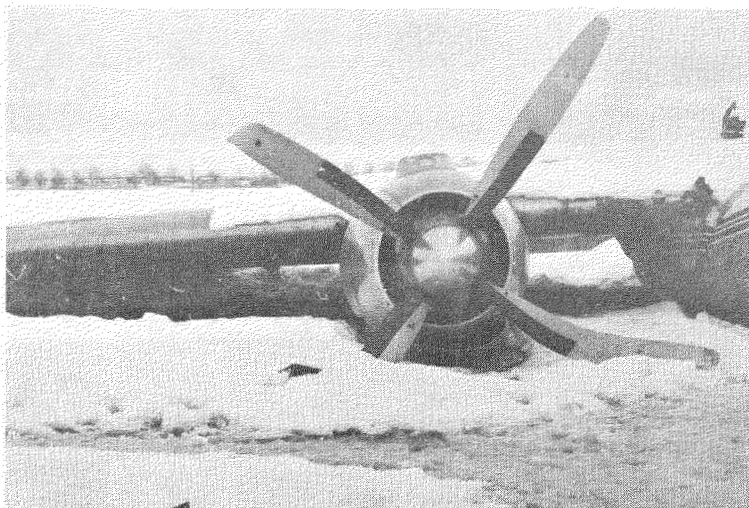
FIGURE 12

Left side of fuselage and
port engine mounting.

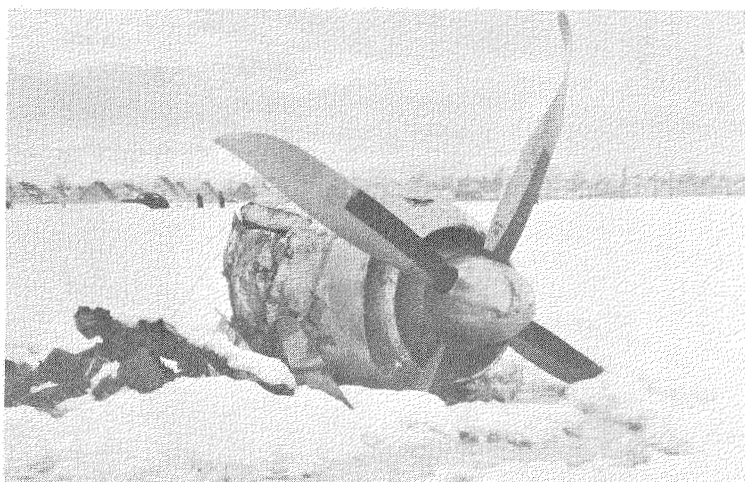
FIGURE 13

Port engine

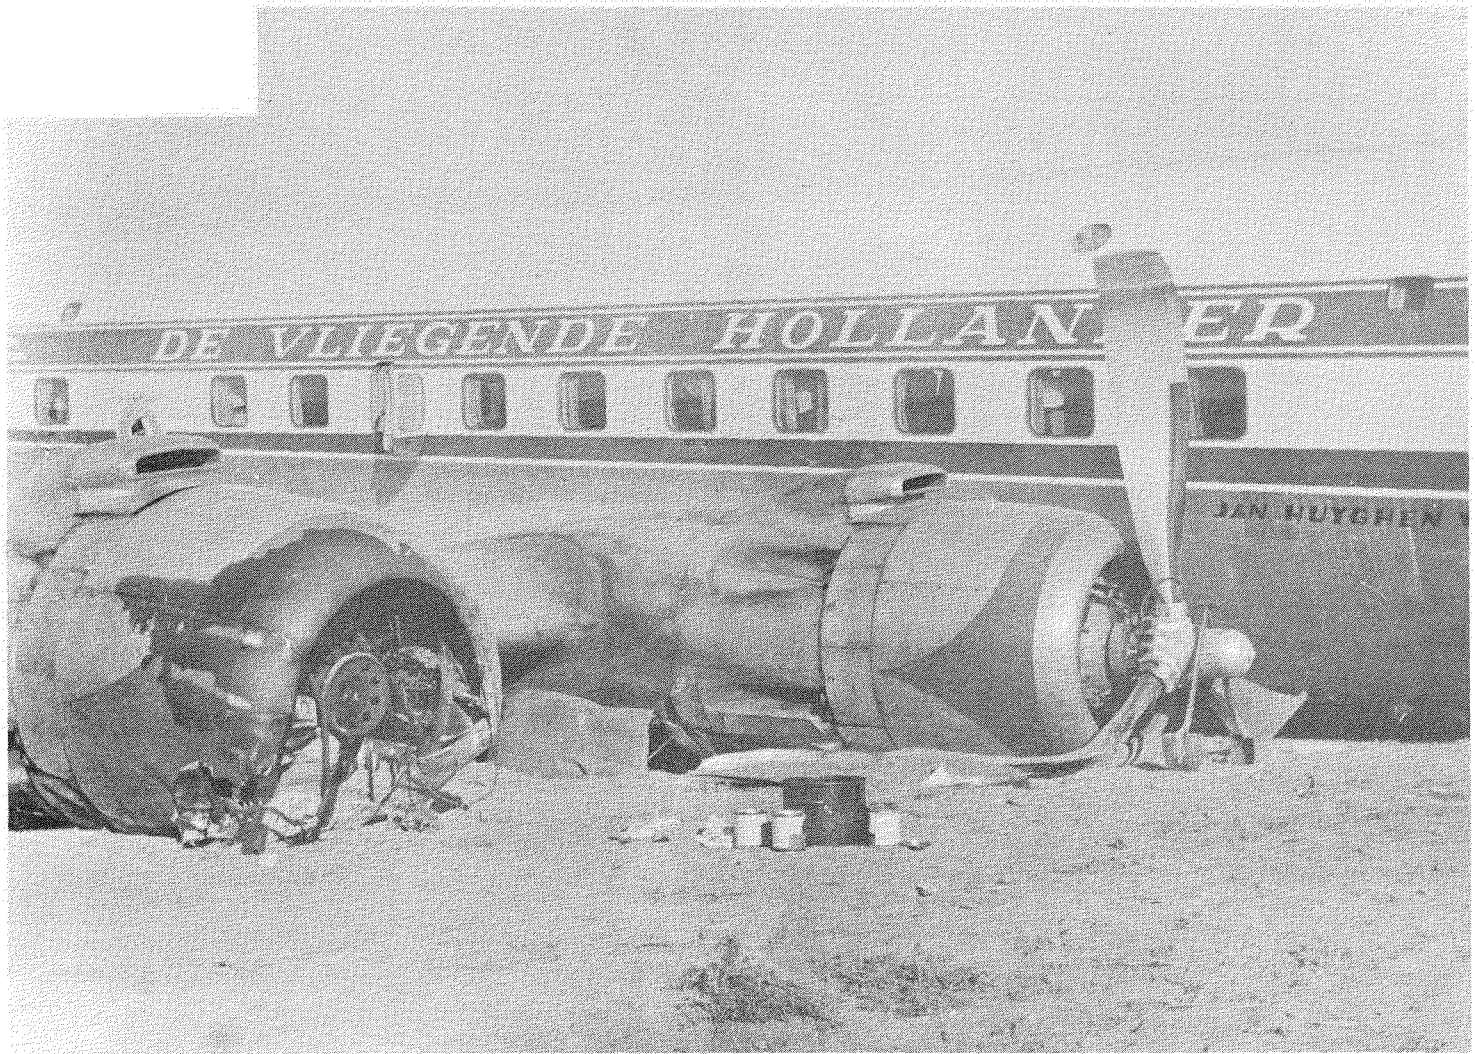
FIGURE 17

View of PH-DFK after coming to rest on soft sand. Picture shows engine No. 4 with propeller missing (was torn off at impact site) - Engine No. 3 propeller is shown feathered.

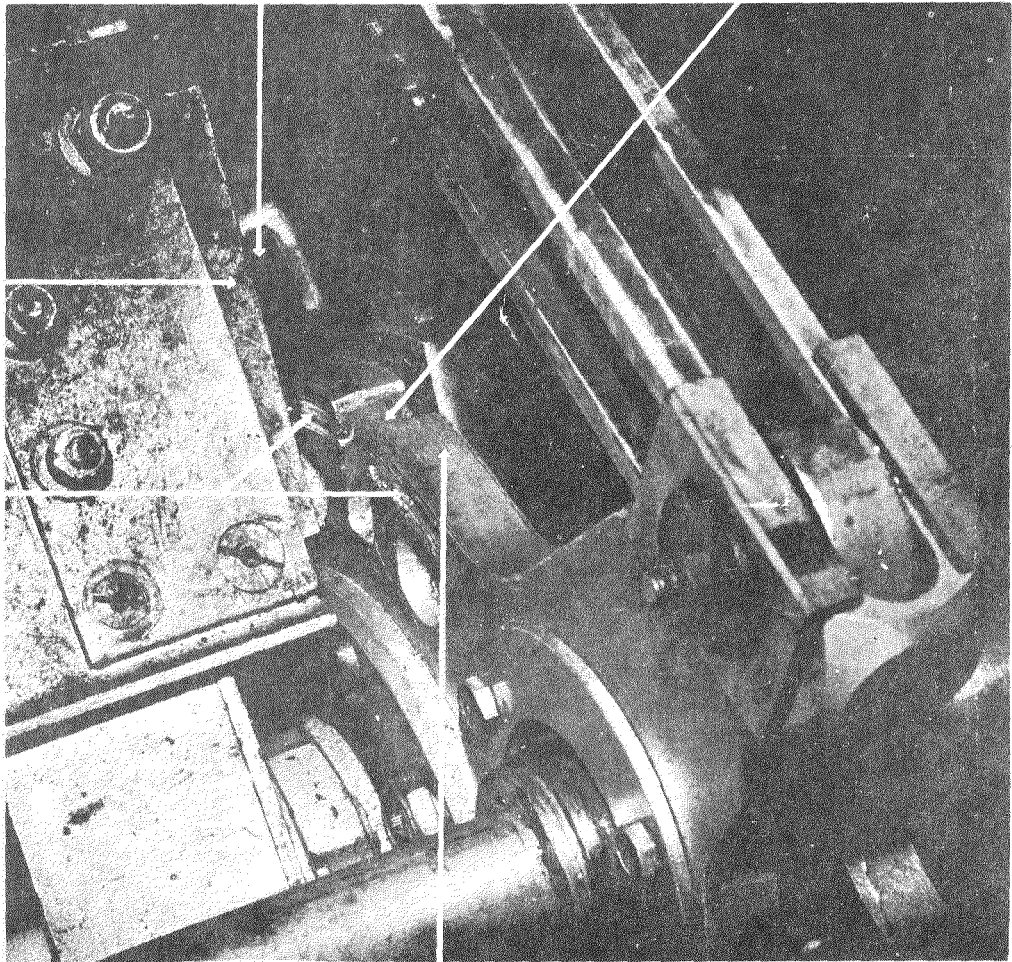
FIGURE 18

HEAVY SCORE
MARKS

SHOWING SECTION OF ELEVATOR CONTROL
ASSEMBLY WHERE JAMMING OCCURRED

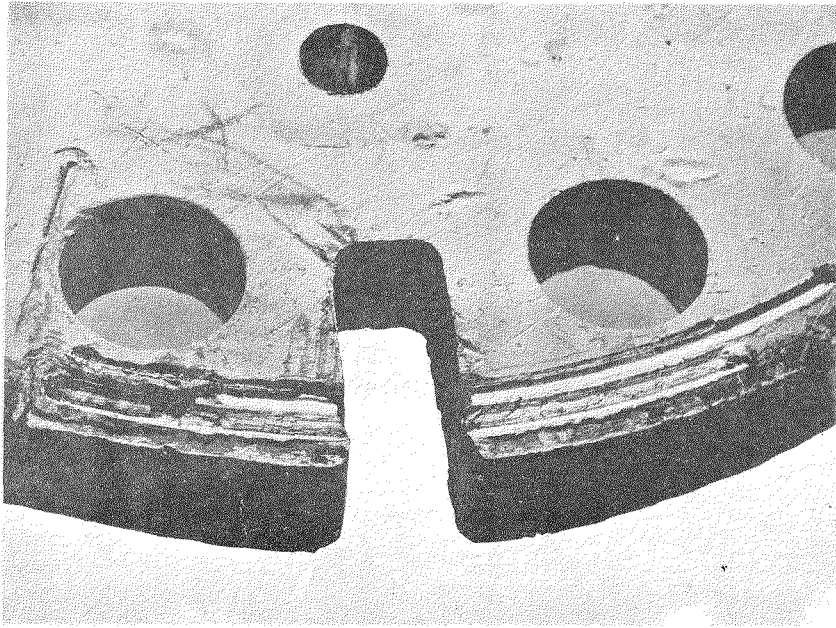
FIGURE 19
SHOWING SCORE MARKS ON BOTH SIDES OF
LOCKING SLOT OF ELEVATOR DATUM LEVER.

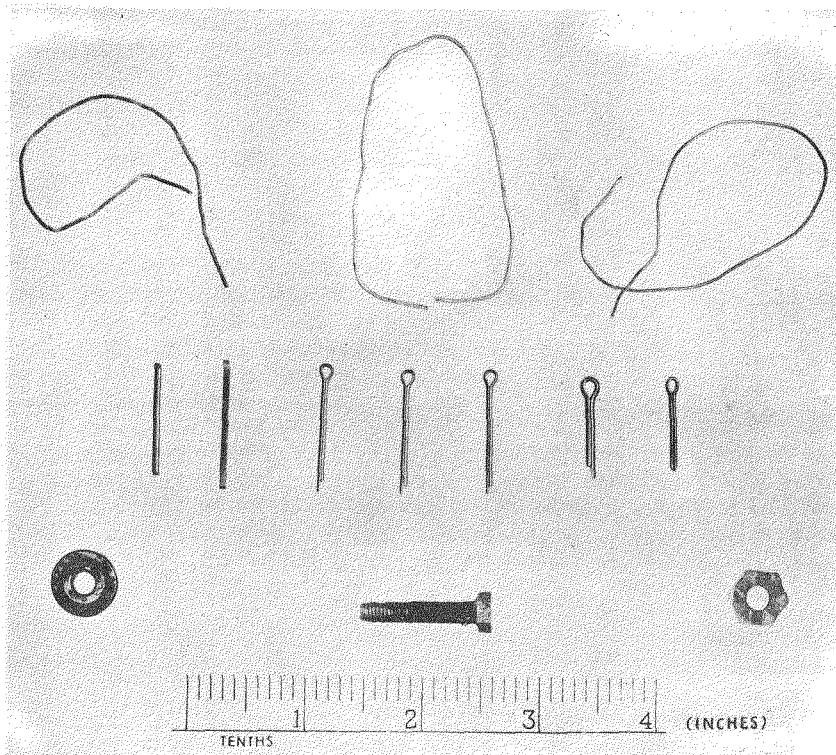
FIGURE 20
EXTRANEOUS LOOSE ARTICLES FOUND IN THE
STERN FRAME BAY OF THE CRASHED AIRCRAFT

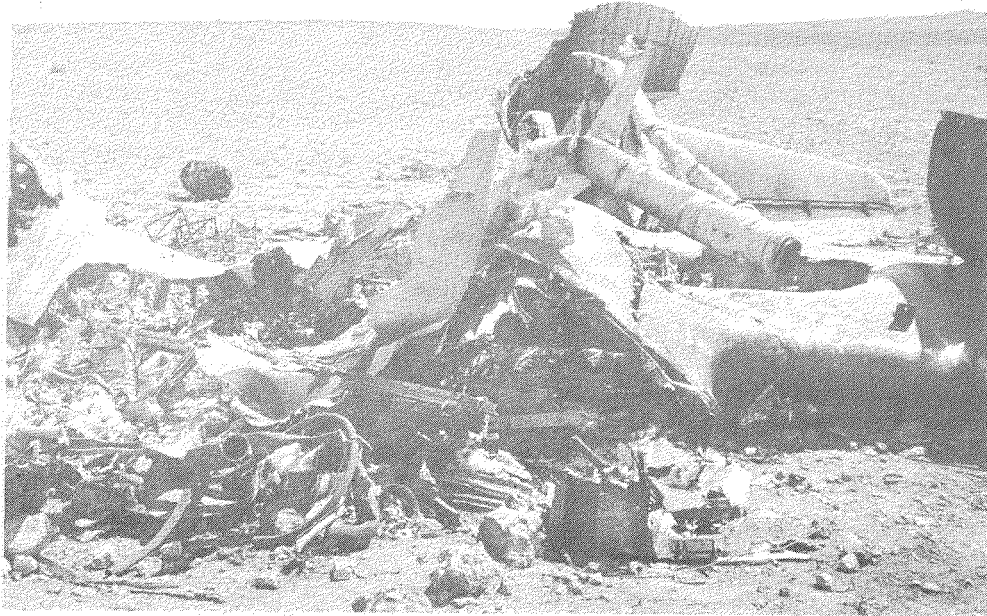
FIGURE 24

CENTRAL AFRICAN AIRWAYS, VISCOUNT, VP-YNE, ACCIDENT
SOUTHEAST OF BENINA AERODROME, CYRENAICA, 9 AUGUST 1958.
- General view of the main wreckage - fuselage

Statements made by certain of the survivors indicate that difficulty was experienced in locating the operating handles of the emergency exits after the crash. When considering these statements it must be appreciated that the crash occurred in darkness and caused the fuselage to become inverted although some of the survivors were not aware of the fuselage position until after they had evacuated the aircraft. Whilst instructions explaining the method of operation are printed on the flap covering the operating handle of each emergency exit, it is thought that passengers should, in addition, be informed either orally or by illustrated printed instruction, of the correct method of operating these exits so that in an emergency the exits can be released immediately.

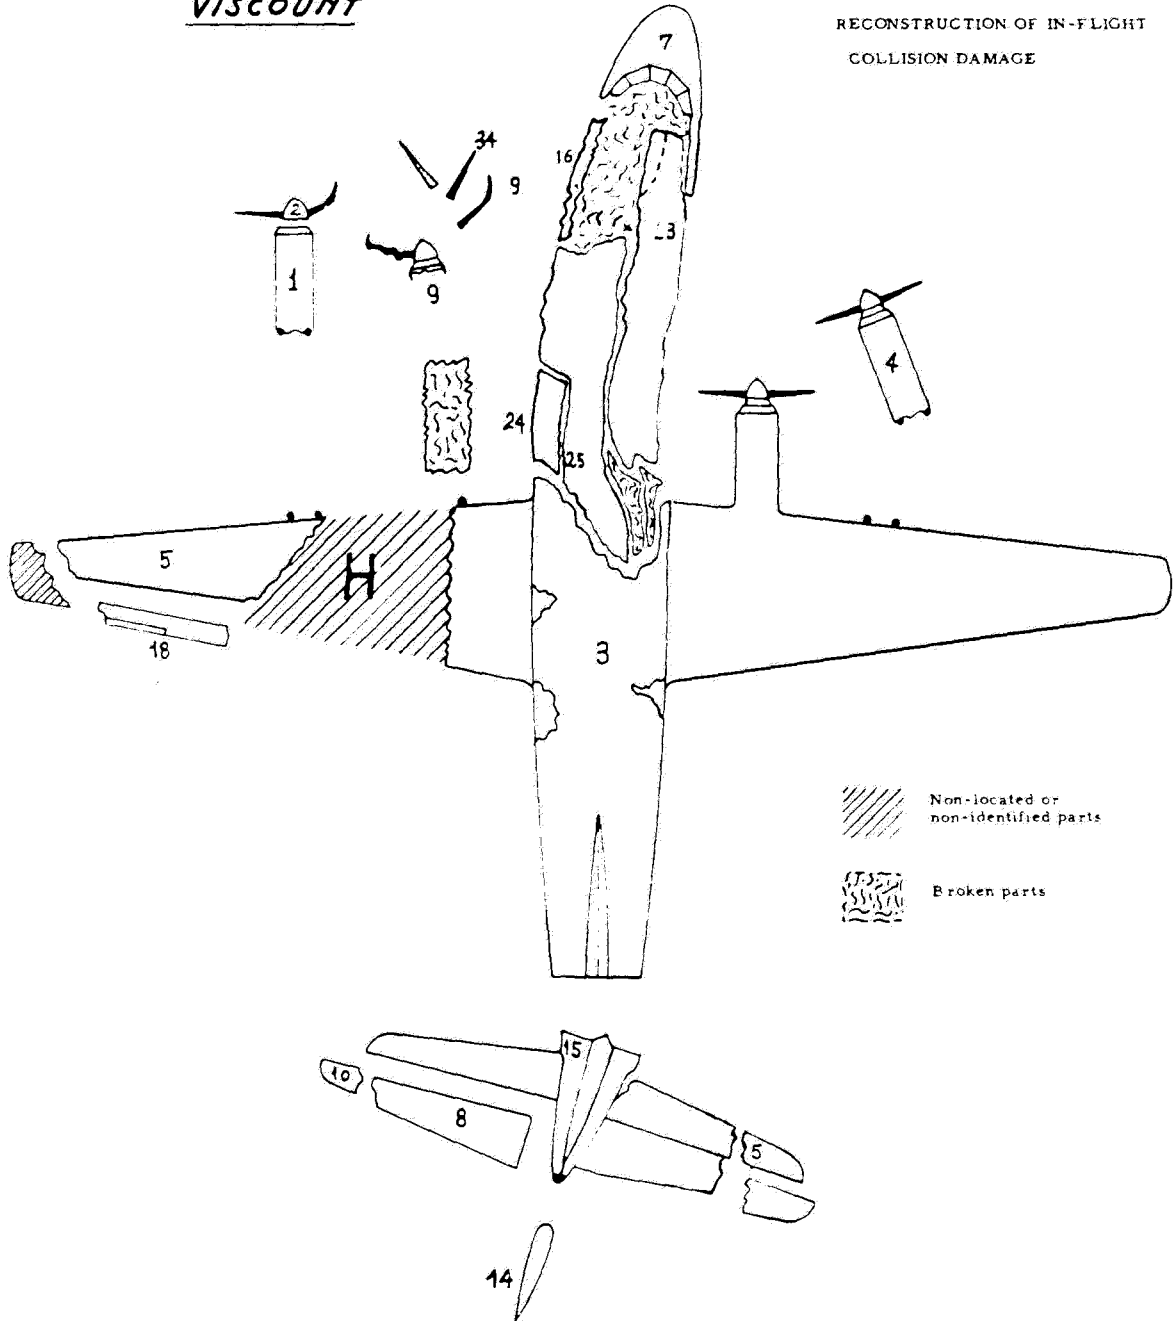
FIGURE 29

RECONSTRUCTION OF IN-FLIGHT COLLISION DAMAGE
