CIRCULAR 62-AN/57

AIRCRAFT ACCIDENT DIGEST

No. 11

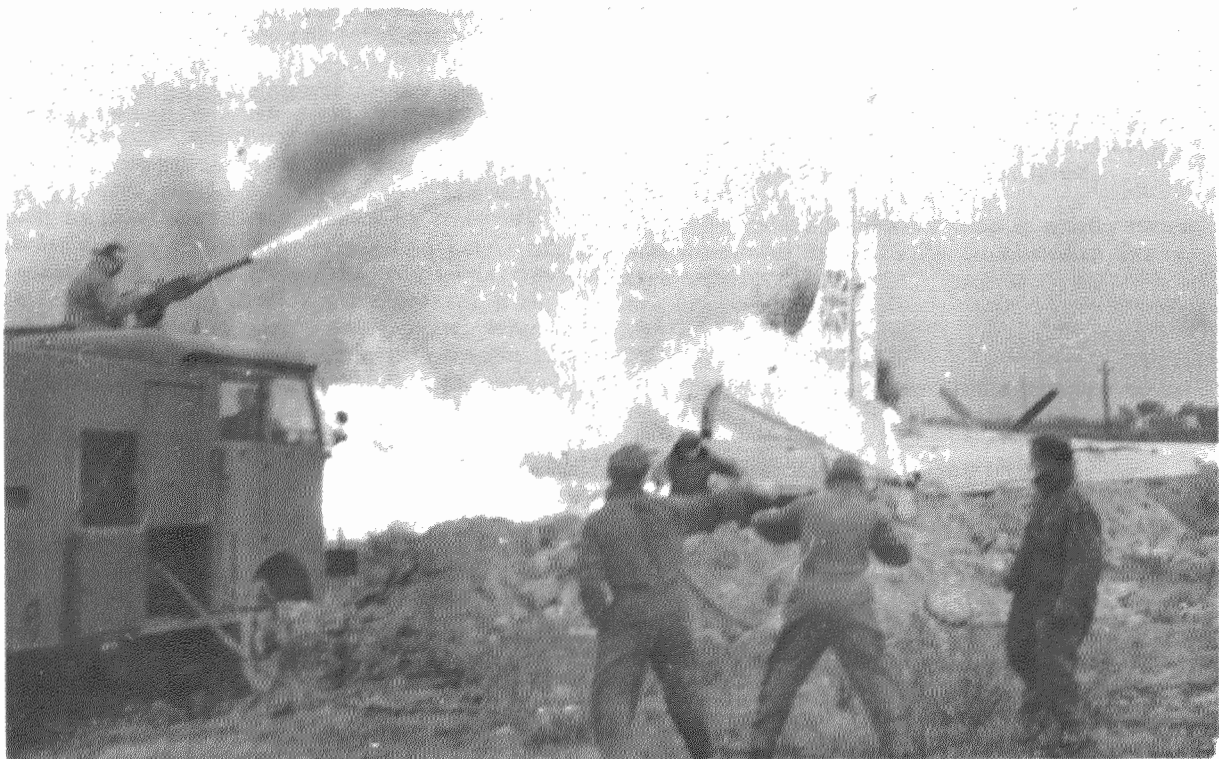
FIGURE 3

FIGHTING THE FIRE WHICH BROKE OUT IN THE LEFT WING OF AVRO 688 SUPER TRADER, G-AGRG, AFTER A TAKE-OFF ACCIDENT AT BRINDISI AIRPORT, ITALY - 27 JANUARY 1959

2. the possibility of urgent action to level the safety shoulders of runway 14/32 at Brindisi Airport should be investigated;
3. the capacity of Brindisi Airport to handle traffic should be increased by making runway 05/23, which is better oriented to northerly winds, serviceable once again.

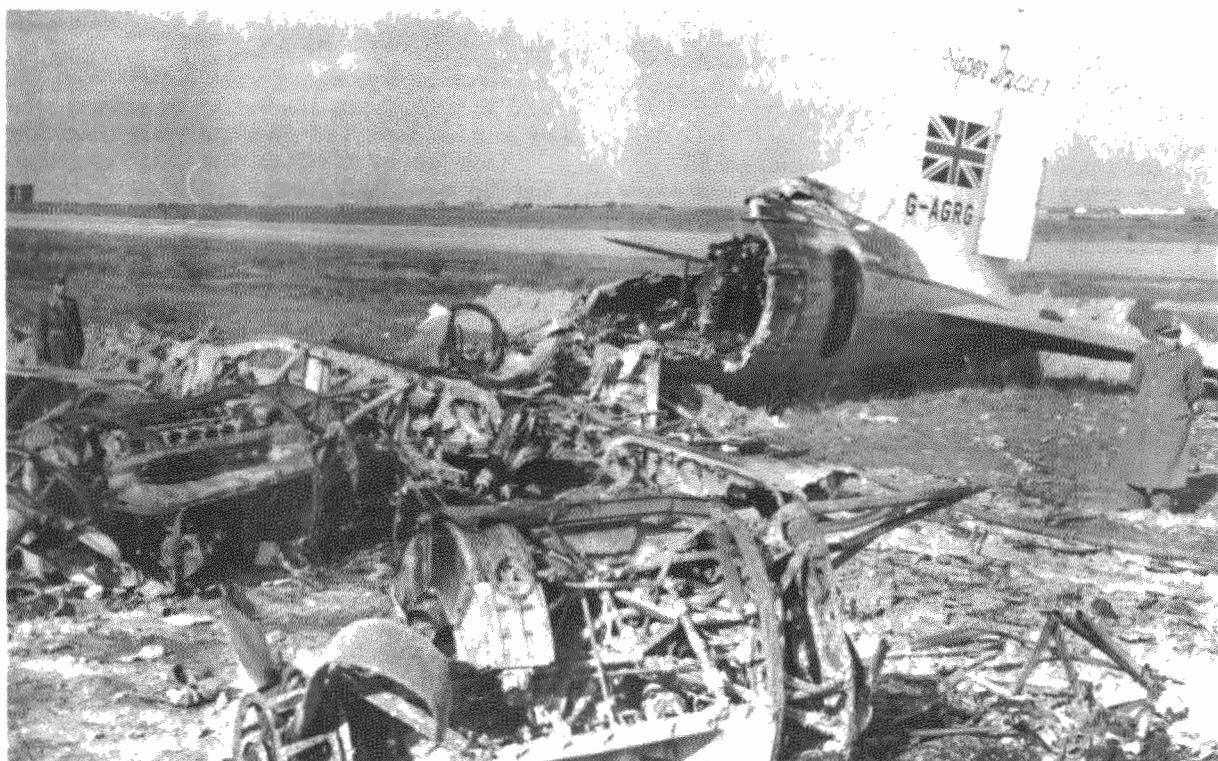
FIGURE 4

GENERAL VIEW OF THE WRECKAGE OF G-AGRG

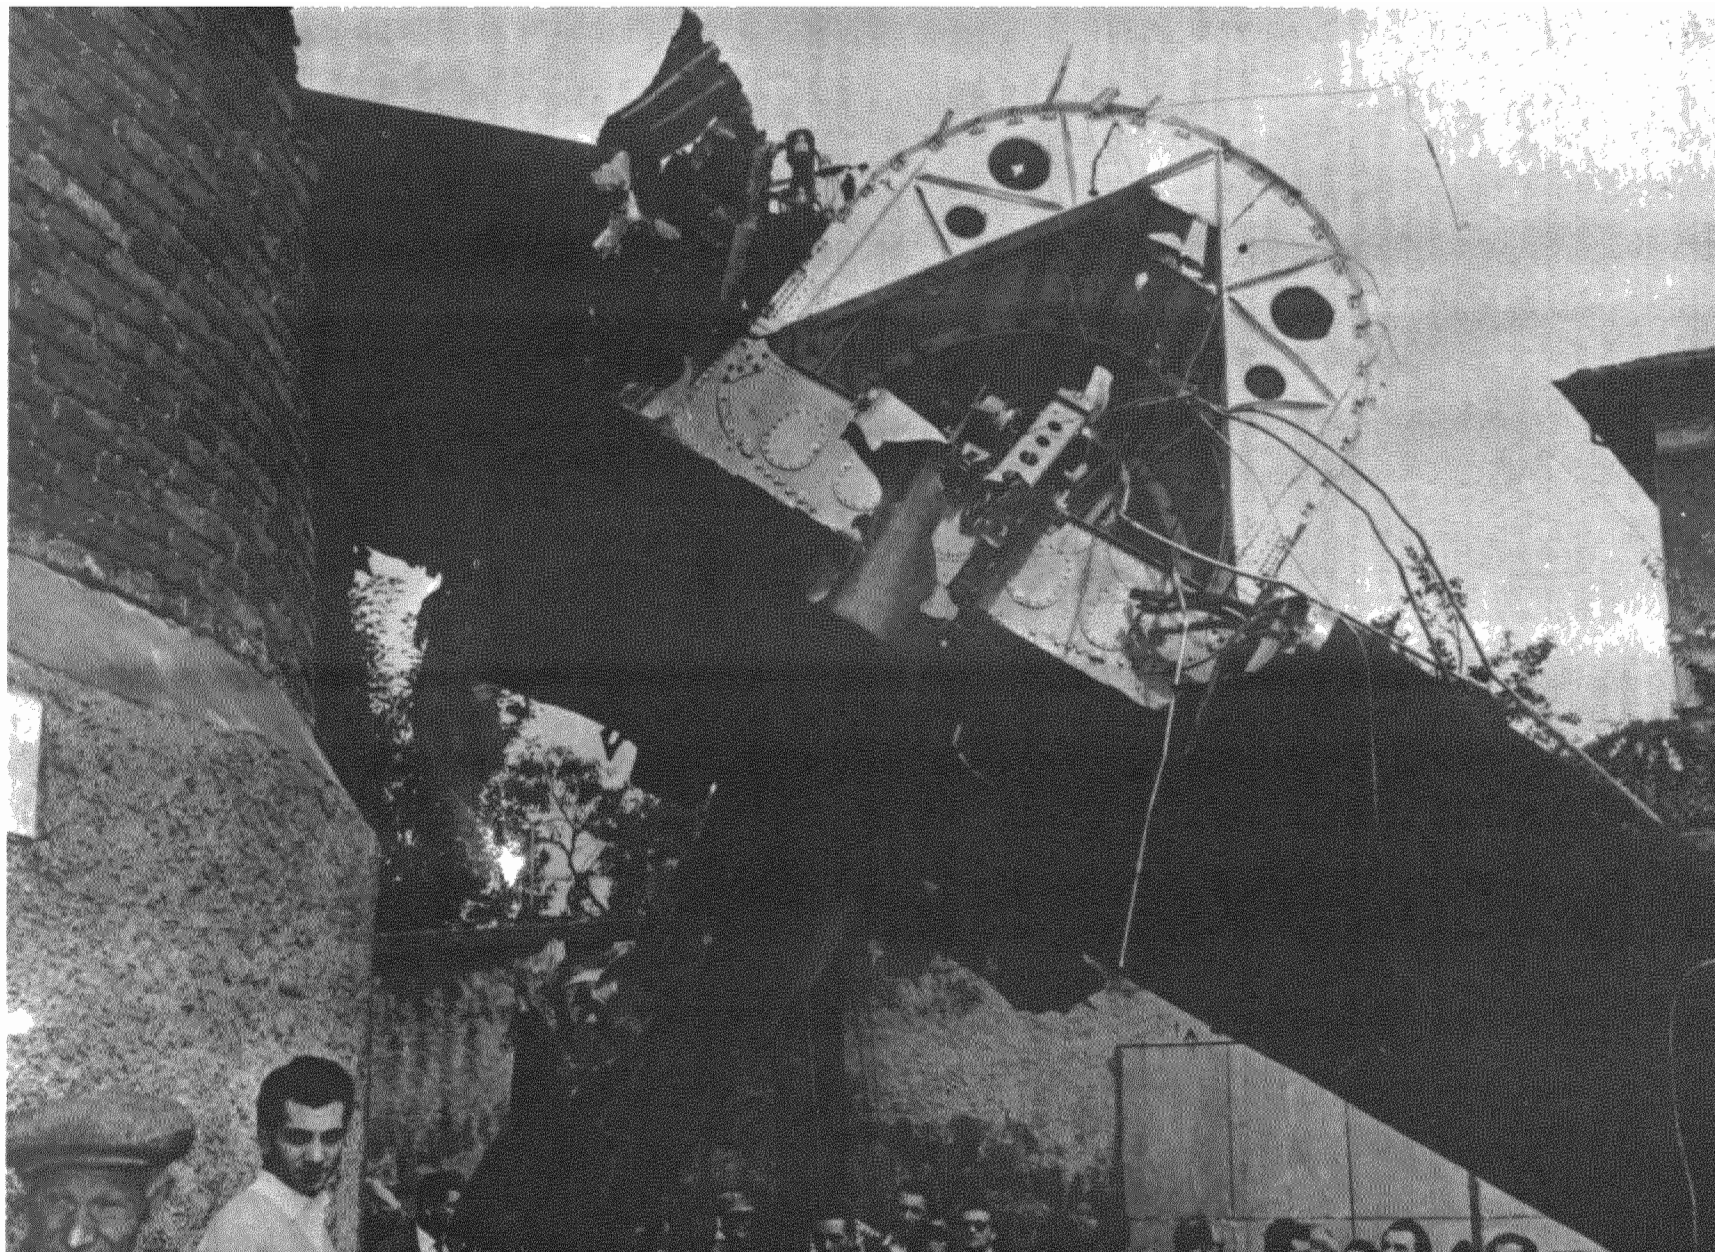
FIGURE 7

Tail assembly of Trans World Airline's, Super Constellation, N 7313C
which crashed in Varese Province, Italy, on 26 June 1959,

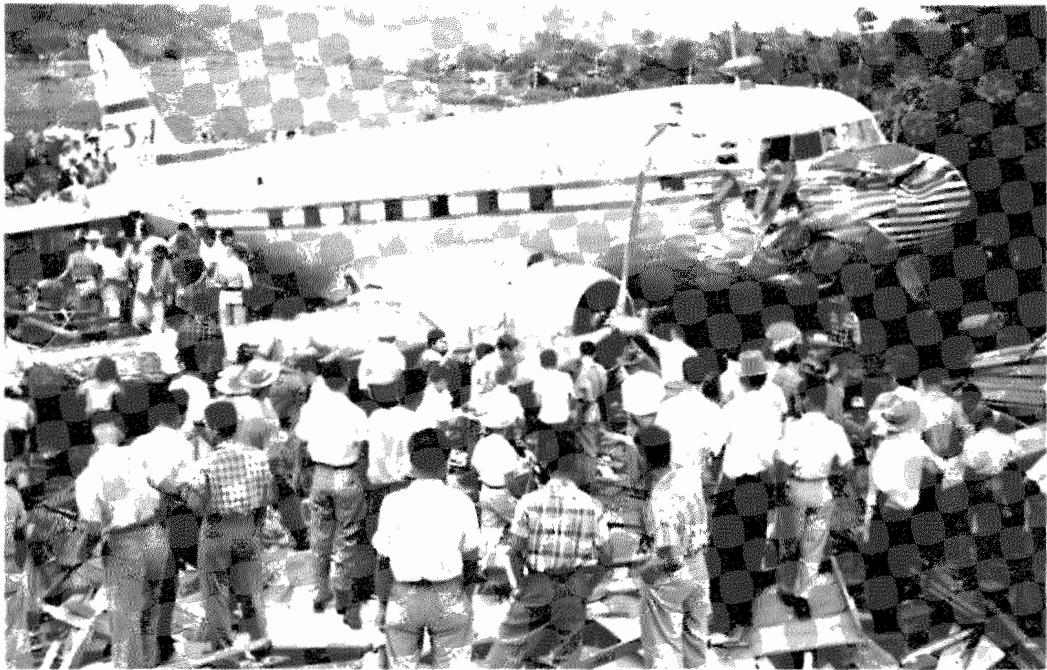
FIGURE 8

THE AIRCRAFT OVERSHOT THE RUNWAY ON LANDING
AS ITS BRAKES WERE INEFFECTIVE ON THE
EXTREMELY WET RUNWAY

In view of the foregoing, it is recommended that San Isidro Airport be closed to such aircraft.

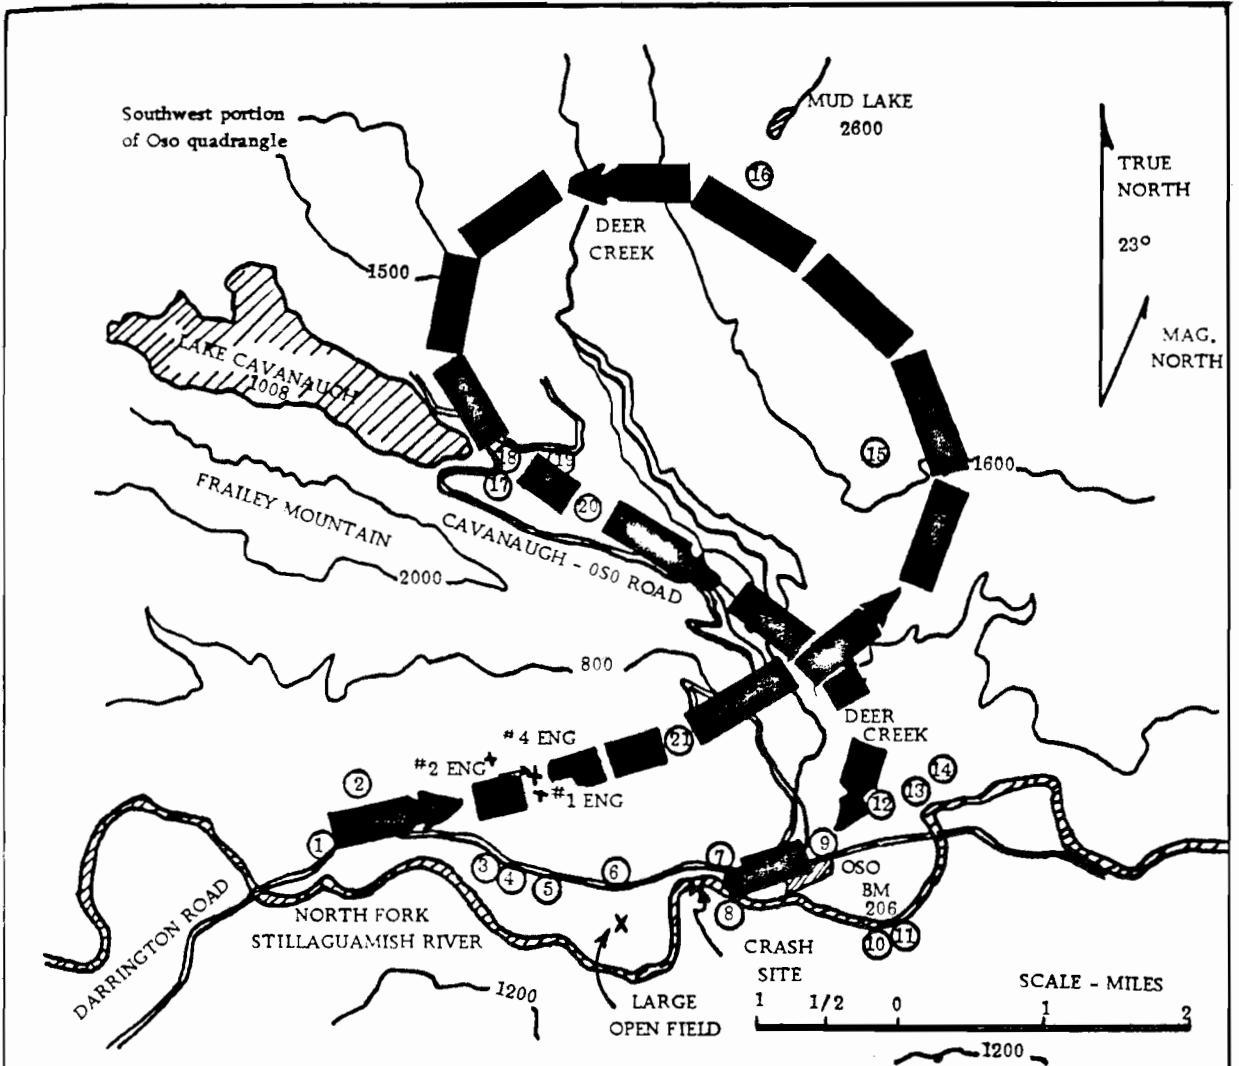
FIGURE 11

Accident involving Aircraft N 7071
occurred one mile west of Oso,
Washington, on October 19, 1959

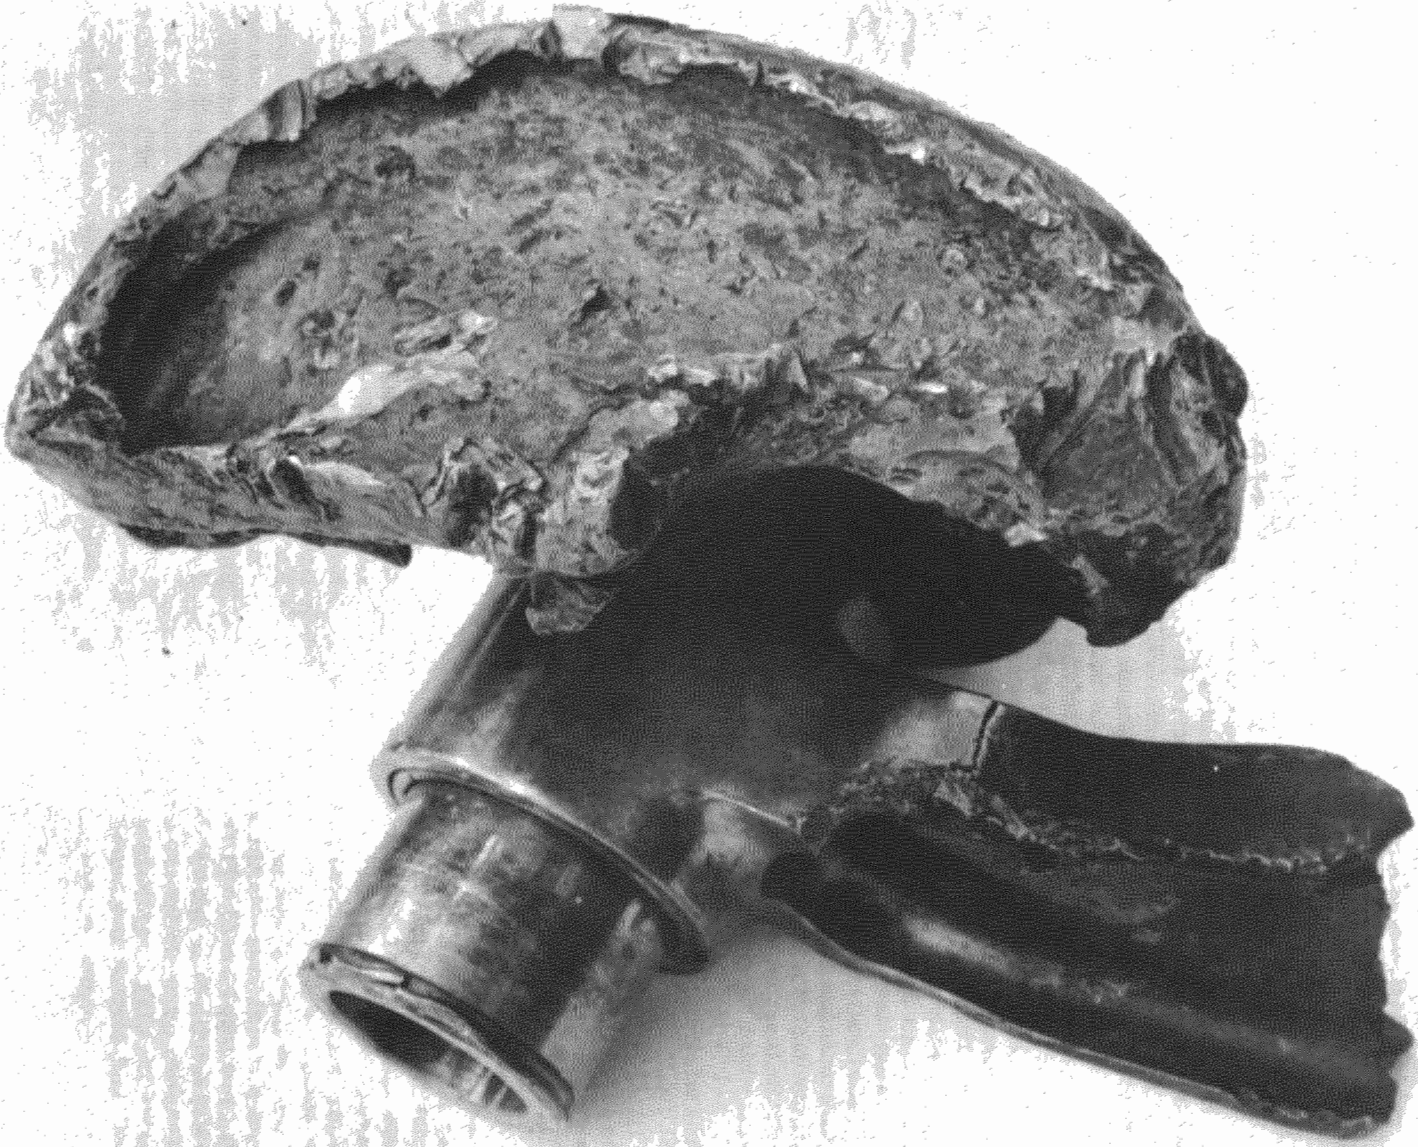
FIGURE 12

Inertia of the propeller at the moment of the breaking of the engine caused failure of the propeller shaft.

The broken propeller, rotating, caused serious cuts on the left wing. The latter then separated and loss of control followed.

PISTON OF NO. 6 CYLINDER

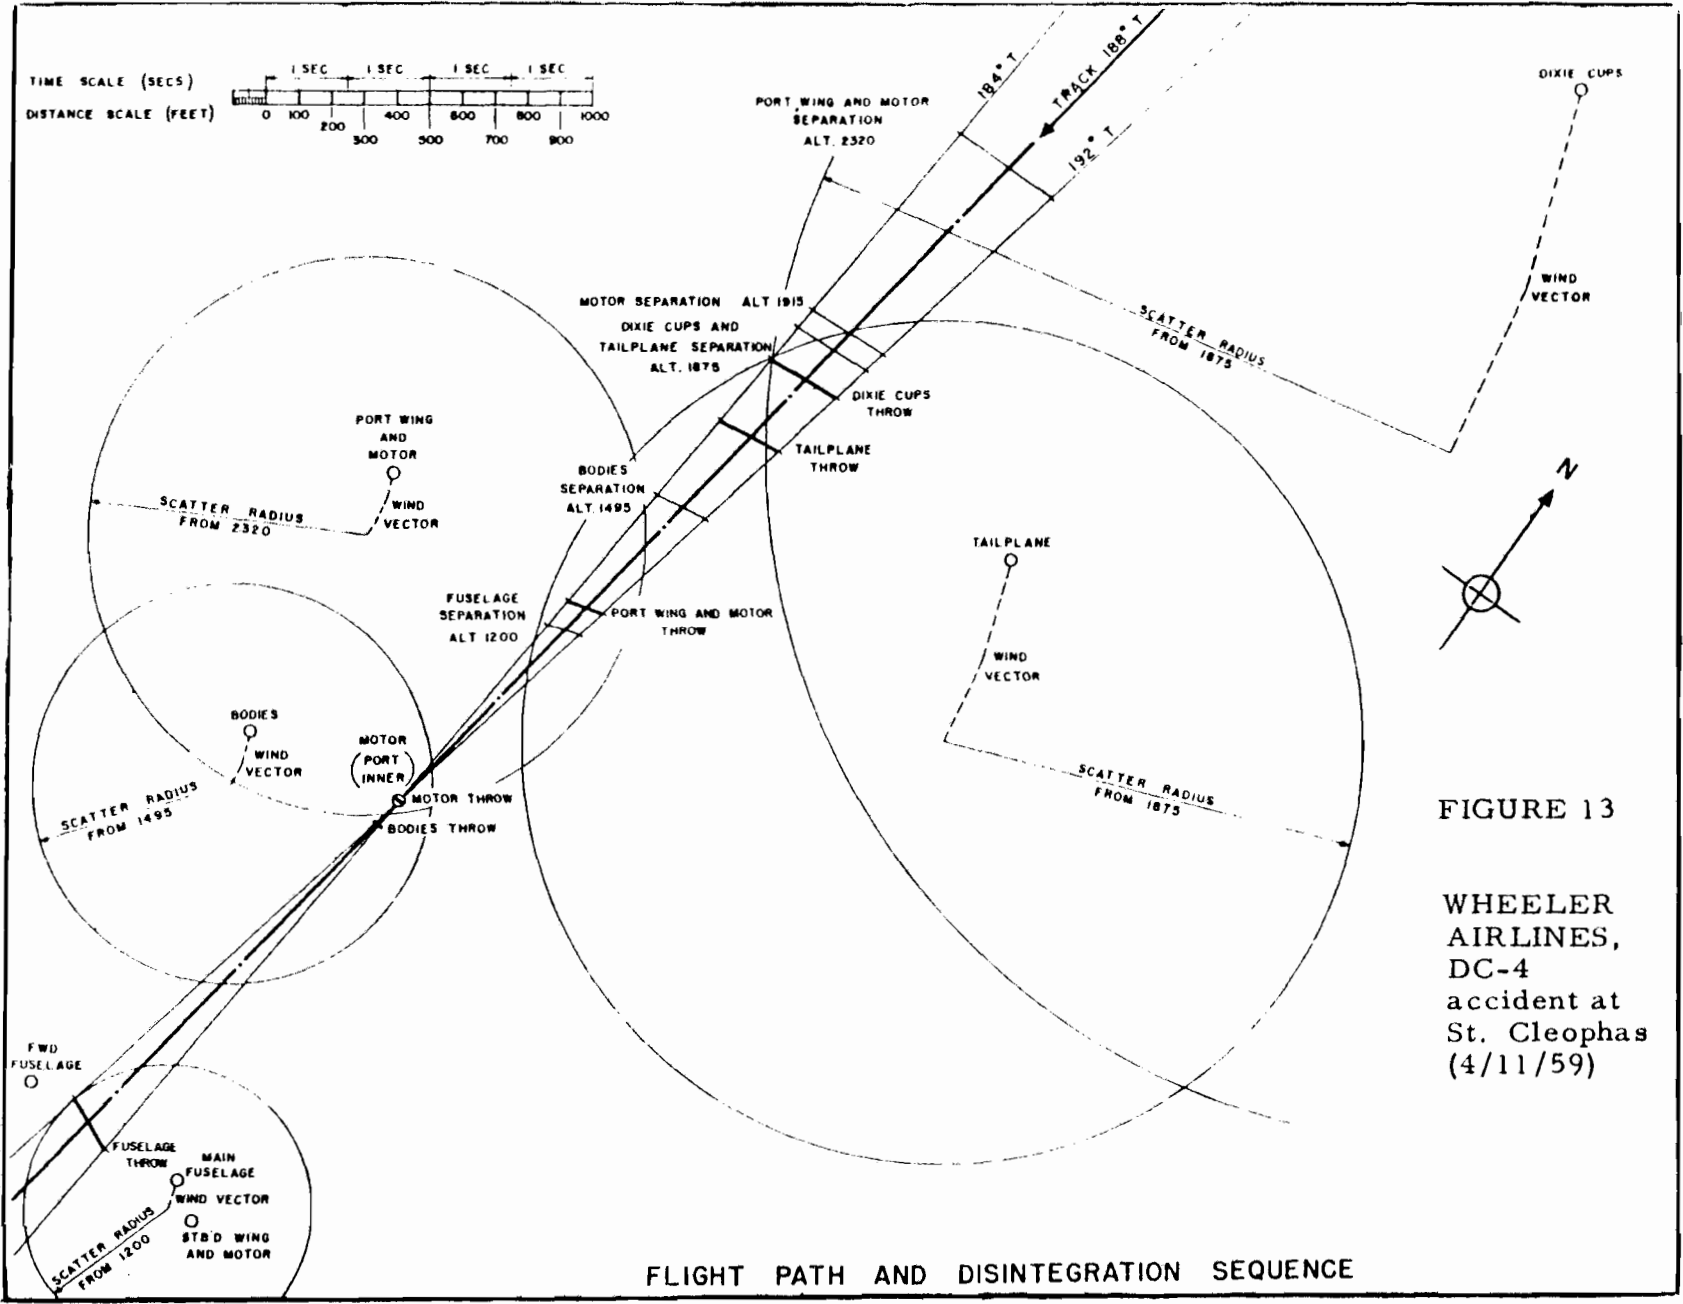
FIGURE 13
WHEELER AIRLINES, DC-4 accident at St. Cleophas (4/11/59)

1. The deteriorated condition of the exhaust collector ring;
2. The probable deteriorated condition of the flexible wire braid hose assemblies;
3. The probable use of high power during the climb;
4. The possible failure of the fire detection and warning system to inform the pilot of the existence of a fire before it had penetrated the firewall and ignited the fuel feed system and oil tank to the rear of No. 2 engine.

During the rapid letdown, stresses were imposed on the weakened left wing by manoeuvre and/or gusts which were sufficient to sever the left wing spar. No subsequent action by the pilot could have brought the aircraft safely to the ground; neither was it possible to determine what effect a less rapid letdown would have had.

FLIGHT PATH AND DISINTEGRATION SEQUENCE
