ICAO

CIRCULAR 64-AN/58

AIRCRAFT ACCIDENT DIGEST

No. 12

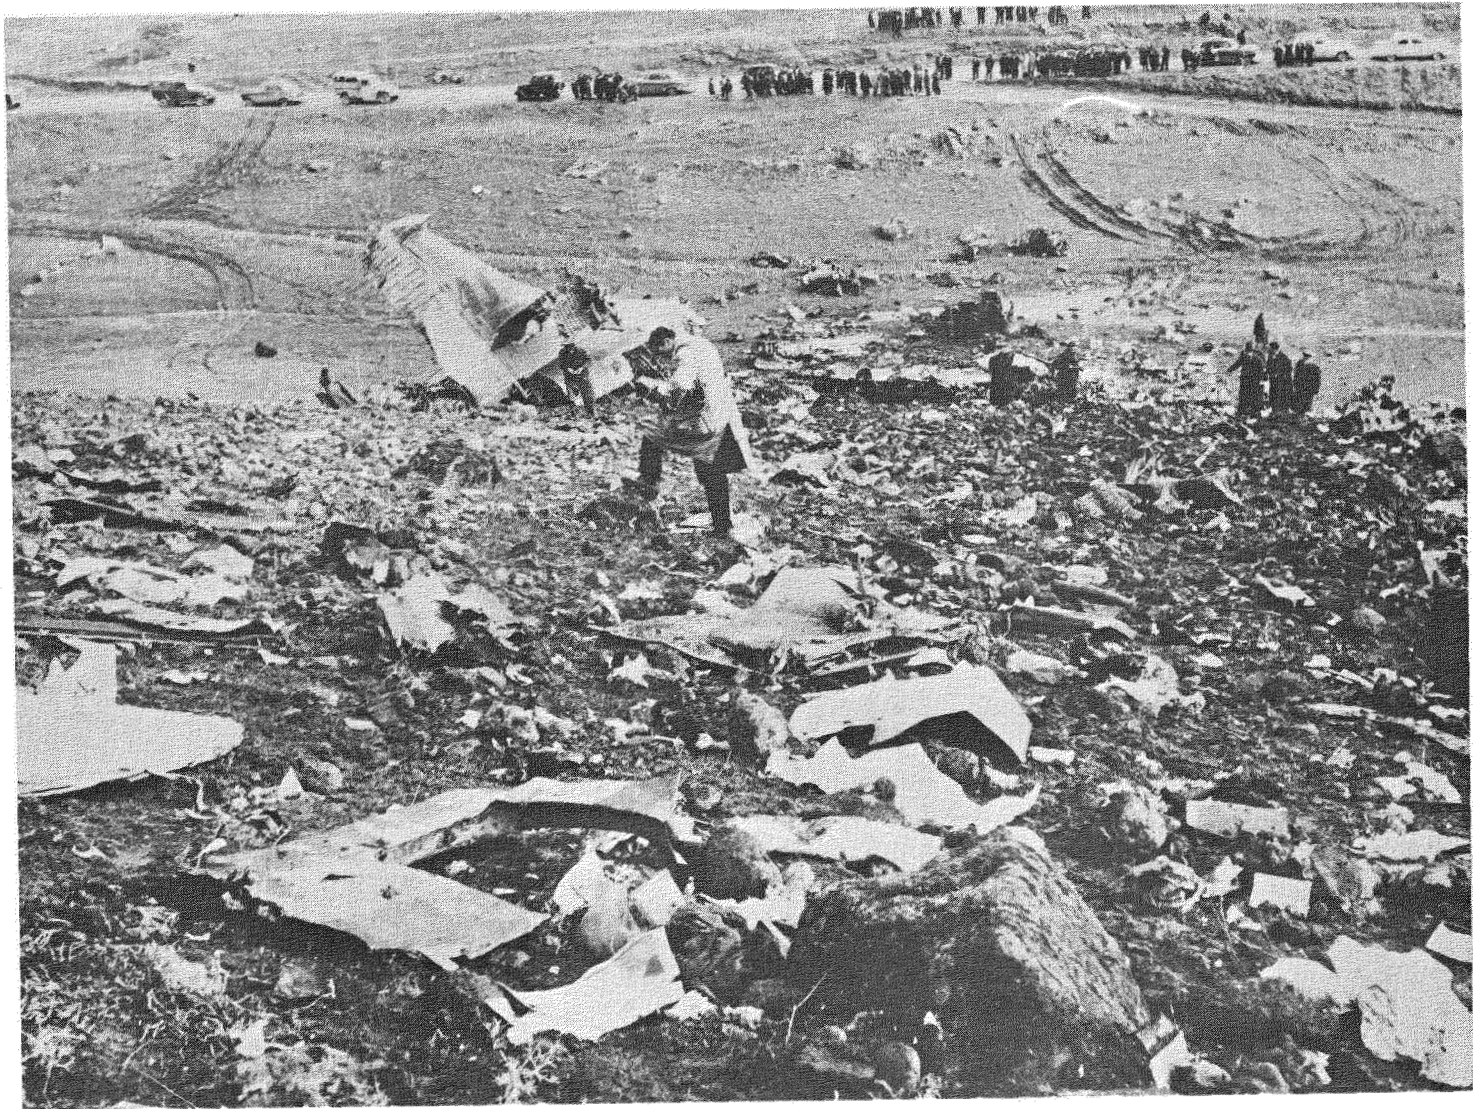
FIGURE 6

SAS, SE 210 Caravelle, OY-KRB, accident at Esenboga Airport, Turkey, 19 January 1960
Main wreckage area

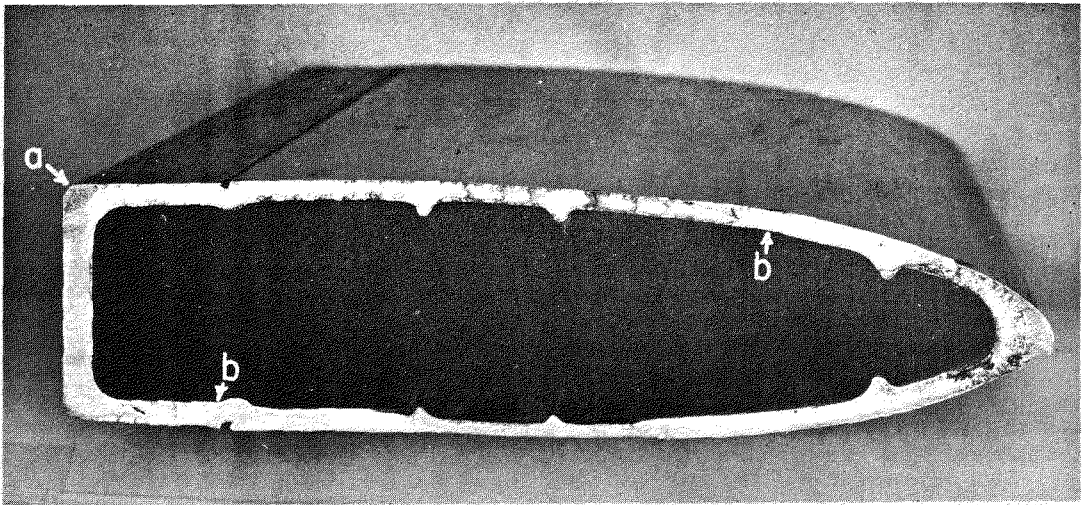
FIGURE 10

The probable cause of this accident was the structural disintegration in flight initiated by a fatigue fracture of a main rotor blade.

Surface of the fracture in the blade from Chicago Helicopter Airways. Arrow "a" indicates the origin and arrows "b" the ends of the fatigue fracture.

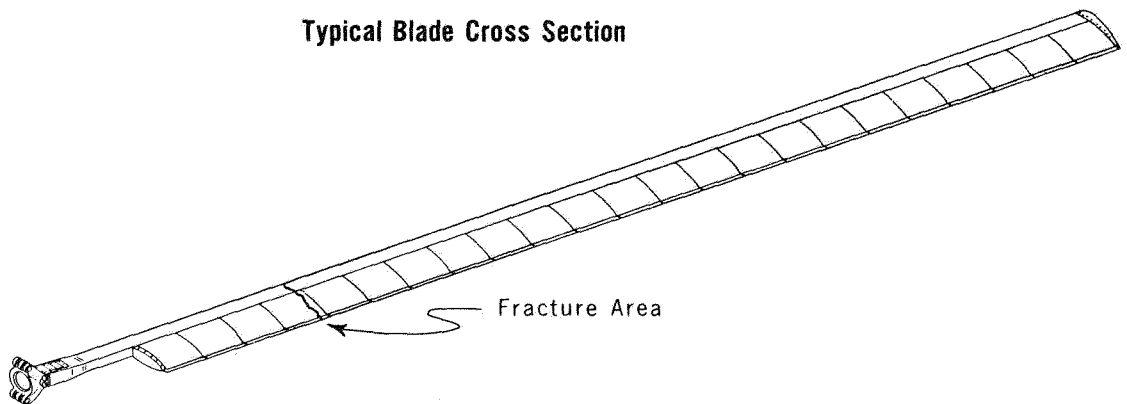
FIGURE 11 - Main Rotor Blade

FOREST PARK, ILLINOIS, CHICAGO HELICOPTER AIRWAYS, N-879, JULY 27, 1960

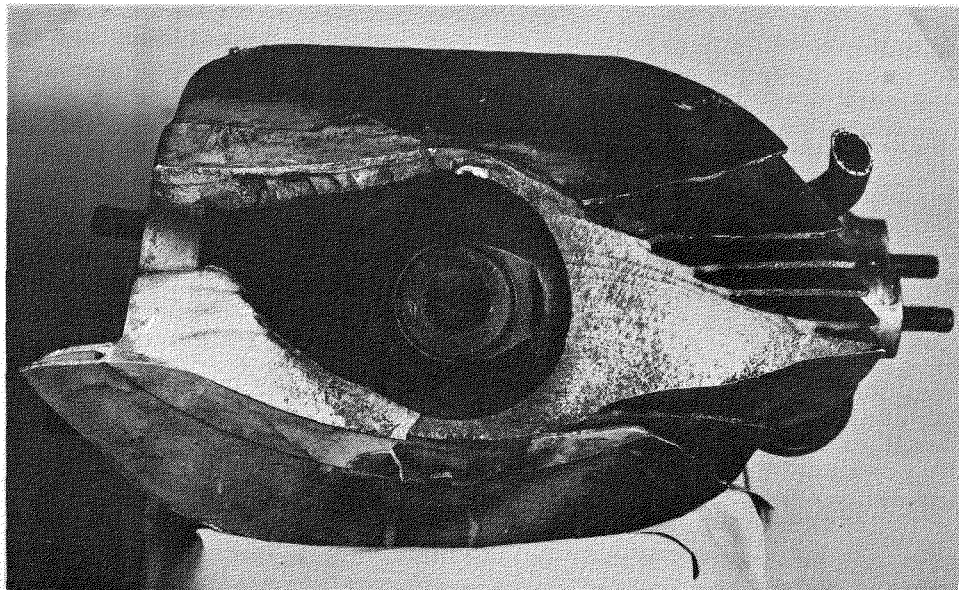
FIGURE 13

CYLINDER HEAD - BROKEN NEAR THE EXHAUST VALVE. THE UPPER PART OF THE HEAD BROKE OFF ABOVE THE VALVE. (LEFT ENGINE, CYLINDER NO. 4)

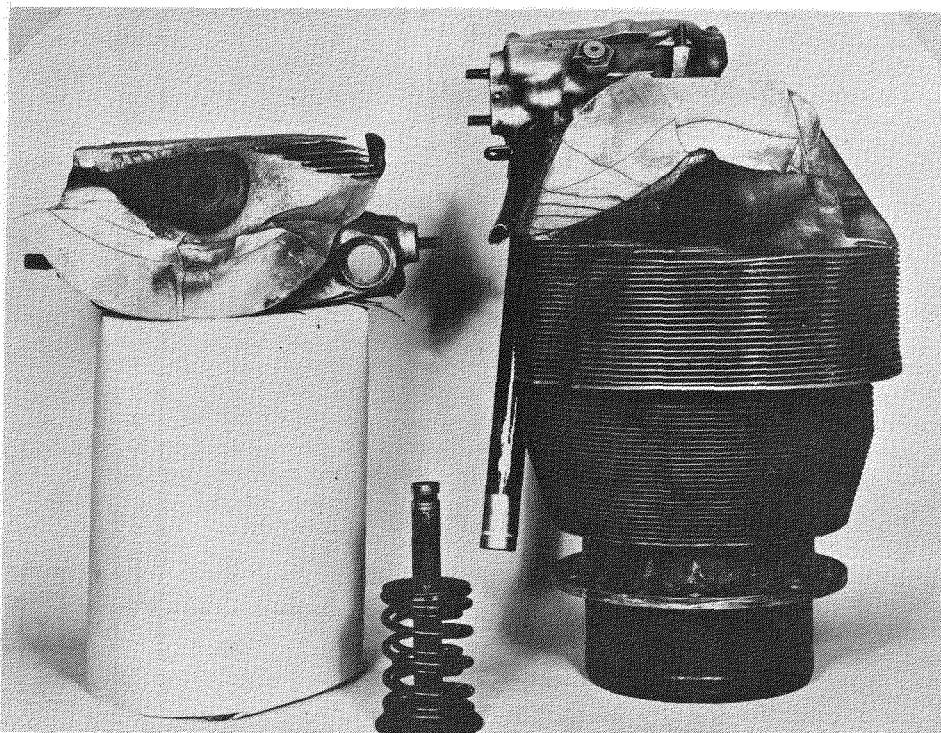
FIGURE 14

THE PATTERN OF THE FRACTURES INDICATES THAT THE FATIGUE CRACK ORIGINATED AT THE POINT OF MINIMUM THICKNESS OF THE OUTER SIDE - THE FRACTURE SURFACES OF THE THINNEST WALL OF THE INNER SIDE INDICATE THAT THE FAILURE OCCURRED SUDDENLY.

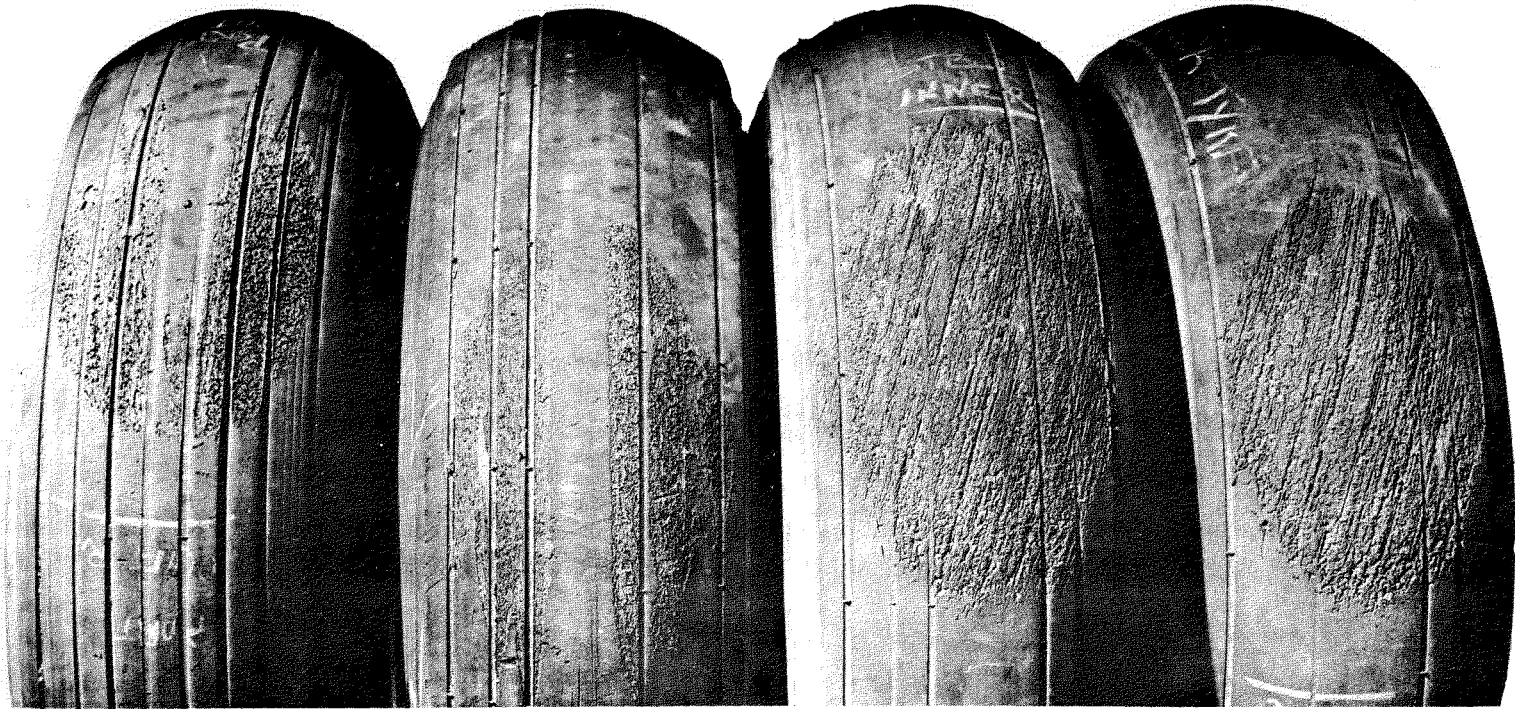
FIGURE 17

THE MAIN WHEEL TIRES
