CIRCULAR 69-AN/61

AIRCRAFT ACCIDENT DIGEST

No. 13

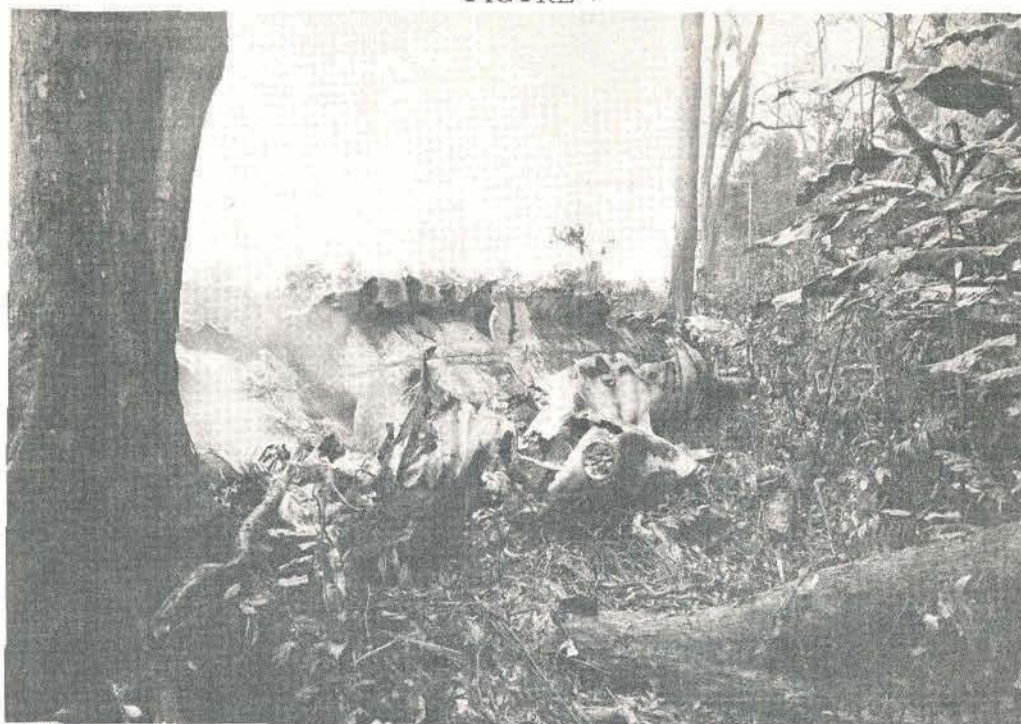
FIGURE 8

FLOOR OF PASSENGER COMPARTMENT WITH UPPER PART MISSING

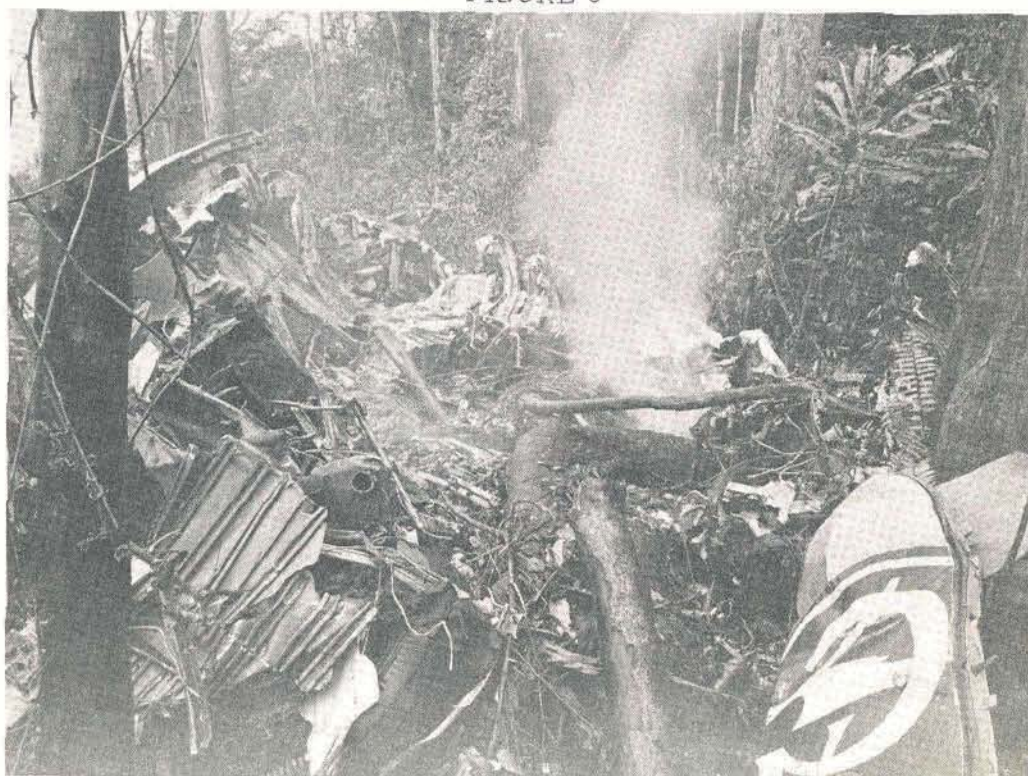
FORWARD FUSELAGE AND NOSE WHEEL

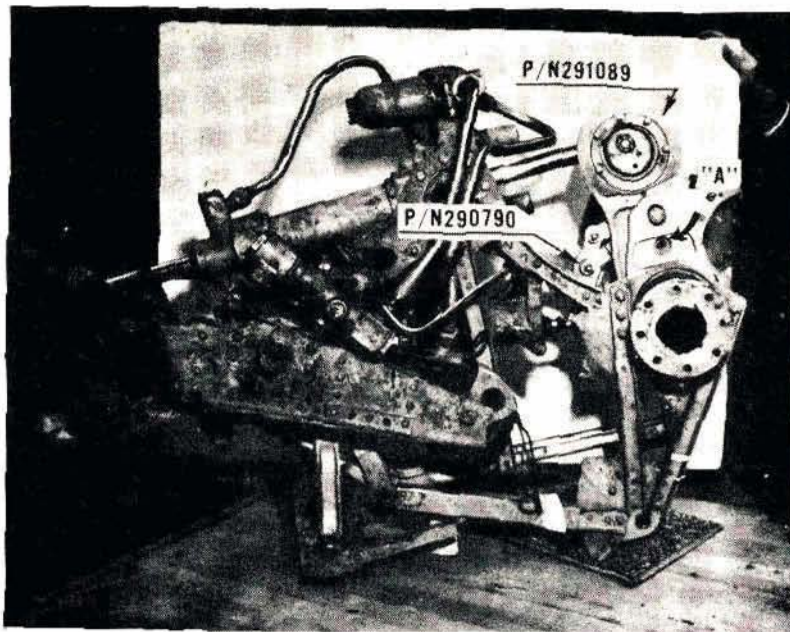
FIG. 15.—Elevator boost package. Bushing where bolt should have been is indicated by arrow "A".

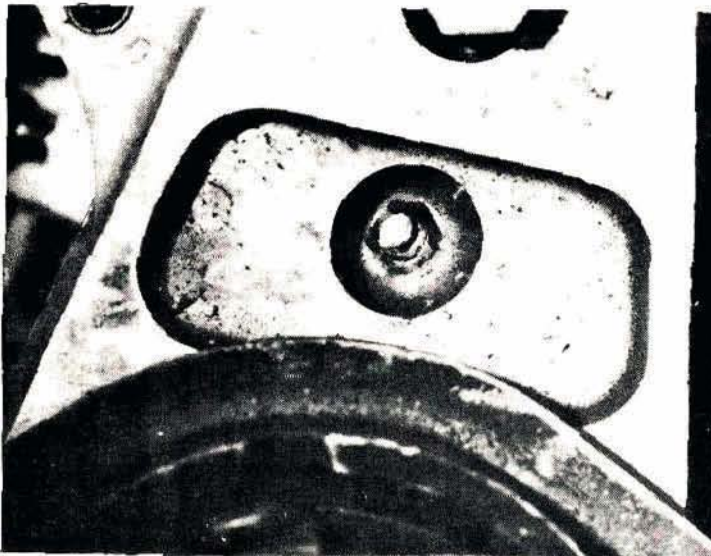
FIG. 16.—Close-up view before disassembly of bushing against which head of bolt should have been.

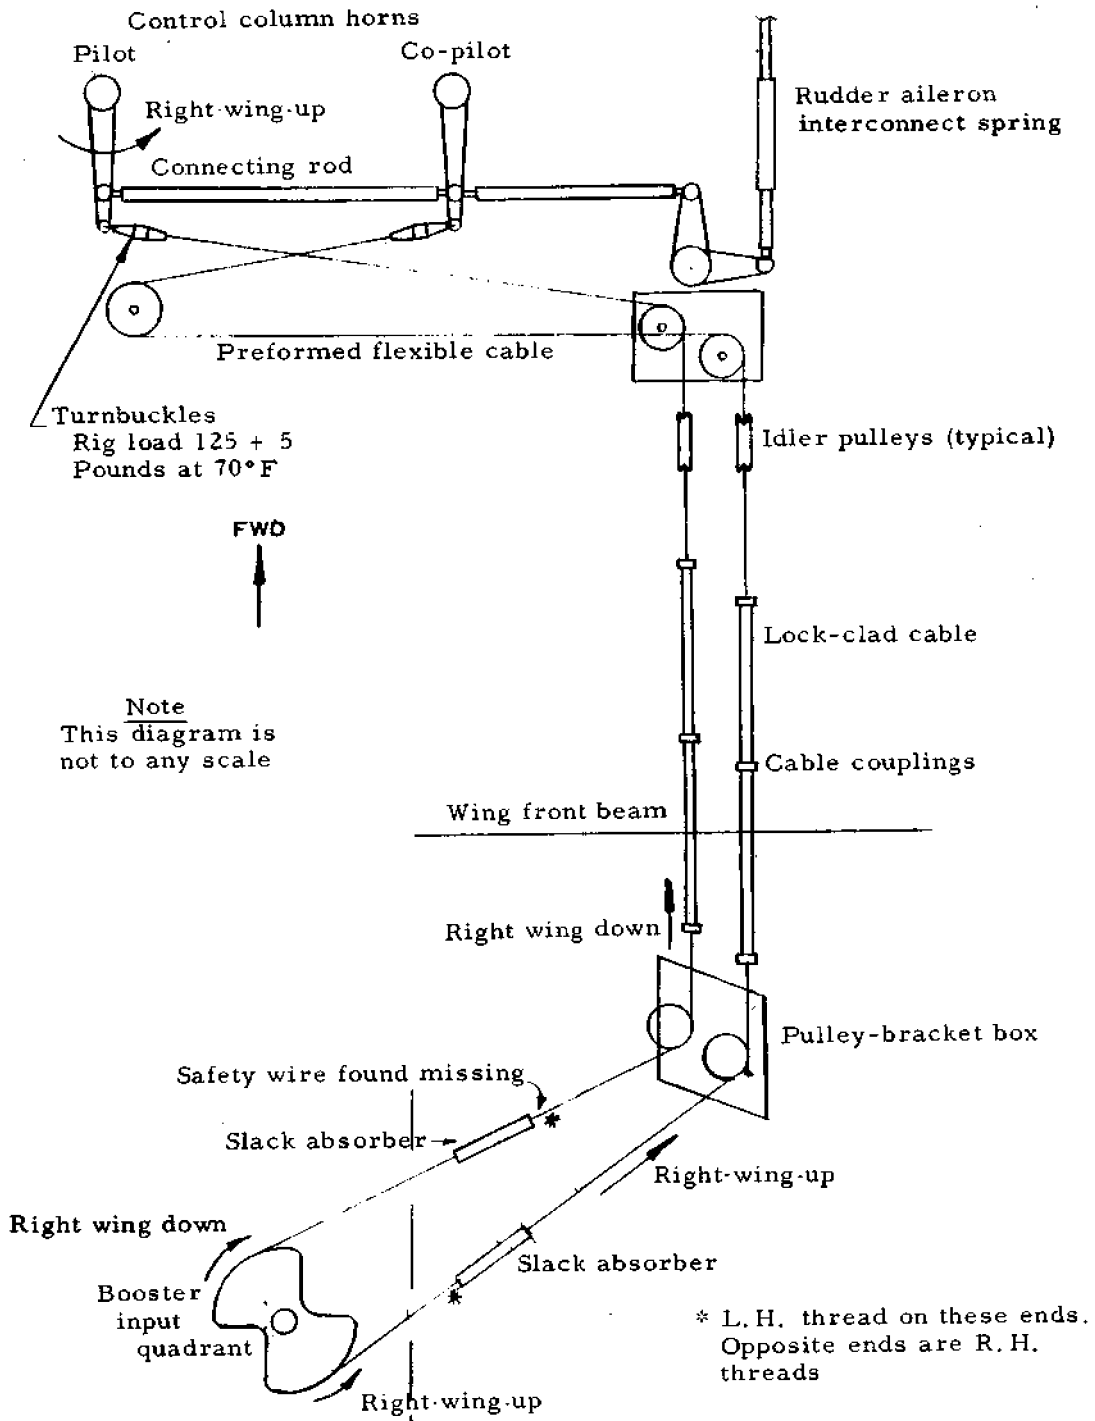
FIGURE 17

The probable cause of this accident was a mechanical failure in the aileron primary control system due to an improper replacement of the aileron boost assembly, resulting in a loss of lateral control of the aircraft at an altitude too low to effect recovery.

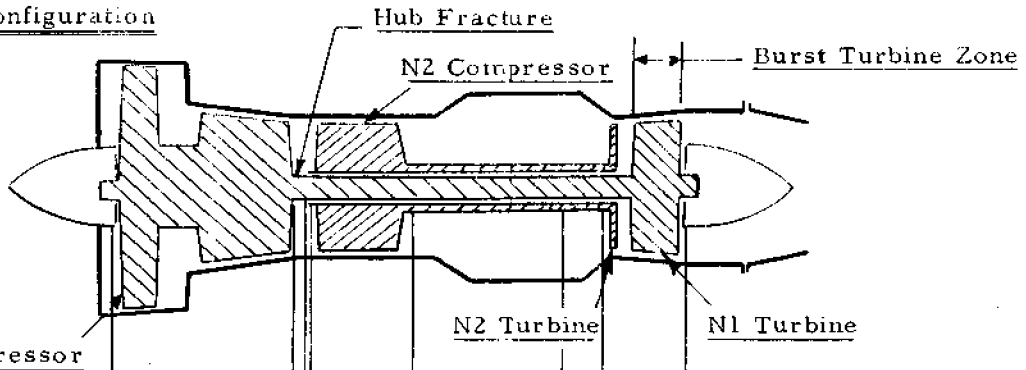
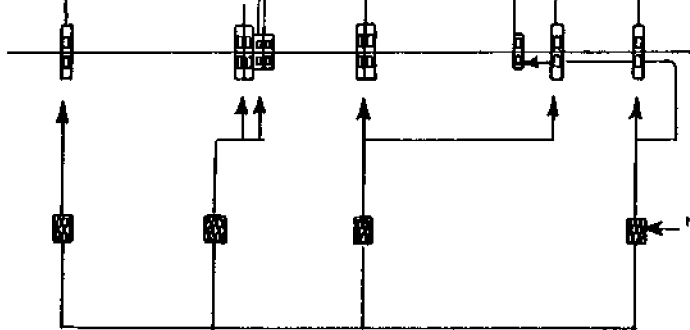
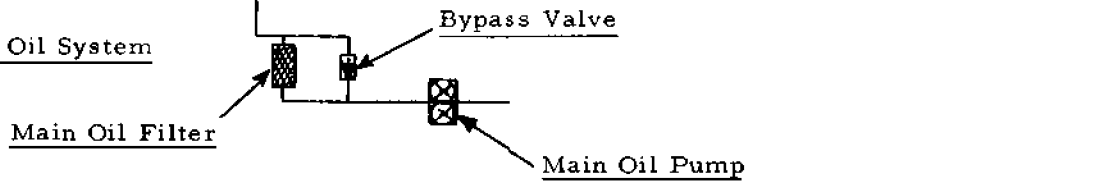
Engine Configuration

The probable cause of this accident was oil starvation of the No. 2 bearing which caused its failure. This precipitated the fracture of the low-pressure compressor rear hub and the overspeeding and subsequent disintegration of the low-pressure turbine section.

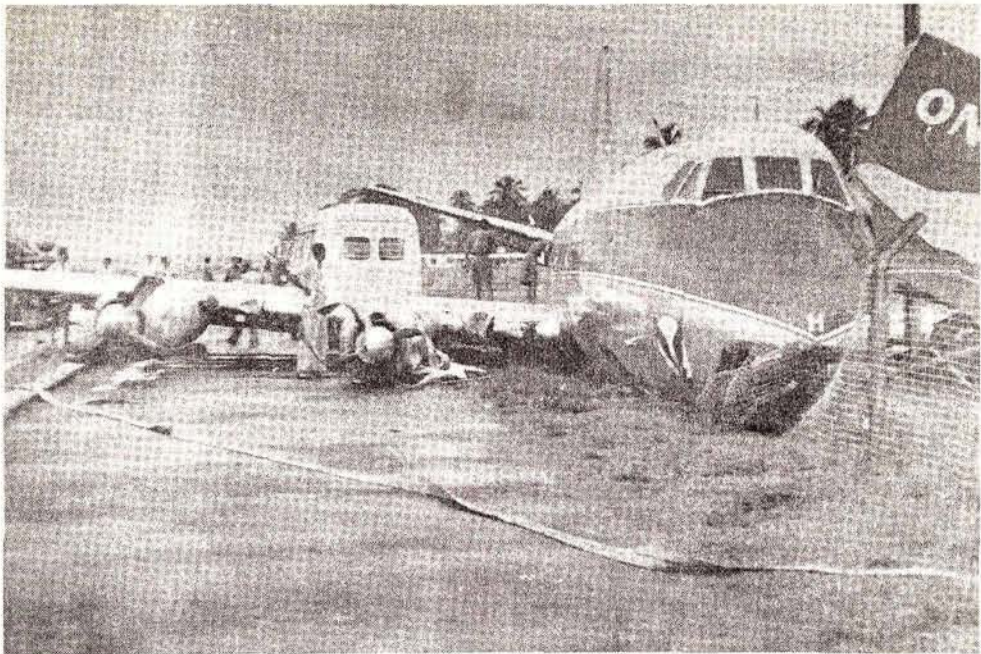
FIGURE 24
FINAL POSITION OF AIRCRAFT AFTER THE ACCIDENT

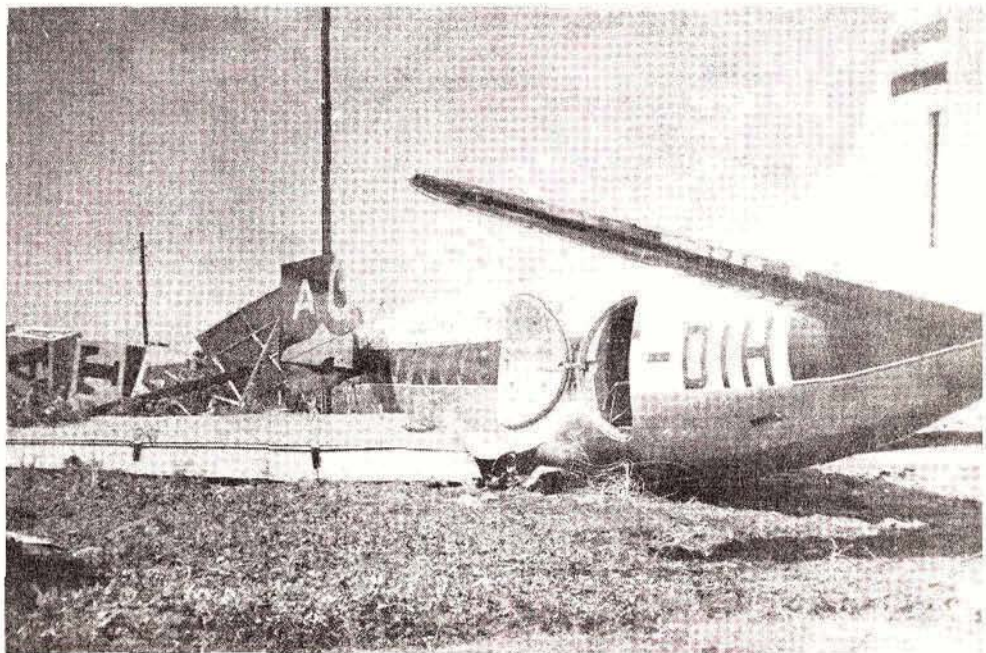
FIGURE 25
VIEW FROM PORT SIDE (REAR)
