# ICAO CIRCULAR

CIRCULAR 71-AN/63  
Volume II

## AIRCRAFT ACCIDENT DIGEST No. 14

### Volume II

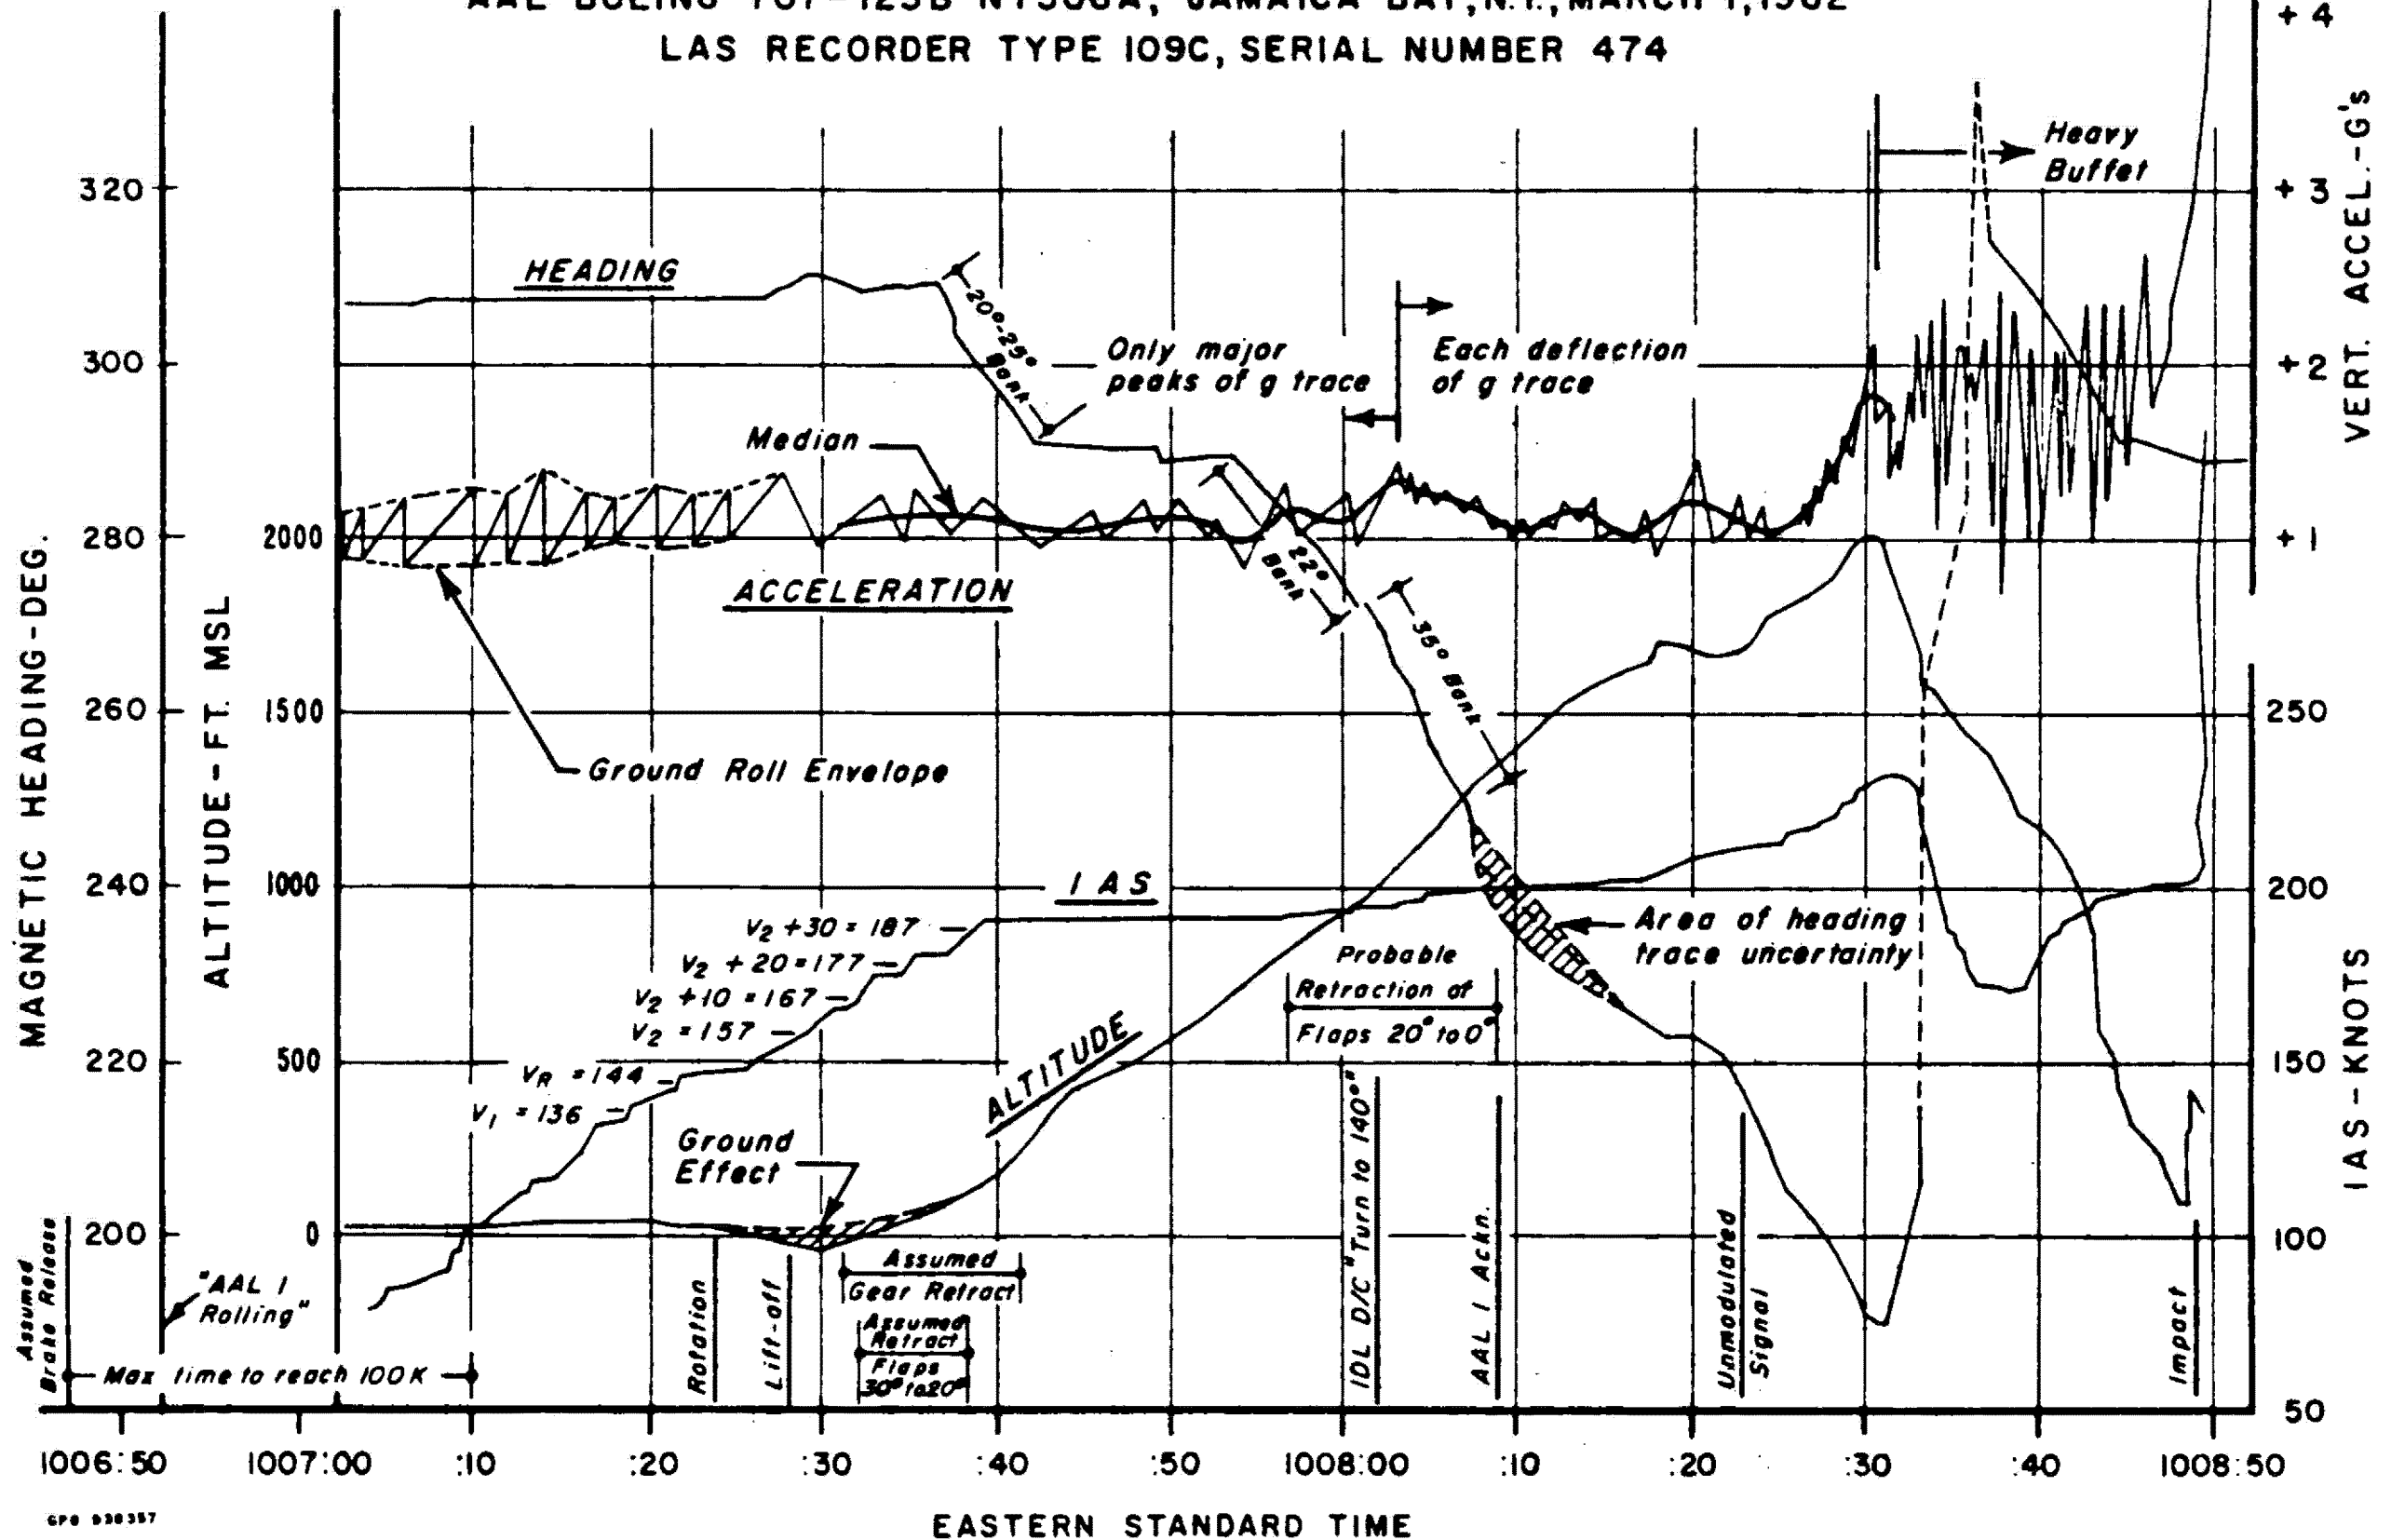
FIGURE 2

AAL BOEING 707-123B N7506A, JAMAICA BAY, N.Y., MARCH 1, 1962  
LAS RECORDER TYPE IO9C, SERIAL NUMBER 474

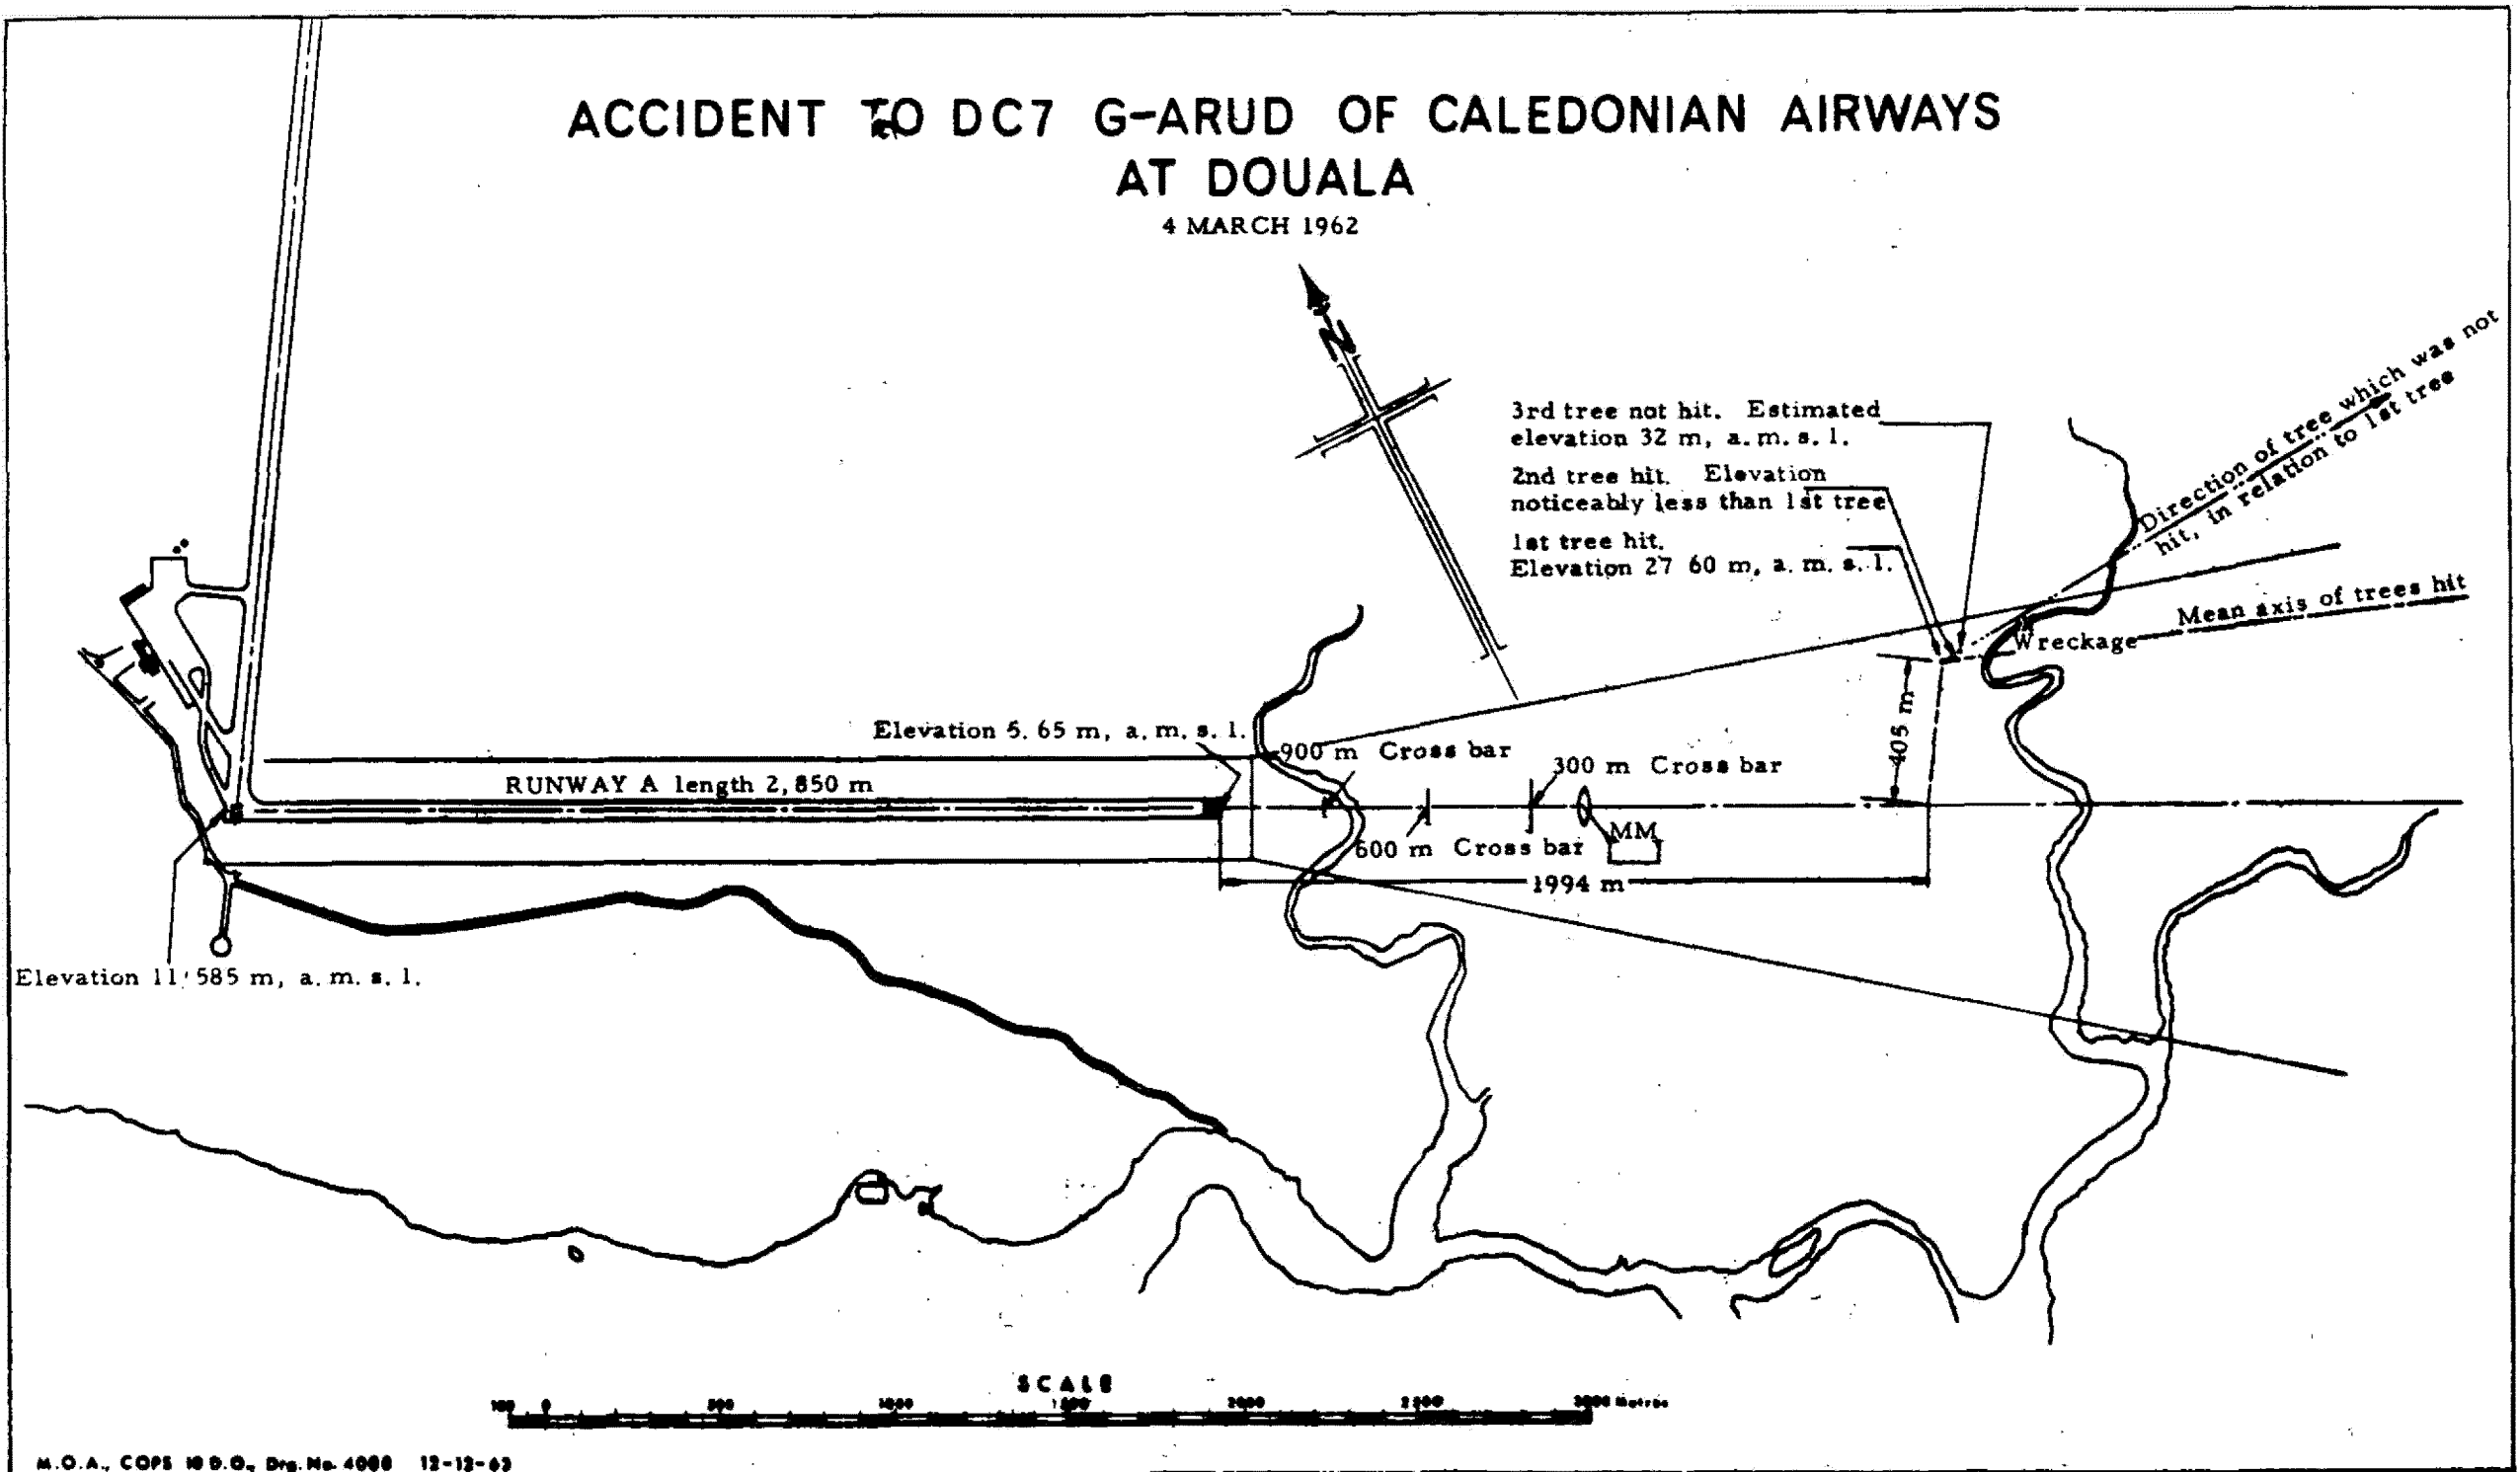
FIGURE 3

# ACCIDENT TO DC7 G-ARUD OF CALEDONIAN AIRWAYS AT DOUALA

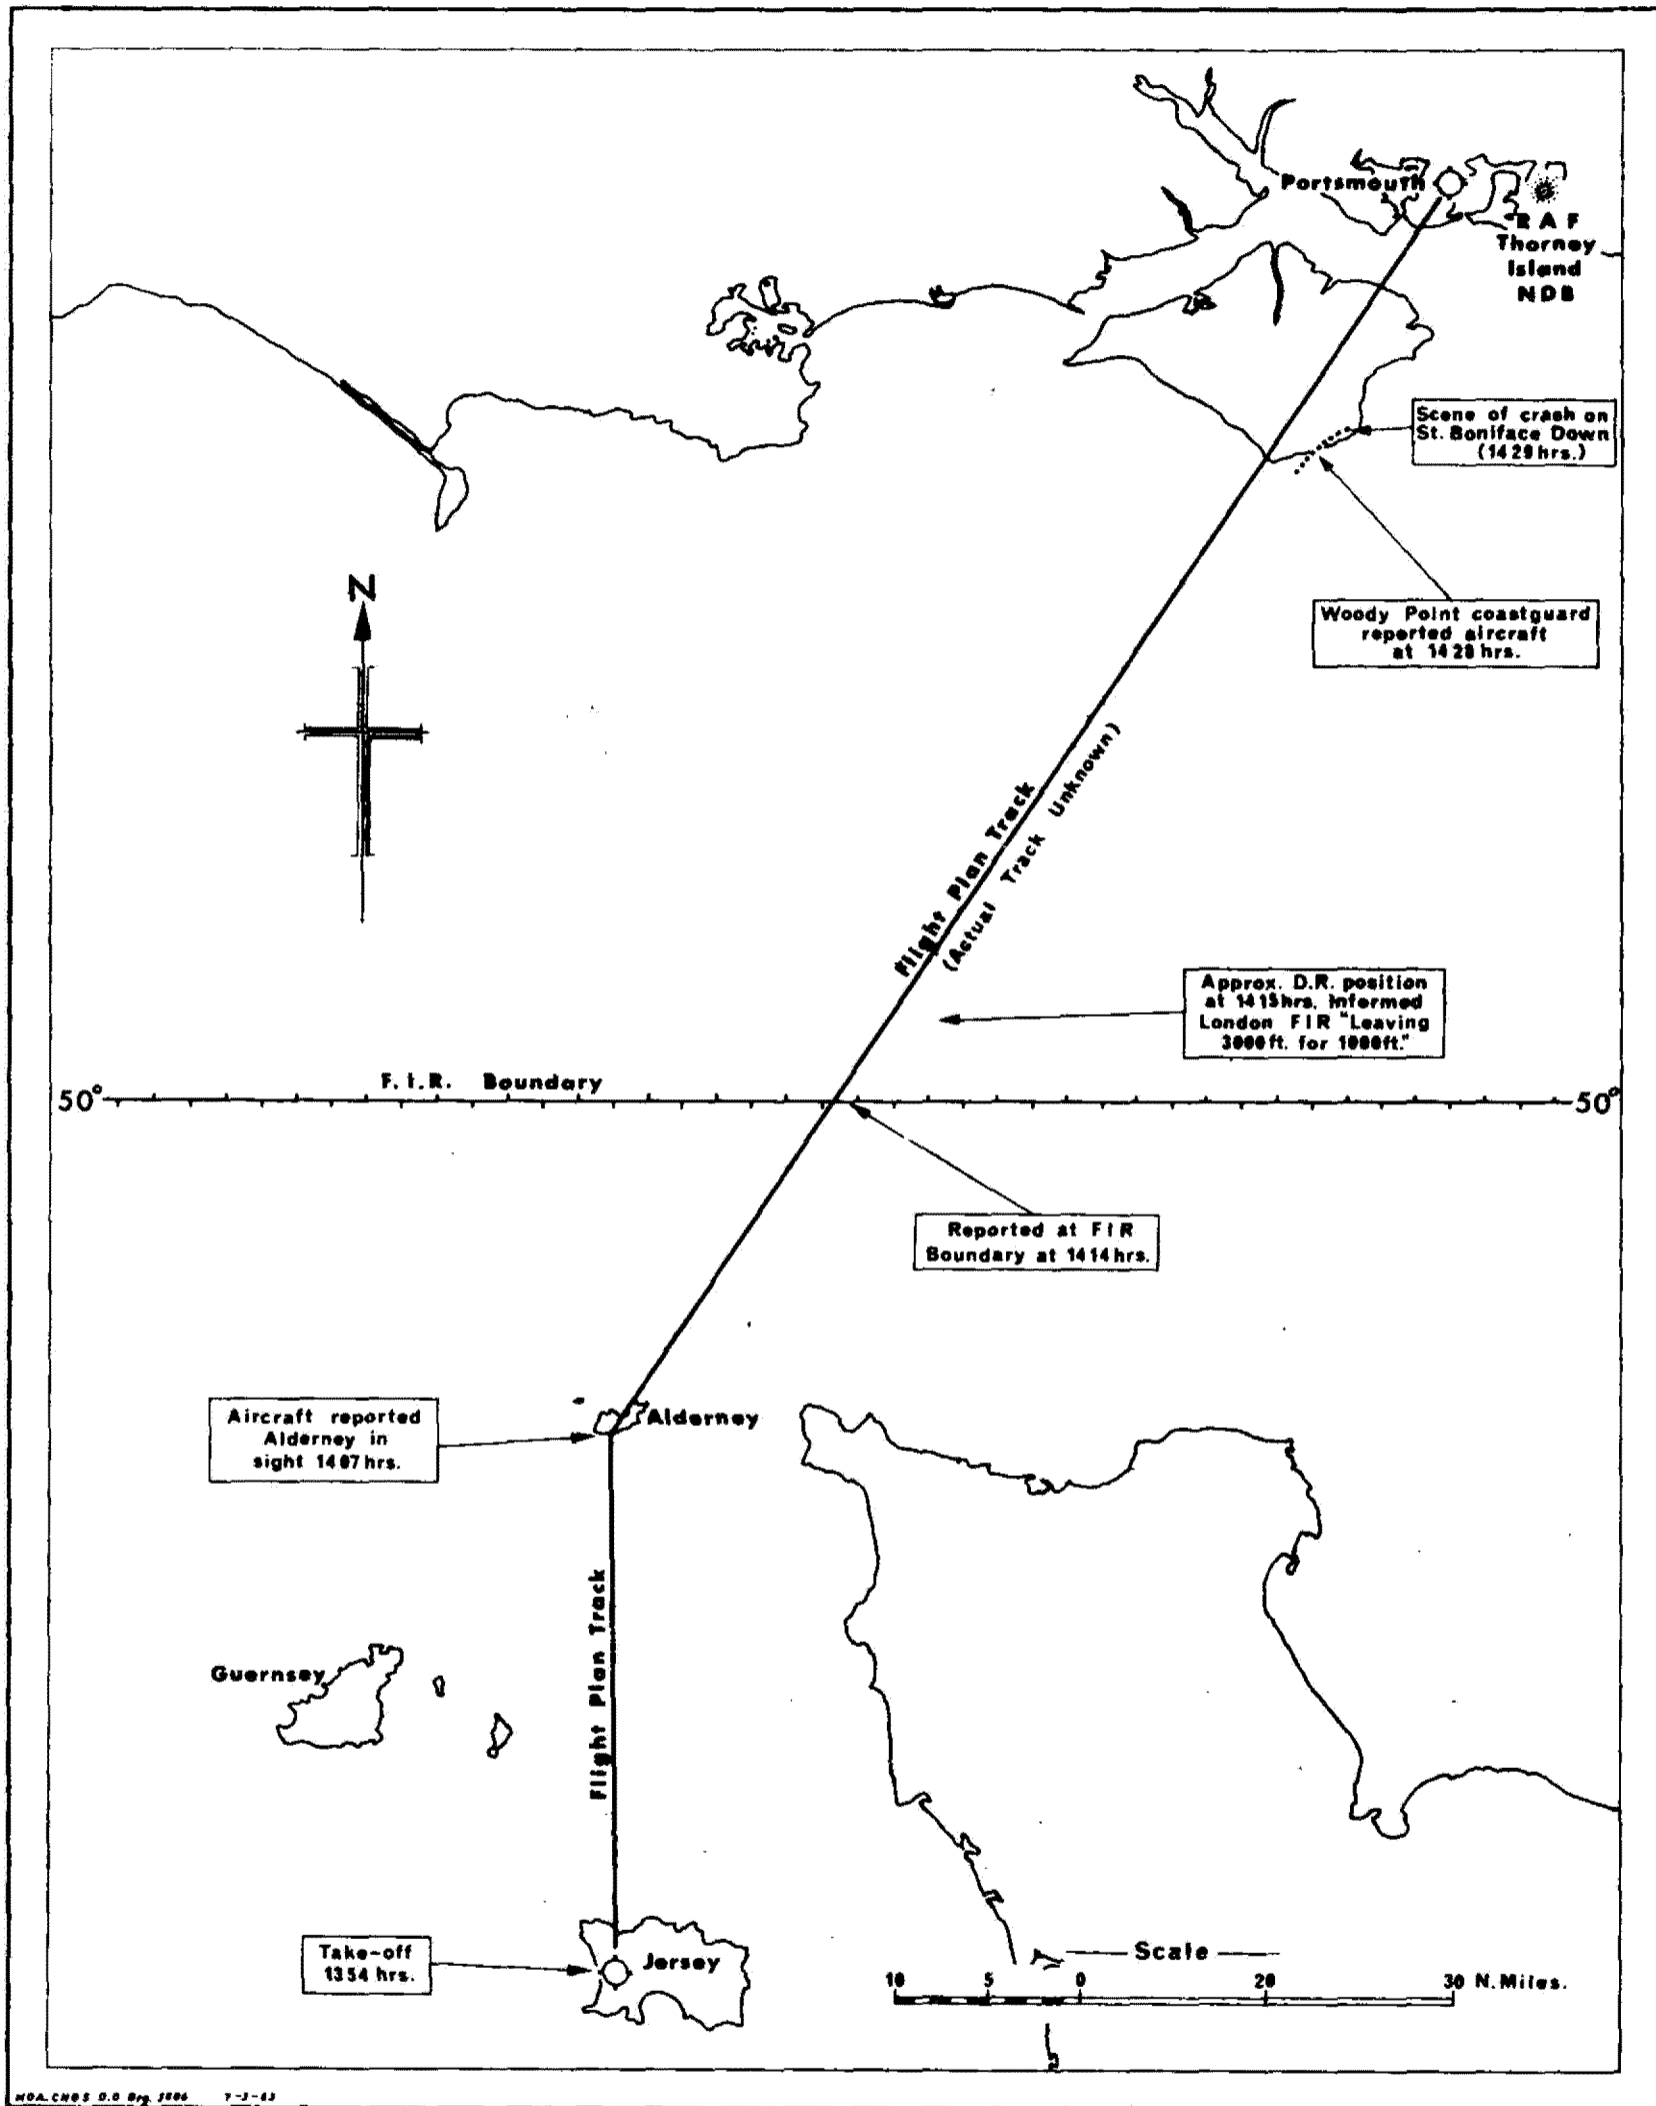
FIGURE 4

ACCIDENT TO C-47 OF CHANNEL AIRWAYS AT ST. BONIFACE DOWN, Near VENTNOR, ISLE OF WIGHT, 6 MAY 1962

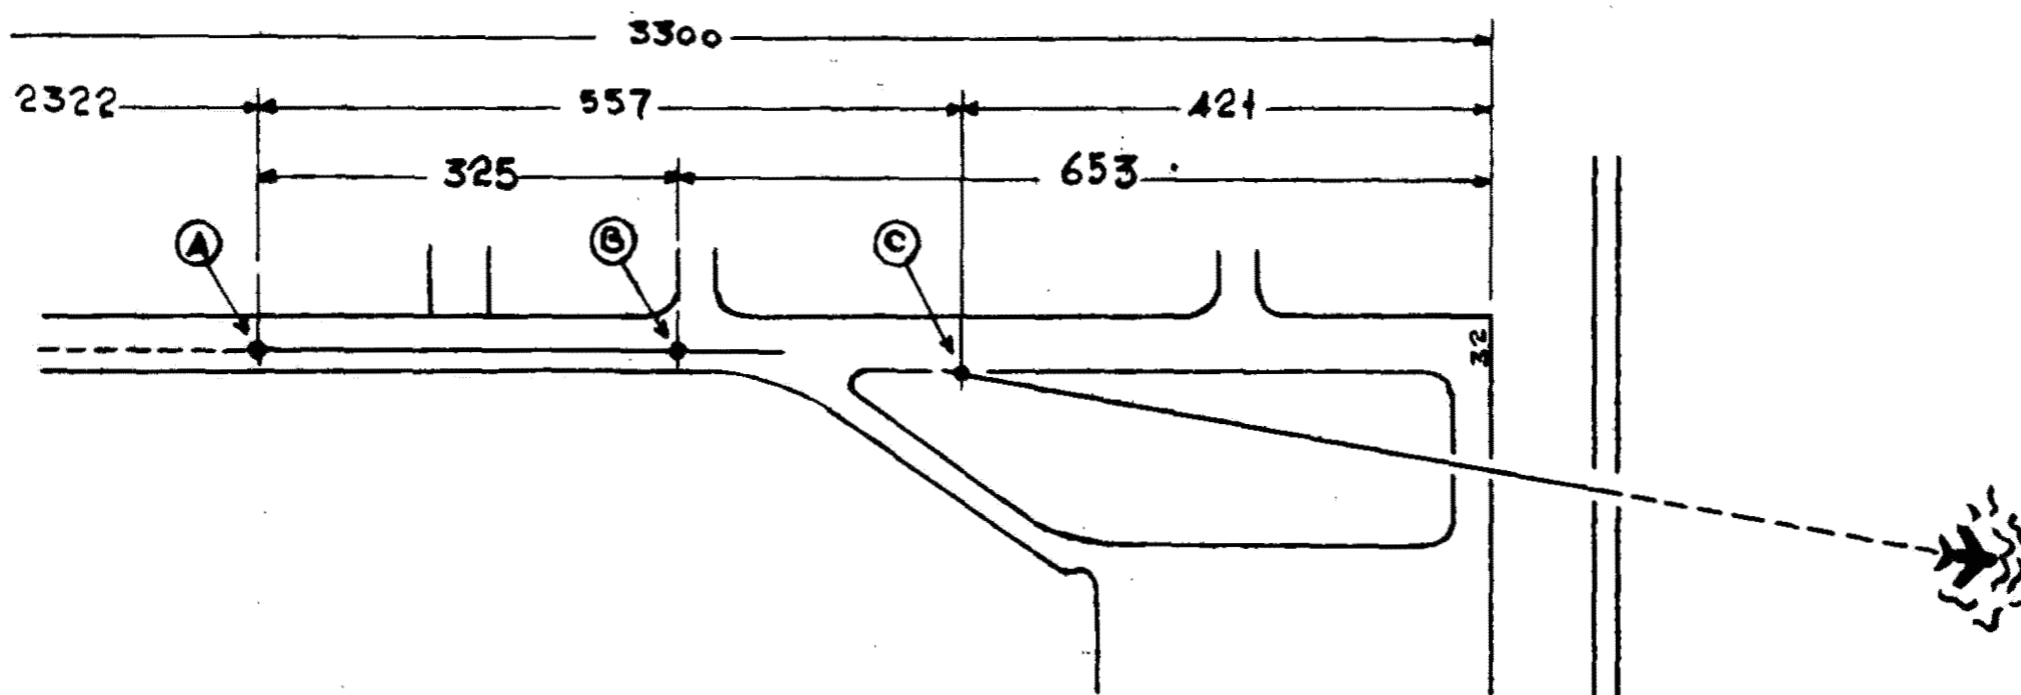
ACCIDENT TO DC-8, PP-PDT OF PANAIR DO BRASIL S. A. AT GALEAO AIRPORT, BRASIL

CORRELATION WITH THE MARKS FOUND ON THE RUNWAY

- A - FIRST BRAKE MARKS
- B - BEGINNING OF VIOLENT BRAKING
- C - POINT WHERE THE AIRCRAFT LEFT THE RUNWAY

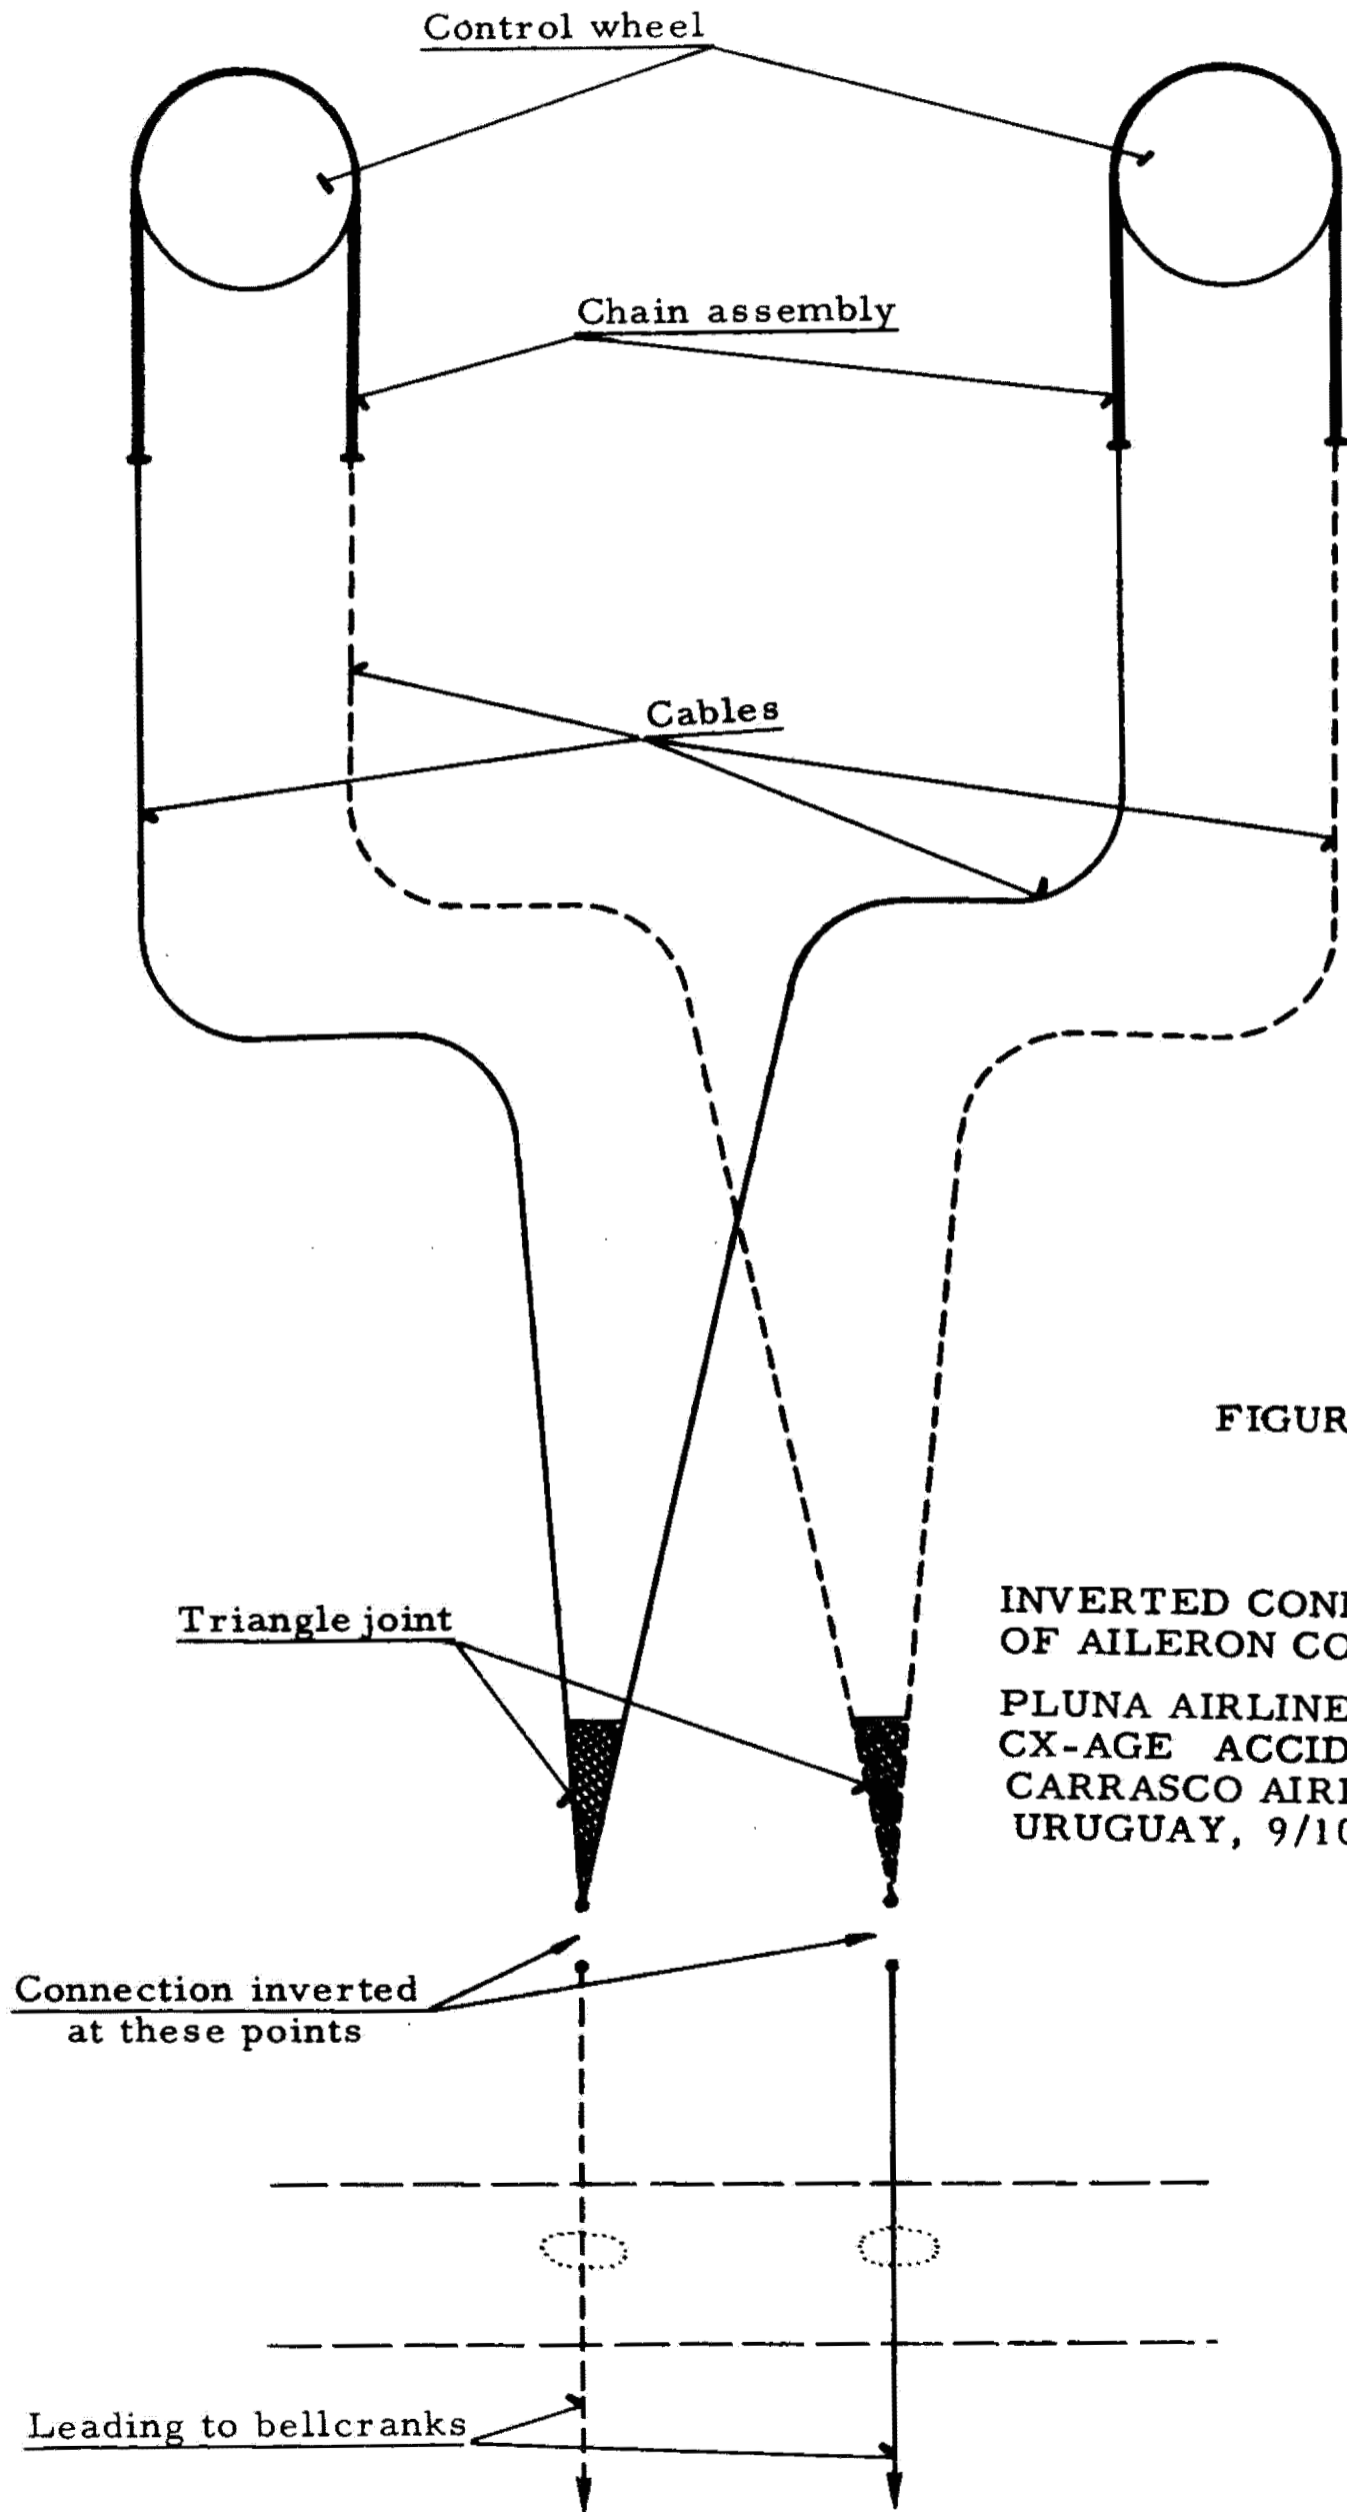
FIGURE 6

INVERTED CONNECTION  
OF AILERON CONTROLS  
PLUNA AIRLINES, DC-3,  
CX-AGE ACCIDENT AT  
CARRASCO AIRPORT,  
URUGUAY, 9/10/62

1. Pluna should take steps to improve its existing system of checks so as to eliminate verbal "Seen. O.K." reports.
2. Pluna should arrange for workshop job schedules to be signed in all cases and only by persons holding a proper licence.
3. Pluna should take steps to provide maintenance staff with Spanish language manuals and make these easily accessible to them.
4. Pluna should entrust trial flights to specific crews specializing in this activity.
5. Pluna should introduce some system to eliminate the possibility of inverted connection of DC-3 aileron controls. It is suggested that bolts of different diameter be used for each aileron or that the length of the right-left cable sections be modified.
6. The airport authority should improve the access facilities of vehicles to the operational area so as to provide more effective control in emergencies.

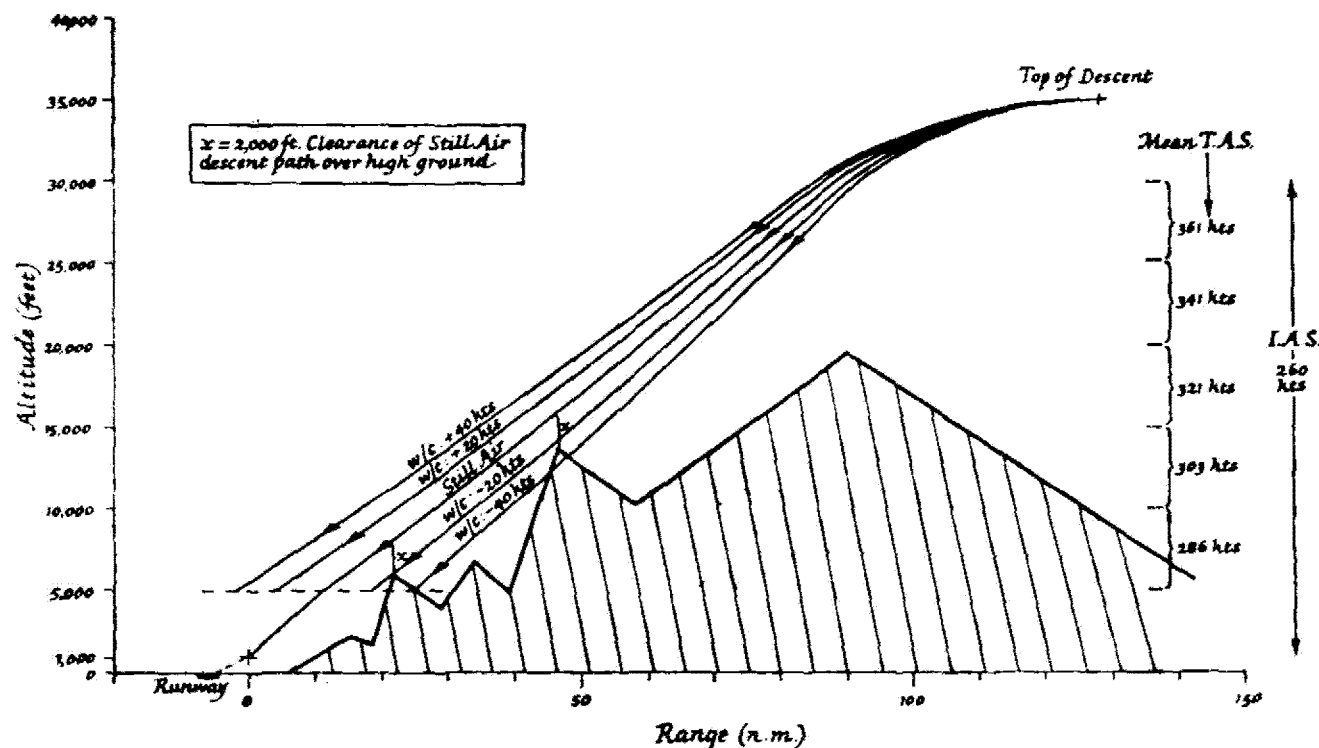
The problem is illustrated in Fig. 1 (B.707 Descent Path I), where height is plotted against distance out in nautical miles. The high ground shown does not portray an actual position but we could all recognize some near approximation; accidents and incidents have occurred, in one case at 11 000 ft and two around 6-7 000 ft. The majority of the scheduled jet cases have occurred below 3 000 ft.

FIG. 1. B707 descent path. Height is plotted against distance out.

The "top of descent" position is correctly placed to provide 2 000 ft clearance of the primary peaks at approximately 6 000 ft and 14 000 ft using the "still air" path as the datum, the other paths being drawn for head and tail wind components of 20 and 40 kt respectively. An indicated airspeed of 260 kt is assumed - a normal procedure - and a mean true airspeed has been derived for each 5 000 ft interval. The rate of descent below 30 000 ft is approximately 1 800 ft per minute.

For any surface profile such as this and flight path ending at the N. D. B., the primary controlling factor is the top of descent position. It can be seen that in this case it would only be necessary to delay the descent by one minute to overcome the 20 kt wind error against this particular profile.

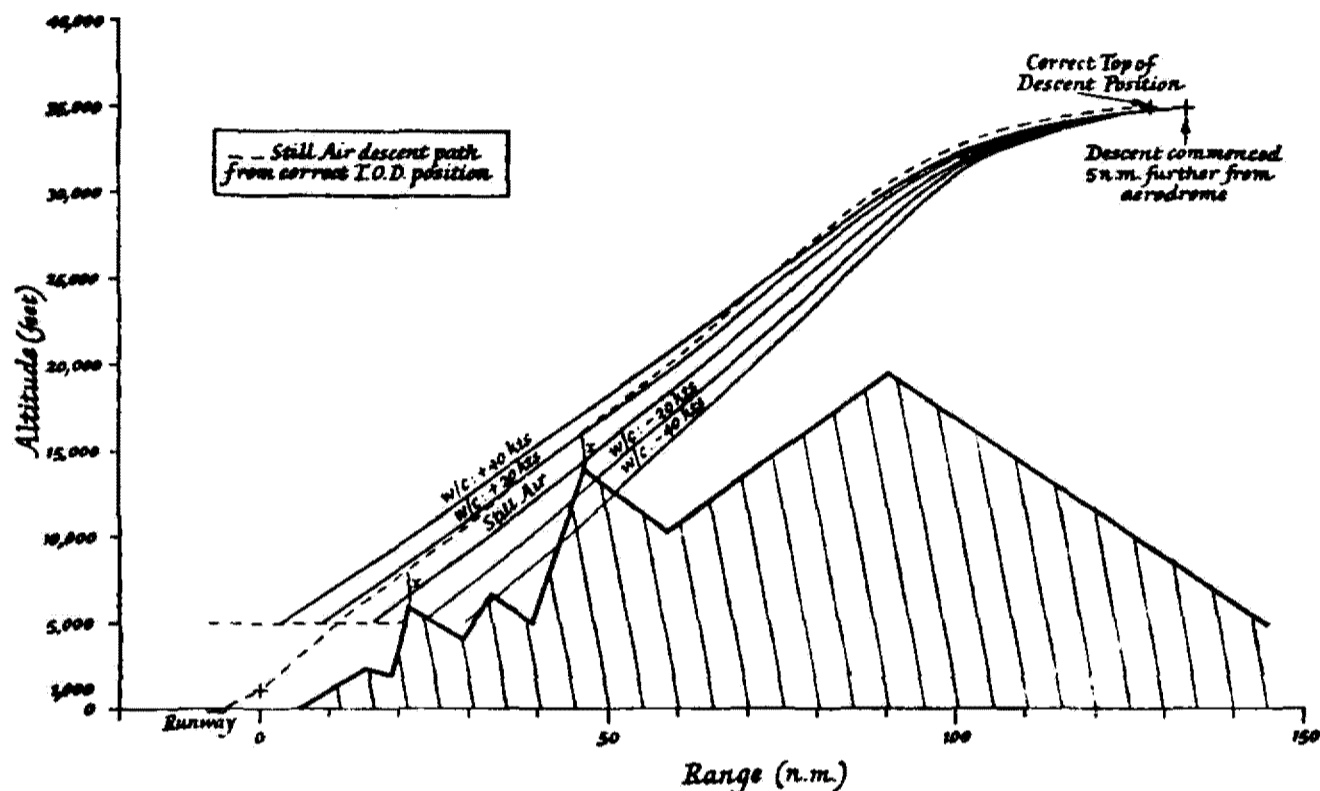
Fig. 2 shows the danger of an early descent (or 5 mile error). The intended top of descent is shown and the broken line depicts the original flight path. The planned 2 000 ft clearance is almost lost as the displacement of the still air indicates; the safeguard is obvious. The avoidance of high ground will remain in the pilot's mind the essential problem until adequate navigation facilities are provided.

FIG. 2. The danger of an early descent (or 5-mile error).

It cannot be expected that the unsatisfactory position which exists in many areas overseas will be rectified overnight, but the urgent need to resolve the primary problem which includes the avoidance of high ground is a real one.
