CIRCULAR 78-AN/66
Volume I

AIRCRAFT ACCIDENT DIGEST No. 15

Volume I

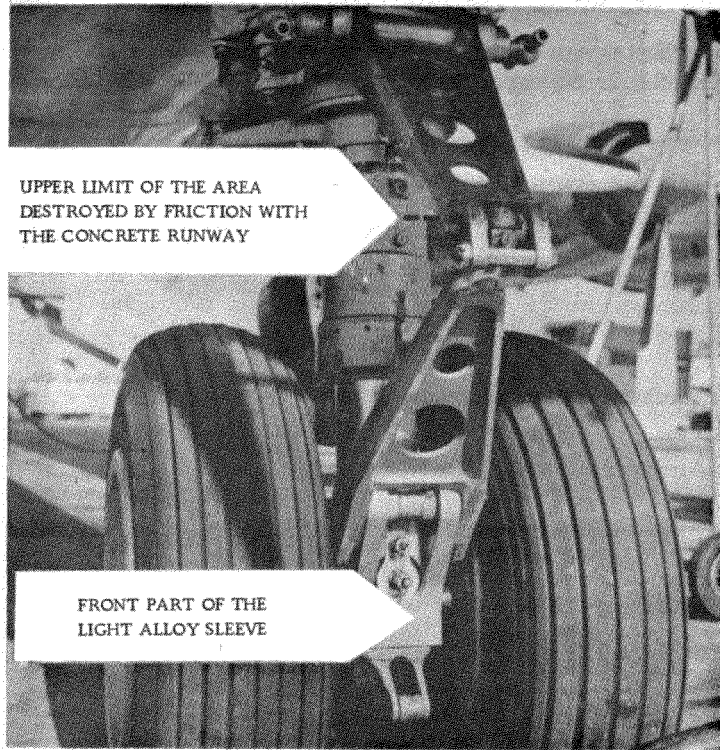
FIGURE 3

LOWER PART OF THE NOSE GEAR

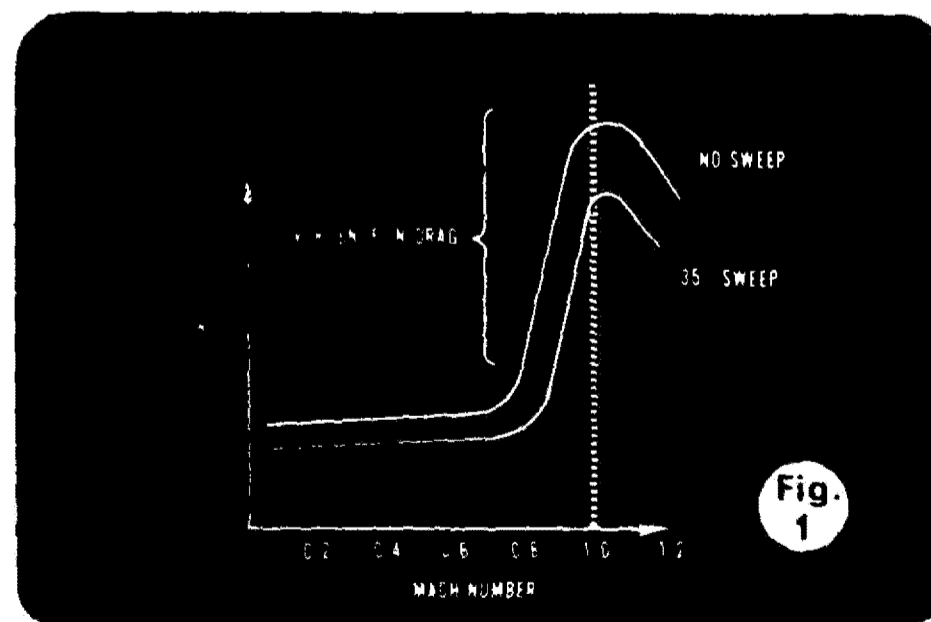
A sweep angle of 30 to 35 degrees will increase the speed at which the drag-divergence occurs due to Mach number (Fig. 1).

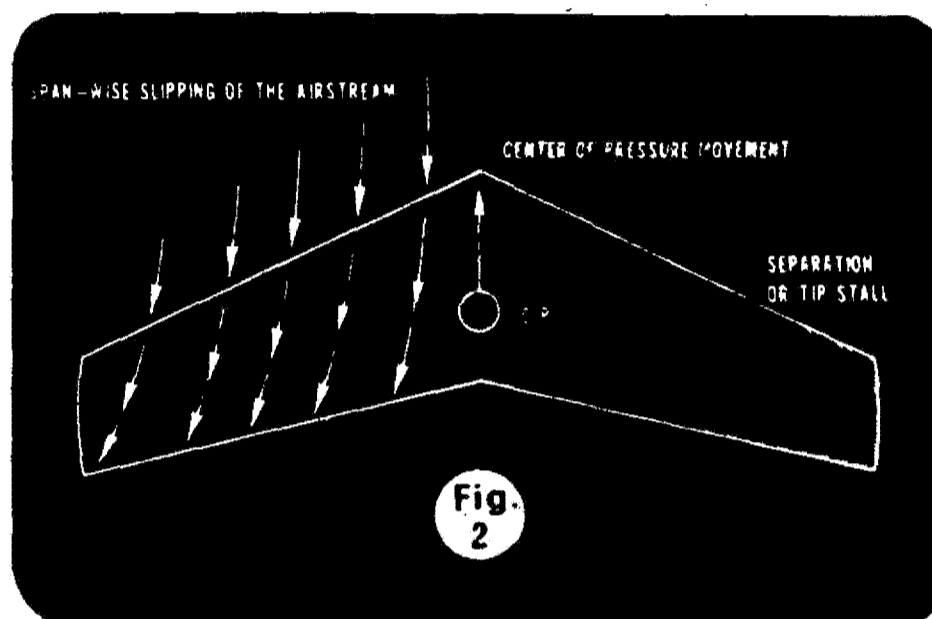
The increase in performance doesn't occur without penalty; the high-tail aircraft configuration has a pitch-up possibility. Both the swept-wing and the high-tail contribute to the aircraft instability, the wing because of its airflow patterns. The pressure gradient along the wing surface causes span-wise slipping of the airstream (Fig. 2).

This produces a thicker boundary layer of air near the tip. Air flow separation will occur first at the tip and thus the stall occurs first at the tip.

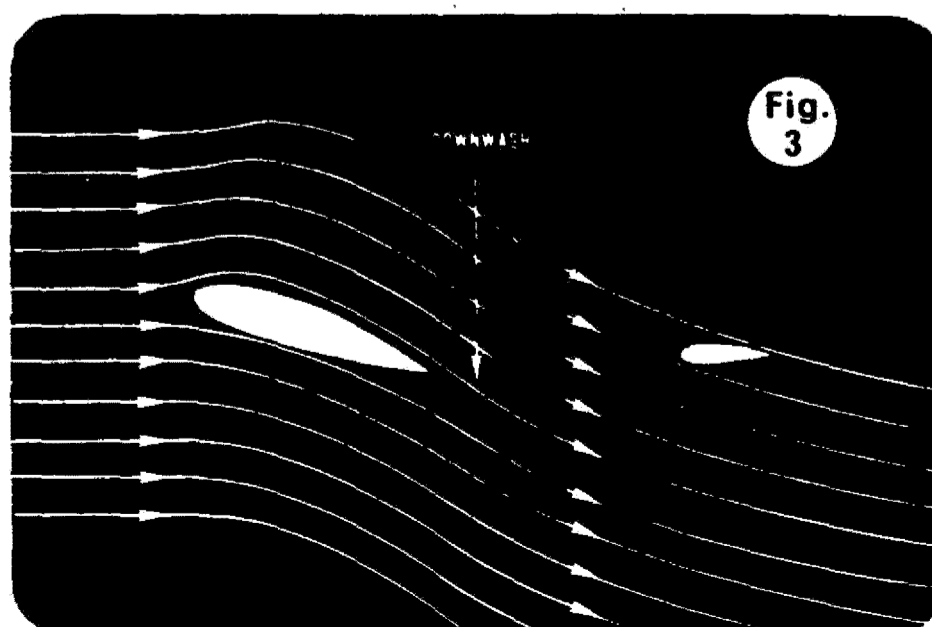
Airfoil and control surfaces at the rear of the airplane are used to stabilize and control the moments on the airplane. The horizontal stabilizer gets its name because of the function it performs. By virtue of its position behind the wing, it operates in air flow from the wing. Airflow over the wing is deflected up by the shape of the wing. This air must come back down and this change in air flow pattern is known as downwash (Fig. 3).

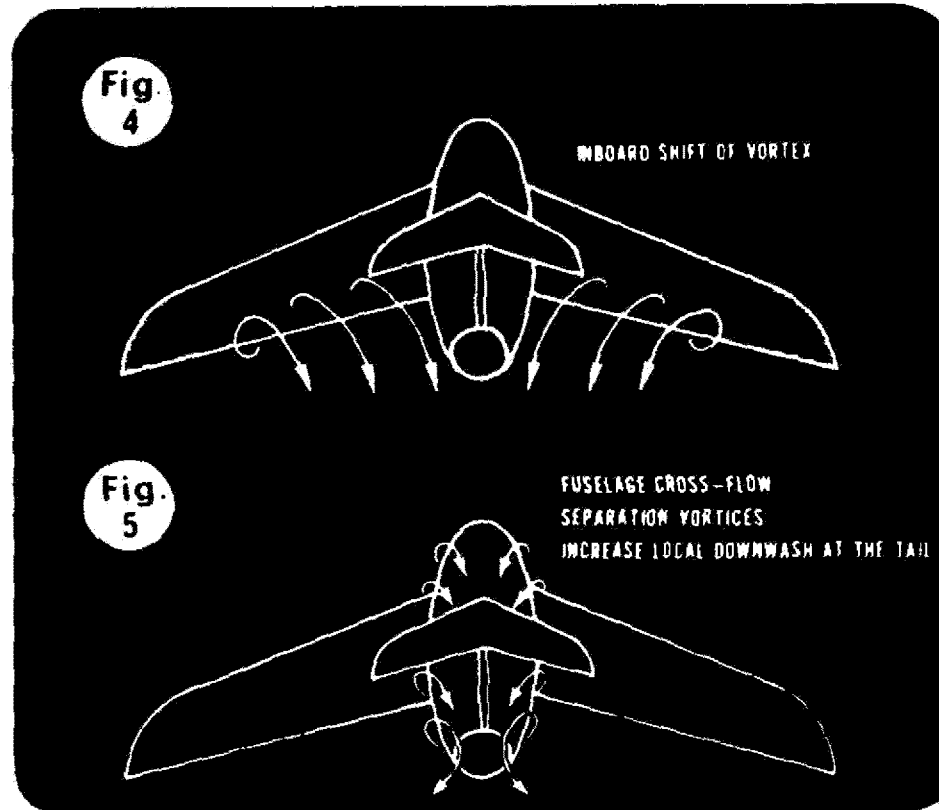
When the airplane wingtips stall, the wing vortex shifts inboard increasing the local downwash at the tail (Fig. 4). At high attack angles (approaching stall) the air flow across the fuselage separates and the resulting vortices also increase local downwash at the tail (Fig. 5). Thus the tail suffers a decrease in effectiveness and stabilizing ability as the airplane angle of attack increases.

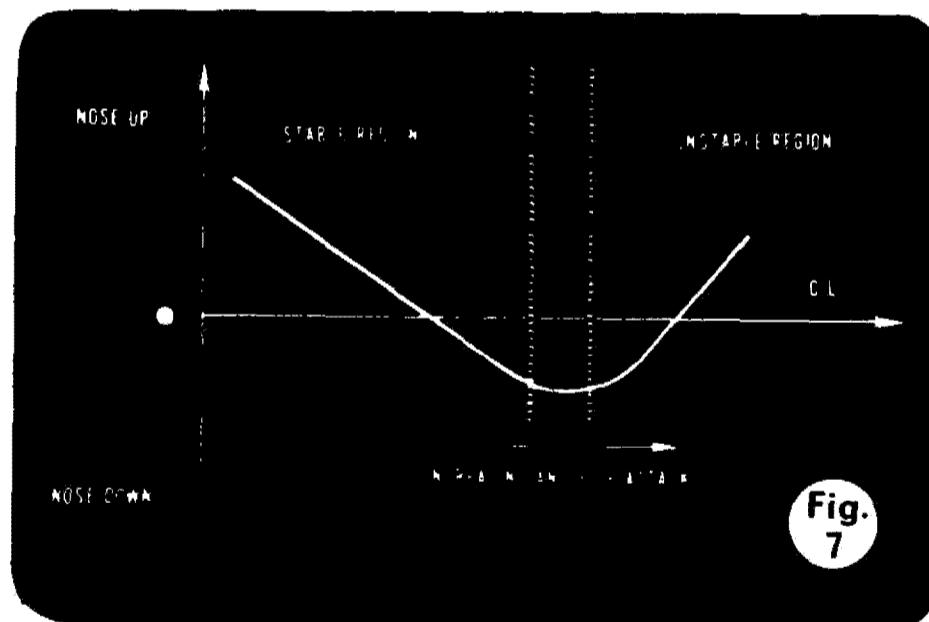
If we examine a plot of pitching moment versus lift of the high-tail, swept-wing airplane we can see why it is that the aircraft can suddenly pitch nose up. Technically we apply the term "pitch-up" to a longitudinal static instability that can occur with this aircraft configuration at high angle of attack. The plot of pitching moment coefficient versus lift coefficient shows a stable region for low values of C_L and a transition to an unstable region at high C_L 's. The unstable region is caused by the horizontal stabilizer being moved into an area of strong downwash (Fig. 7).

The slope of the C_m versus C_L curve indicates the longitudinal static stability level of the airplane. If the airplane is flying in equilibrium in the stable region and experiences a nose-up disturbance the resulting increase in C_L indicates a nose-down moment is created. Thus there is a tendency to return the airplane to its undisturbed position. Conversely, if the disturbance occurs with the airplane in the unstable region, the moment created tends to reinforce the nose-up disturbance, hence the instability.
