CIRCULAR 78-AN/66
Volume II

AIRCRAFT ACCIDENT DIGEST No. 15

Volume II

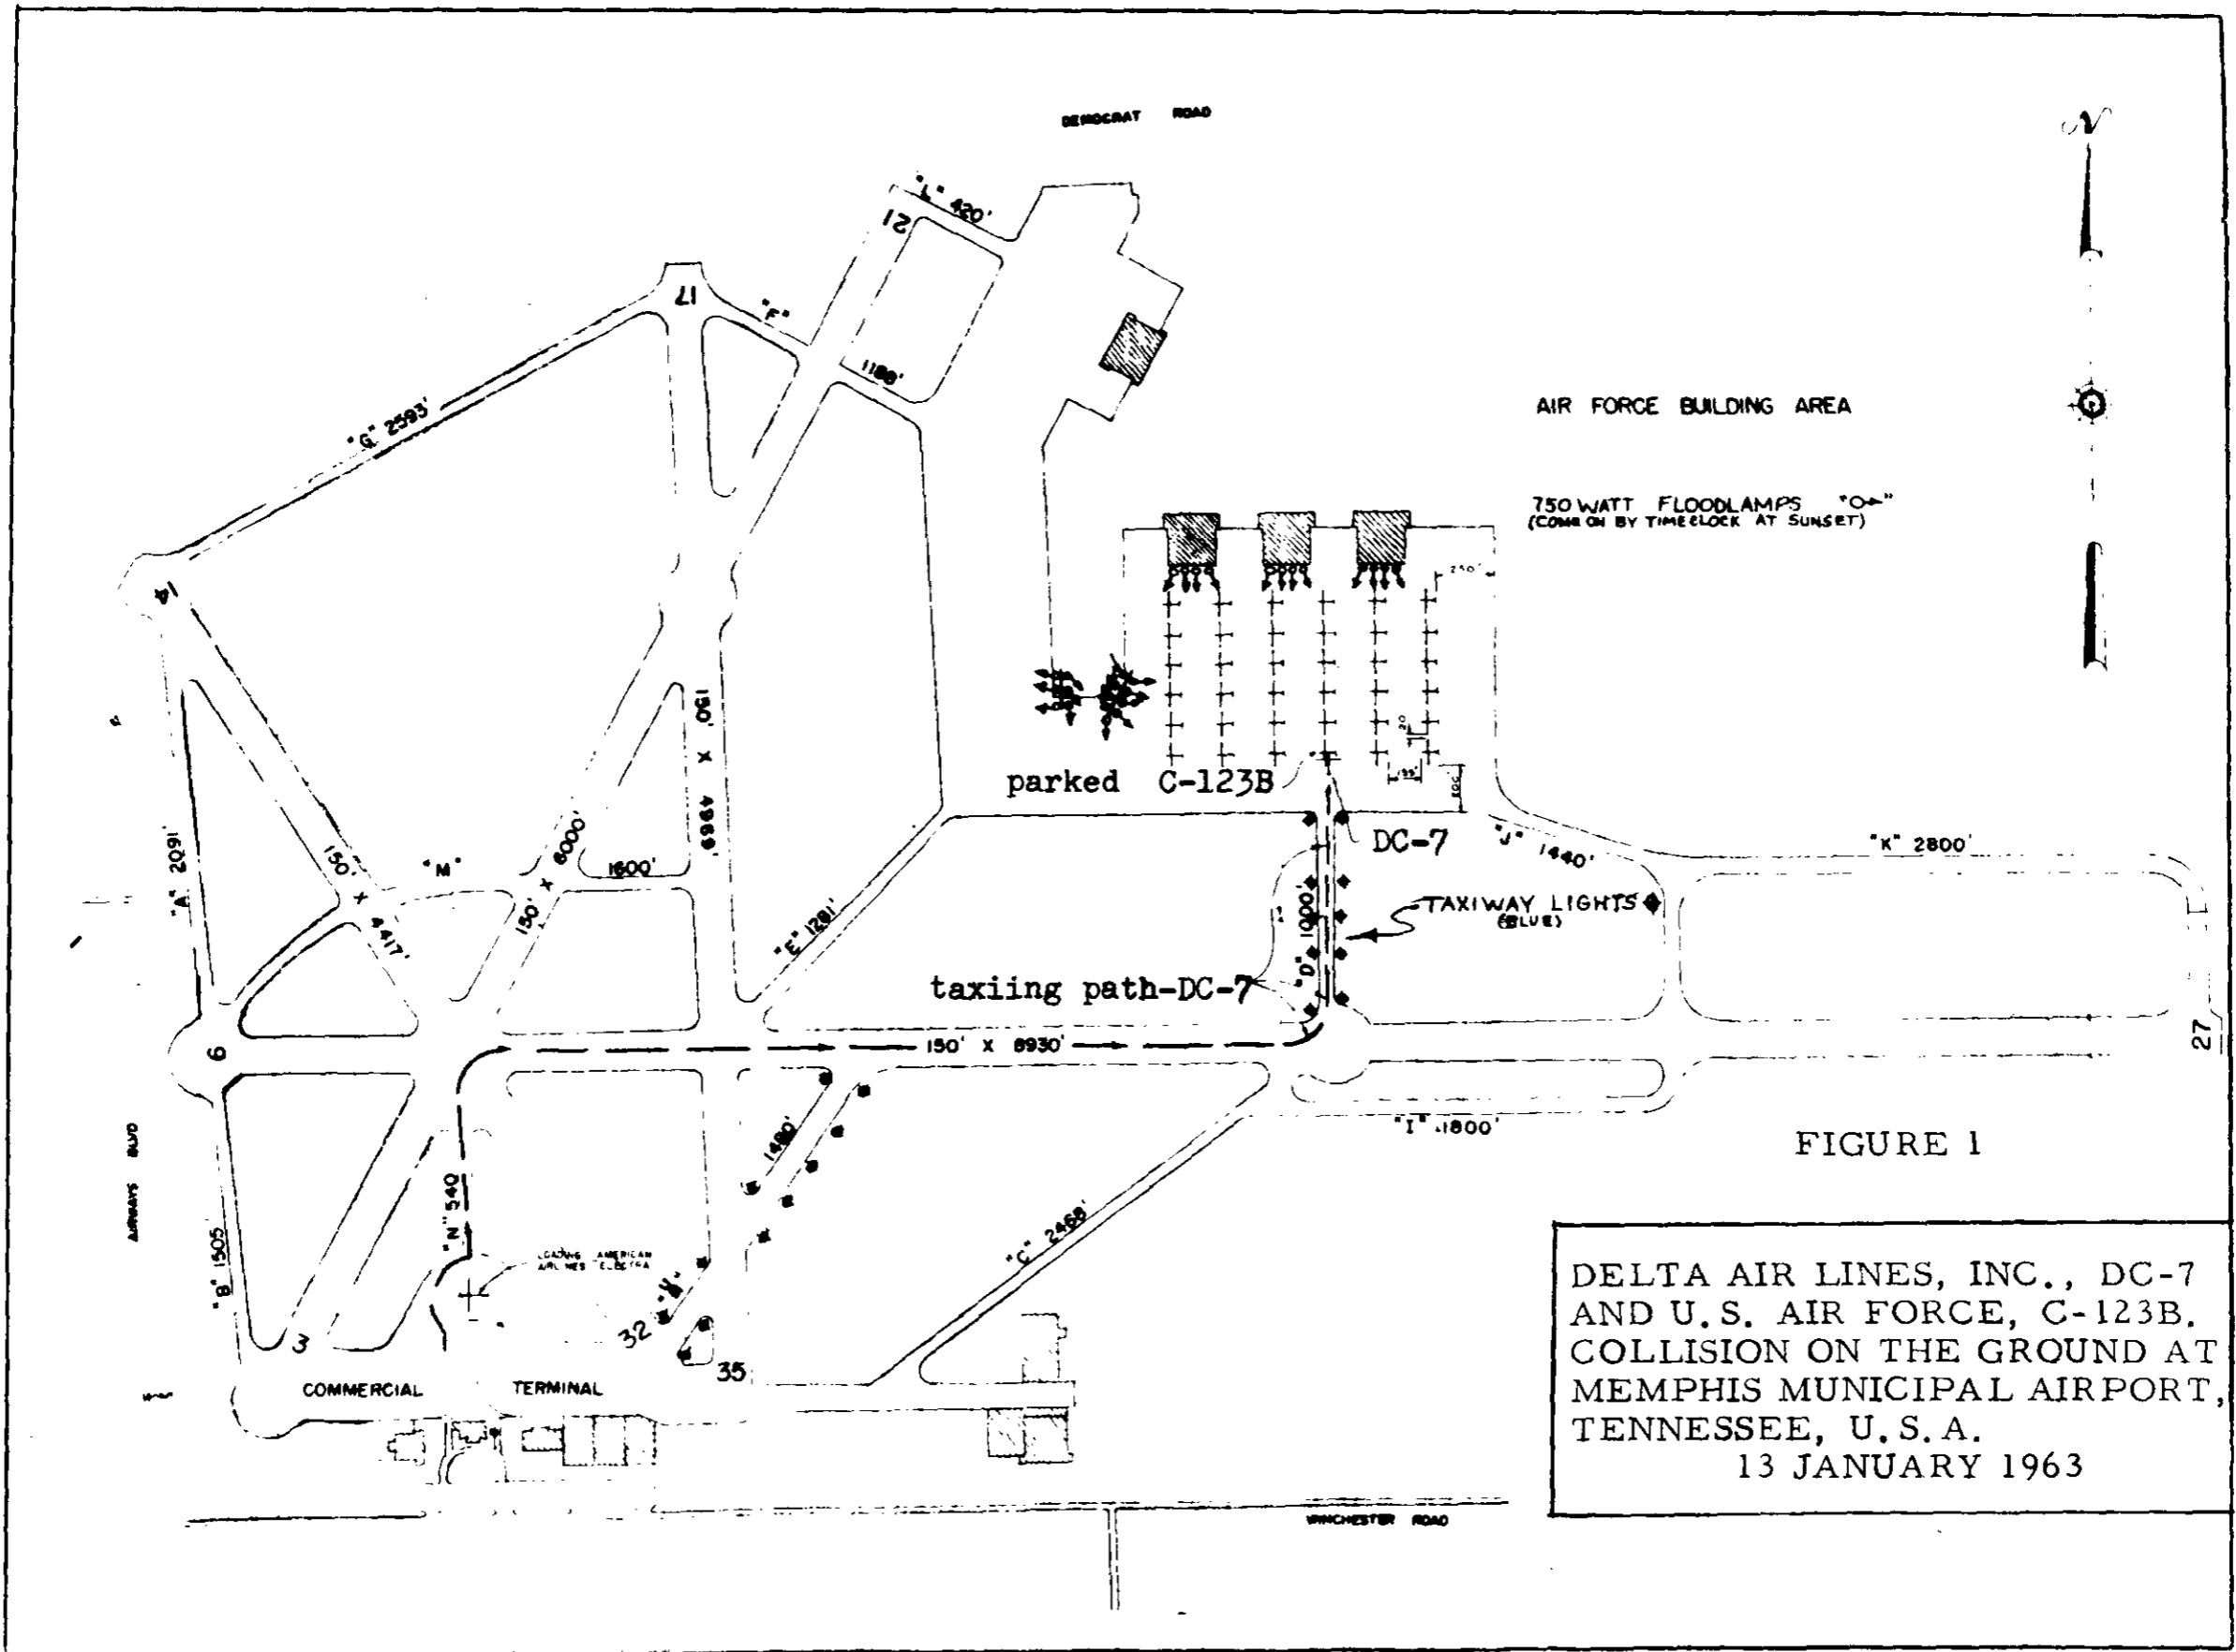
FIGURE 1

DELTA AIR LINES, INC., DC-7
 AND U. S. AIR FORCE, C-123B.
 COLLISION ON THE GROUND AT
 MEMPHIS MUNICIPAL AIRPORT,
 TENNESSEE, U. S. A.
 13 JANUARY 1963

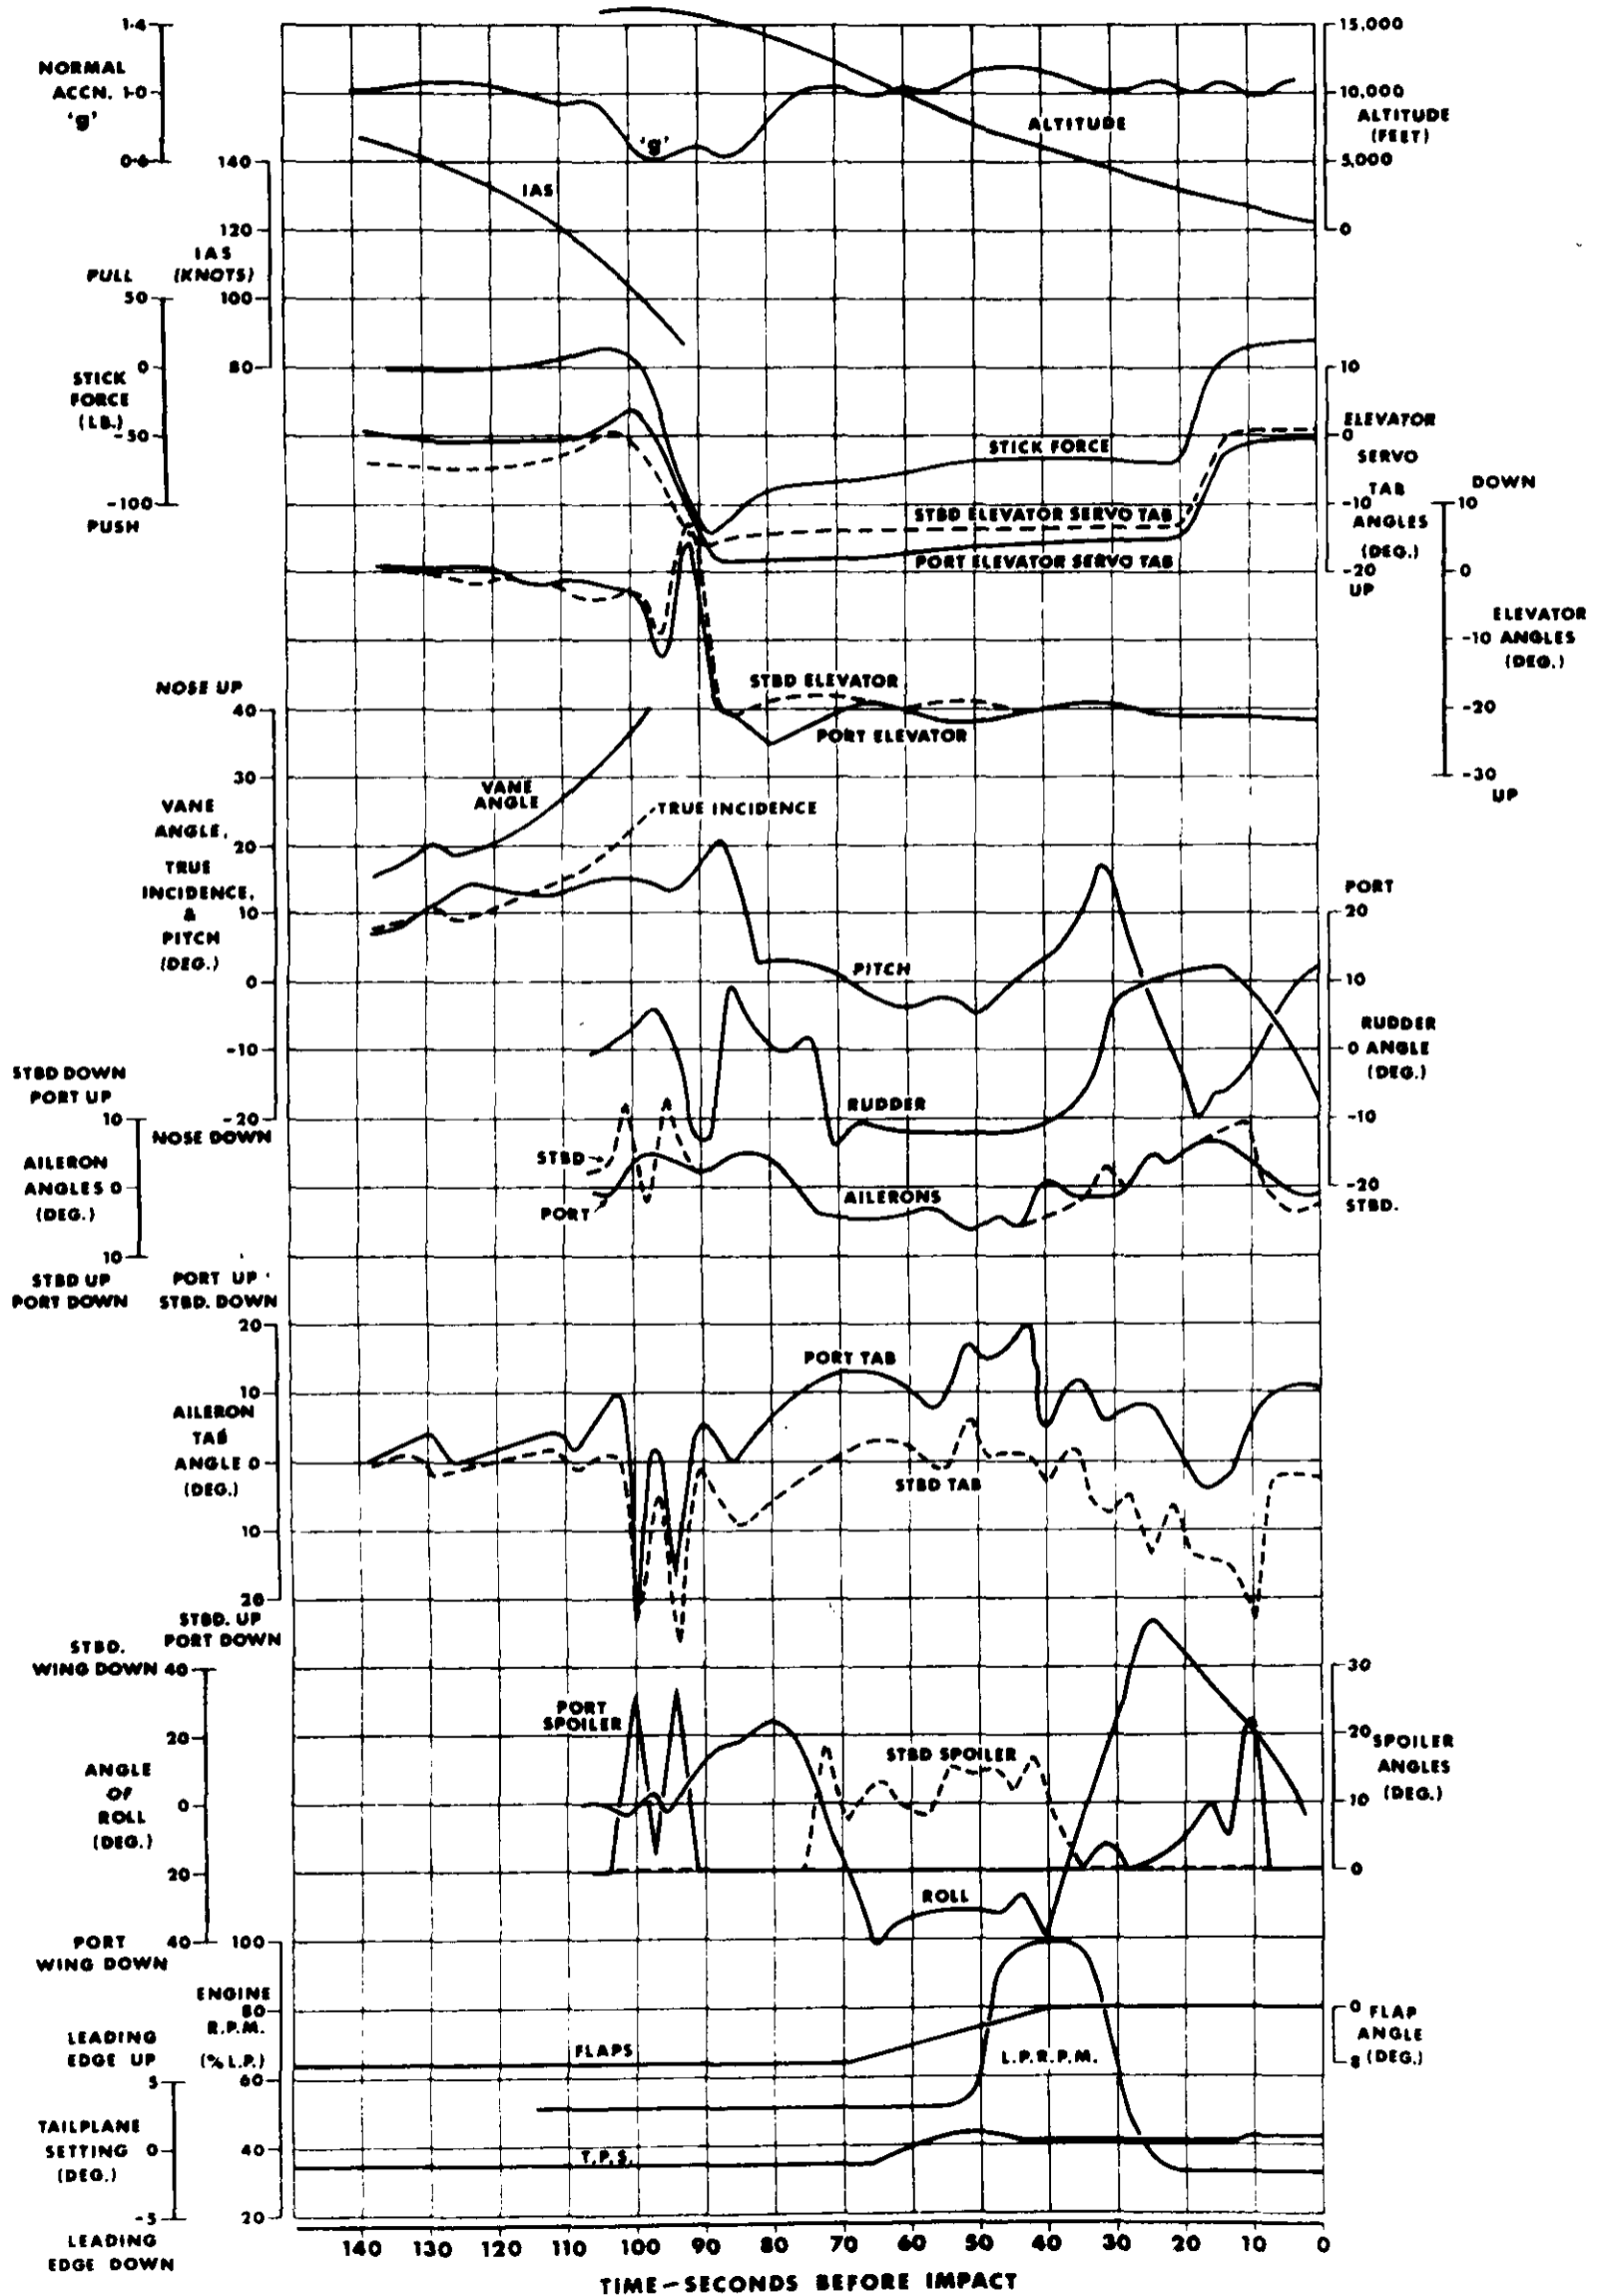
FIGURE 5

TIME HISTORY FOR THE 140 SECONDS BEFORE
GROUND IMPACT BASED ON FLIGHT RECORDER DATA

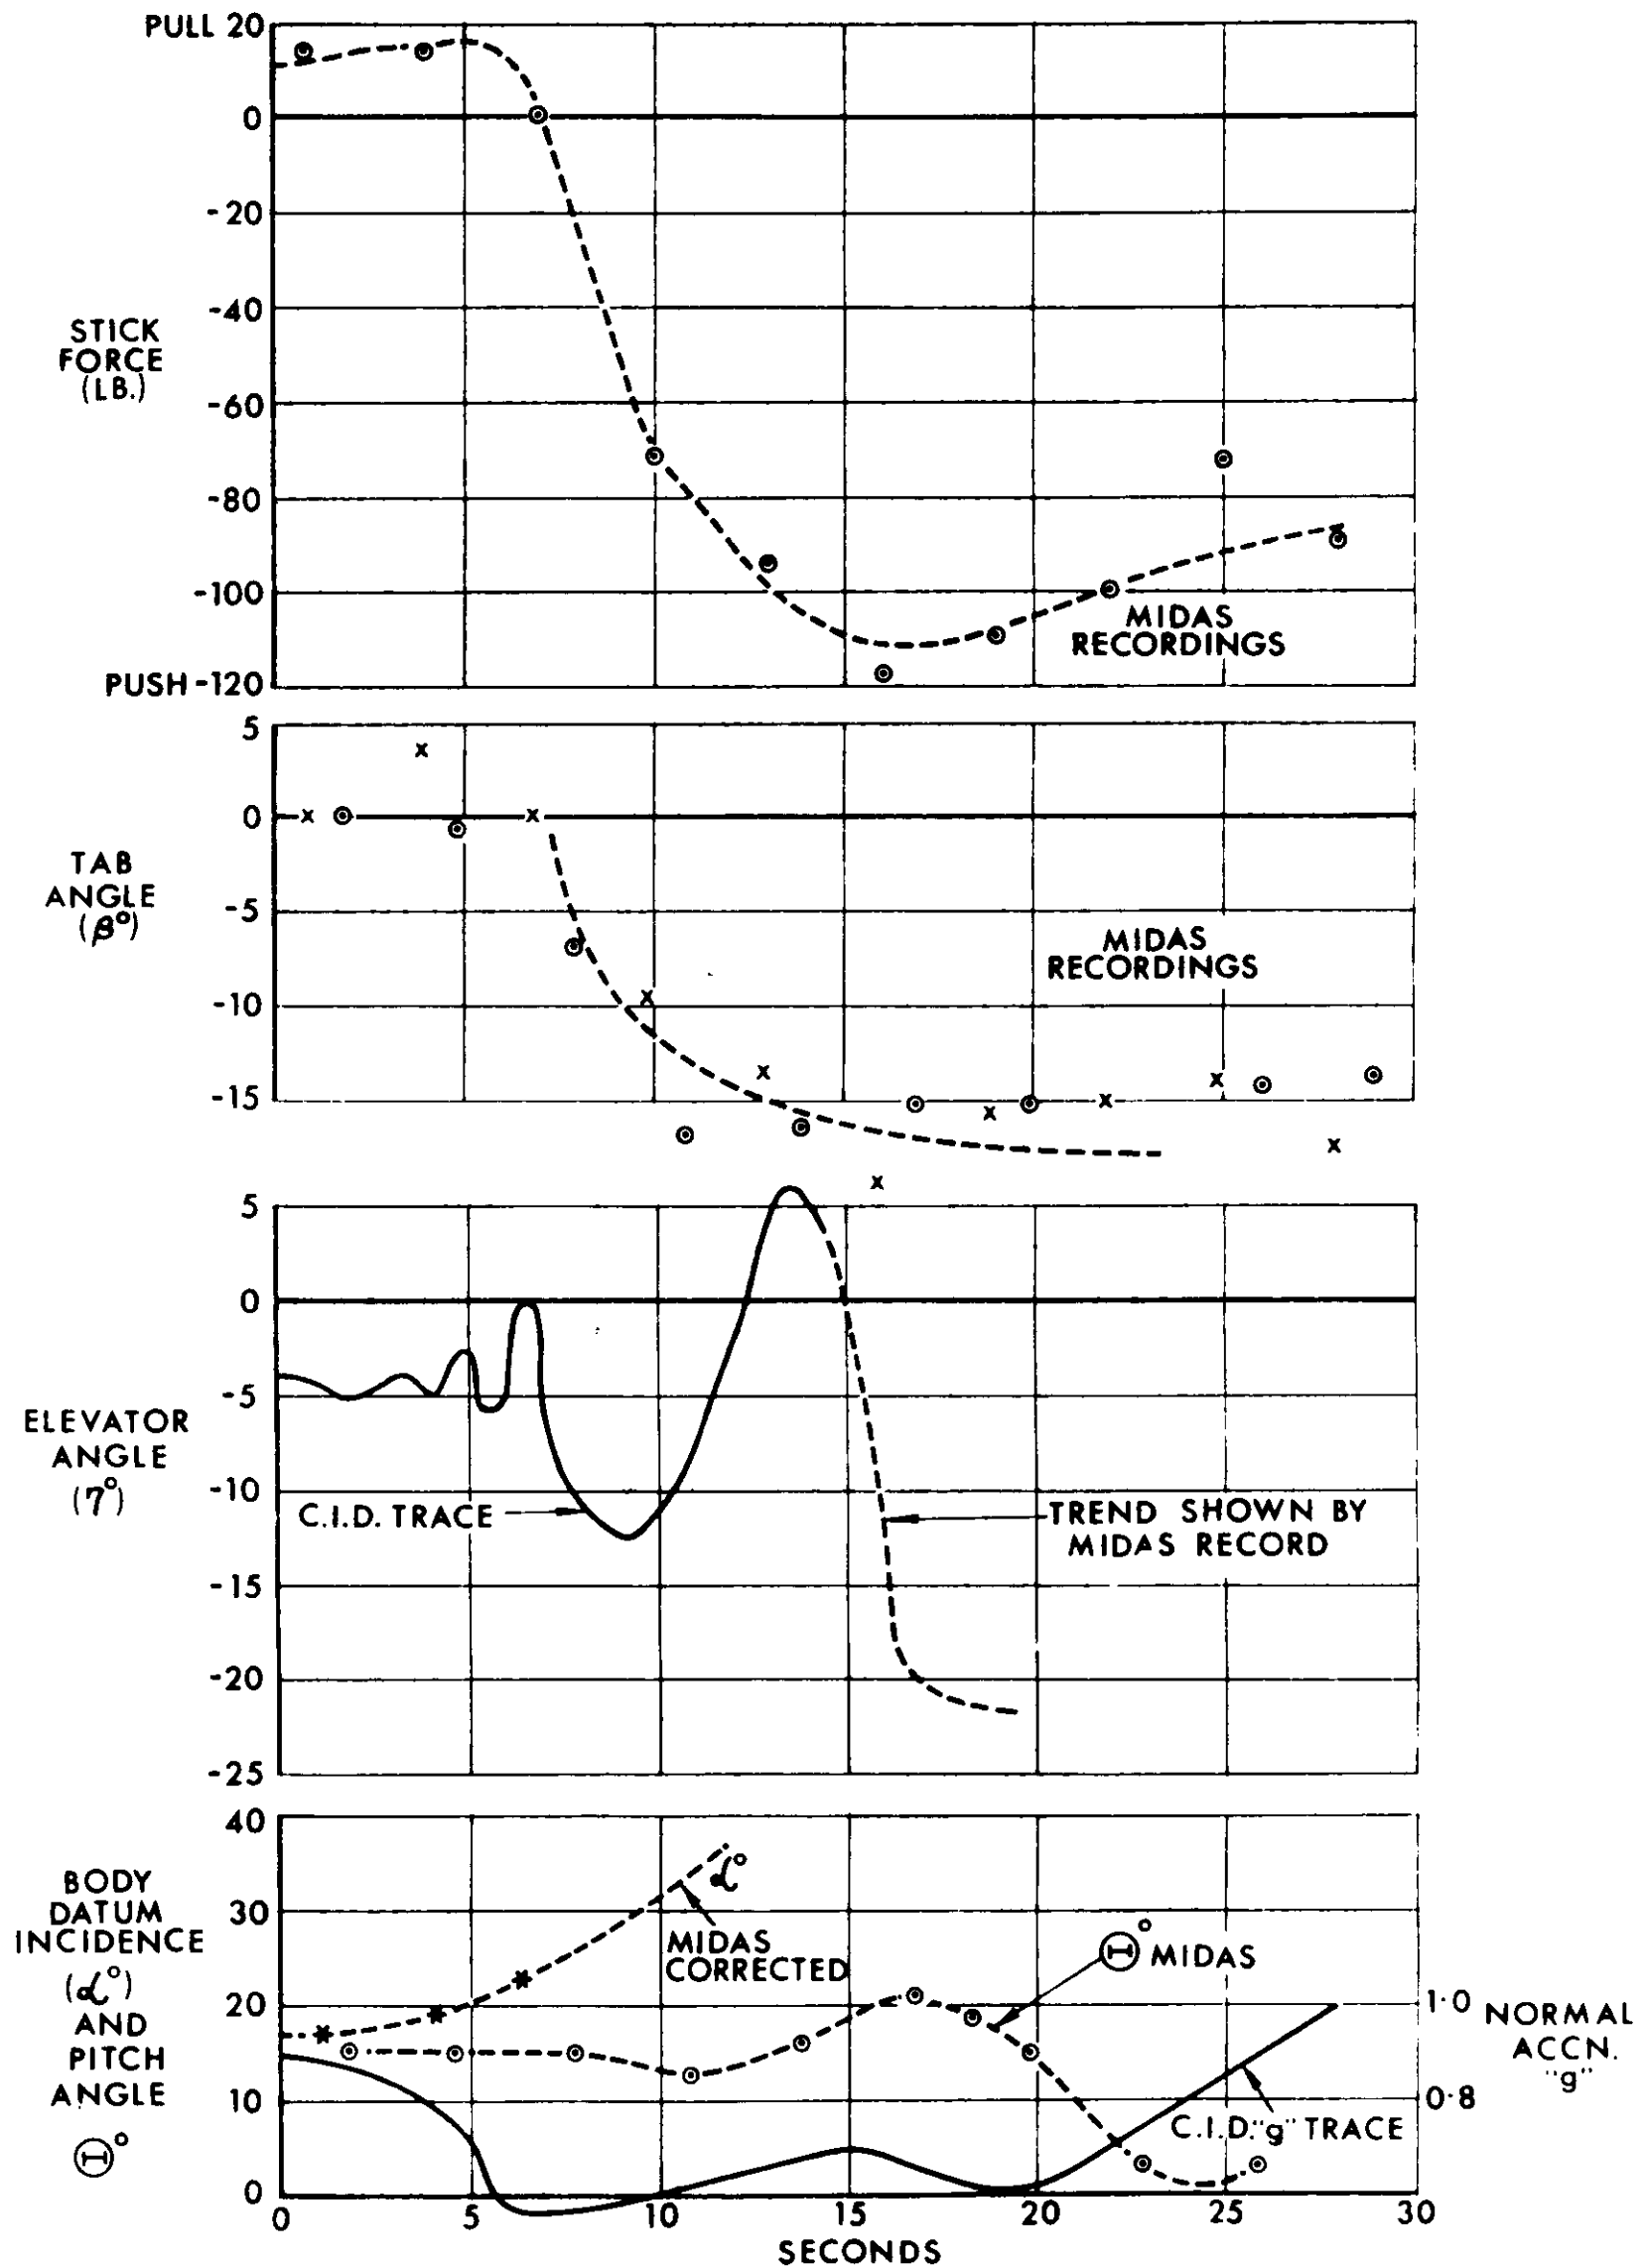
FIGURE 6

DATA OBTAINED FROM MIDAS AND C.I.D.
FLIGHT RECORDERS AT THE STALL

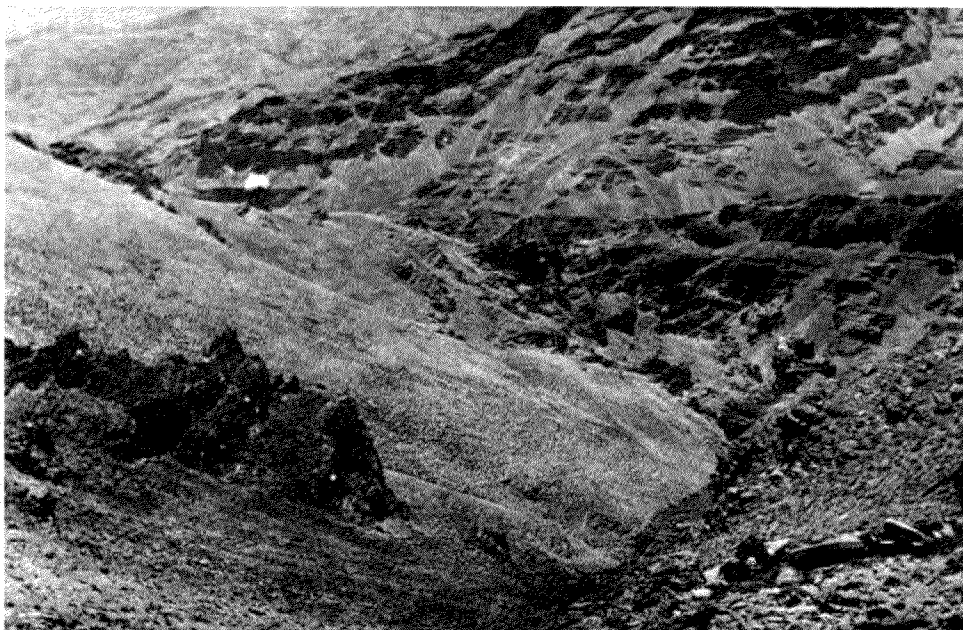
FIGURE 8

Aircraft struck ridge at 13940 feet (4250 metres) above sea level
and disintegrated.

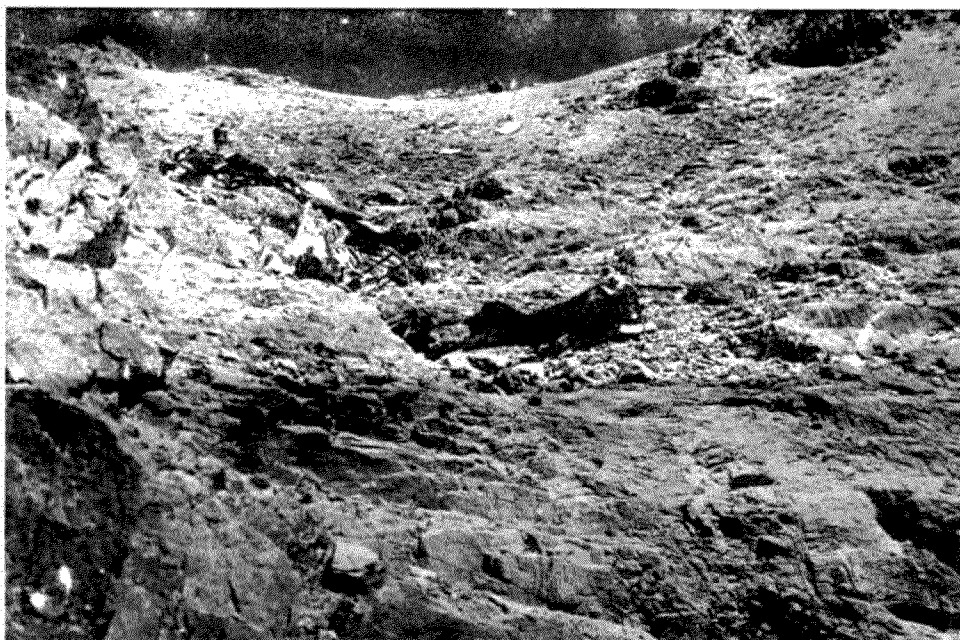
FIGURE 9

Wreckage fell down steep slope on other side of ridge

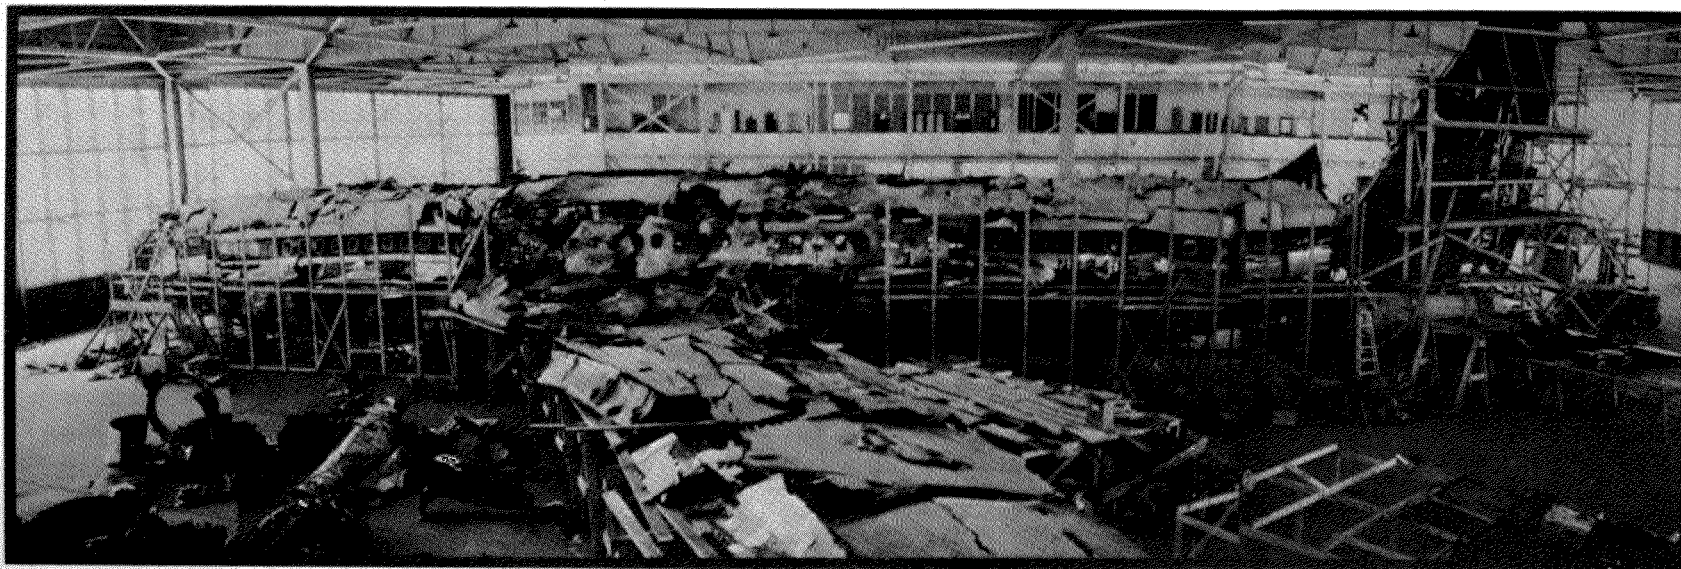
FIGURE 13

CIVIL AERONAUTICS BOARD
WRECKAGE MOCKUP

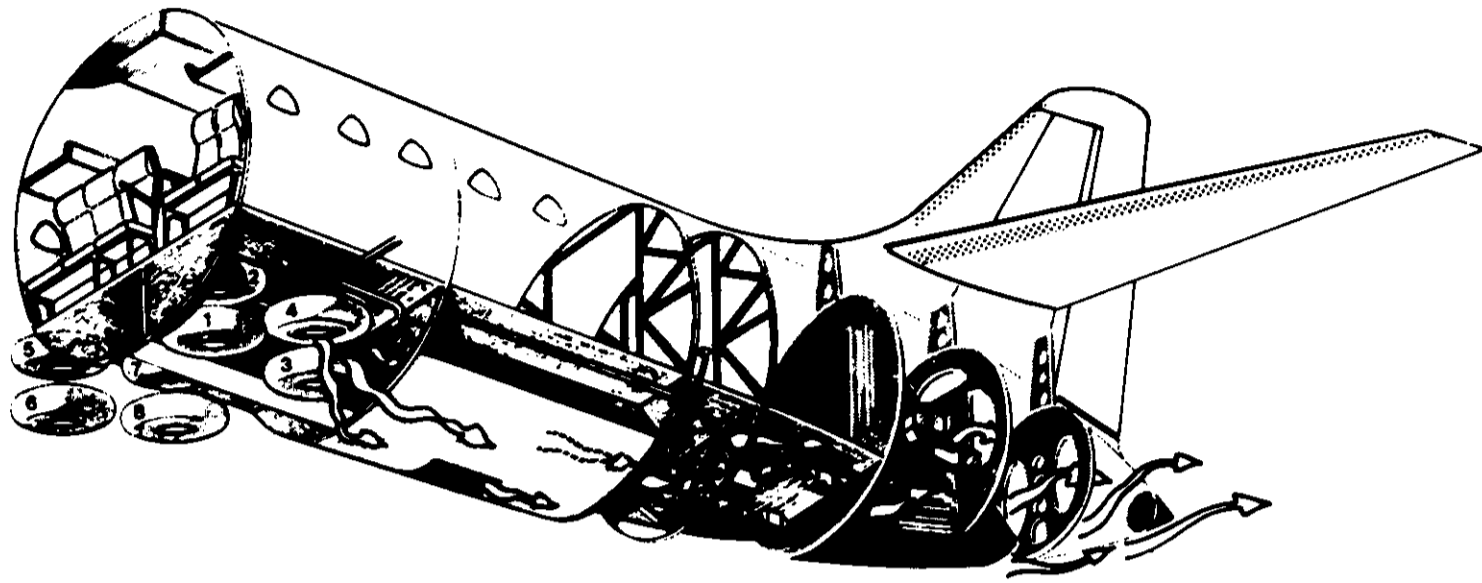
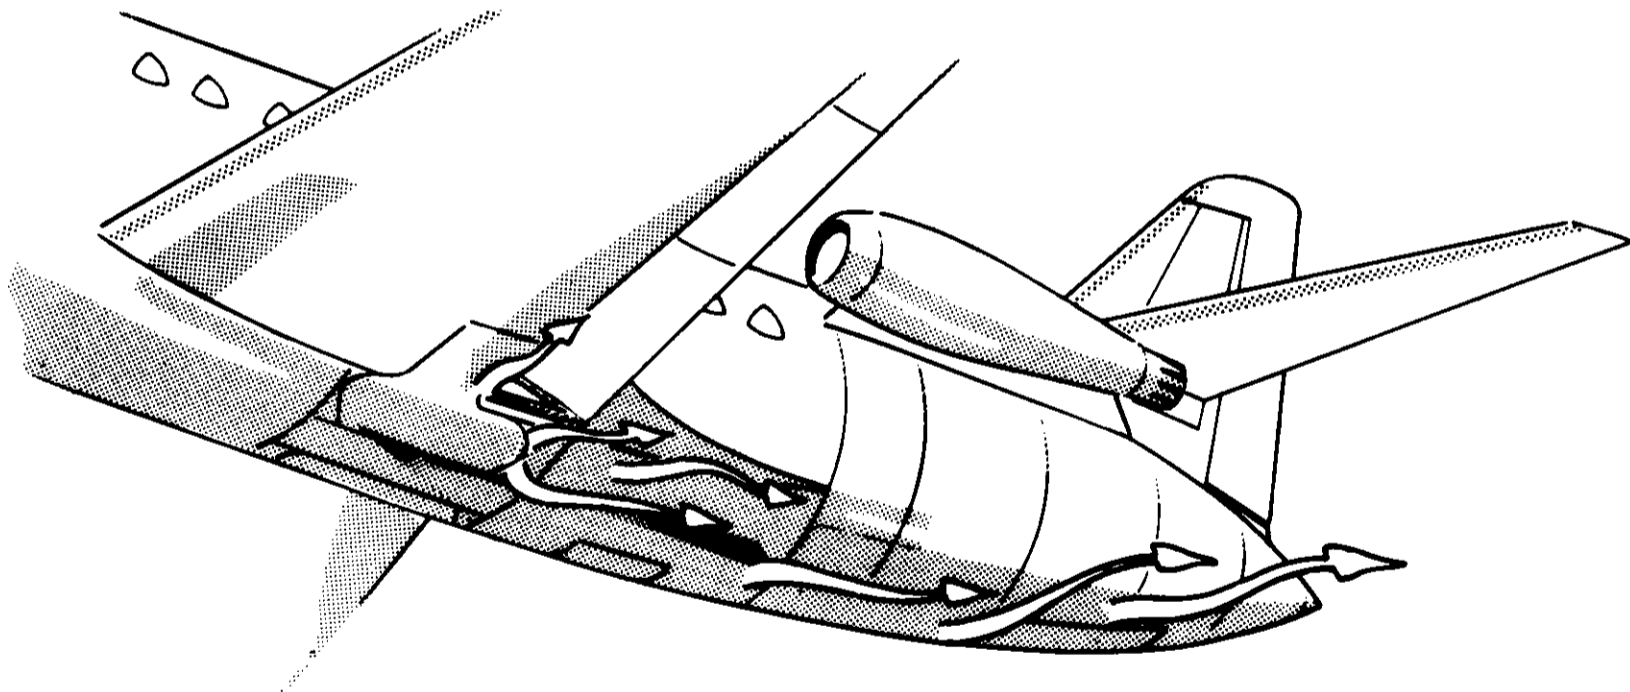
FIGURE 20

PRESUMED PATH OF THE FIRE
