CIRCULAR 82-AN/69
Volume I

AIRCRAFT ACCIDENT DIGEST No. 16

Prepared by the Secretariat and published
by authority of the Secretary General

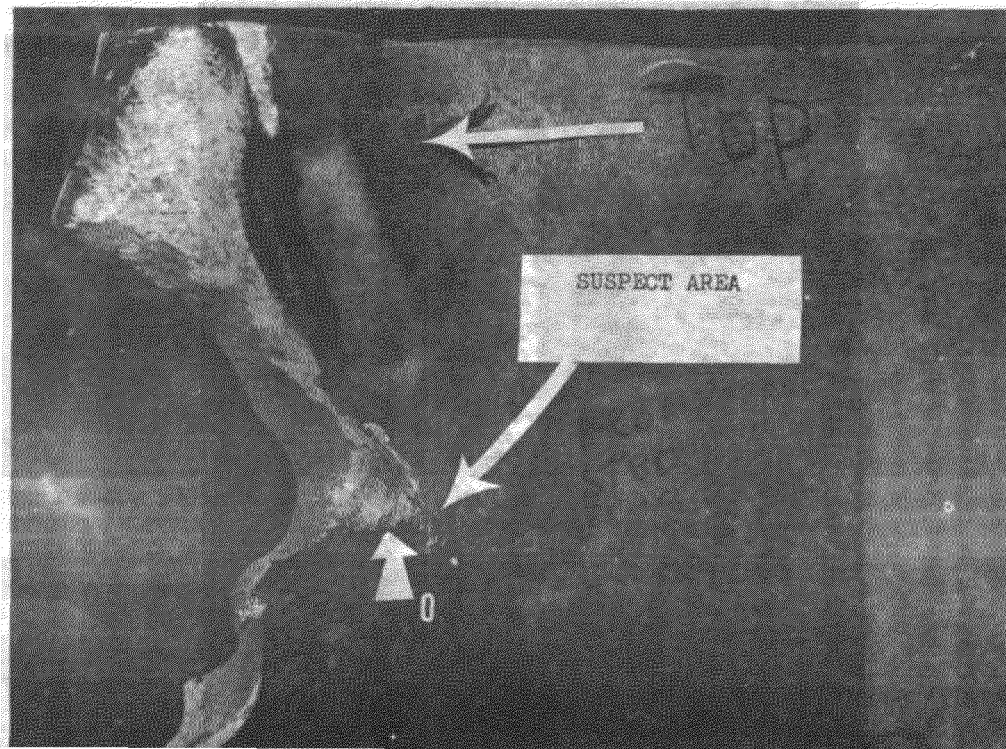
FIGURE 19-1

FRACTURED MAIN UNDERCARRIAGE LEG WITH ARROW "0" SHOWING ORIGIN OF FRACTURE

The approved life of 8 000 landings was later re-introduced, subject to the legs having undergone modification, including shot peening and ultrasonic testing, in conformity with a mandatory directive issued by the Air Registration Board.

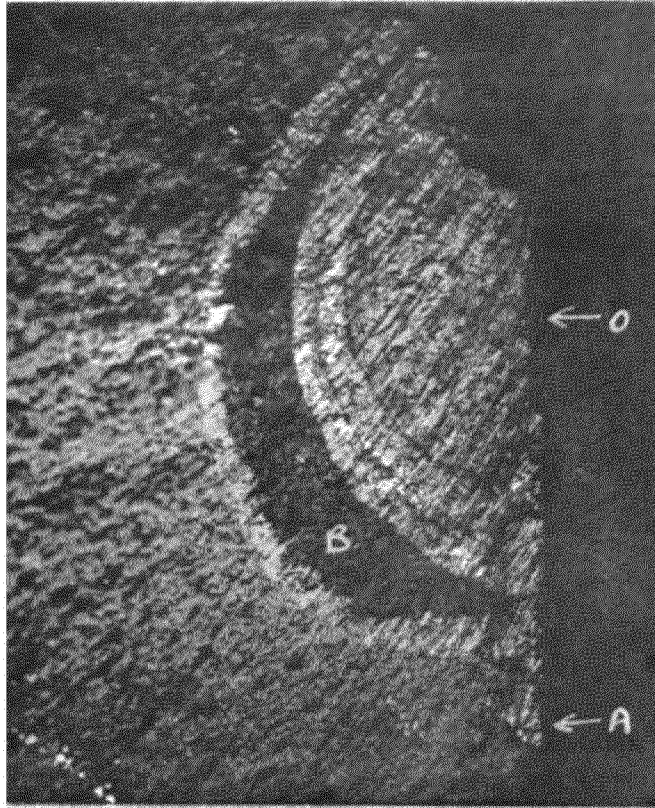
FIGURE 19-2

ARROW "A" -
SECONDARY FRACTURE
NUCLEUS

AREA "B" -
FATIGUE FRACTURE
AREA

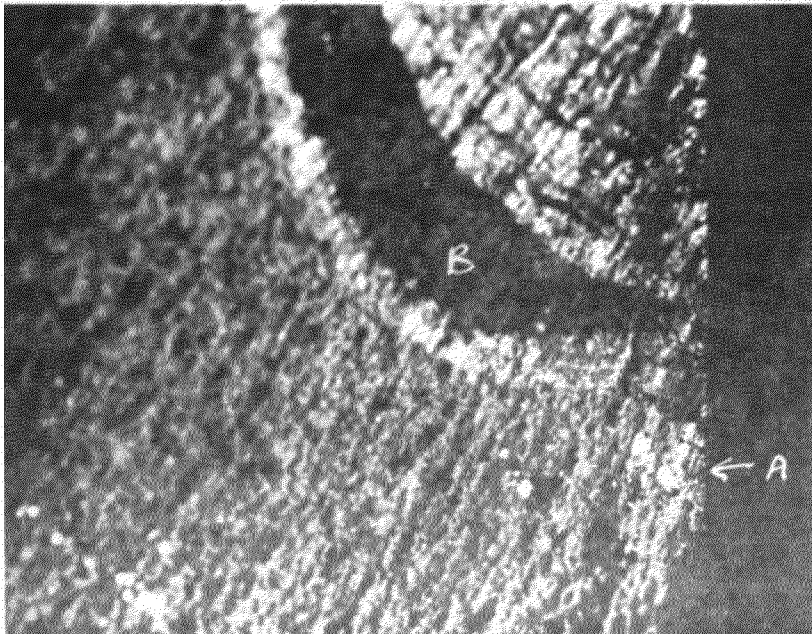
FIGURE 19-3

ARROW "A" -
SECONDARY FRACTURE
NUCLEUS

AREA "B" -
FATIGUE FRACTURE
AREA

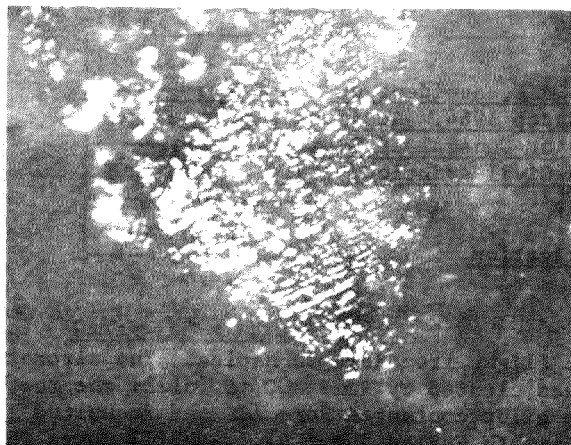
FIGURE 19-4.- 500X MICROPHOTO SHOWING STRIATED PATTERN OF FRACTURE SURFACE

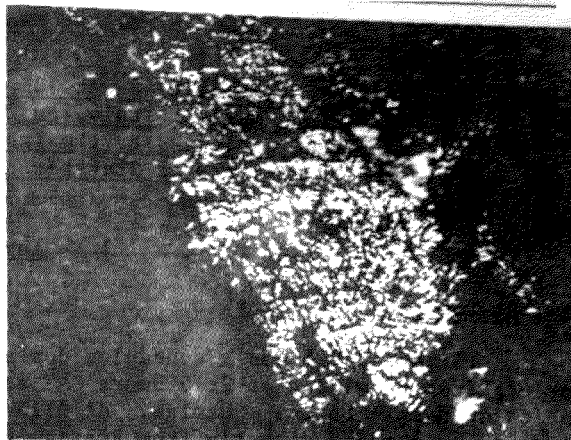
FIGURE 19-5.- 500X MICROPHOTO SHOWING STRIATED PATTERN OF FRACTURE SURFACE

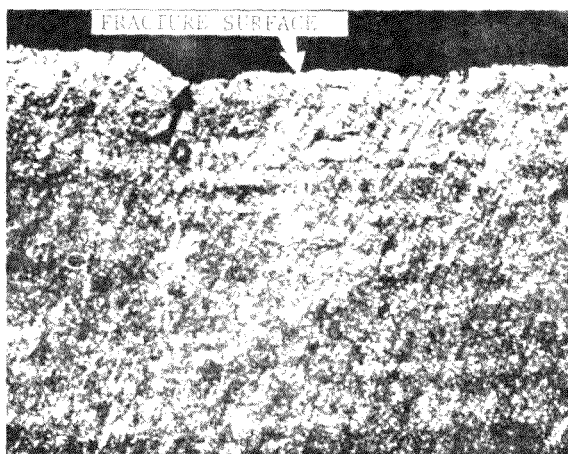
FIGURE 19-6.- 25X MICROPHOTO OF SMALL PITS IN ANODIC FILM

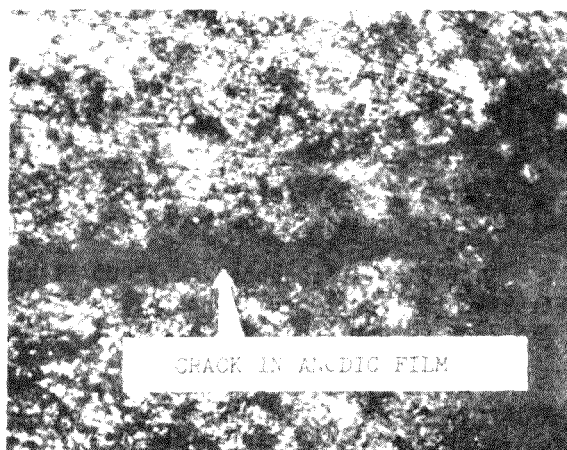
FIGURE 19-7.- 200X MICROPHOTO OF CRACK IN ANODIC FILM

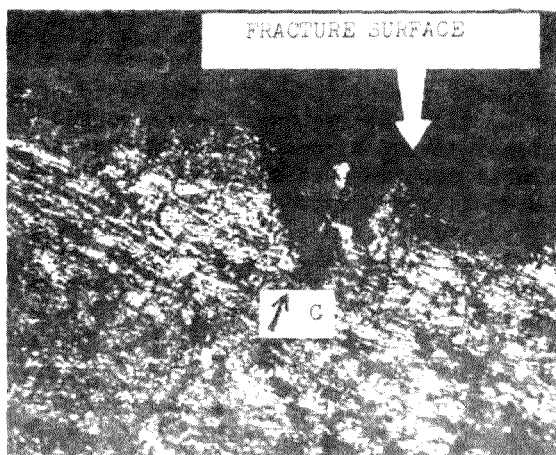
FIGURE 19-8.- 200X MICROPHOTO OF ORIGIN OF FATIGUE CRACK - APPROX 1000X
