# ICAO

CIRCULAR 82-AN/69  
Volume II

### AIRCRAFT ACCIDENT DIGEST No. 16

### Volume II

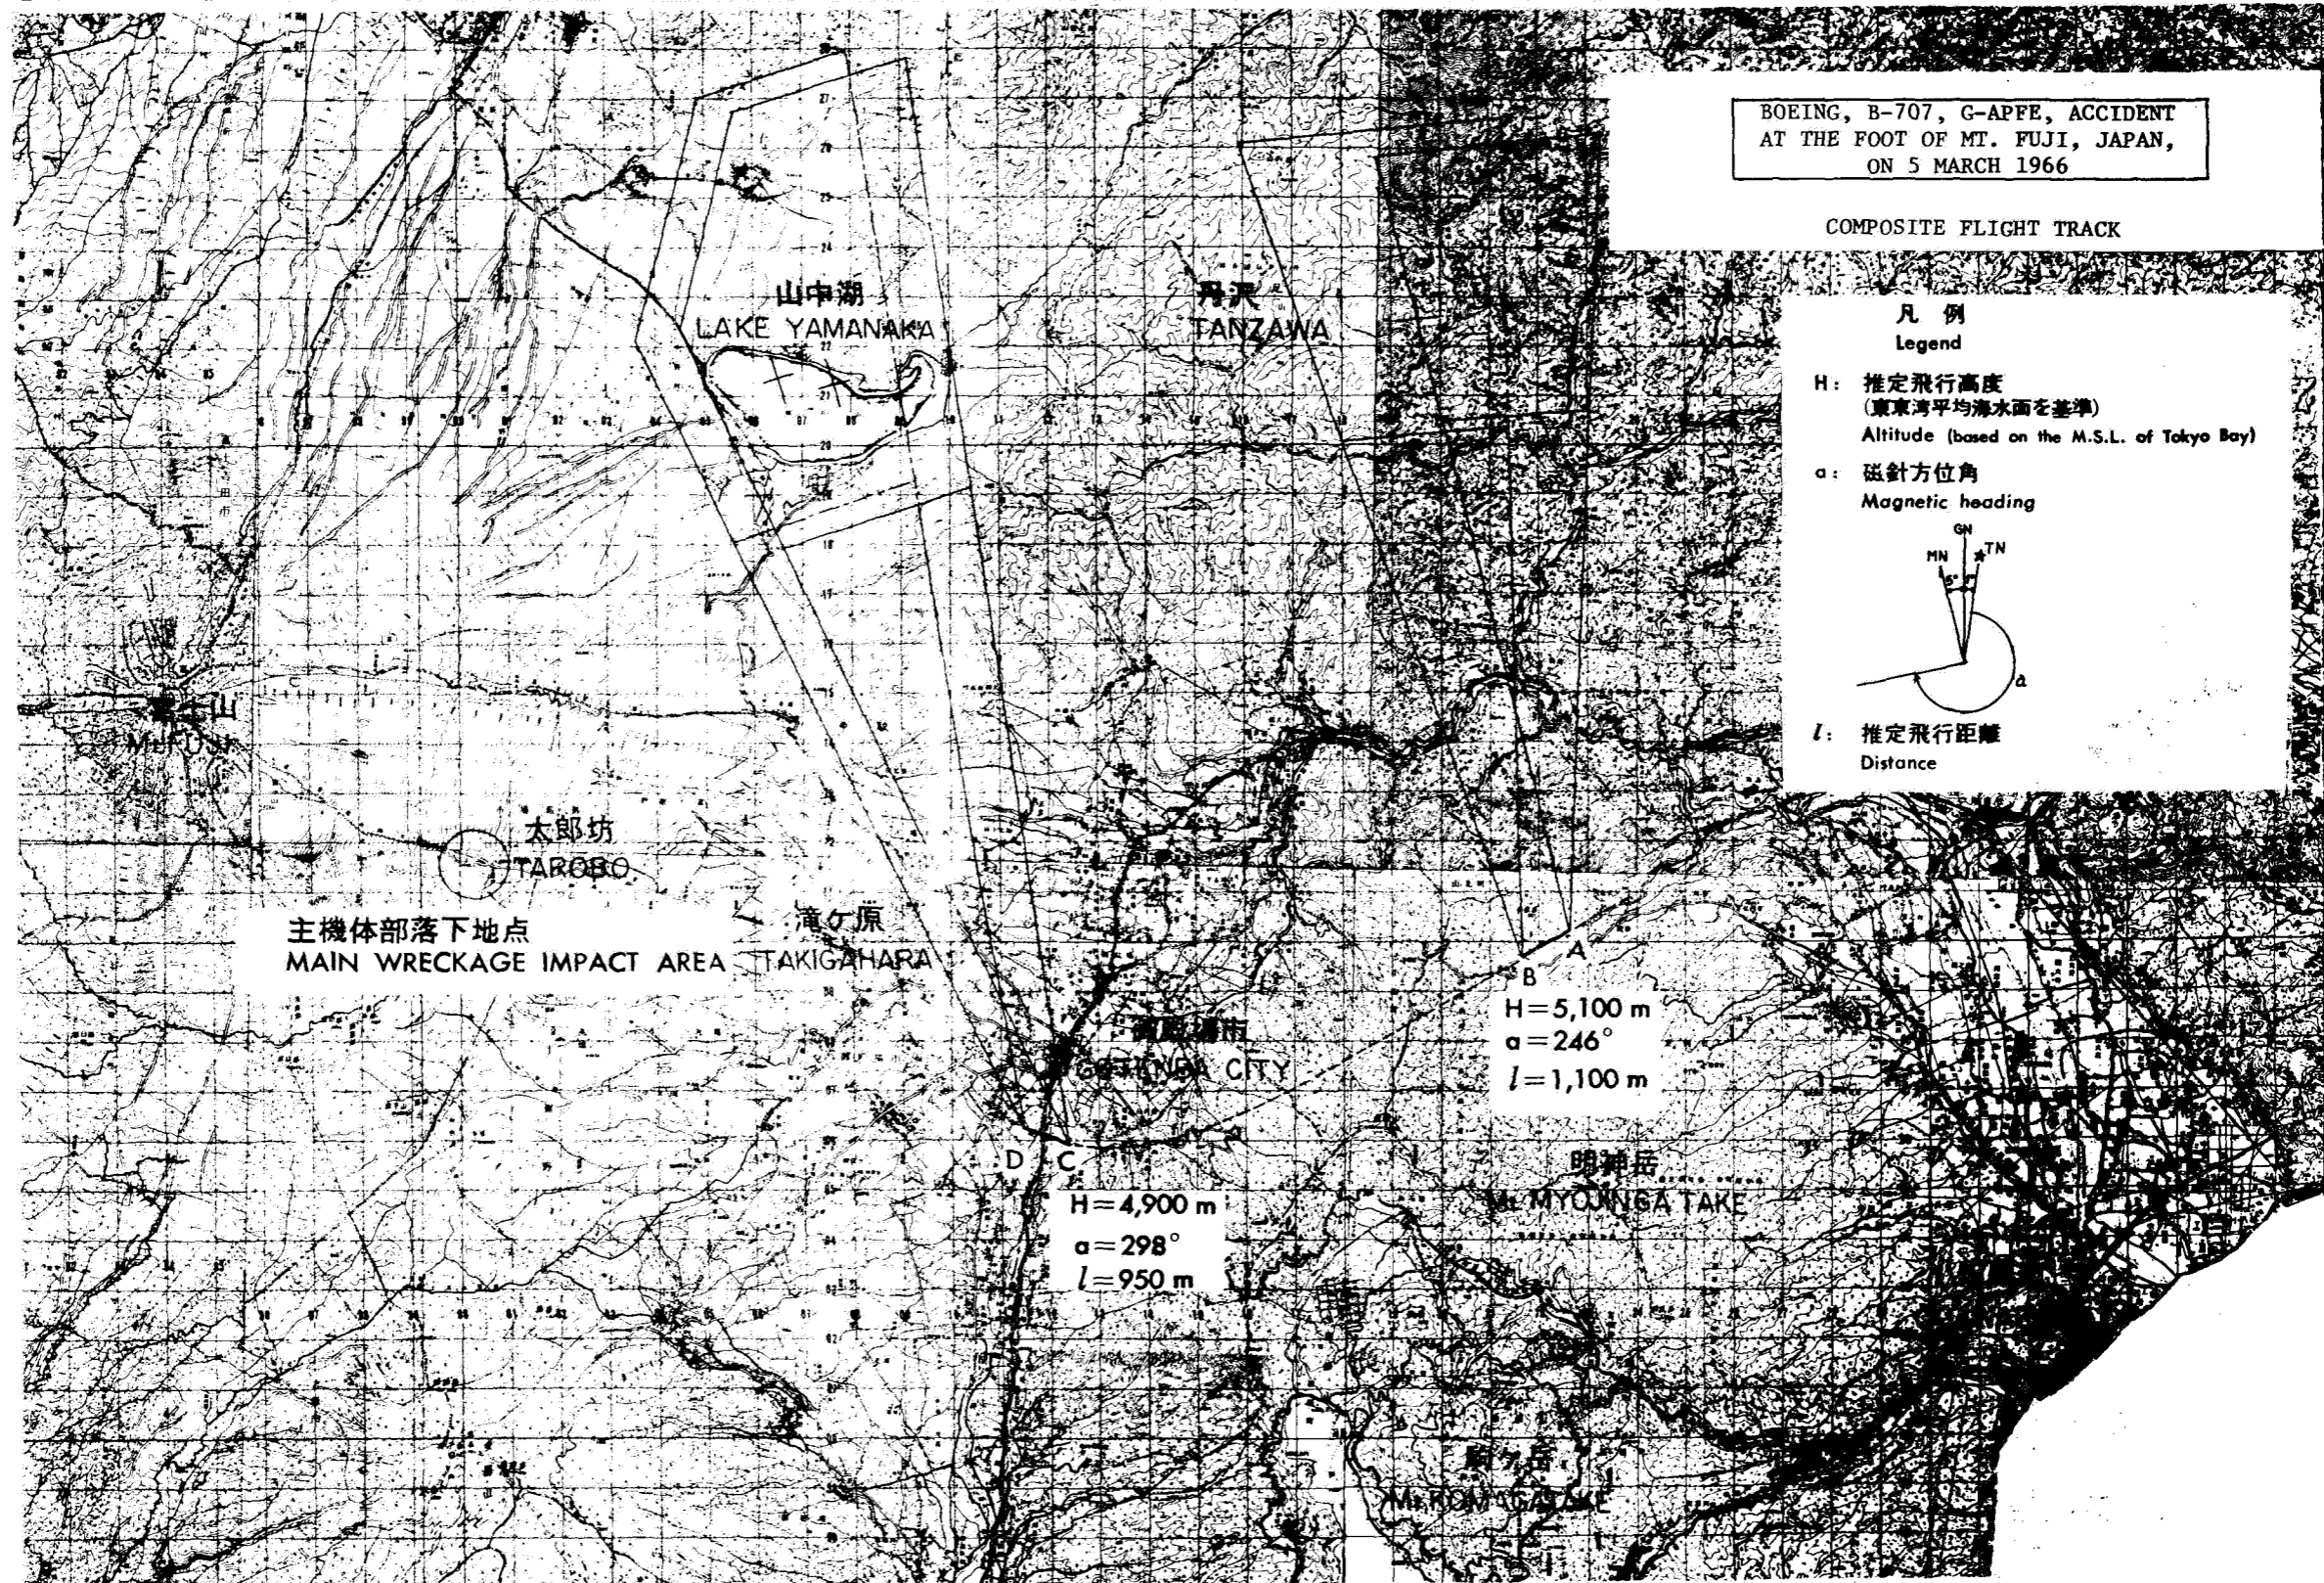
FIGURE 7-1

BOEING, B-707, G-APFE, ACCIDENT AT THE FOOT OF MT. FUJI, JAPAN, ON 5 MARCH 1966

WRECKAGE DISTRIBUTION CHART

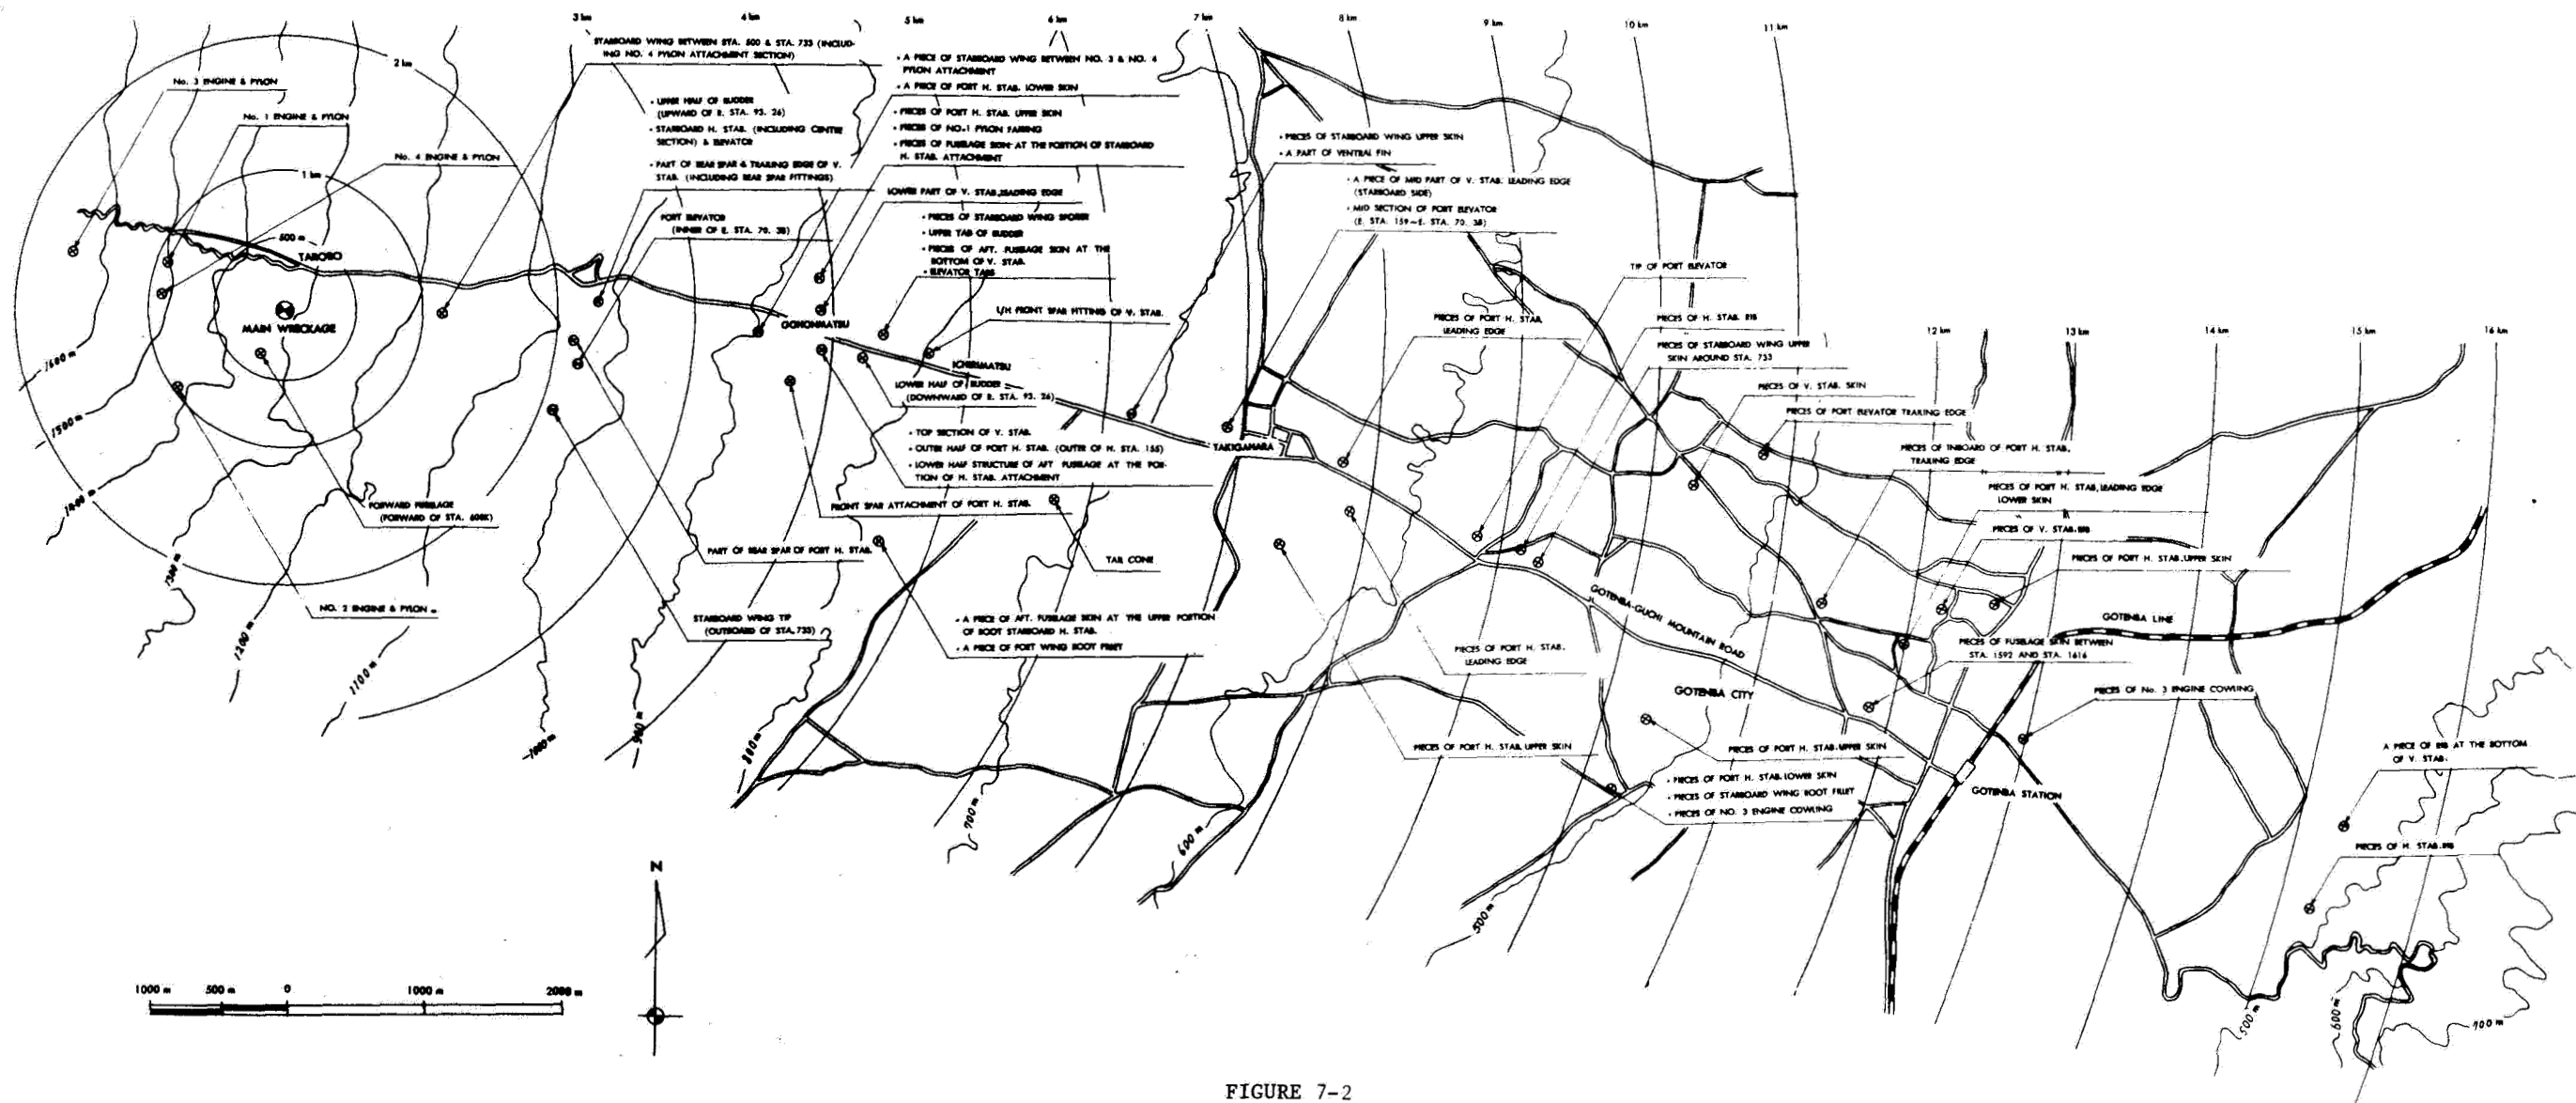
FIGURE 7-2

BOAC, B-707, G-APFE, ACCIDENT AT THE FOOT OF MT. FUJI, JAPAN, ON 5 MARCH 1966

ESTIMATED ALTITUDE PROFILE

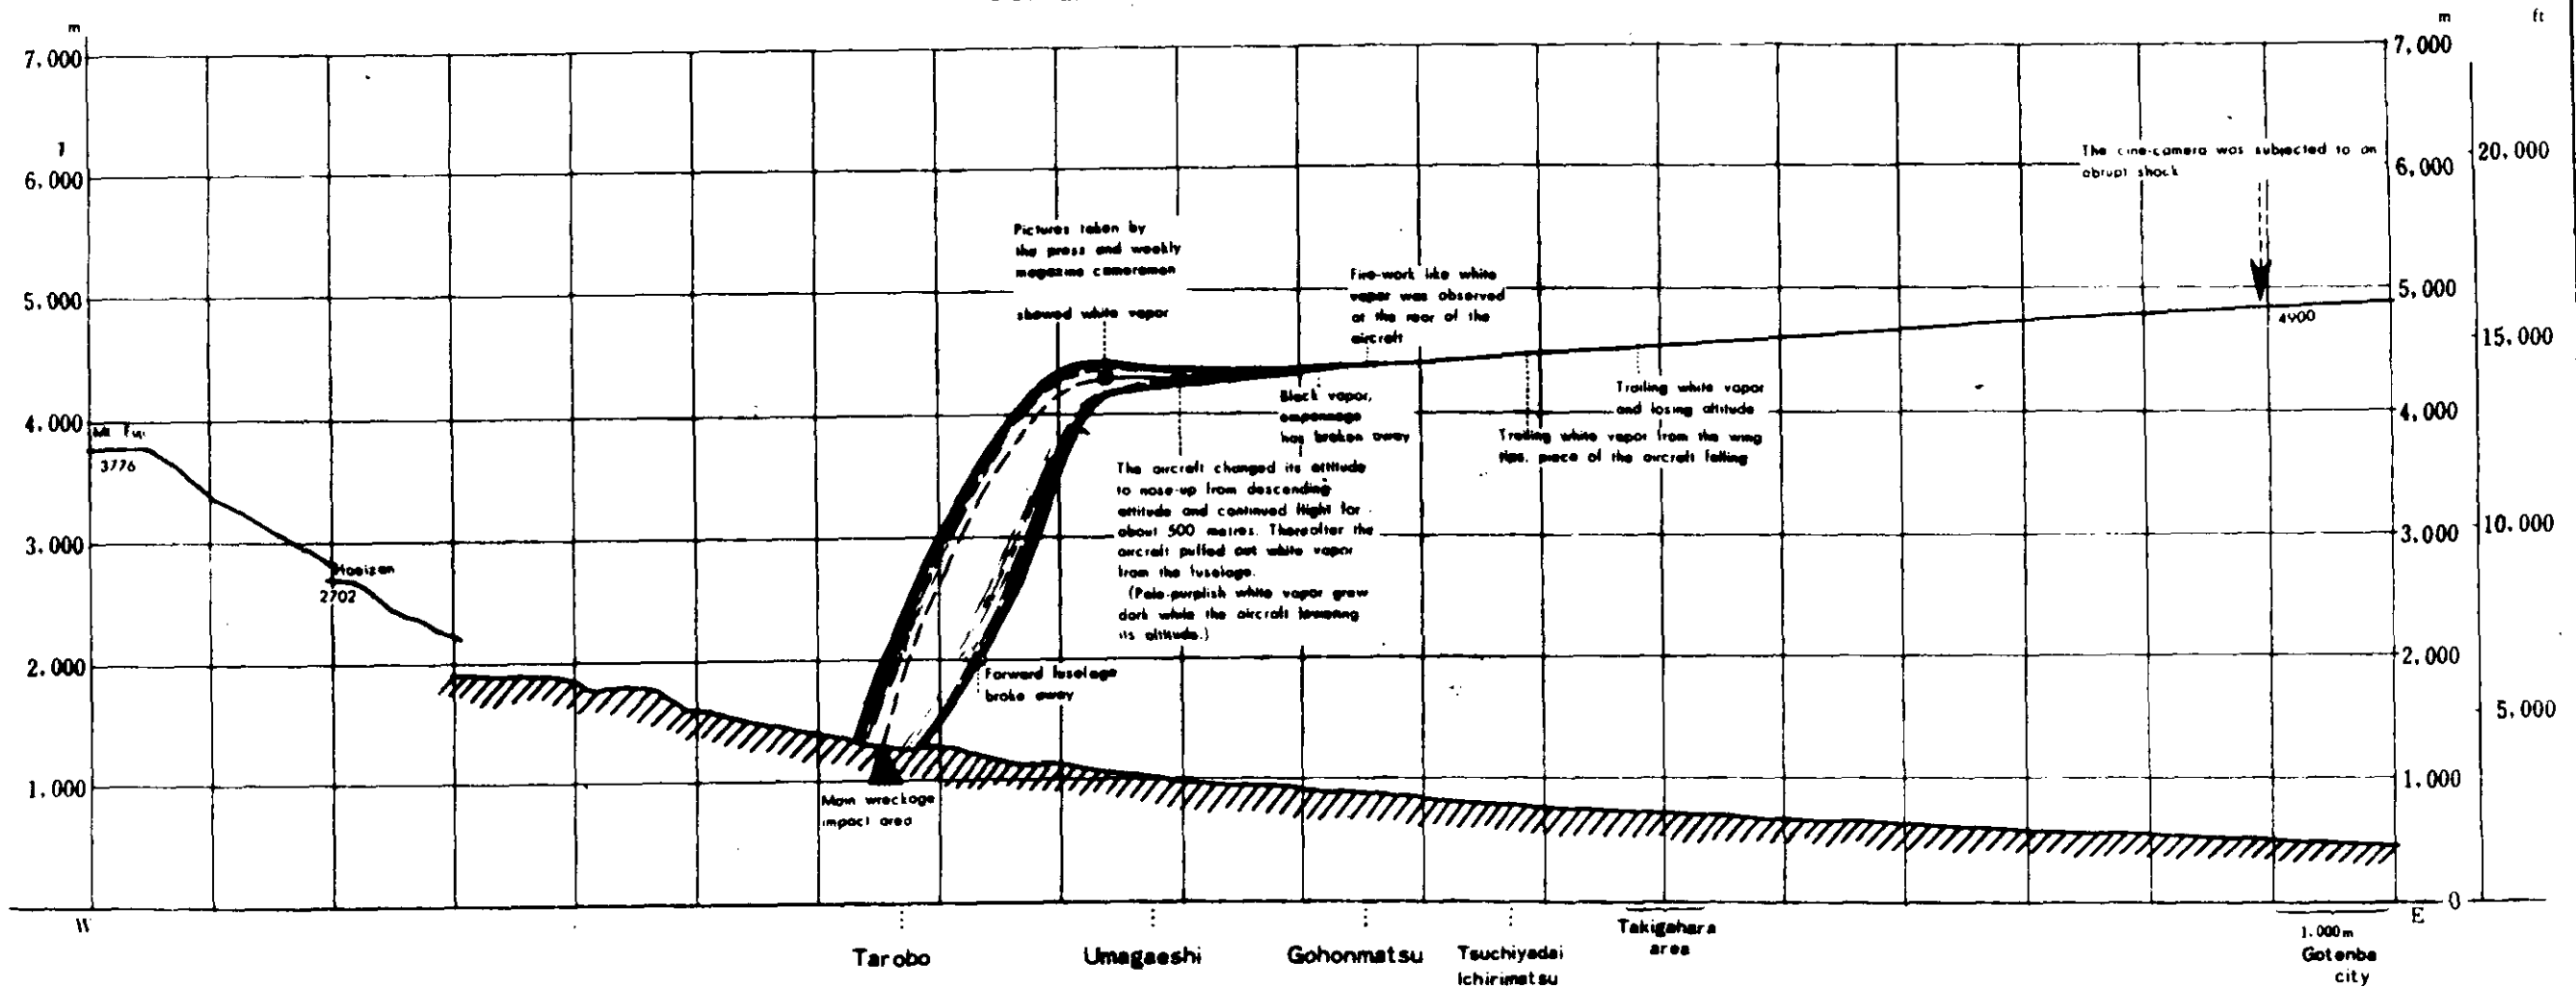
FIGURE 7-3

BOAC, B-707, G-APFE, ACCIDENT AT THE FOOT OF MT. FUJI, JAPAN, ON 5 MARCH 1966
