ICAO CIRCULAR

CIRCULAR 82-AN/69
Volume III

AIRCRAFT ACCIDENT DIGEST No. 16

Volume III

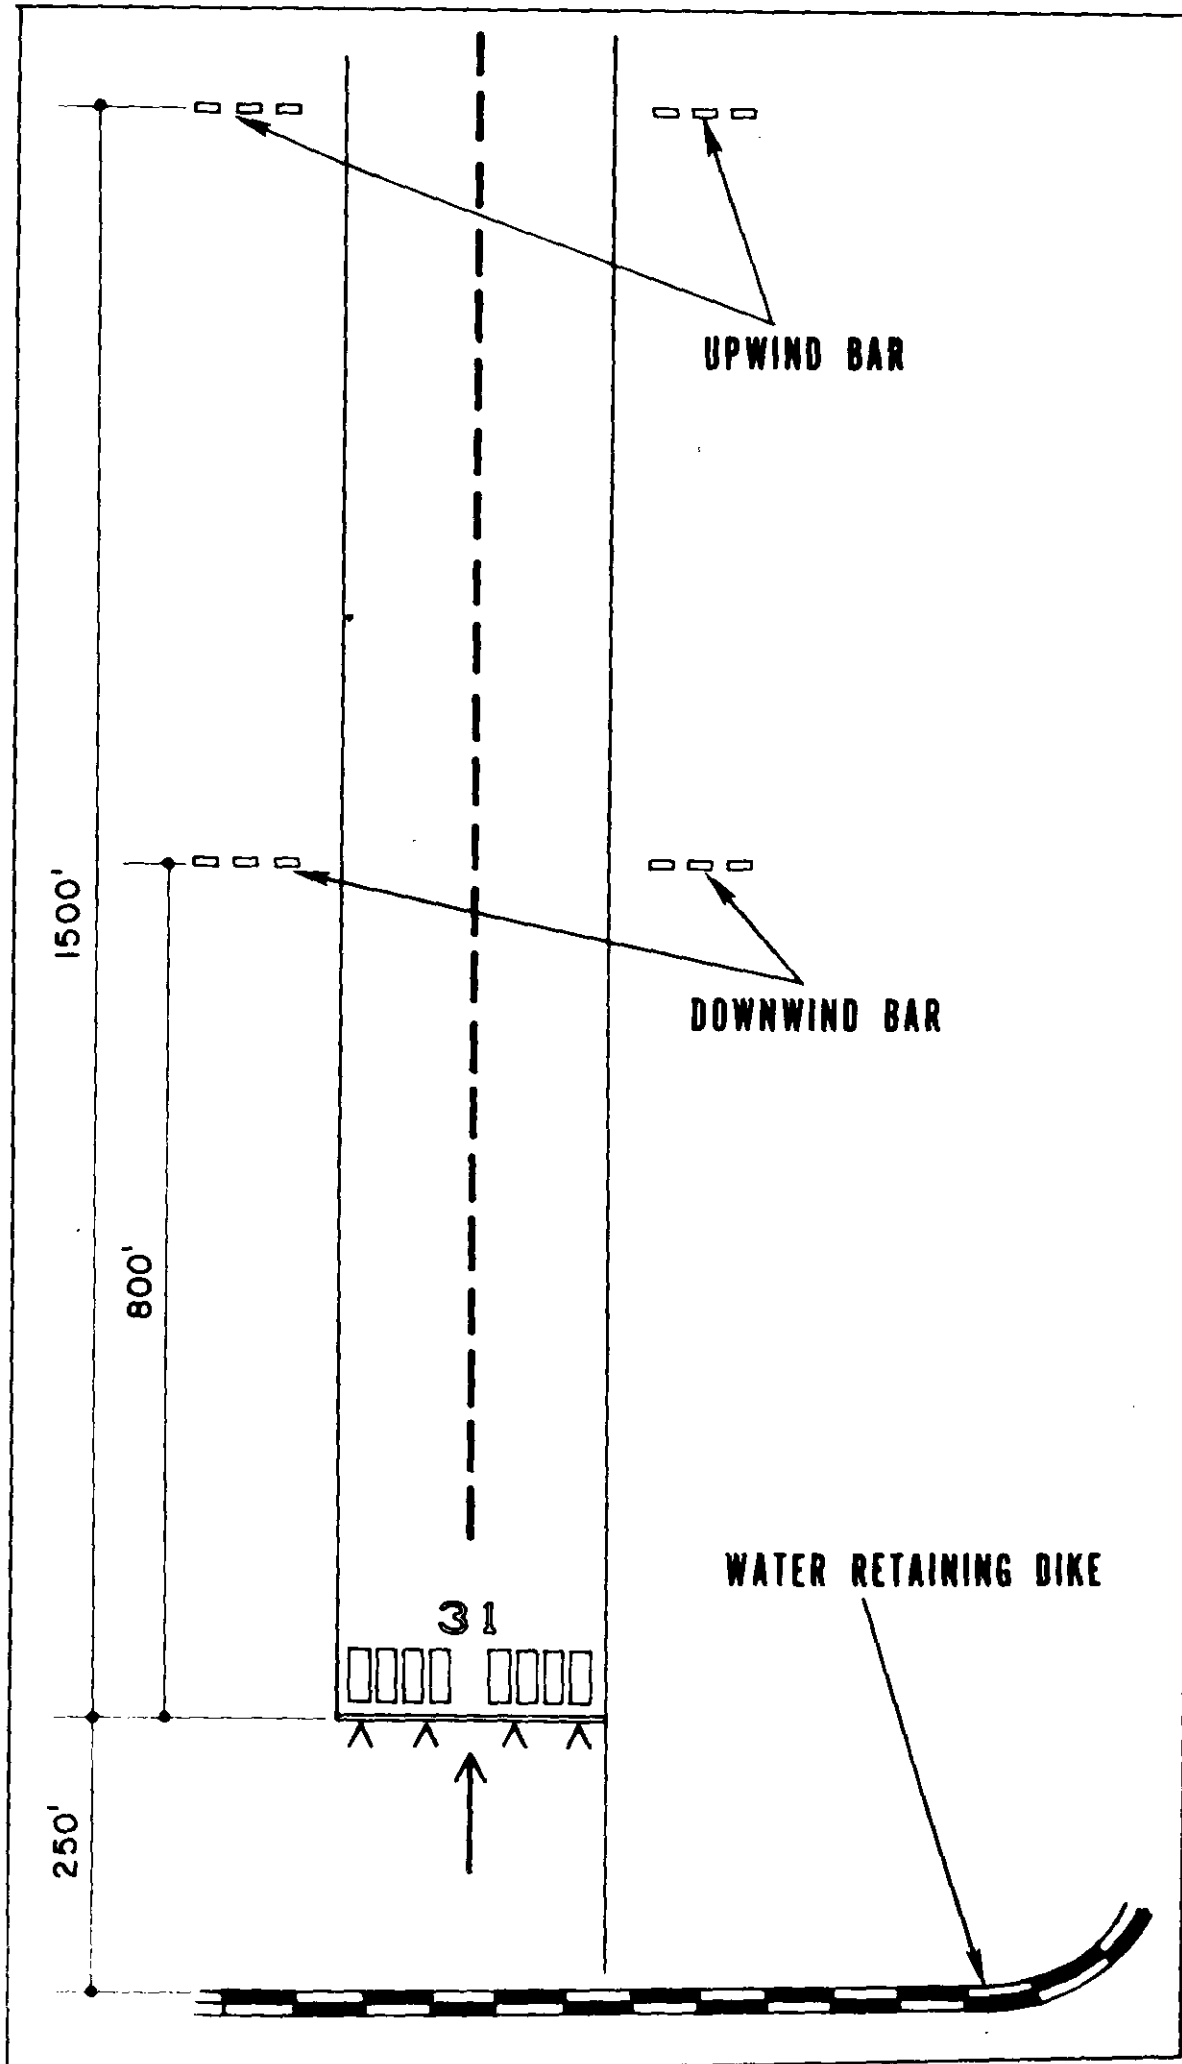
FIGURE 4-1

Following the accident, Federal Aviation Agency (FAA) Systems Maintenance personnel ground checked the runway 31 VASI installation for proper operation and approach slope alignment. All light units, with the exception of the inboard unit on the right side down wind bar which was found at a setting of 2.5°, were within proper tolerances.* One unit out of tolerance does not affect the overall operation of the system.

VISUAL APPROACH SLOPE INDICATOR (VASI) RUNWAY 31

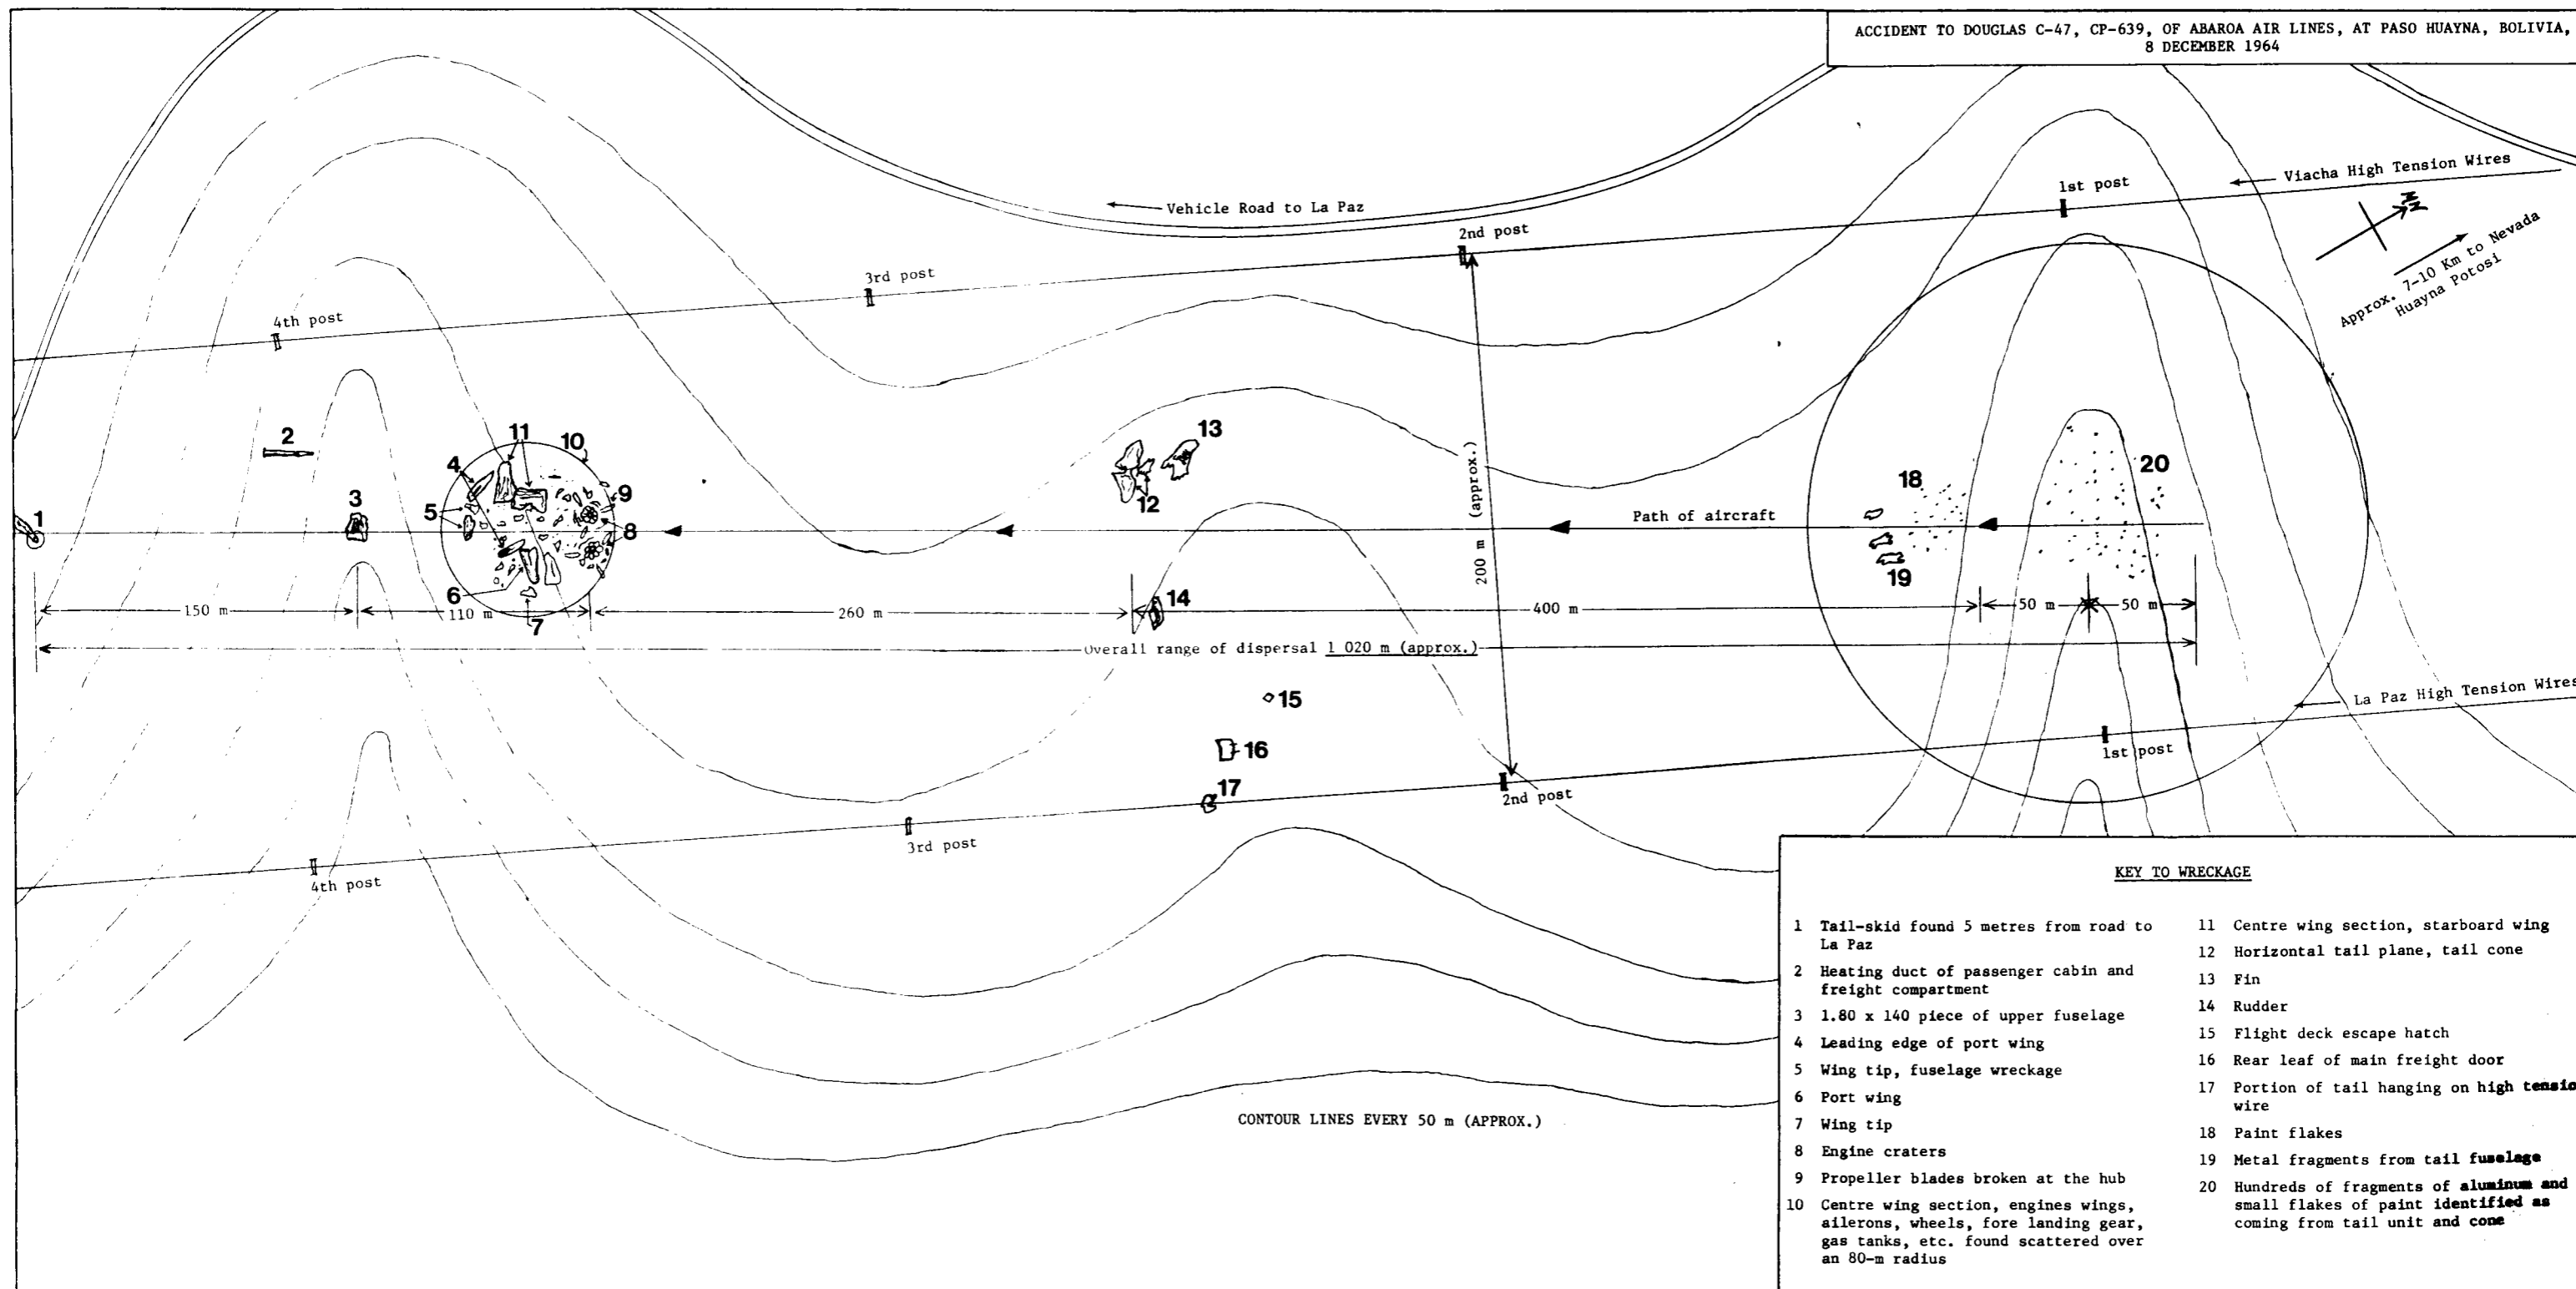
KEY TO WRECKAGE

1 Tail-skid found 5 metres from road to La Paz	11 Centre wing section, starboard wing
2 Heating duct of passenger cabin and freight compartment	12 Horizontal tail plane, tail cone
3 1.80 x 140 piece of upper fuselage	13 Fin
4 Leading edge of port wing	14 Rudder
5 Wing tip, fuselage wreckage	15 Flight deck escape hatch
6 Port wing	16 Rear leaf of main freight door
7 Wing tip	17 Portion of tail hanging on high tension wire
8 Engine craters	18 Paint flakes
9 Propeller blades broken at the hub	19 Metal fragments from tail fuselage
10 Centre wing section, engines wings, ailerons, wheels, fore landing gear, gas tanks, etc. found scattered over an 80-m radius	20 Hundreds of fragments of aluminum and small flakes of paint identified as coming from tail unit and cone

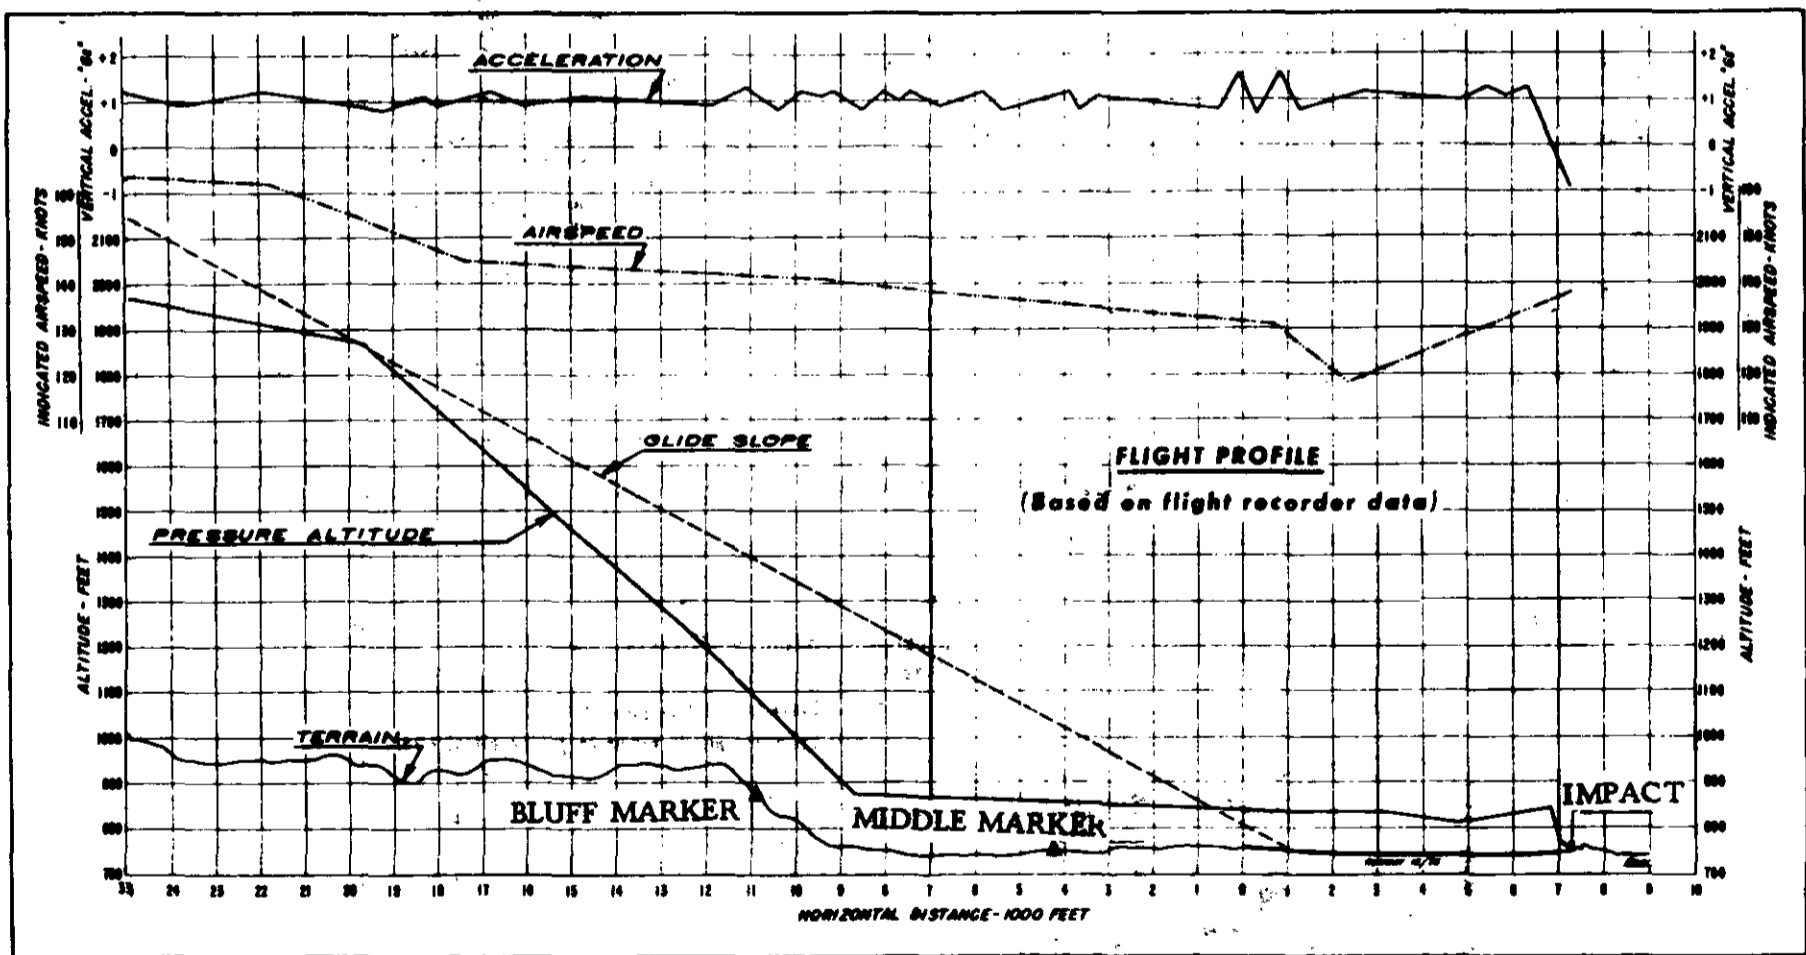
FIGURE 1.- Flight profile

A Viscount on a go-around pitched over sharply from less than 200 ft, crashing nose down just beyond the far end of the runway. Upon examination of the recorder readout plot, there was a suspicion that the aircraft may have struck a bluff or other obstacles under the approach, thus damaging the control system. Figure 1 shows the profile of the flight, made by converting indicated airspeed to true airspeed and ground speed, then integrated to find the geographic points under the altitude trace. The profile shows that, while the aircraft was close to the bluff, it did not strike it or other obstructions. The profile also revealed excessive airspeed for landing near and over the runway, followed by rapid deceleration, probably flap actuation, but too far down the runway for a landing. While this investigation was underway the flight recorder readout of an approach incident involving empennage rime ice led to wind tunnel tests and other analytical work. It was finally concluded that the accident resulted from empennage ice. On the basis of these developments through the flight recorder, the CAB reopened the investigation and changed the probable cause of a Viscount accident in 1958 before the installations of flight recorders.

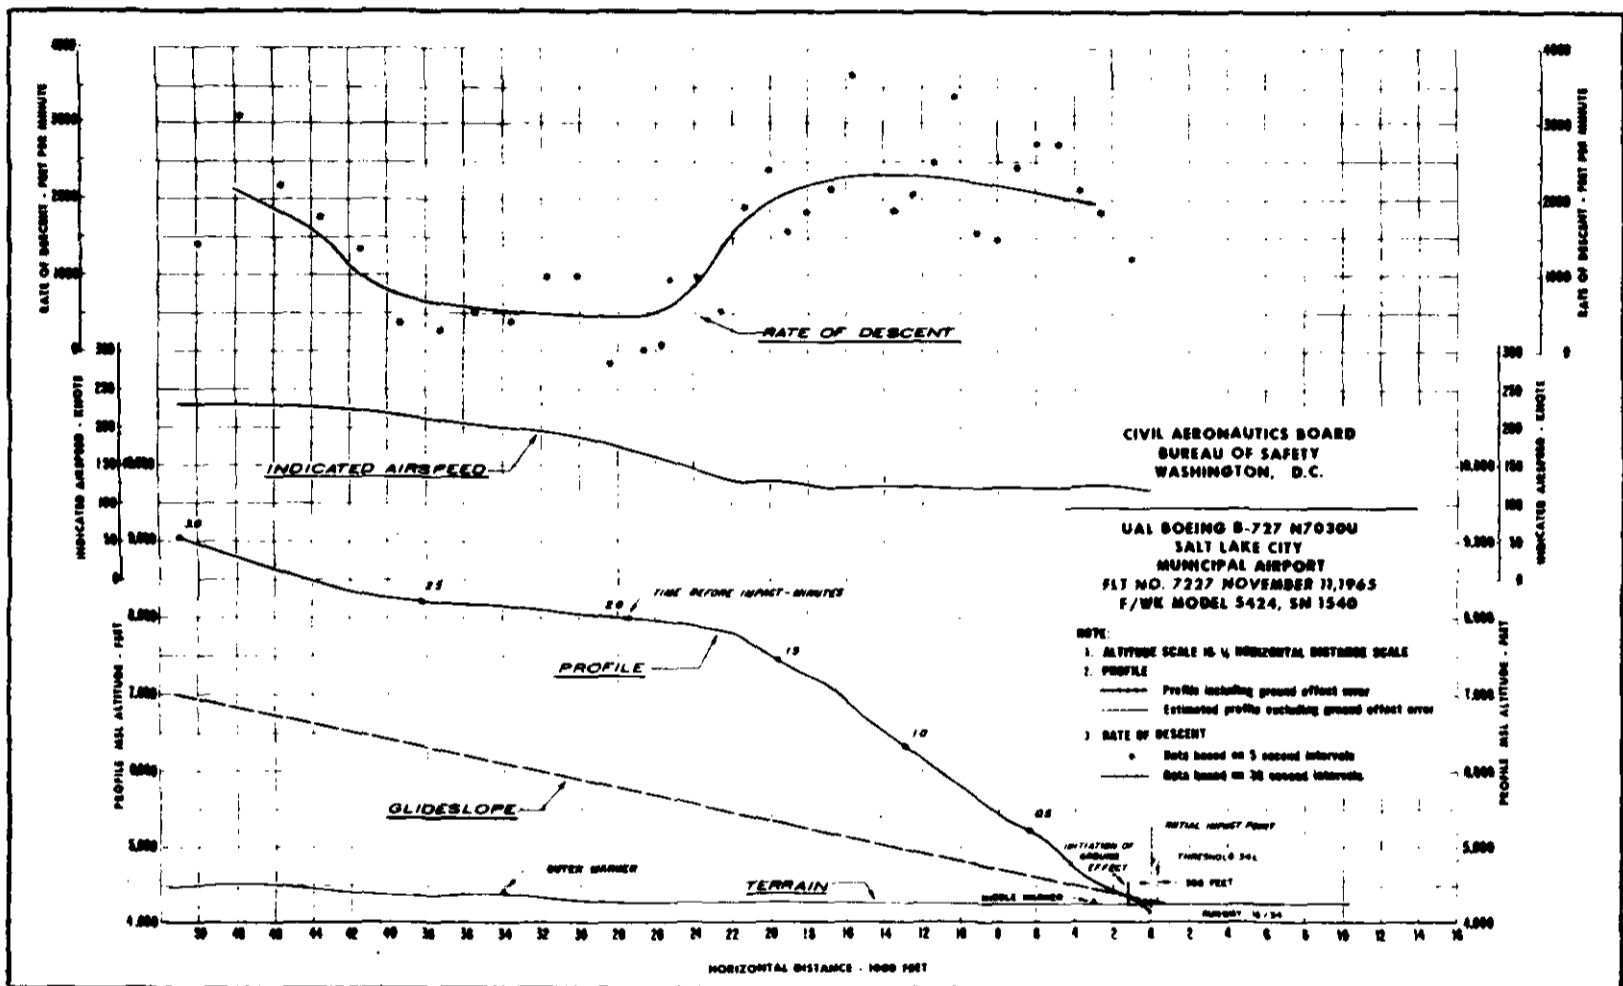
FIGURE 2.- Flight profile (based on flight recorder data)

A Boeing 727 struck the ground short of the runway on a long, straight-in, visual approach. Figure 2 shows the profile obtained by integrating the readout and plotting the result against a terrain profile. Also depicted is the high rate of descent as the aircraft approached the airport. This information, obtained from the flight recorder, helped materially to define the flight conditions surrounding this accident and to arrive at the probable cause: failure of the captain to take timely action to arrest an excessive descent rate during the landing approach. Figure 3 shows only the final stage of this approach and, therefore, better detail of the descent path with relation to the glide slope and the runway.

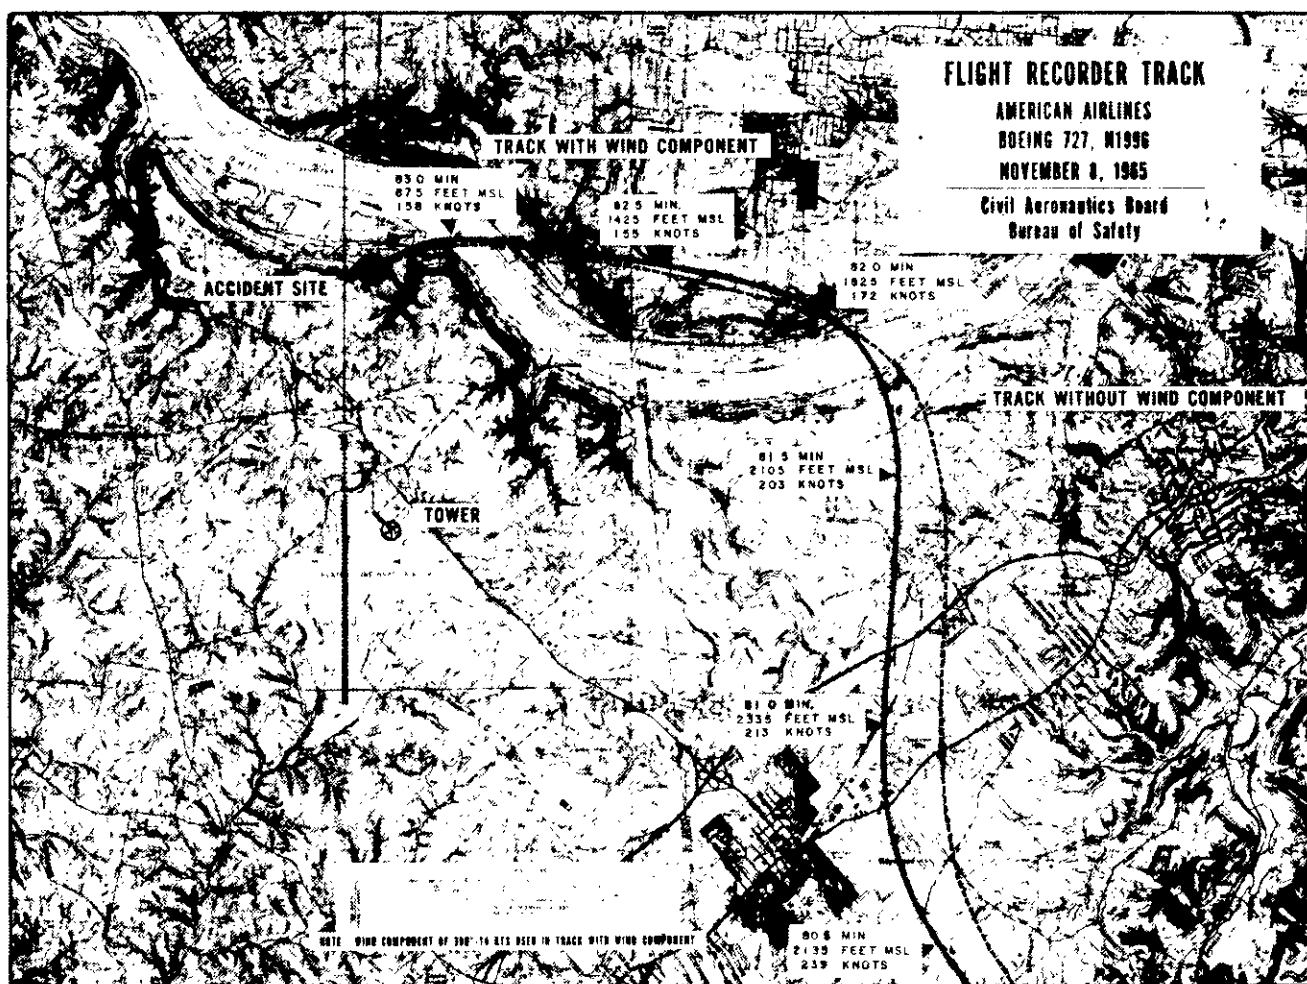
FIGURE 4.- Flight recorder track

Another 727 crashed short of the airport while making a circling, visual approach in deteriorating weather. The flight recorder in this case gave the usual airspeed, altitude, heading and normal acceleration, thus giving valuable information on rates of descent, turning rates etc. Additionally, as shown in Figure 4, it was used to recreate the airplane's track during its final moments. The first calculations were done on a no-wind basis, producing the broken line shown in Figure 4. Later, after the low altitude wind velocity and direction had been well firmed up, the wind was applied to produce the hash line. By merging this information with data gathered by the Witness Group and the ATC Group, the superimposed tracks from the several sources appear as shown in Figure 5.

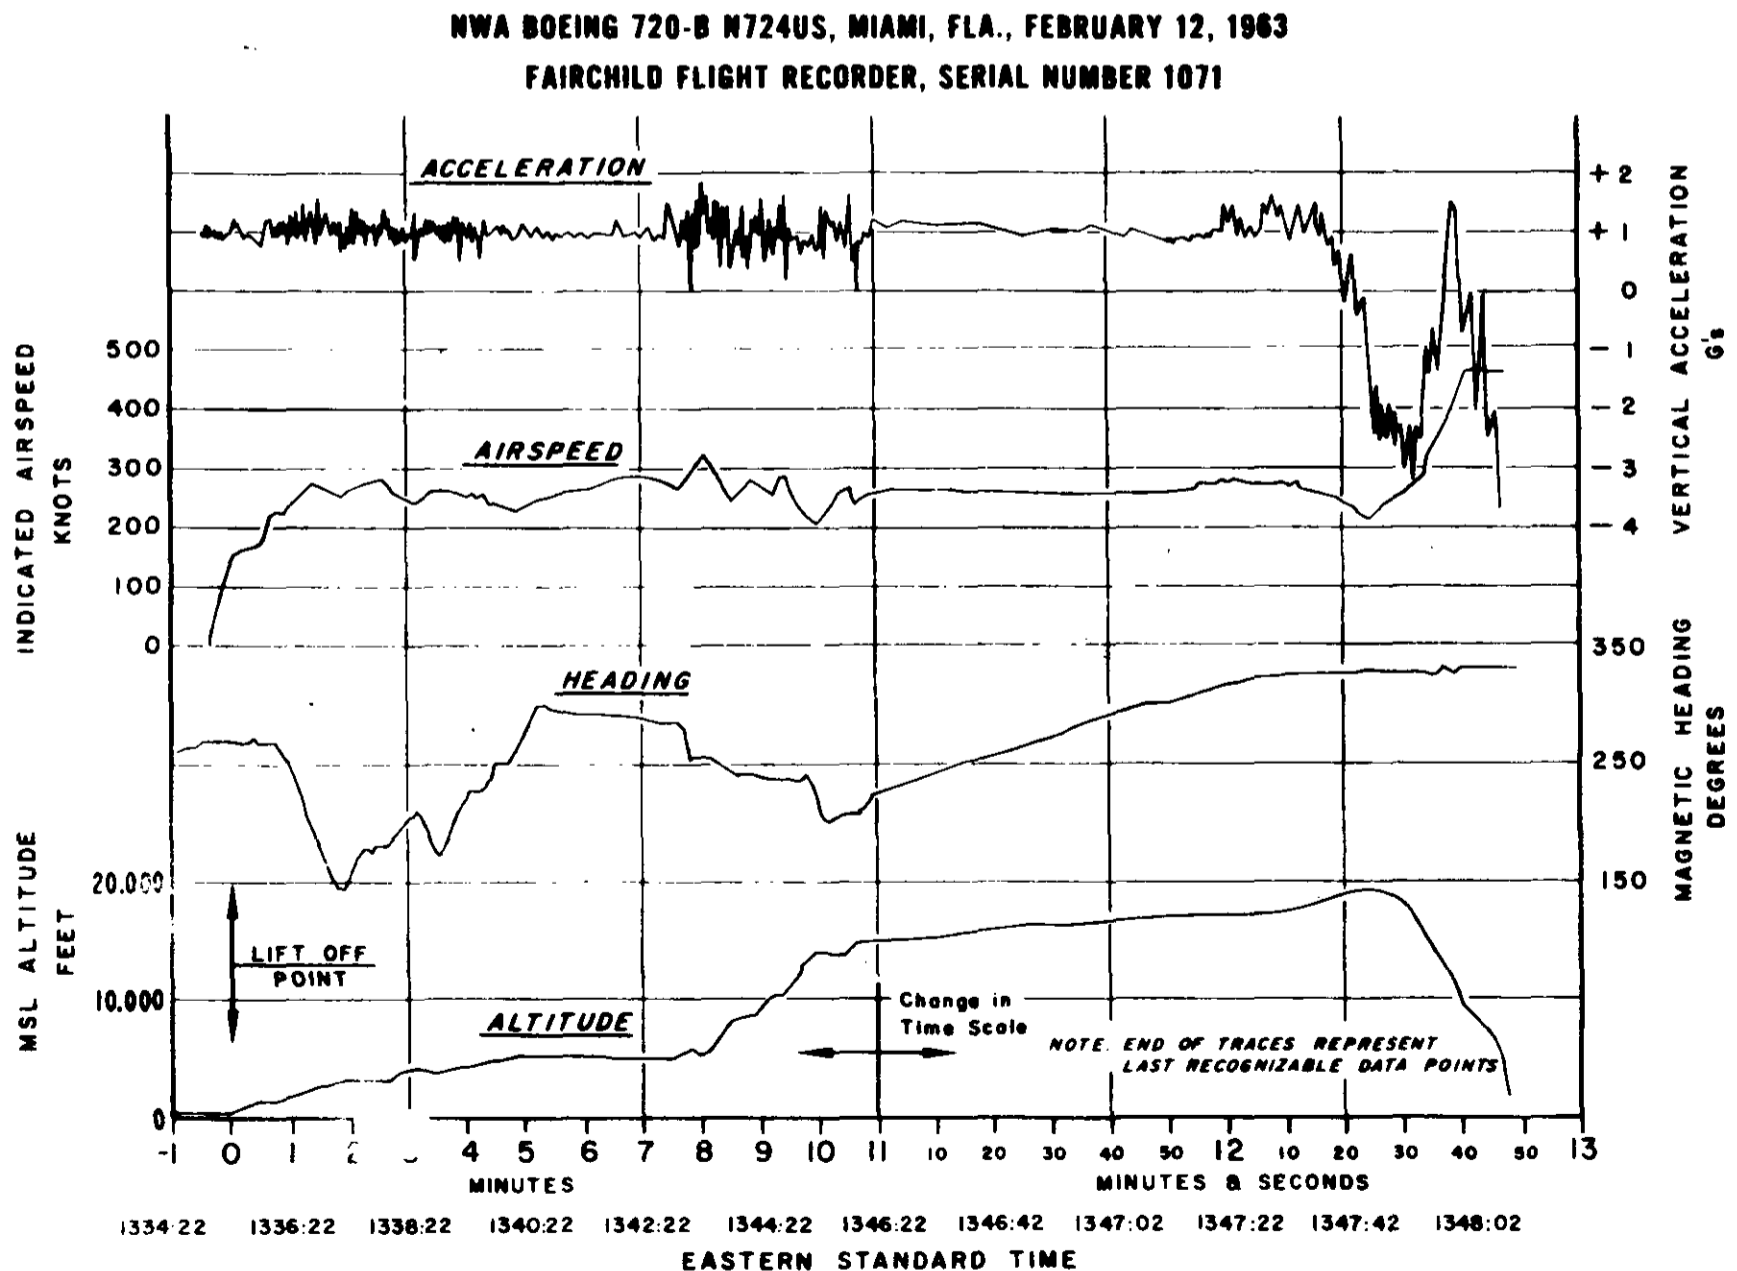
FIGURE 6.- Flight recorder data

A Boeing 720 crashed after reaching about 18 000 ft during climb through a turbulent area. Before reaching the ground all four engines had separated as had the outer wing sections, the forward fuselage and the empennage. Figure 6 depicts the readout. One of the first areas of interest in this figure was the normal acceleration trace. It became evident from this trace that turbulence, per se, was not a likely candidate for probable cause. It can be seen that the early portion of the flight was conducted through far worse conditions than the latter. The Boeing Company, in a cooperative effort with the CAB, undertook several studies based on the flight recorder data. The early analog and digital studies were most helpful in demonstrating that the aircraft was intact during the initial steep climb, the pitchover and during most of the ensuing dive. The angle of attack, pitch attitude, elevator angle and stick force time histories (Figure 7) resulting from the digital computer study, coupled with the derived flight path (Figure 8), provided an excellent graphic display of the final maneuver and a clearer understanding of the problems confronting the crew. Perhaps the most significant finding was that the maneuver required (a) full nose-down trim, (b) full nose-down elevator for about eight seconds followed by (c) full up elevator about nine seconds later. This one finding was perhaps the most convincing of all in indicating an essentially intact aircraft down to a lower altitude. Still, air was assumed for the study, an assumption which might first appear ridiculous; however, the excellent parametric comparison shown in Figure 8 certainly indicates that the motions must have been produced principally by elevator and stabilizer controls rather than vertical gust inputs. For gusts to have been the major generating forces for the initial negative g portion of the maneuver, their velocities would have had to be inconceivably greater than the most severe measured during the National Severe Storms Project, and would have had to persist in one direction for nearly ten seconds.
