# ICAO CIRCULAR

CIRCULAR 232-AN/139

## AIRCRAFT ACCIDENT DIGEST 1985 (No. 32)

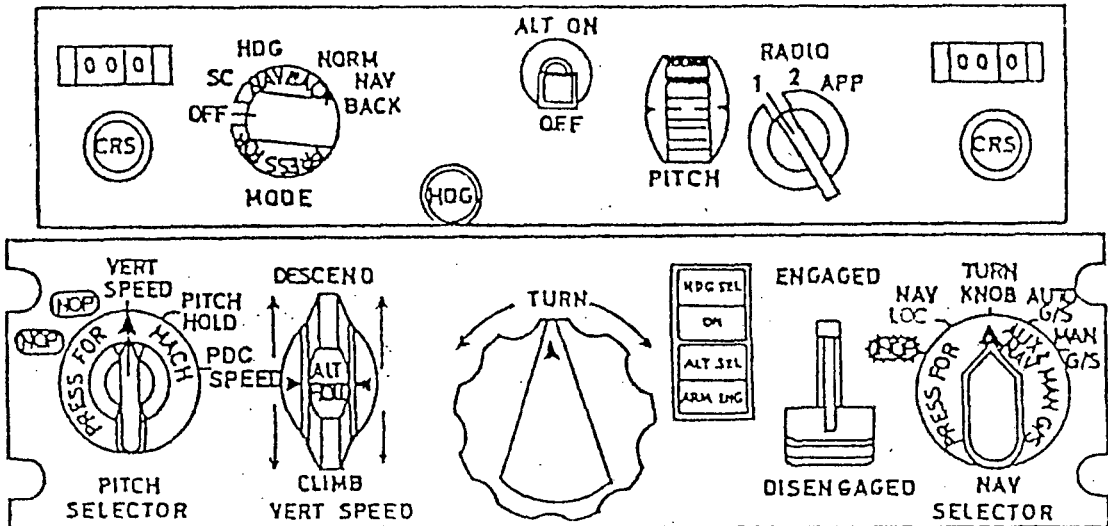
Figure 1

Its controls were located on the rear electronic panel of the centre pedestal, within reach of both pilots. It comprised the following elements (Figure 1):

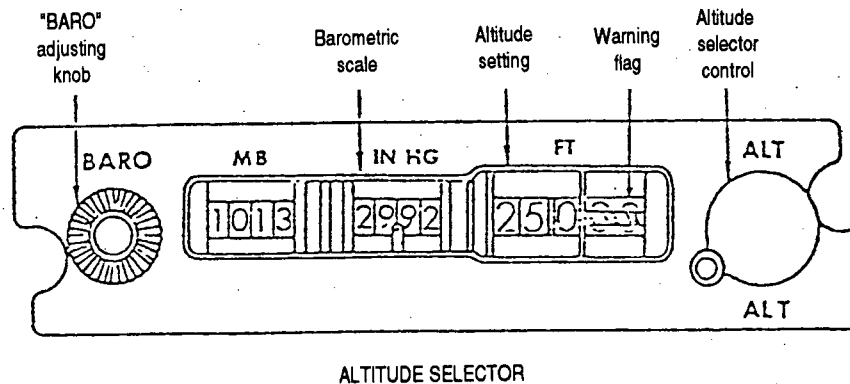
Figure 2

The altitude alert system comprises the following elements (Figure 2):

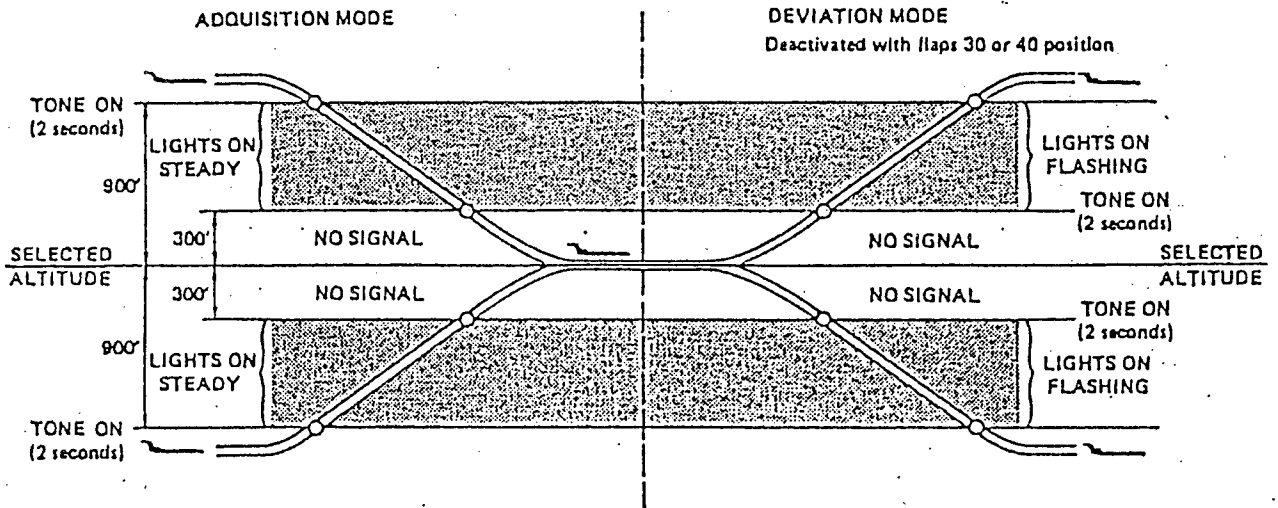
Figure 3

In general the altitude alert system is used in conjunction with the A/P. In this case, the operating sequence is as follows (Figure 3): once the pilot has selected the required altitude and has set the barometric pressure with the "BARO" control, the altitude selector knob is pressed to "RESET", the system is armed by pressing the "ALT SEL" switch located on the A/P control panel and the amber ARM light incorporated in the switch itself lights up. When the aircraft reaches 900 ft from the altitude selected the audio generator switches on and the steady, amber "ALTITUDE ALERT" lights on the panels in front of each pilot switch on. While the aircraft is still approaching and is 300 ft from the altitude selected, the lights go off and depending on the rate of descent and the altitude error, at a pre-set distance from the altitude selected the amber ARM light goes out and the green ENG light comes on indicating that the aircraft has changed to ENGAGED mode and is starting to level off towards the altitude selected until it captures it, at which point it changes to capture mode. This light remains on until the aircraft leaves the captured altitude.

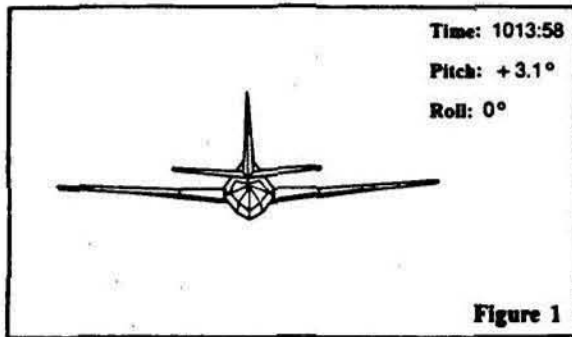
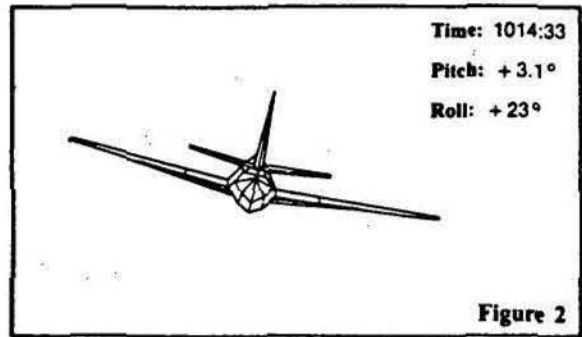
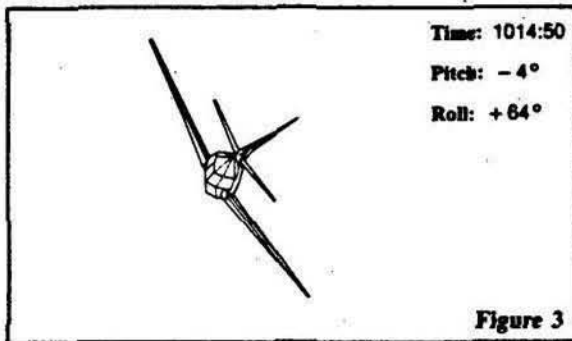
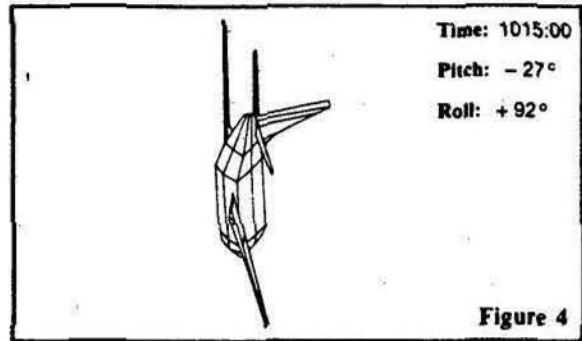
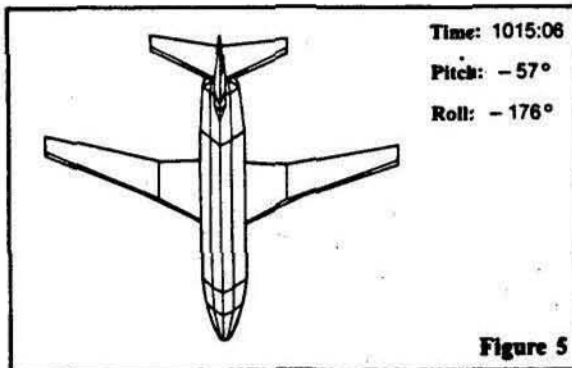
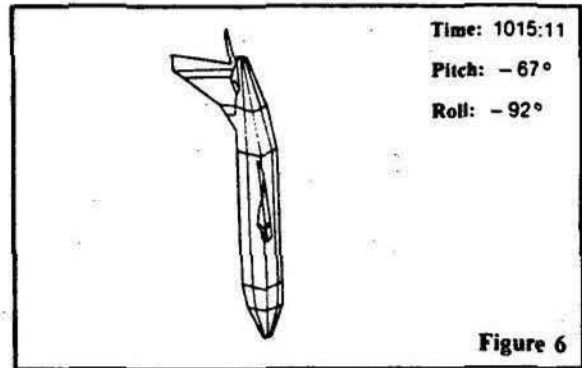
Figures 1.--Excerpts from Computer Animation.

Between 1013:10 and 1015:06, the Nos. 1, 2, and 3 engines remained at about 1.5 EPR while the No. 4 engine remained at about 1.1 to 1.2 EPR. The airplane continued level at 40,900 feet, but the airspeed continued to decrease at a rate of about 0.25 KIAS/sec. Although the roll angle of the airplane remained fairly constant at about  $2.6^\circ$  to  $3.5^\circ$  left-wing-down, the left-wing-down deflection of the control wheel continued to increase as the indicated airspeed decreased, and, by 1013:43 the deflection had increased to  $22.9^\circ$ , the maximum available input from the autopilot. As the airspeed continued to decrease and with the control wheel deflected to, and remaining essentially at, the  $22.9^\circ$  left-wing-down deflection, the airplane began rolling slowly to the right, reaching a wings-level attitude by 1013:58 and then continuing on into a right-wing-down attitude. (See figure 1.)

By 1014:33, the airspeed had decreased to 225 KIAS. Despite the  $22^\circ$  left-wing-down control wheel deflection, the airplane had rolled  $23^\circ$  right-wing-down. (See figure 2.) The airplane's pitch attitude, which until this time had remained constant at  $3.1^\circ$  noseup, now decreased to  $1.8^\circ$  noseup and remained at that angle for about 5 to 6 seconds before returning to the original noseup attitude. During this period, the airspeed increased about 1 KIAS and then began decreasing again. The airplane continued rolling to the right at an increasing rate. In addition, the airplane had begun descending at a rate of about 1,200 feet per minute.

By 1014:50, the airplane had descended to 40,442 feet, the airspeed had decreased to 221 KIAS, and the airplane had rolled and pitched to a  $64^\circ$  right-wing-down and  $4^\circ$  nosedown. (See figure 3.) The  $22.9^\circ$  left-wing-down control wheel deflection had decreased to  $20^\circ$  and, over the next 3 to 4 seconds the control wheel returned to center. In addition, between 1013:06 and 1014:50, the heading had increased from the original  $106^\circ$  heading to  $163^\circ$ .

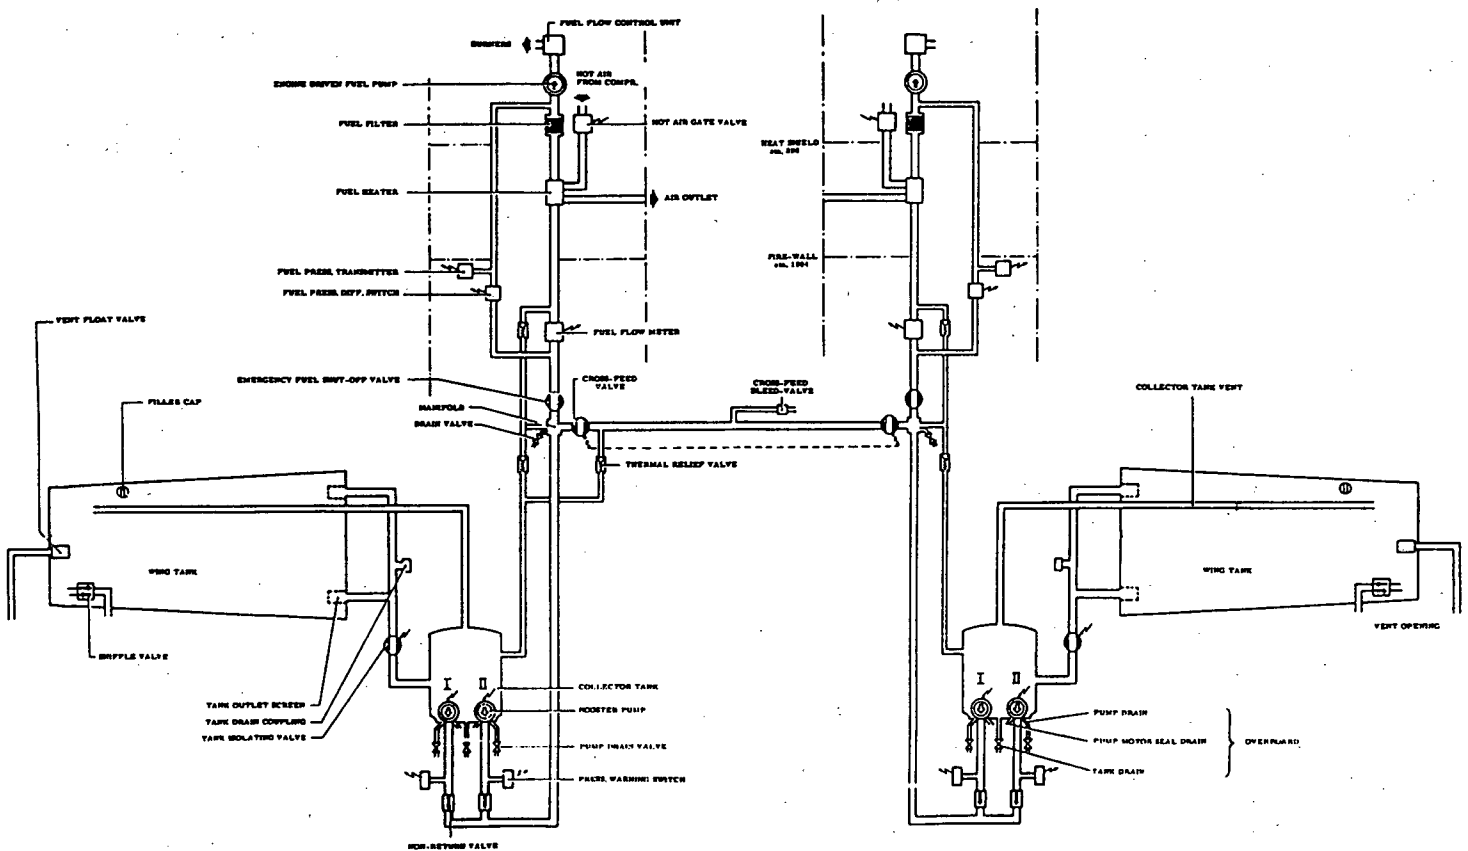
FUEL SYSTEM DIAGRAM

For the purpose of having extended range the aircraft was fitted with a "ferry kit", consisting of two 200 US gal drums interconnected. During flight this equipment was seemingly not working as expected, while ground operations were satisfactory according to the crew.

Due to the problems with the ferry kit, the aircraft had to return from over the Icecap to BGKK, where refuelling could be undertaken. Due to deteriorating weather conditions at that aero-
