CIRCULAR 24-AN/21

AIRCRAFT ACCIDENT DIGEST NO. 2

*Prepared in the Air Navigation Bureau
and published by authority of the Secretary General*

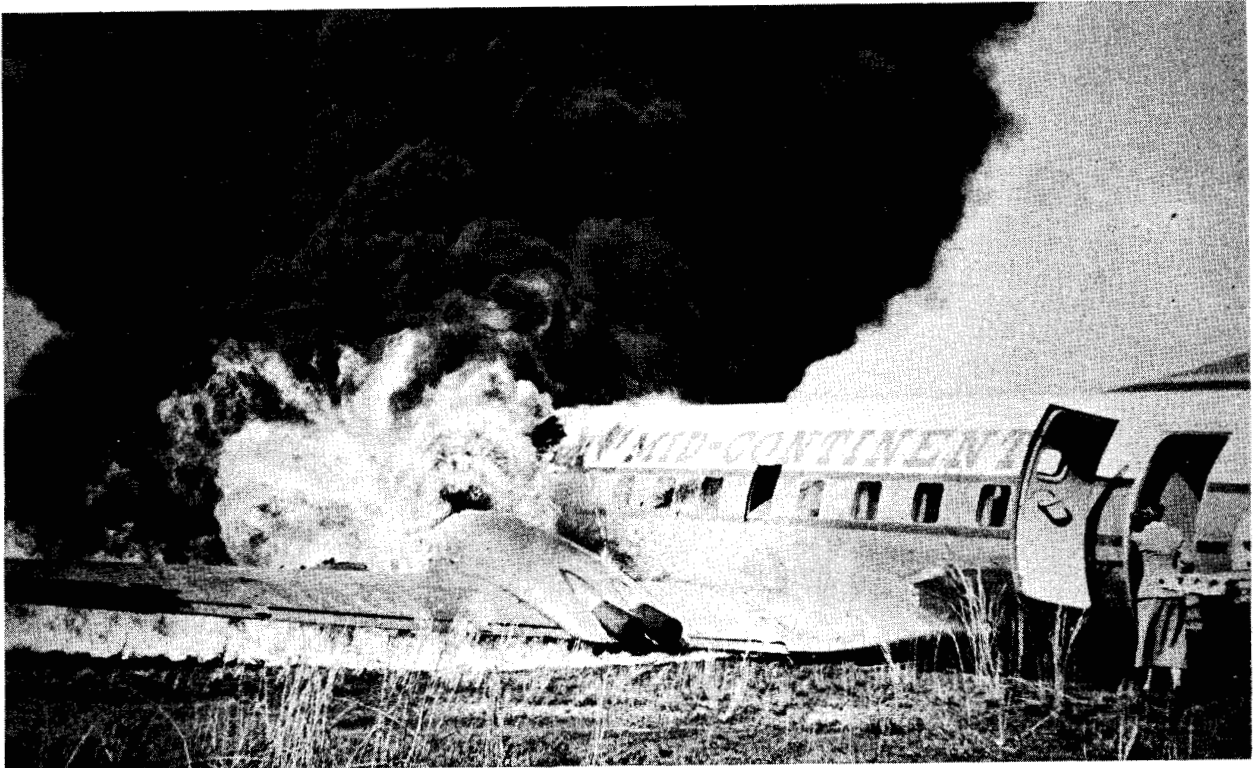
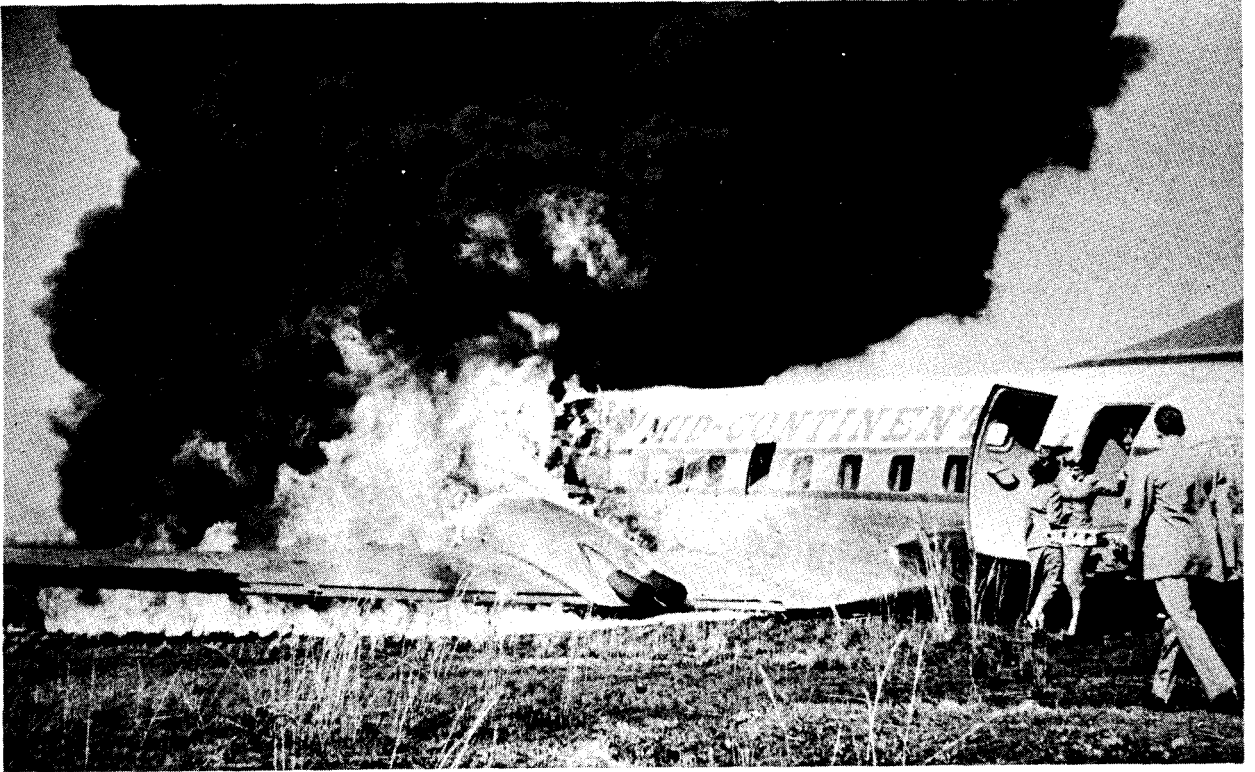
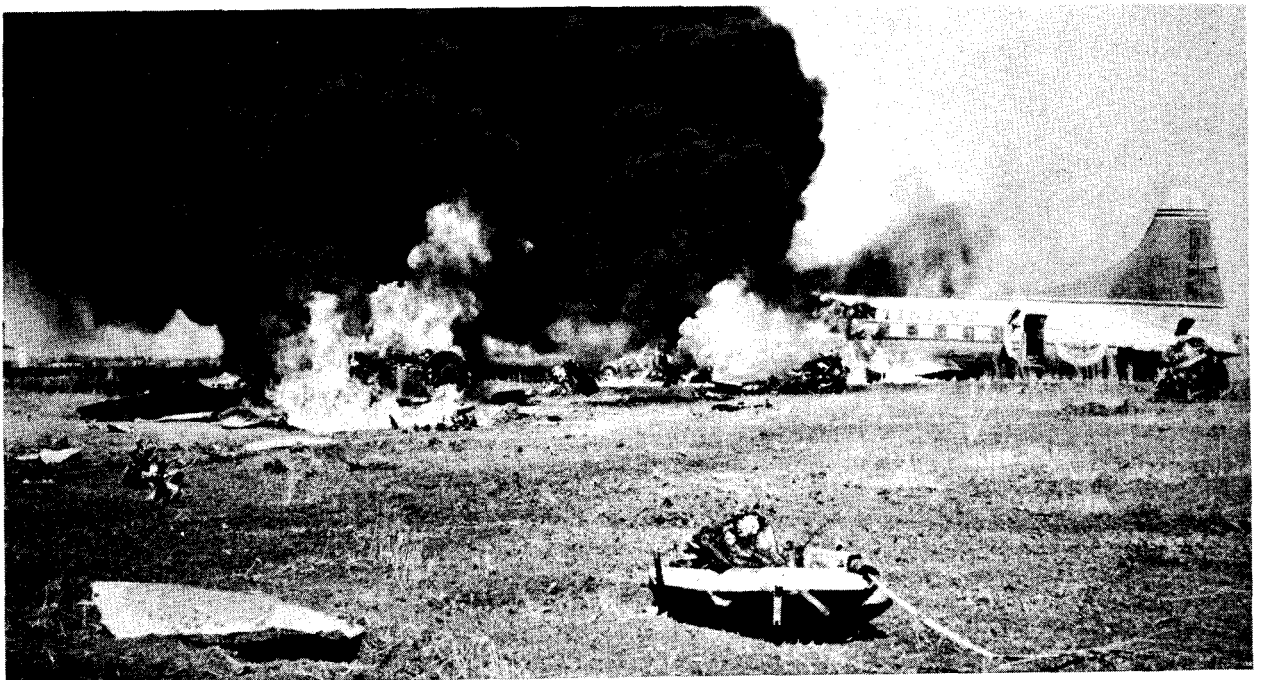
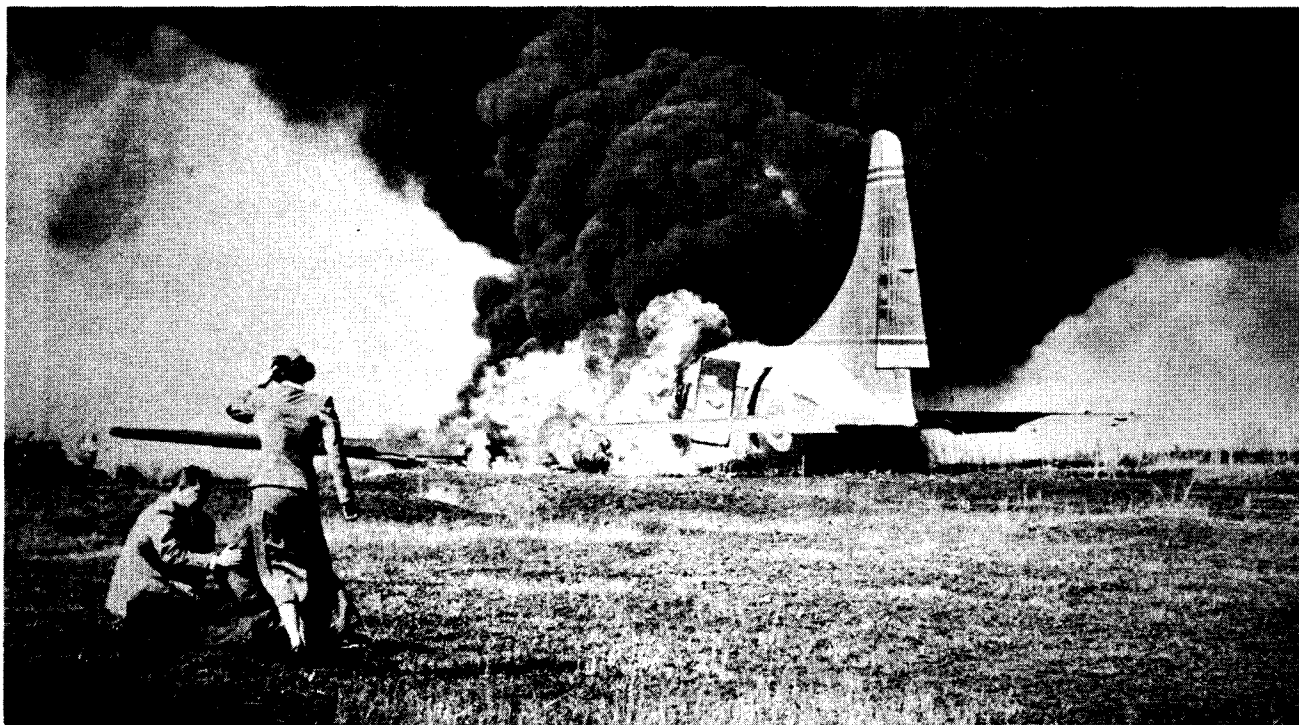
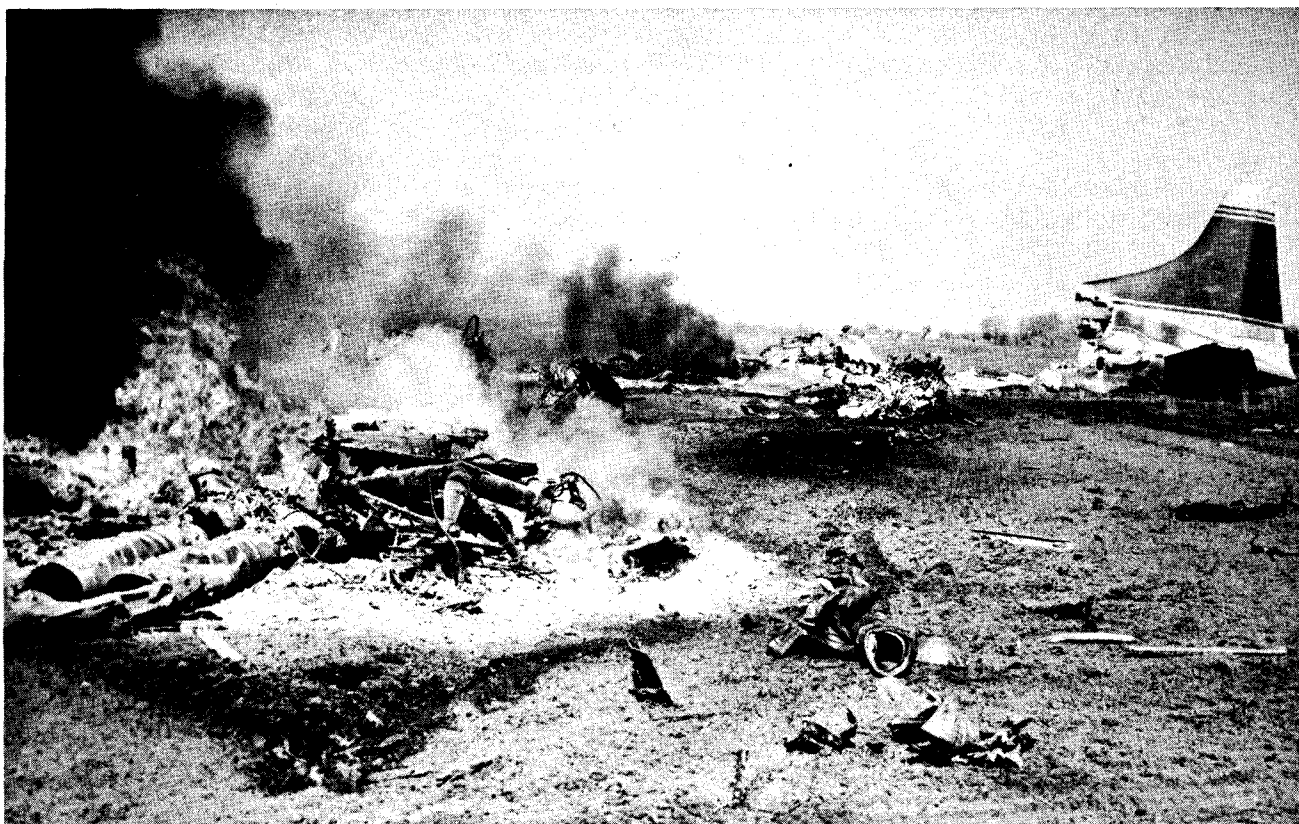
The very unusual photographs published herein, rather than words, can best describe the significant fire factors of this accident.

The aircraft made contact with the ground on a heading of 30 degrees, slid 540 feet and turned anti-clockwise to a heading of approximately 310 degrees as it came to rest. Both fuel tanks ruptured, and the fire that followed consumed all of the fuselage forward of the tail section. The right wing and part of the centre section were torn from the aircraft by impact with a tree and were subsequently destroyed by fire. Investigation failed to
