ICAO

CIRCULAR 31-AN/26

AIRCRAFT ACCIDENT DIGEST NO. 3

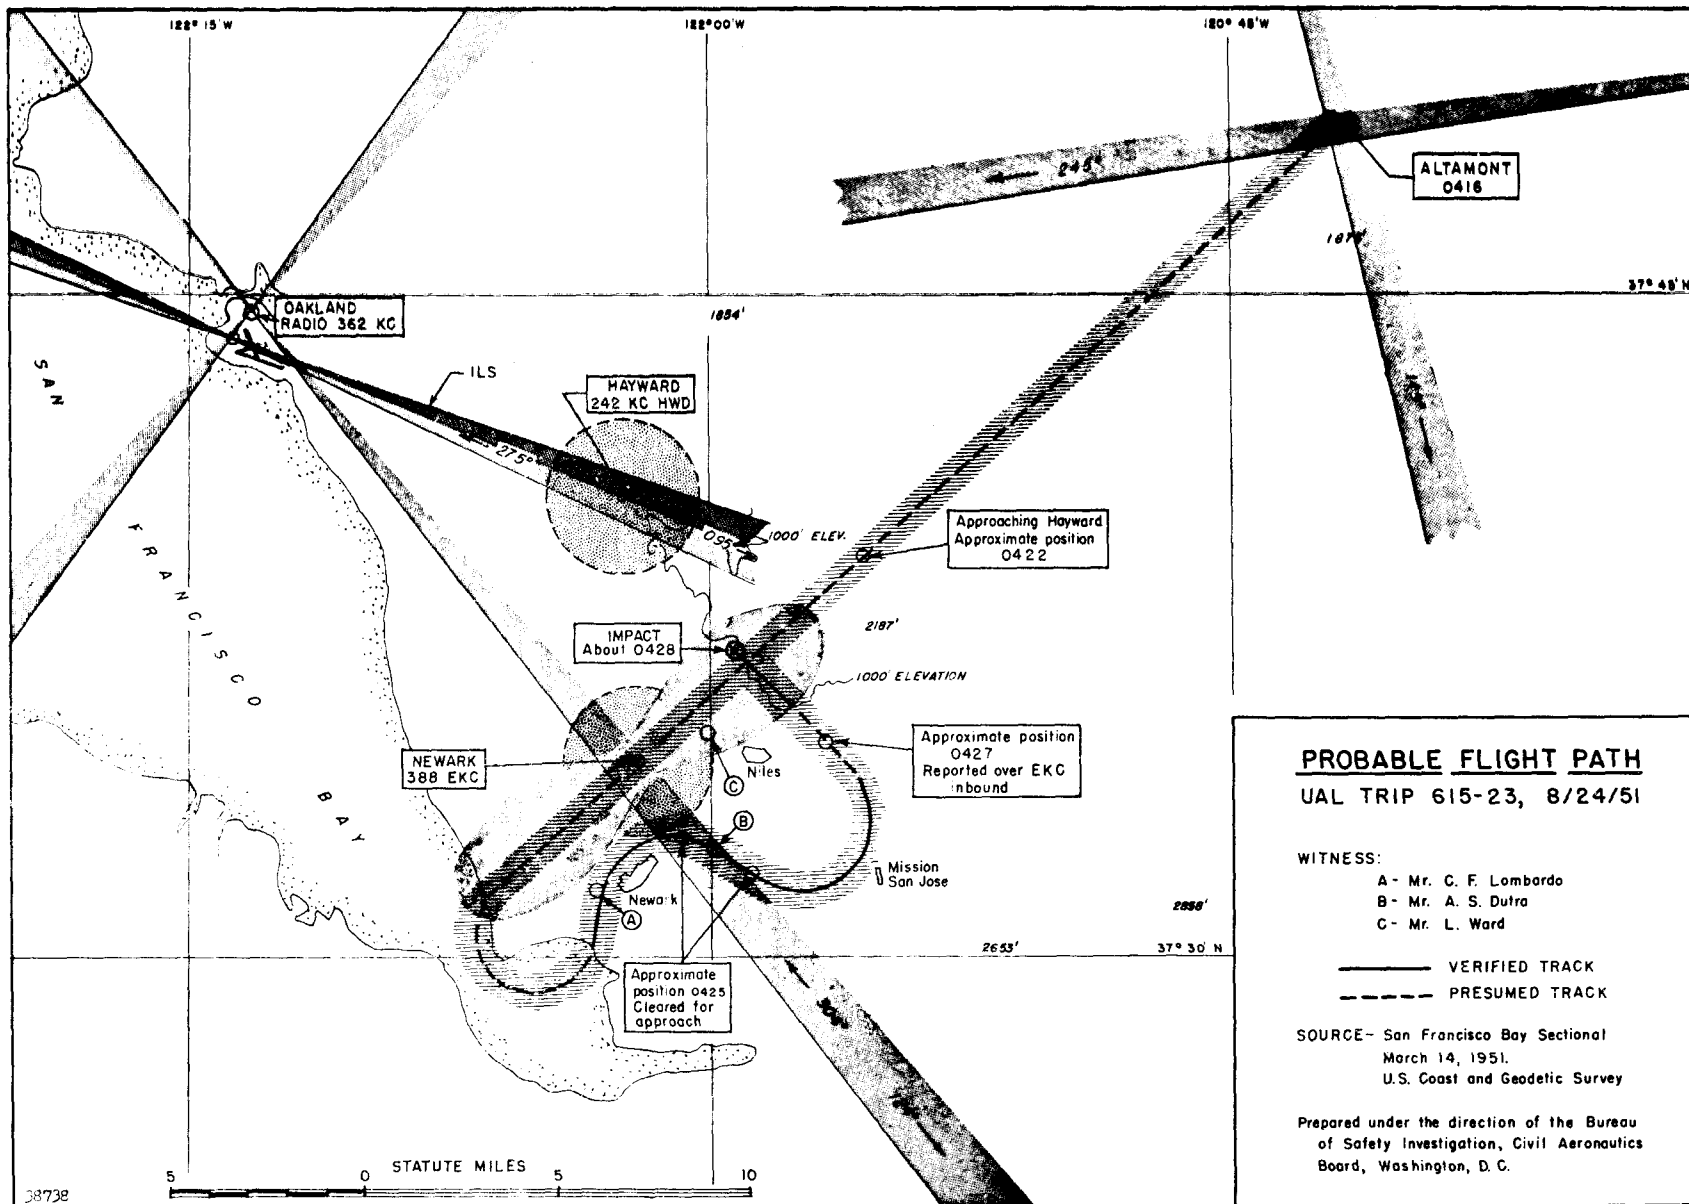
PROBABLE FLIGHT PATH
UAL TRIP 615-23, 8/24/51

The Board determined that the probable cause of this accident was the failure of the captain to adhere to instrument procedures in the Newark area during an approach to the Oakland Municipal Airport.

Note.- Shortly after this accident, United Air Lines made certain revisions in their Flight Operations Manual to prevent, in so far as possible, the recurrence of this type of accident. All pilots were instructed that United Air Lines' flights over the top of an overcast must be conducted in accordance with IFR and must be flown not lower than the CAA approved minimum IFR flight levels. The Manual revision further instructed them that IFR en-route minimum altitudes shown in radio procedure charts must be strictly adhered to, even though the flight be operating on a clearance of at least 500 feet on top. Thus, adherence to minimum en-route altitudes would always be equal to or greater than an on-top clearance, should the cloud tops be lower than 500 feet below the minimum en-route altitude. This includes altitudes prescribed for procedure turns and those between fixes or markers. Pilots were also directed to make full use of the aural range signals during ADF or holding procedures whenever aural signals are available.

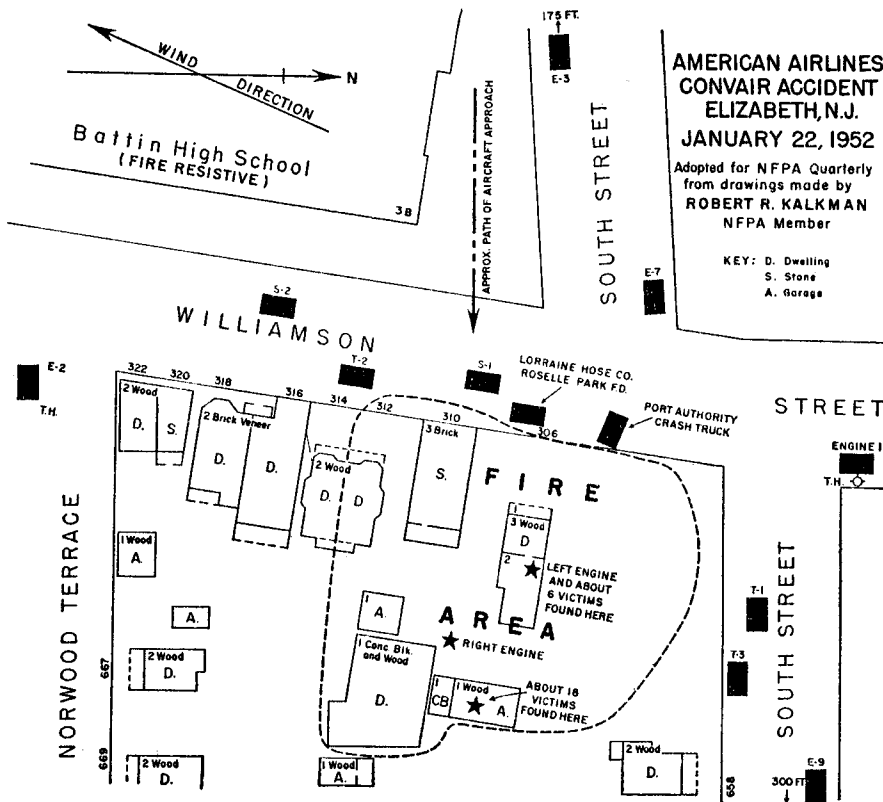
Figure 2

It is assumed that the Convair was also out of control when it struck three dwellings, completely demolished one, and damaged beyond repair a three-story brick building housing a store. (See Figure 2) Telephone wires surrounding the crash site along the streets were not knocked down.

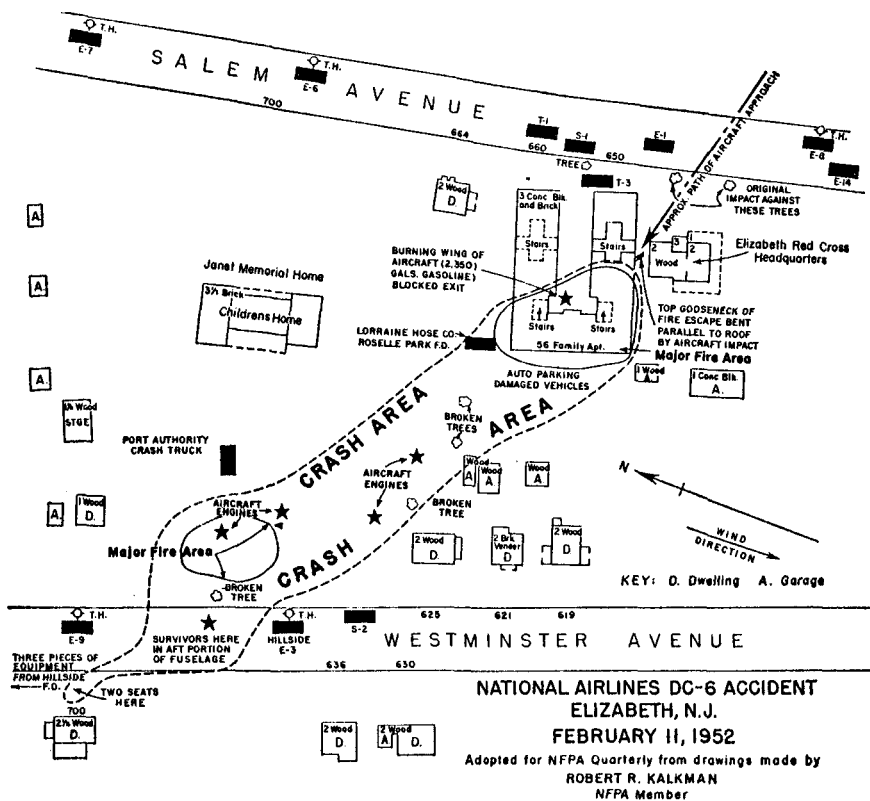
Figure 3

A wing section dropped in the apartment courtyard when the aircraft struck and moved several inches the entire top story wall section at the northeast corner of the south stairway, skidded across the roof, demolishing an eight-inch cinder block, brick coped fire wall and tore down a section of the rear wall about five feet in depth and approximately eighty feet in length. This wall fell on automobiles parked in the rear of the building.

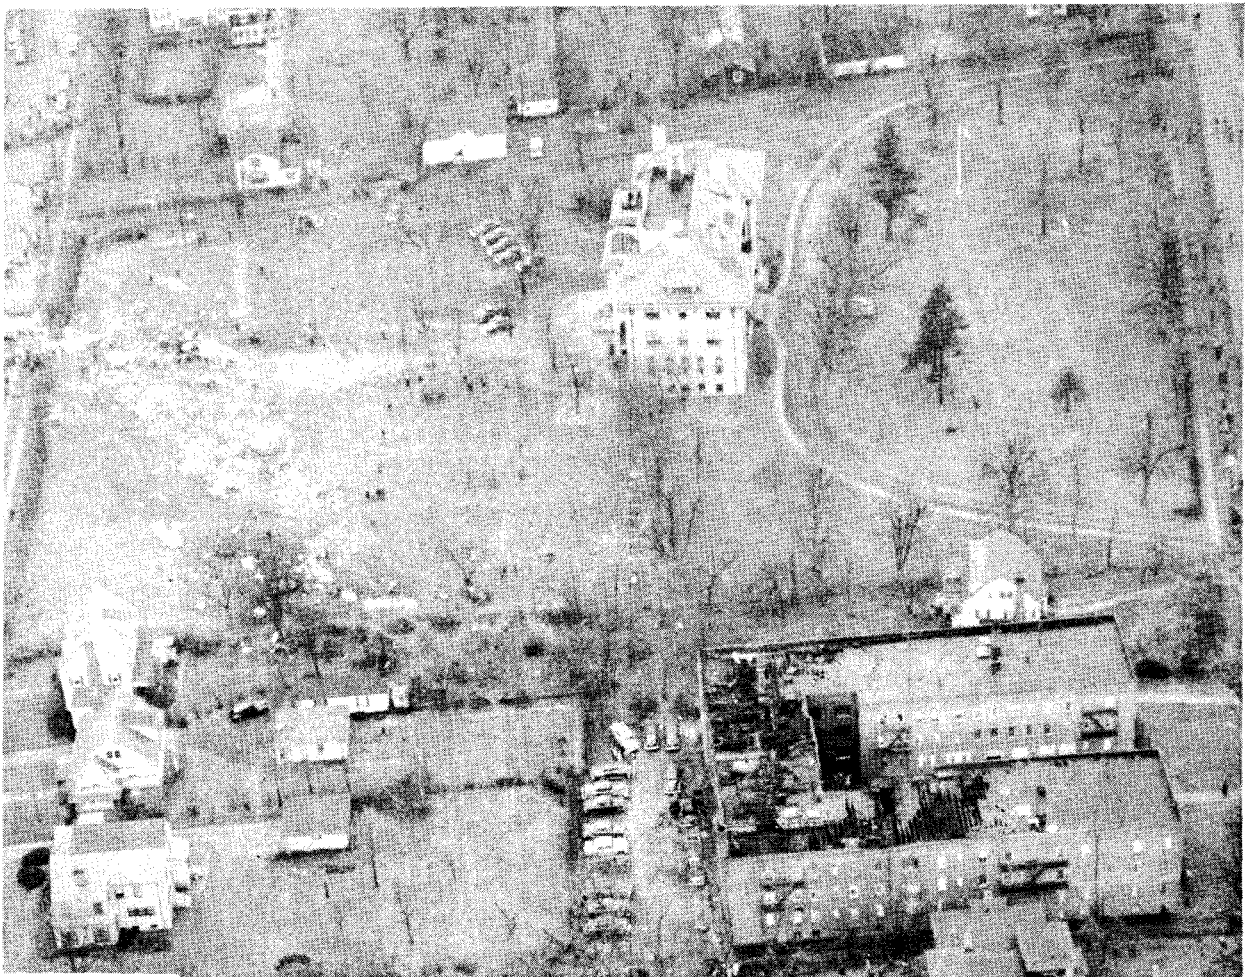
As firemen reached the scene of the third accident, a severe fire was in progress in the apartment house and its courtyard, involving building contents on the top floor, the cockpit and about 2,350 gallons of gasoline in the wing which fell into the yard. Other fires were in the open around the parts of wreckage as shown in Figure 3. Fortunately, the aft section of the fuselage, where survivors were found, was not involved in fire. Other, less fortunate, occupants of the DC-6, were found in an area of about 200 ft. by 850 ft., with indications that some had been catapulted as far as 650 ft. following the impact.
