ICAO

CIRCULAR 38-AN/33

AIRCRAFT ACCIDENT DIGEST NO. 4

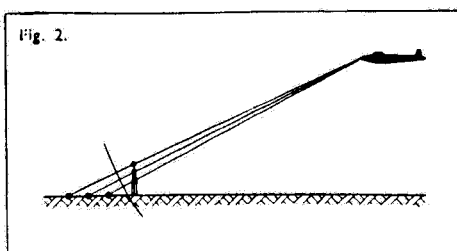
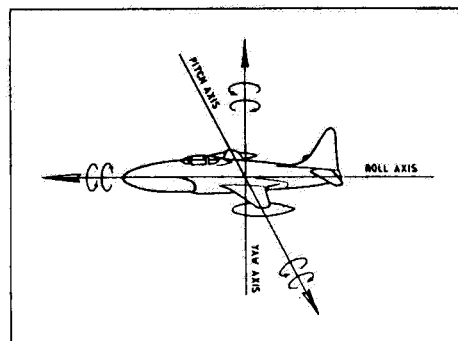
FIG. 3. AIRCRAFT'S AXIS OF FREEDOM

Here are some examples showing what can happen if the pilot neglects to consult his instruments. Under conditions of poor visibility over an area without landmarks (sea, desert, even ground - more particularly when covered with snow, forest, ect.), the pilot is unable to determine the position of the aircraft with relation to any of the three axes of freedom (Figure 3).

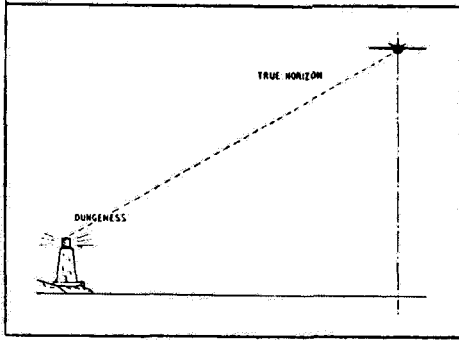
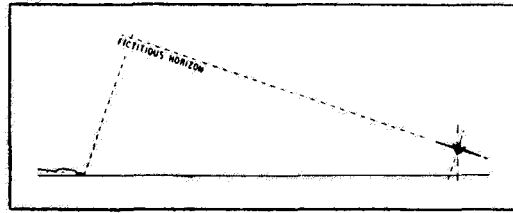
In comparing this incident with the two accidents described above, I was convinced that I must have had my aircraft banked to the right and that the co-pilot had made a correct estimation of the height in judging from the reflection of the green light in the water. My estimation of the distance to the coast was correct, but my estimation of the height above the water was completely wrong, as I had indeed the sensation of flying the aircraft in a normal attitude although it was undoubtedly banked to the right. This is the typical optical illusion with respect to the rolling axis (Figure 4).

FIG. 4A (left) NORMAL FLIGHT PASSING THE LIGHTHOUSE OF DUNGENESS AND LOOKING LEFT

FIG. 4B (below) FLIGHT ALONG THE COAST AT AN ESTIMATED HEIGHT OF 300 FT.—ILLUSION OF 20° TO THE RIGHT

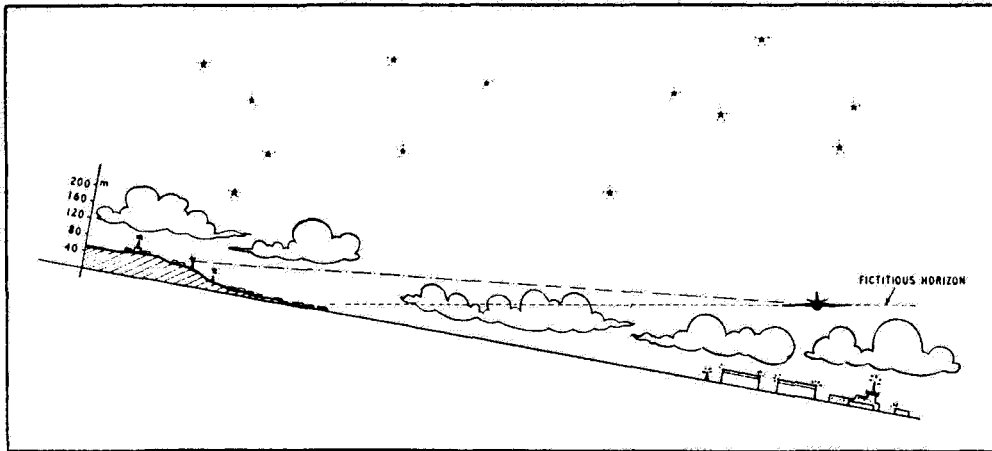
Another case of optical illusion about the rolling axis was experienced by another crew which, on arriving at Croydon at night in good visibility about 3 to 5/10 low stratus cloud, mistook the lights of Purley for stars (Figure 5).

FIG. 5. 10° ILLUSION TO THE LEFT OF THE ROLL AXIS

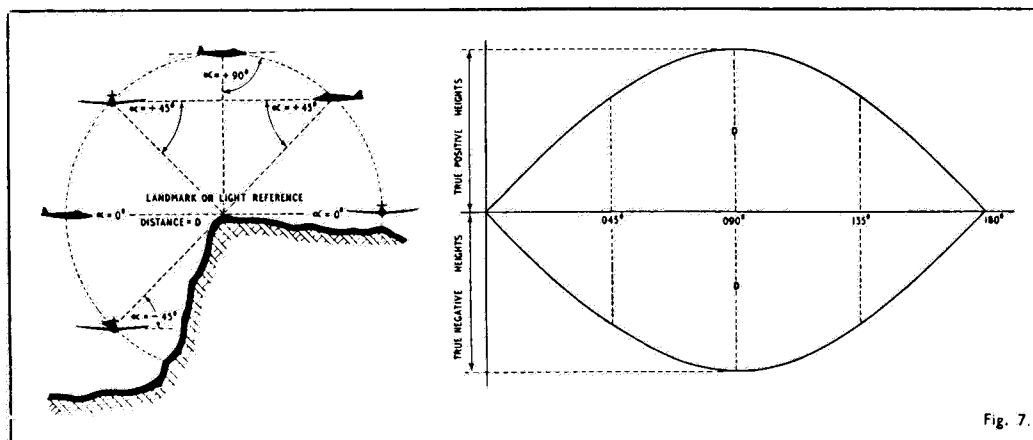
Fig. 7.

The true height is proportional to the distance from landmark D and to the sine of the angle α : for a given distance its variation is thus given by a sinusoid (Figure 7). This condition could also be represented by a cone of vision wherefrom the top corresponds to the eye of the pilot and the base coincides with the horizontal ground plane.

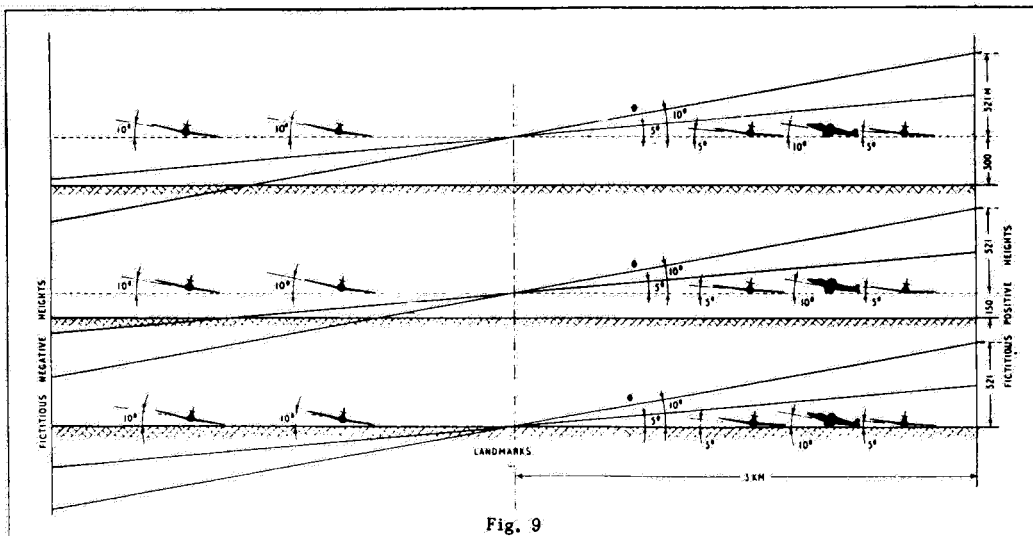
Fig. 9

Figure 9 represents the errors in height estimations resulting from optical illusions about rolling and pitching axes with respect to a landmark or a row of landmarks; this figure clearly shows the effects of these illusions. Imaginary heights H' are proportional to distance D of landmark (as the true height) and to sine of angle $(\alpha + \theta)$.

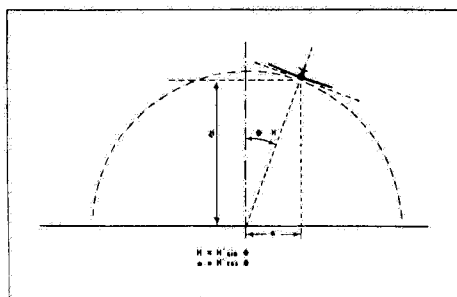
A particular illusion will arise when the pilot believes he is flying above a row of landmarks. True height is then equal to imaginary height H' multiplied by sine of angle of illusion θ , thus distance D will be equal to $H' \cos \theta$. (Figure 12).

FIG. 12. ILLUSION ABOVE A LINE OF LIGHTS OR LANDMARKS

It is imperative to warn all pilots against such illusions. A good practice for landing which should become compulsory during the visual approach of the pilot is to call out the heights and speeds of the plane by a member of the crew who is keeping a permanent watch on the instruments. To this end it would be necessary to devote more time to the study of the problem and to disseminate reports covering this question. In my opinion however the best means would be to produce a film presenting some illusions of current life, the illusions to which one may be subject in flight, and statistical data of the accidents resulting from these illusions, stressing their importance. I am naturally unable to produce such a film myself and even less able to carry out a thorough study of the human element. The authorities responsible for this task would, in performing it, bring a further contribution to the realm of flight safety.

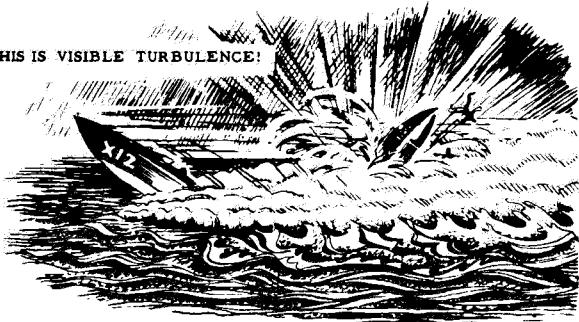
4. THIS IS VISIBLE TURBULENCE!

A MINUTE'S DELAY MAY SAVE YOUR
LIFE . . .

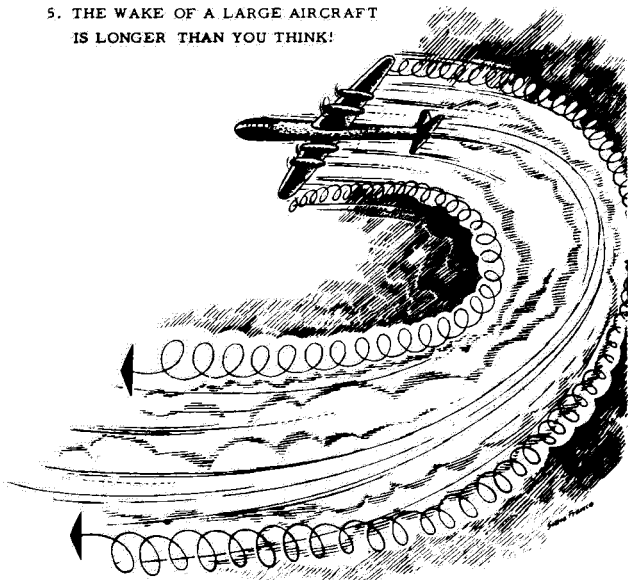
5. THE WAKE OF A LARGE AIRCRAFT
IS LONGER THAN YOU THINK!
