CIRCULAR 39-AN/34

AIRCRAFT ACCIDENT DIGEST

No. 5

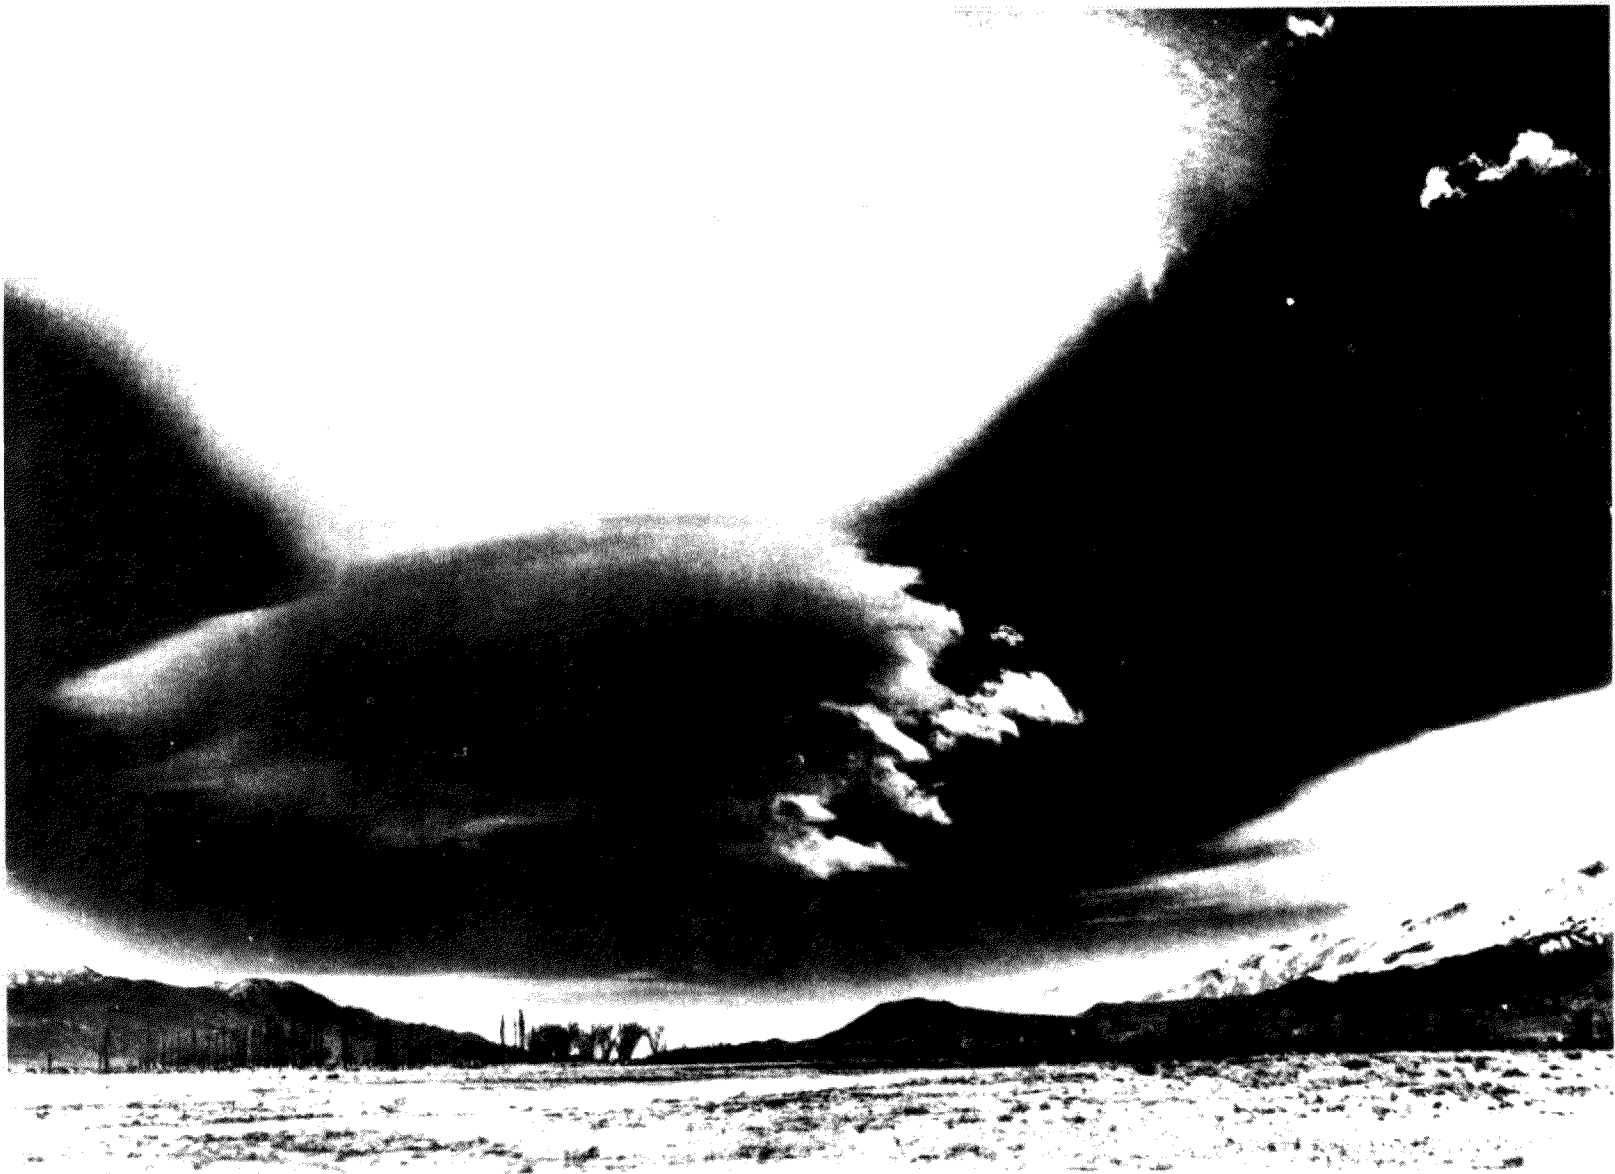
Figure 2 is an "ideal wave" picture taken from the ground. The mountains are to the right and the flow from right to left. The foehnwall hides the Sierra Nevada mountain peaks to the right. The rotor cloud appears in the lower center portion of the picture with the lenticular clouds fanning out above.

Fig. 2. Typical wave clouds from below (wind from right to left)

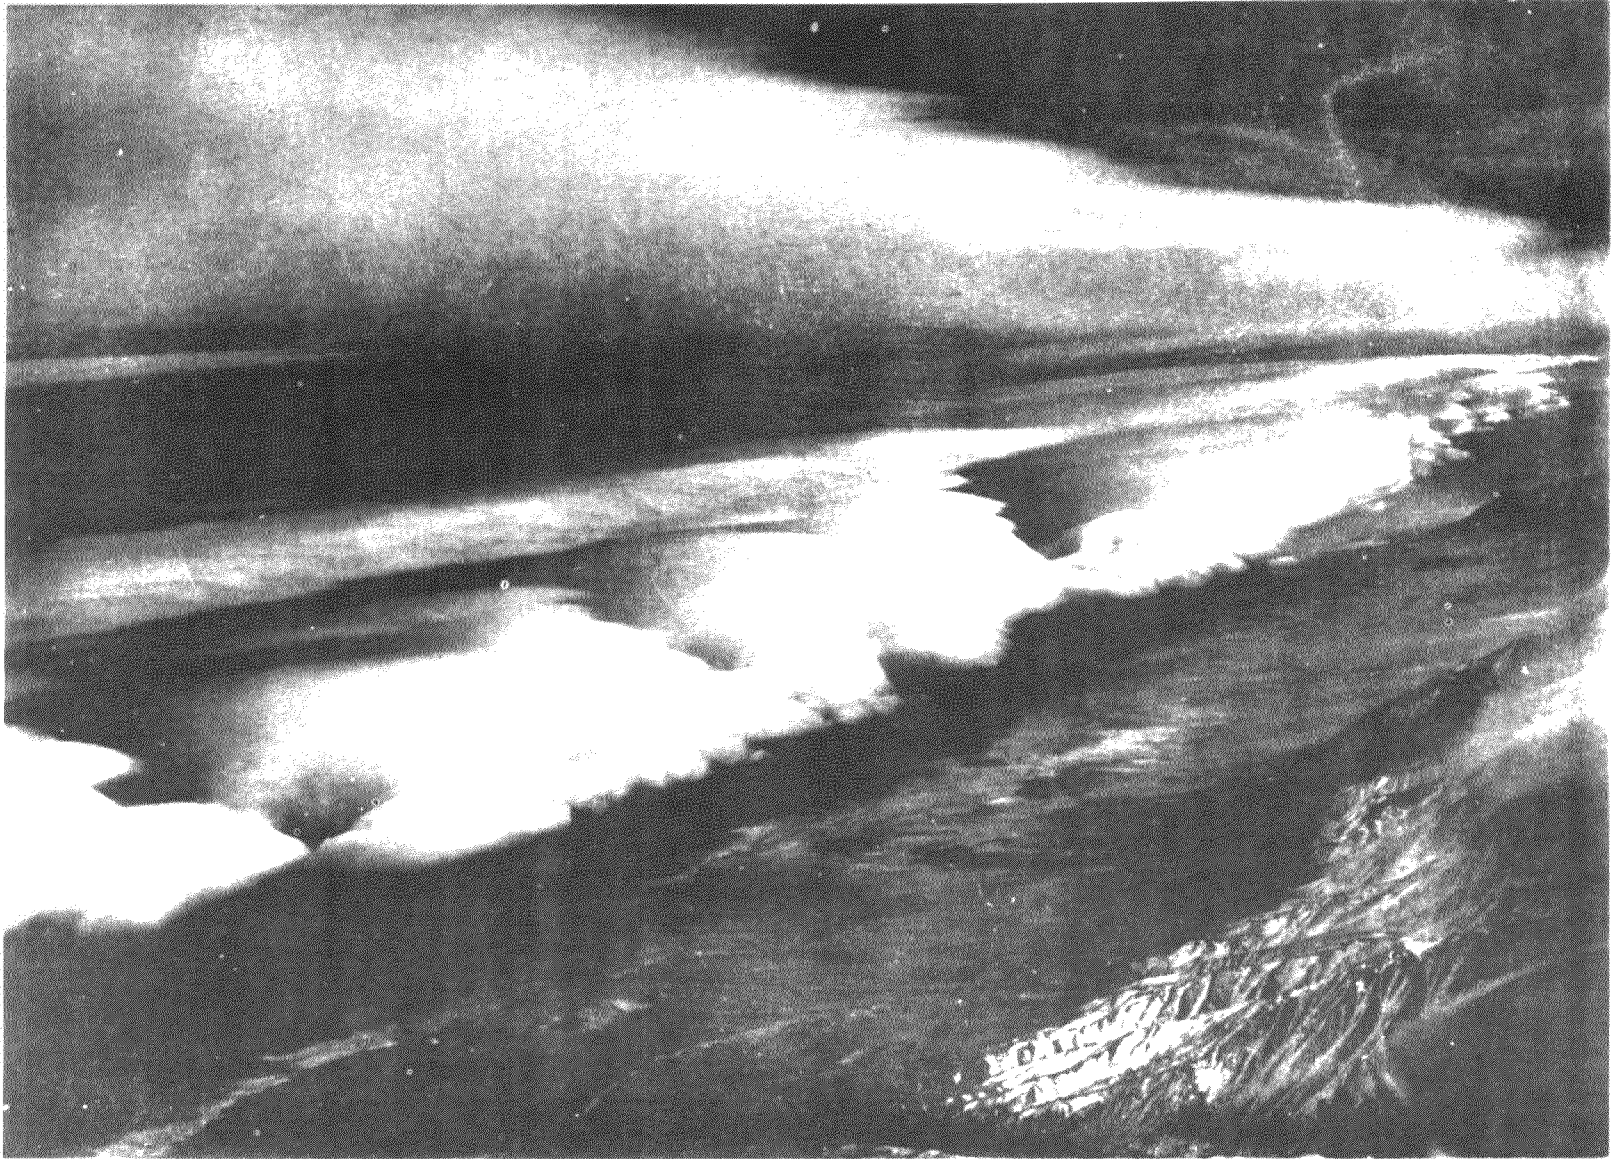
Figure 3 is a picture taken from above the same wave. This picture shows the horizontal extent of the rotor cloud and the tops of this cloud merging with the lowest lenticular layers. Several lenticular layers can be seen to the right of the picture. The slopes of the Sierras are visible in the lower right-hand portion of the picture.

Fig. 3. Typical wave clouds from above (wind from right to left).

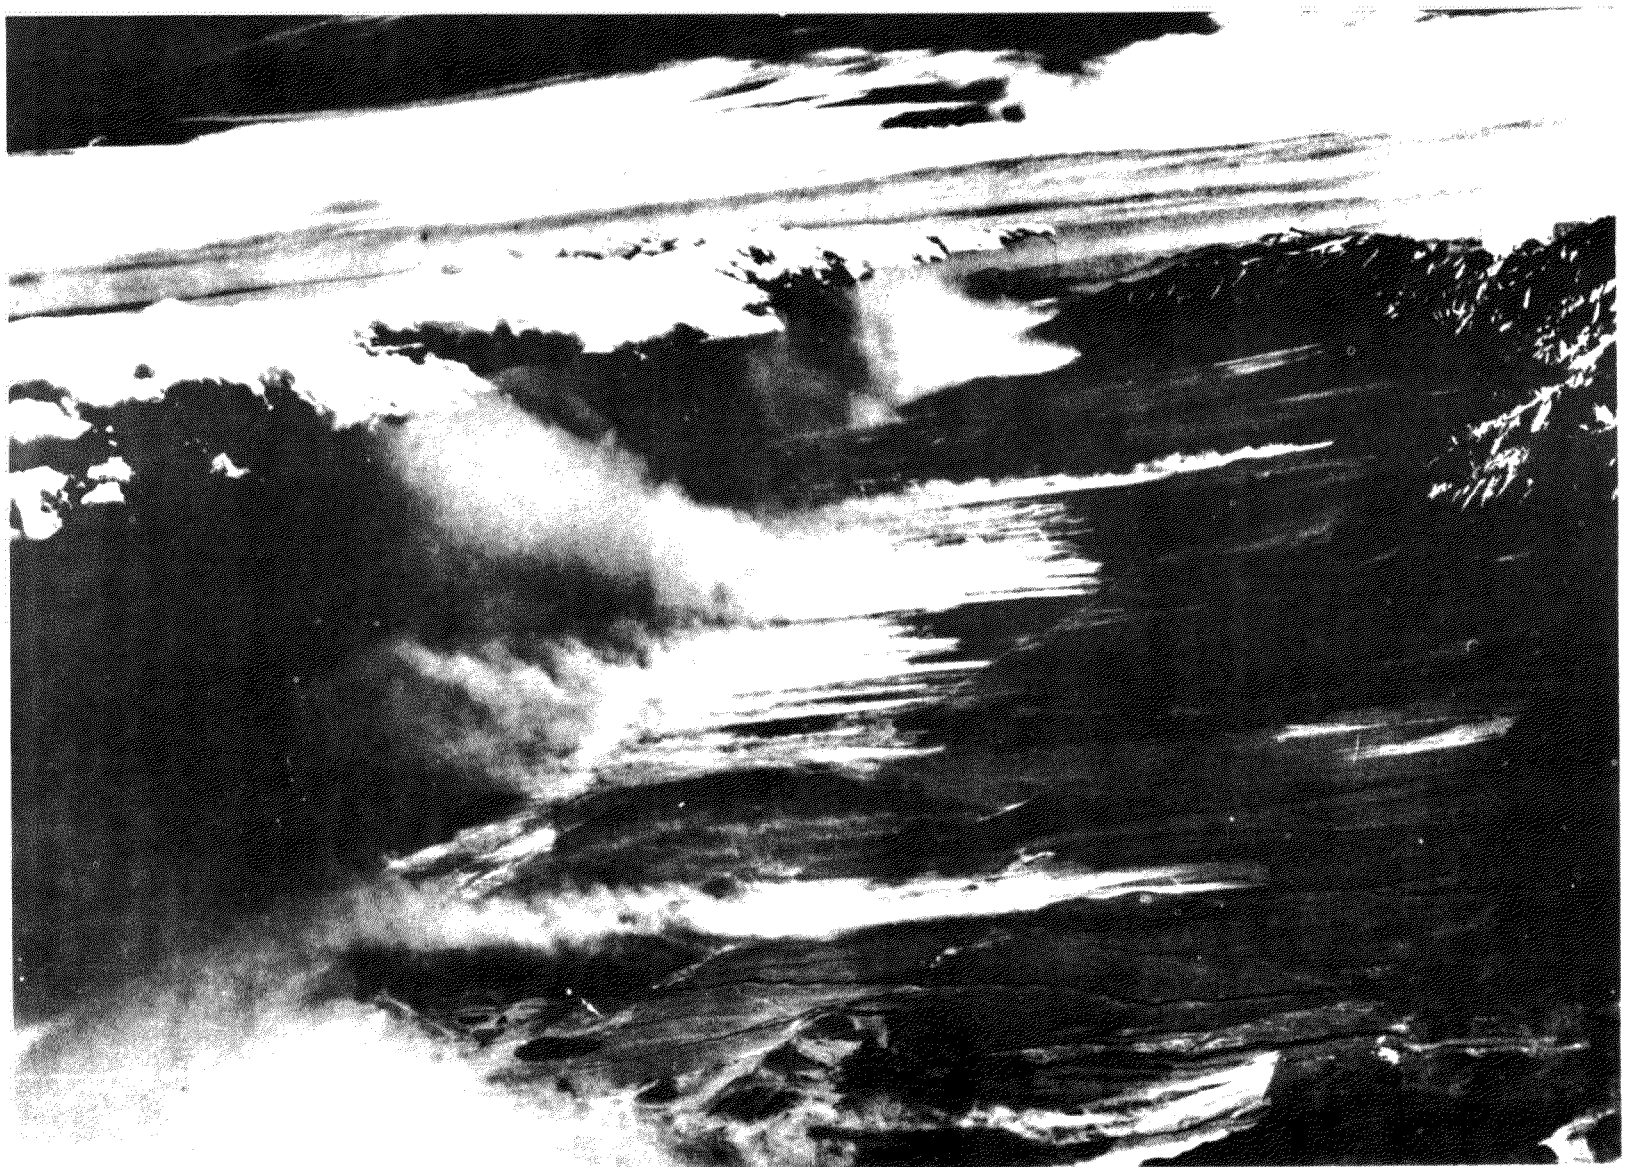
Figure 4 shows the range to the right with the downdrafts striking the floor of the valley, kicking up dust and carrying it up into the rotor cloud zone. This is a rather unusual long wavelength case with the rotor zone very far back from the peaks. The dust shows how the flow hugs the surface and then rises sharply just in advance of the rotor up to 30,000 feet.

Fig. 4. Long wavelength case - dust lifted to 30,000 ft.

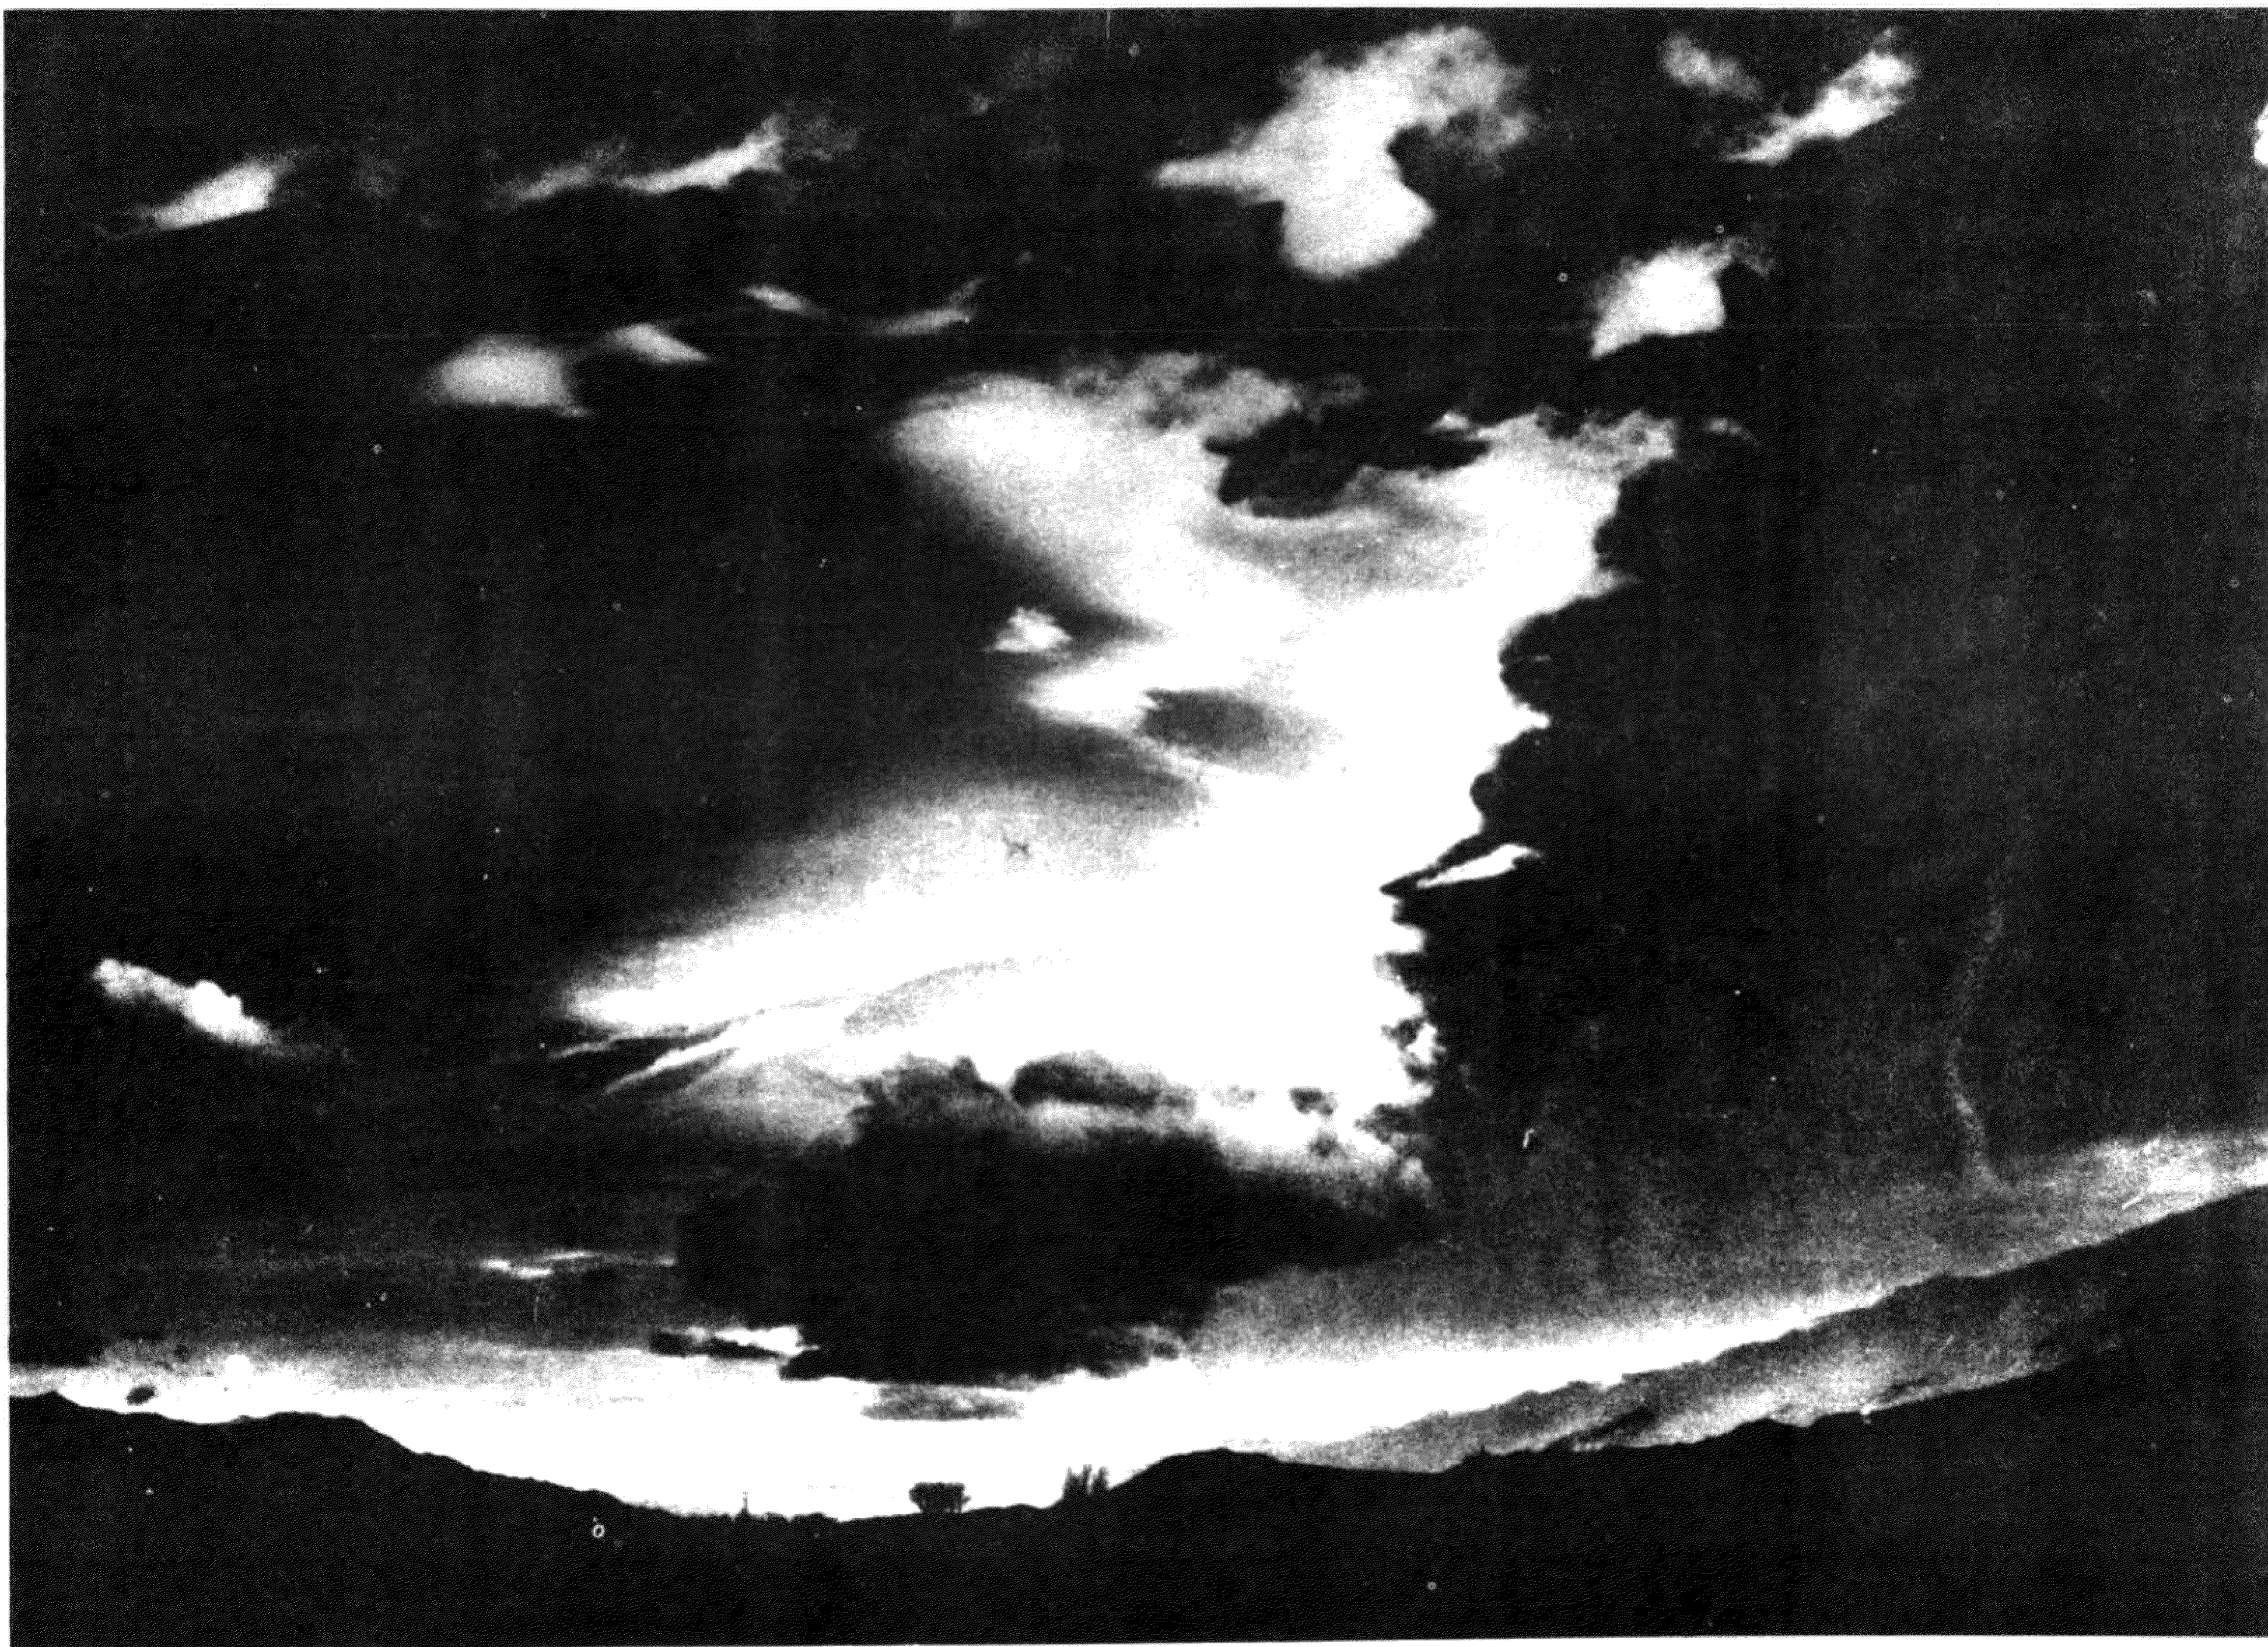
Figure 5 is a picture taken on a day when there was extreme turbulence at high levels. The high lenticulars in this case show very rough edges. Fragments of clouds moved rapidly across the wave showing turbulent motion.

Fig. 5. High-level turbulence (39,000 feet) shown by fragmentation of high lenticulars.

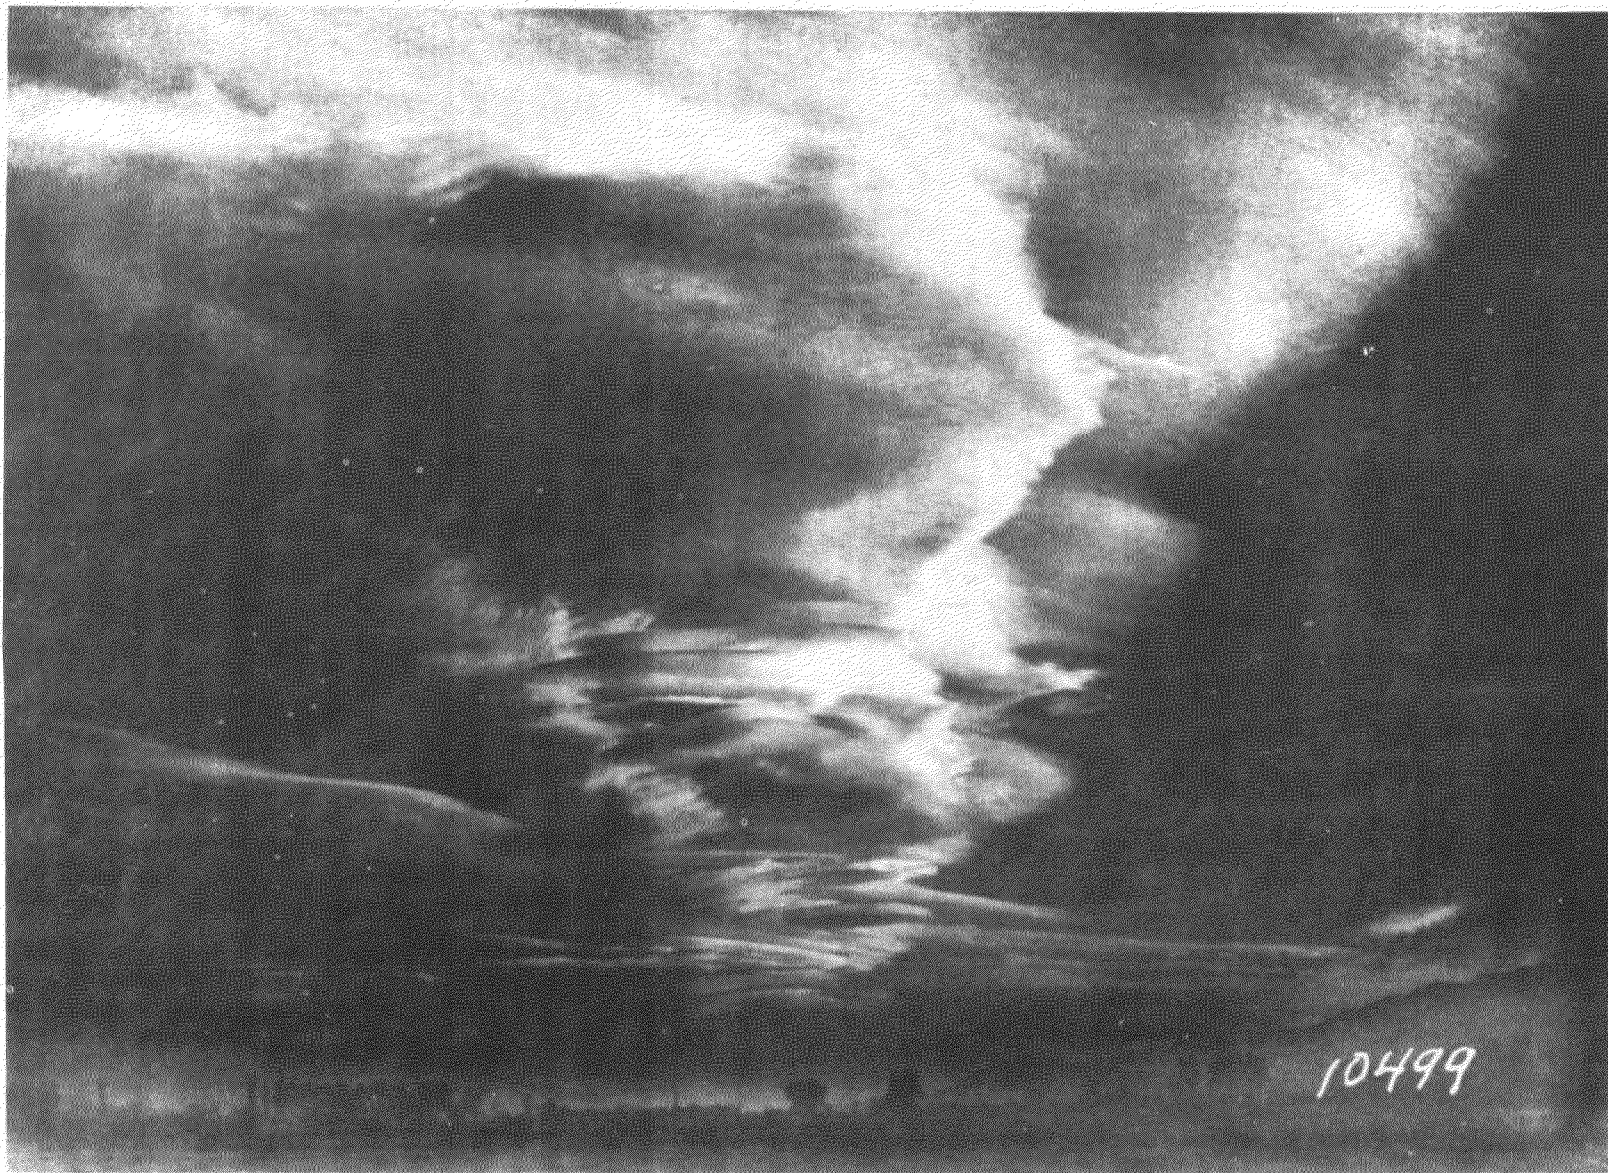
Figure 6 shows many heavy lenticular layers blanketing the sky. The smooth texture and well-defined edges of the clouds indicate the laminar motion.

Fig. 6. Heavy smooth-textured lenticulars.

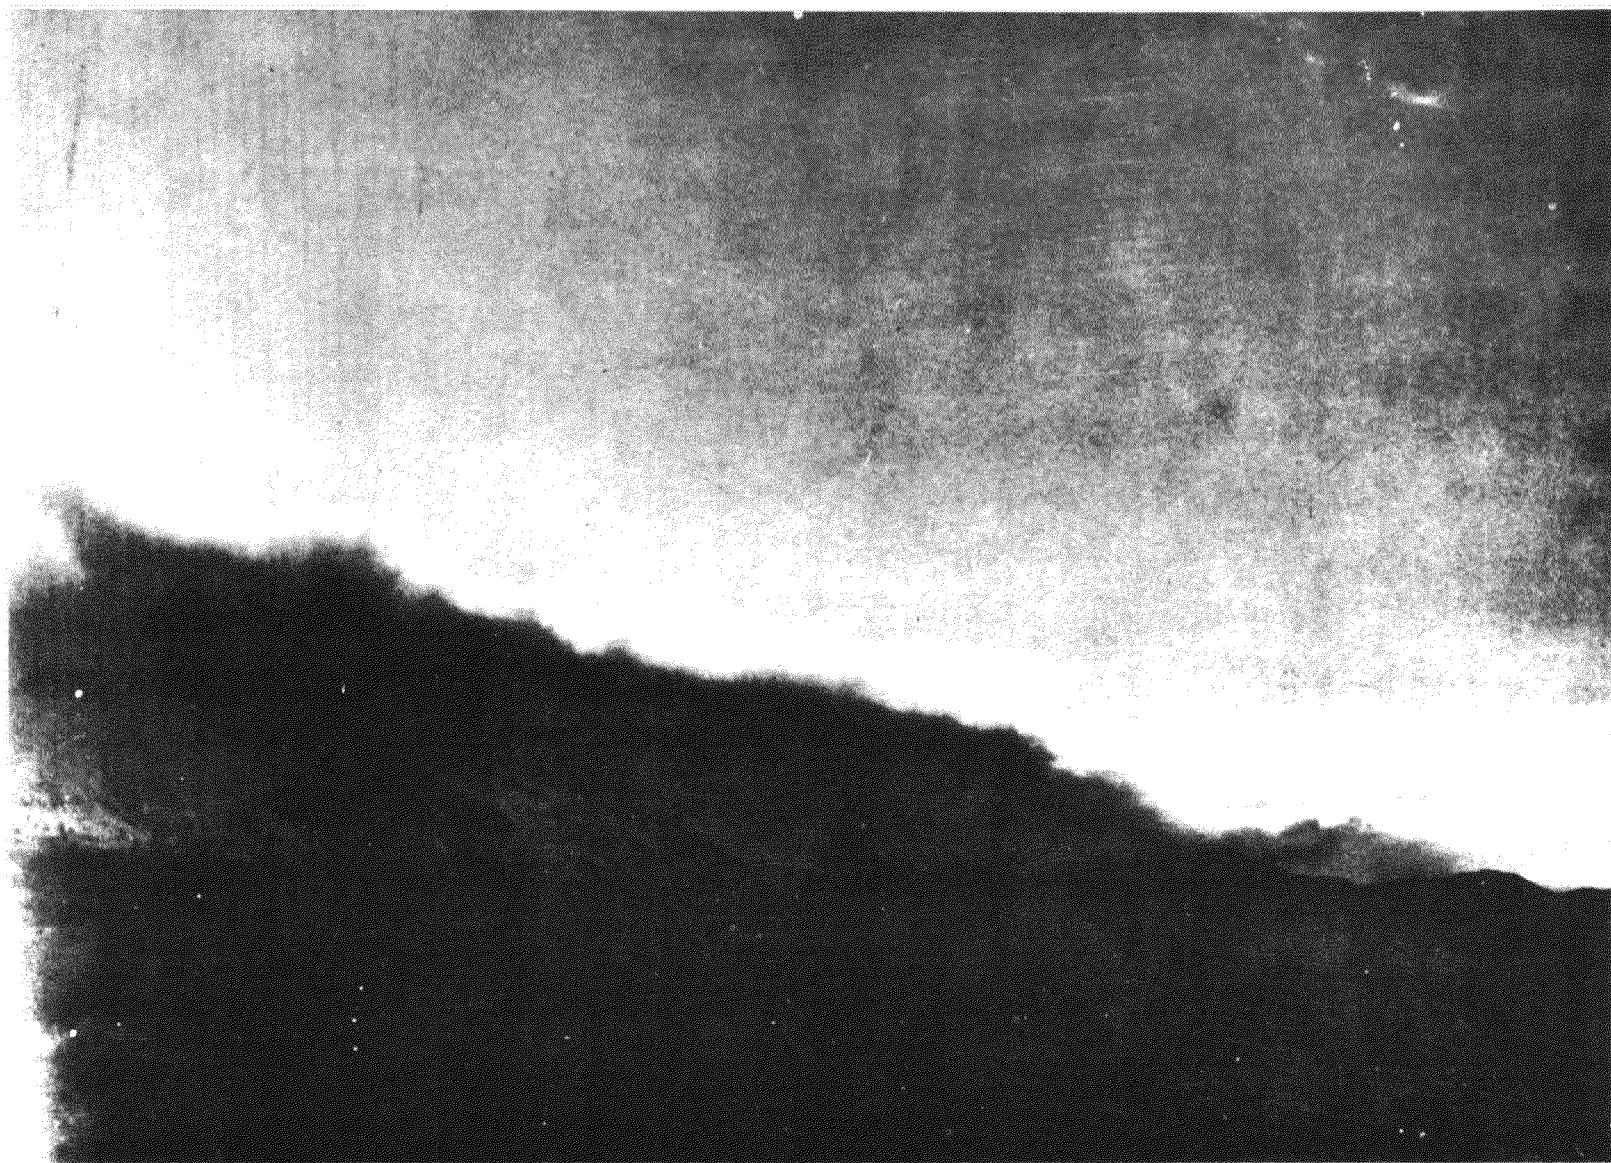
Figure 7 is a good shot of the foehnwall. It shows the complete coverage of the mountain peaks which this cloud affords. In this picture, the wind flow is from left to right.

Fig. 7. The foehnwall (wind from left to right).

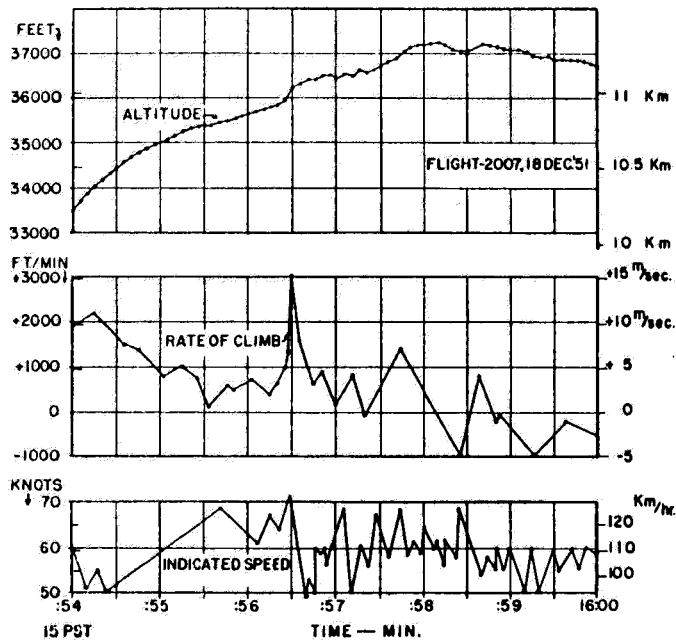
Fig. 2. High level turbulence encountered between 36,000 and 37,000 ft by one of the project gliders. This is a six-minute flight record of the glider instruments. Note the enormous changes in rate of climb.
