CIRCULAR 47-AN/42

AIRCRAFT ACCIDENT DIGEST NO. 6

Prepared by the Secretariat and published
by authority of the Secretary General

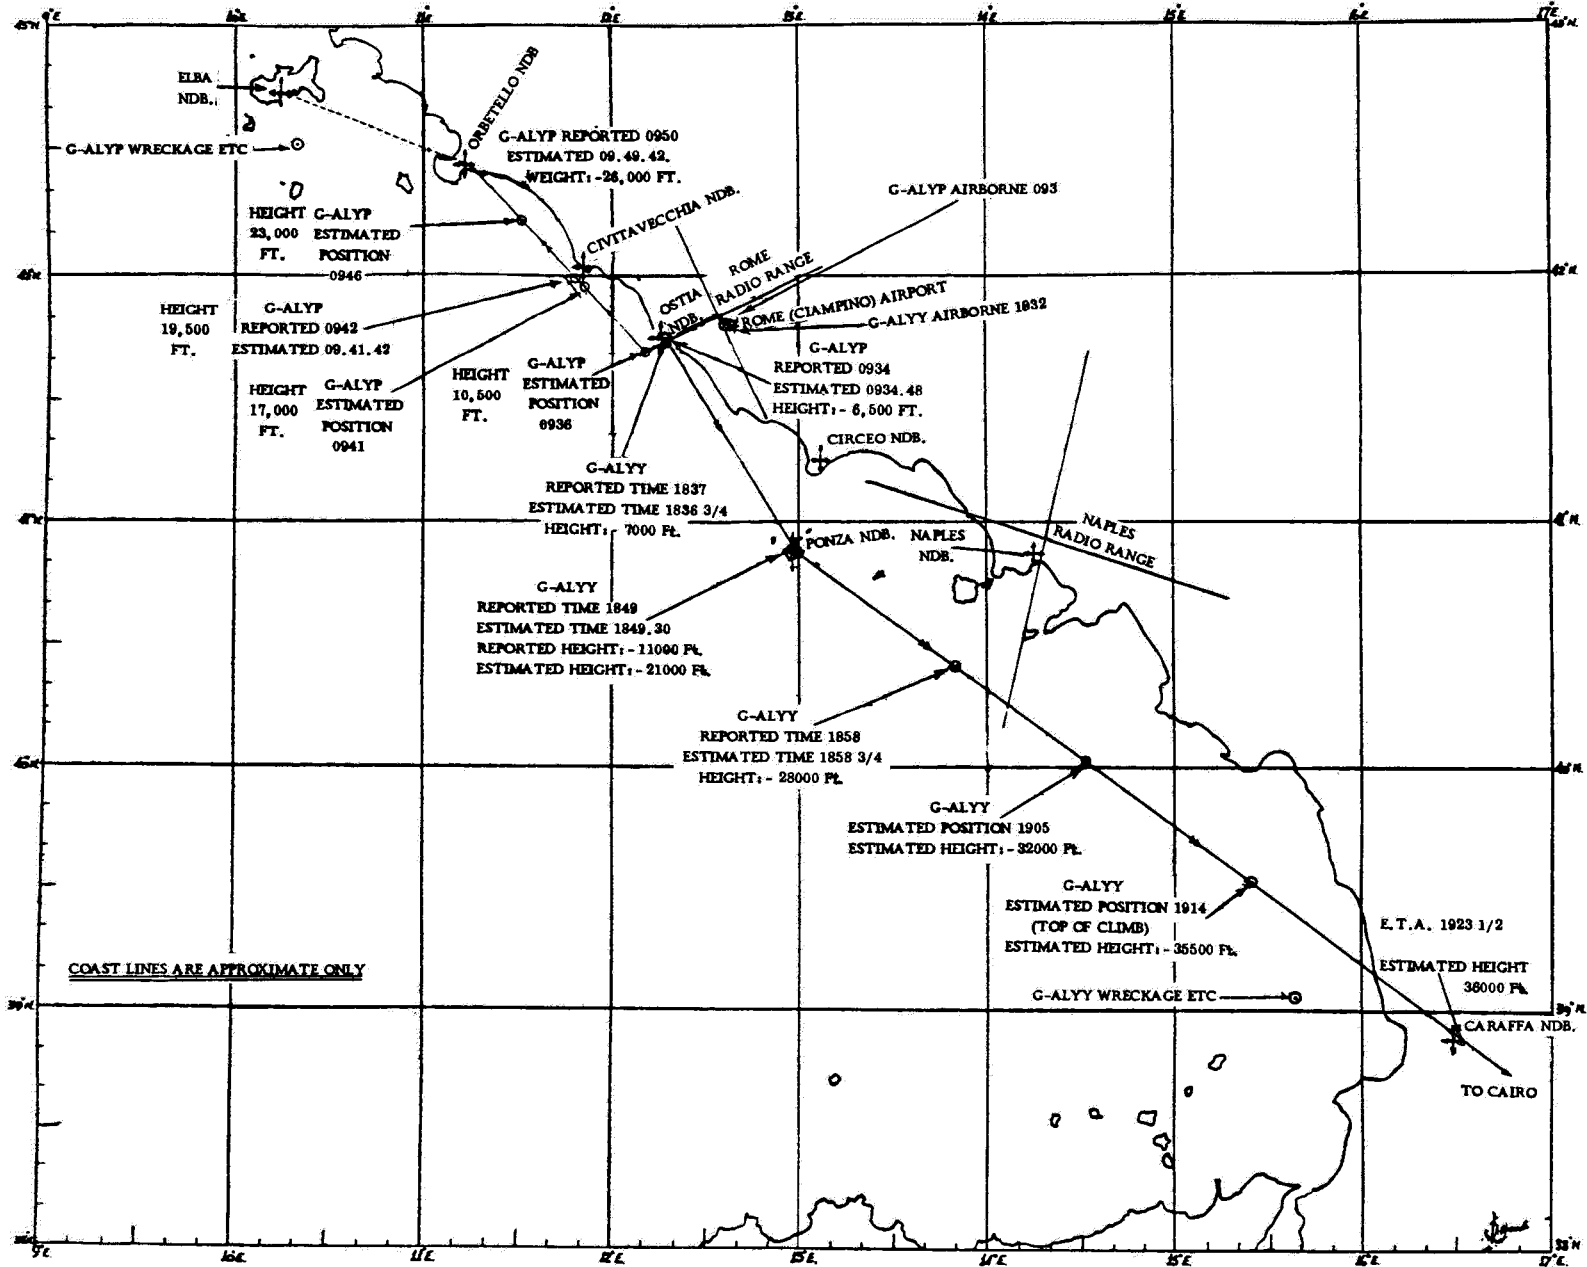
FIG. 1

The chart (Figure 1) contains the estimated flight track of the aircraft and the position in which bodies and wreckage were found. It was estimated that at 0951 hours the aircraft was probably approaching a height of 27 000 feet.

CHART OF AIRCRAFT TRACKS G-ALYP AND G-ALYY

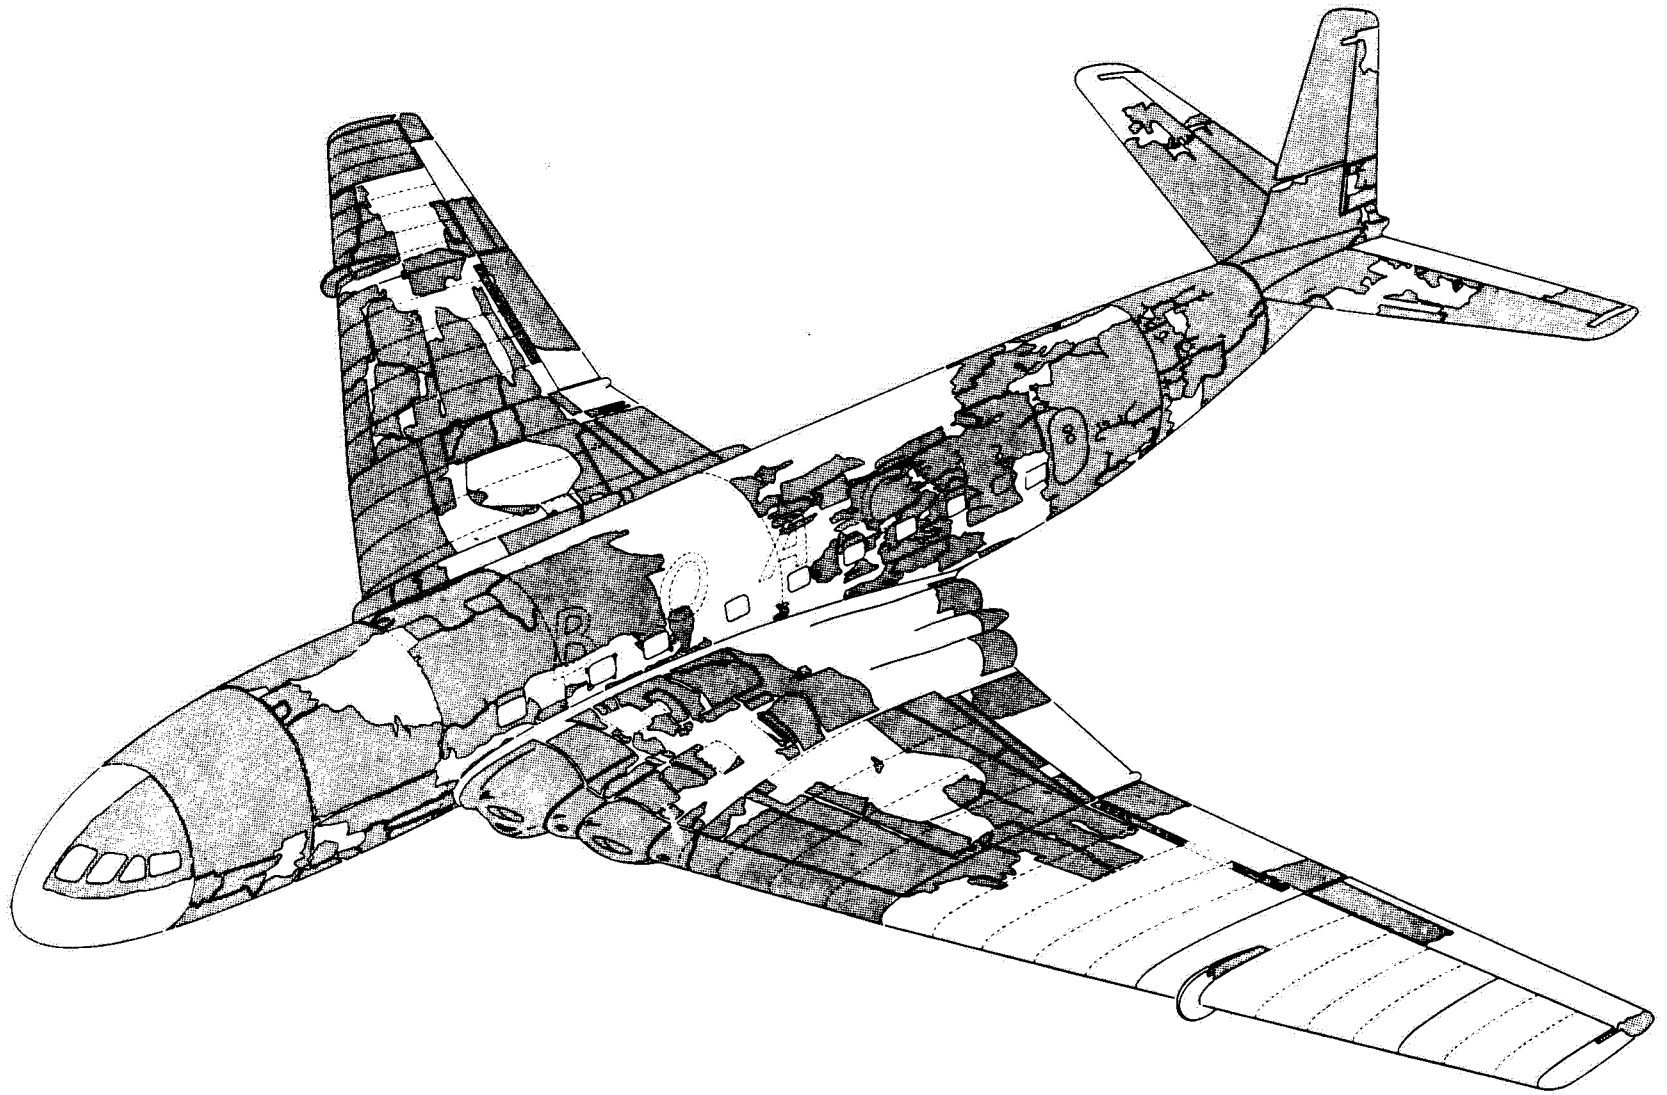
FIG. 2. DIAGRAM SHOWING AMOUNT OF WRECKAGE RECOVERED—G-ALYP.

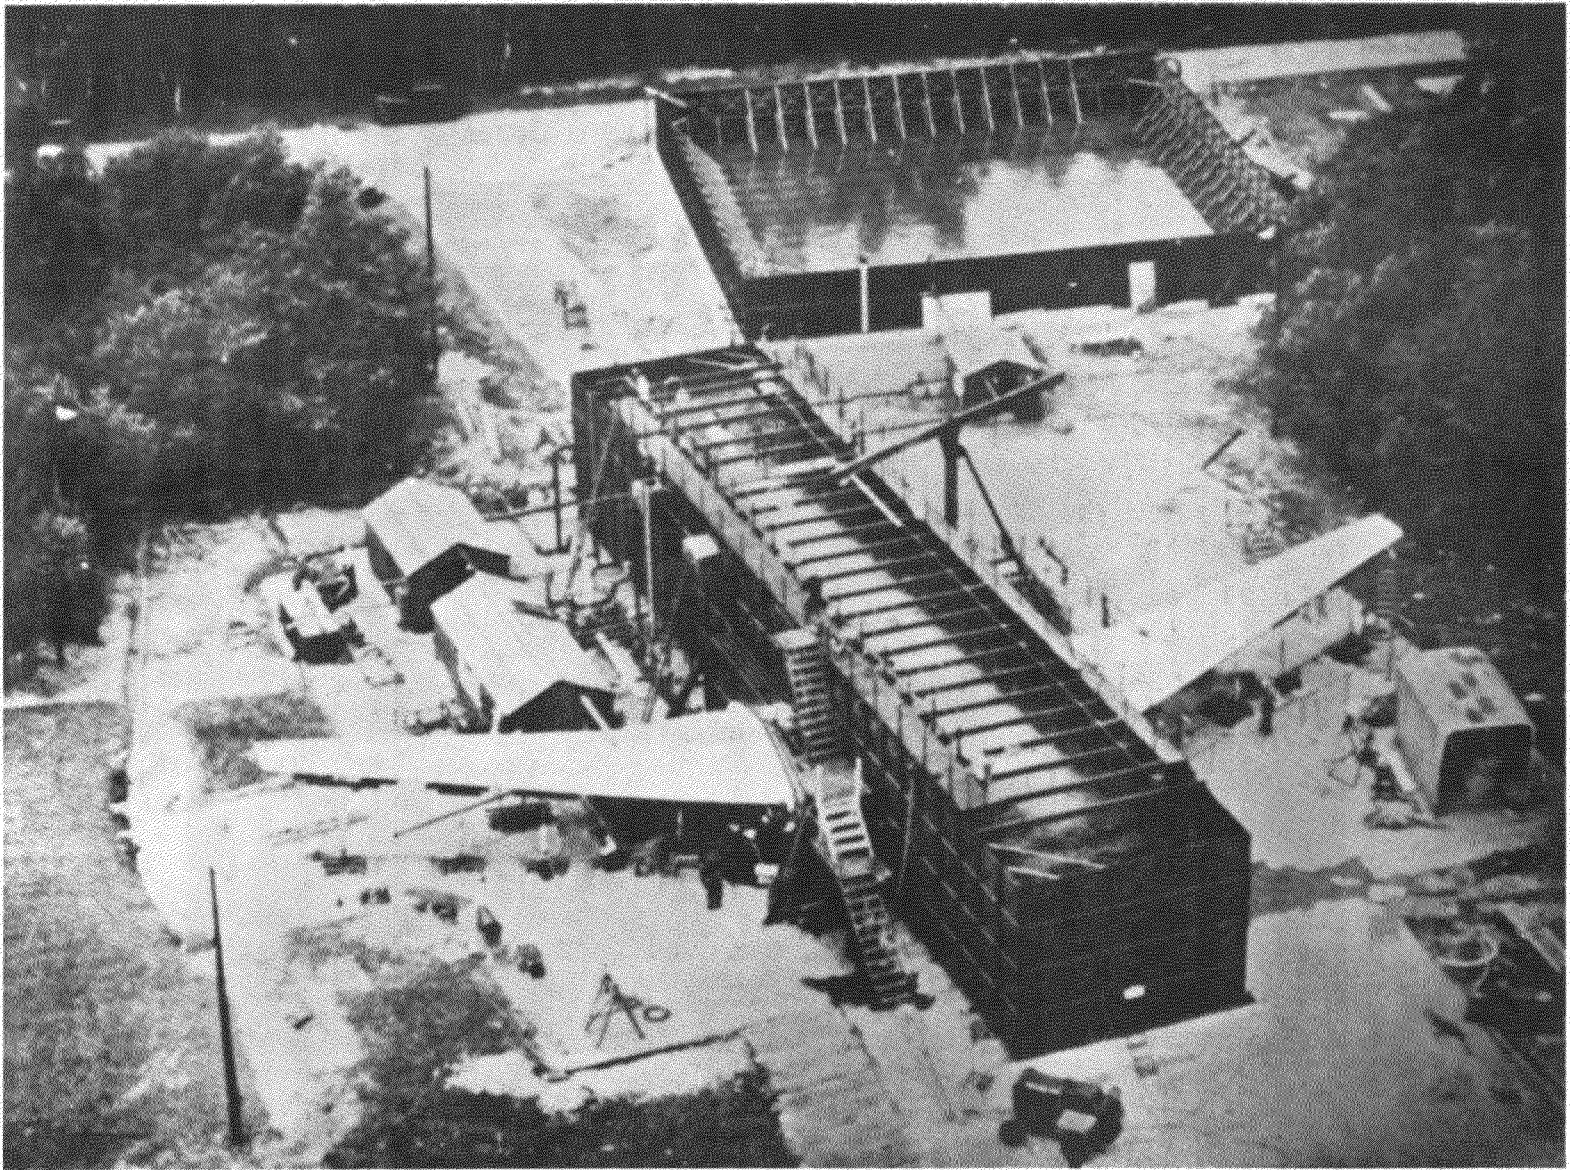
FIG. 5. AERIAL VIEW OF COMET G-ALYU IN TESTING TANK.

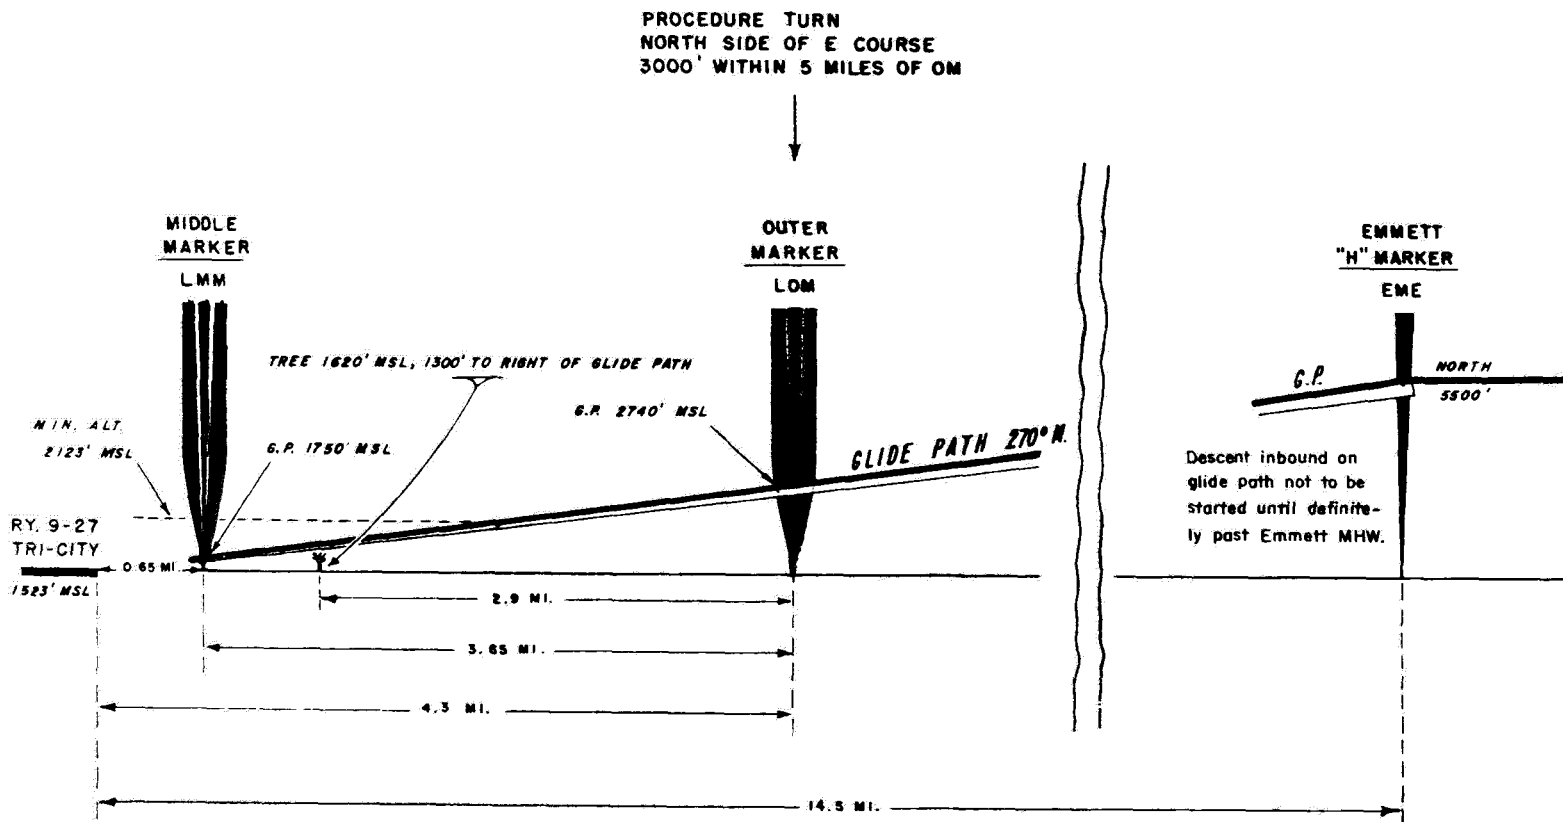
Figure 17

PIEDMONT AIRLINES, FEB. 28, 1954
 TRI - CITY AIRPORT, BRISTOL, TENN.
 ILS GLIDE PATH SHOWING RELATIVE POSITION
 AND ALTITUDE OF TREE STRUCK

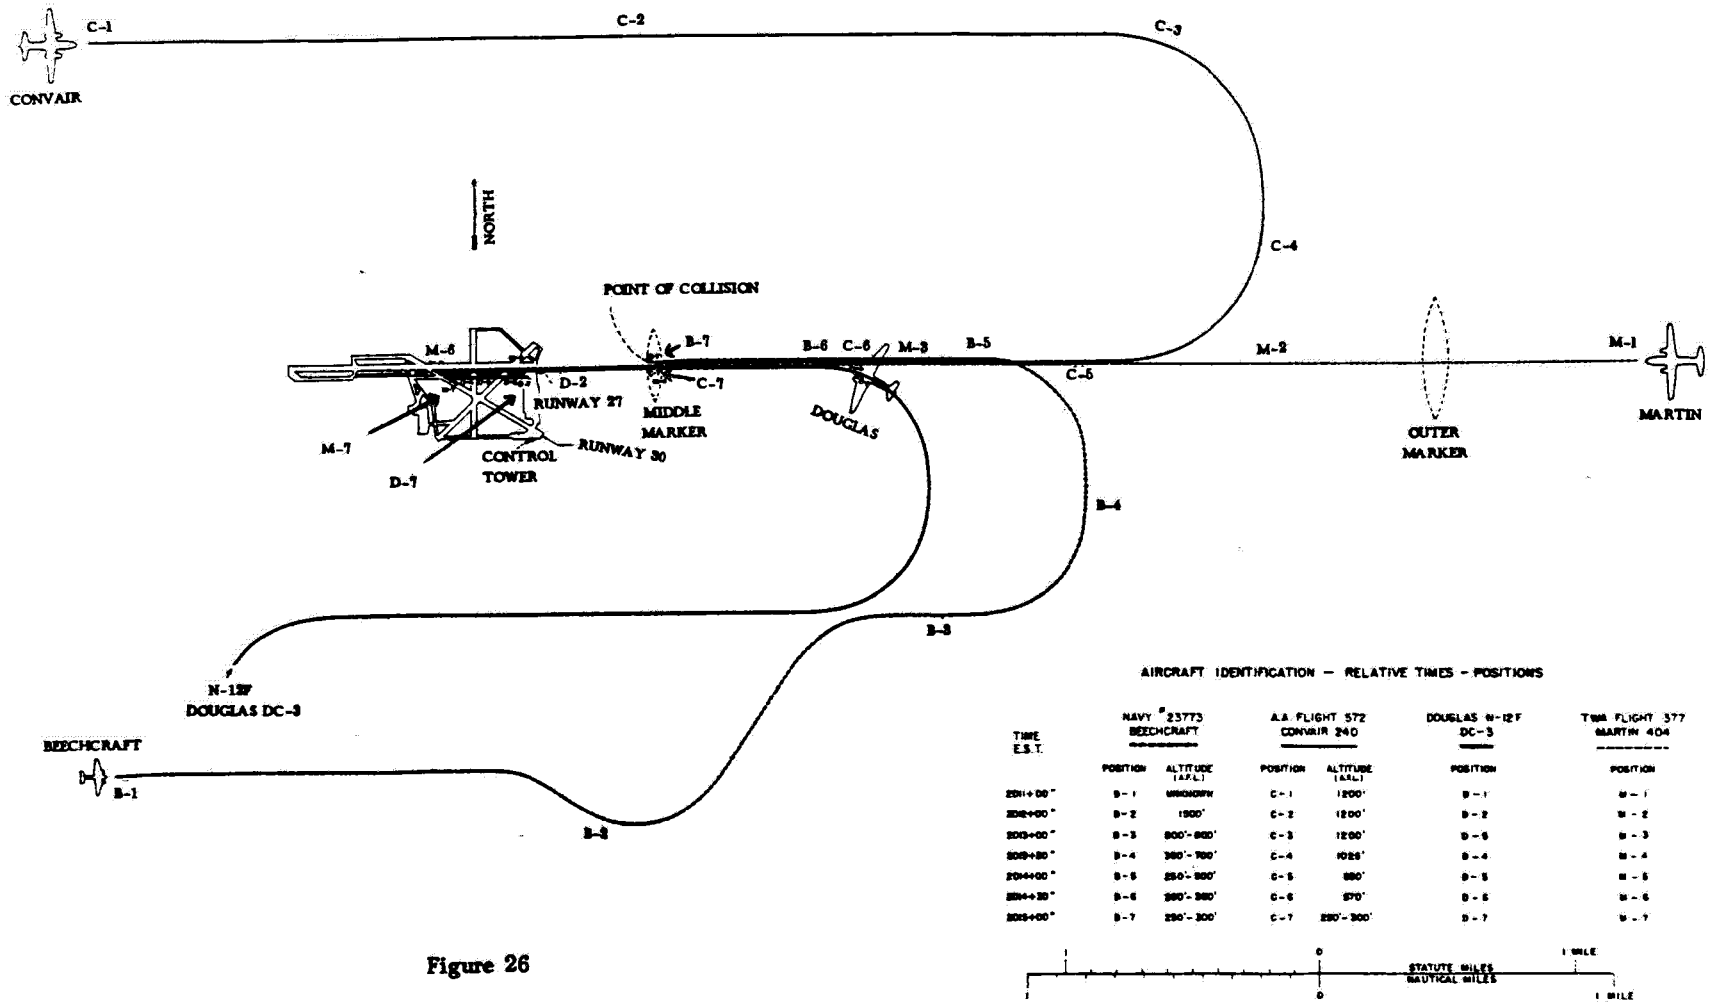
Figure 26

The investigation included a careful study of the flight paths and position reports of the four principal aircraft which were flying in the Port Columbus traffic pattern during the accident period. These factors together with witness testimony were incorporated into an engineering study, fig. 26 and indicate the probable flight paths of the aircraft which collided as well as the TWA Martin and the Douglas DC-3 which preceded them. Considering all available data and the probable flight paths a study was made to determine so far as possible the visual limits of each crew member afforded by the cockpit structure of the Convair and SNB. The limits were applied to each crew member throughout the last two minutes of the flight path in consideration of the aircraft attitudes. It was learned that the SNB first entered the cockpit angular limits of vision for the Convair captain when the Convair was on the base leg. At this time the SNB was approximately 40 degrees to the right of the Convair's longitudinal axis and was about 3 miles away. The SNB remained within the visual limits of the captain's position until both aircraft were on the final approach and the Convair was approximately 1/2 mile behind the Navy aircraft. The total time that the SNB was in the visual limits of the captain's position was approximately 1-1/4 minutes. At the start of this period the SNB blended into the horizon and then continued below it for the remaining time.

PROBABLE FLIGHT PATHS OF AIRCRAFT IN RELATION TO PORT COLUMBUS AIRPORT
JUNE 27, 1954

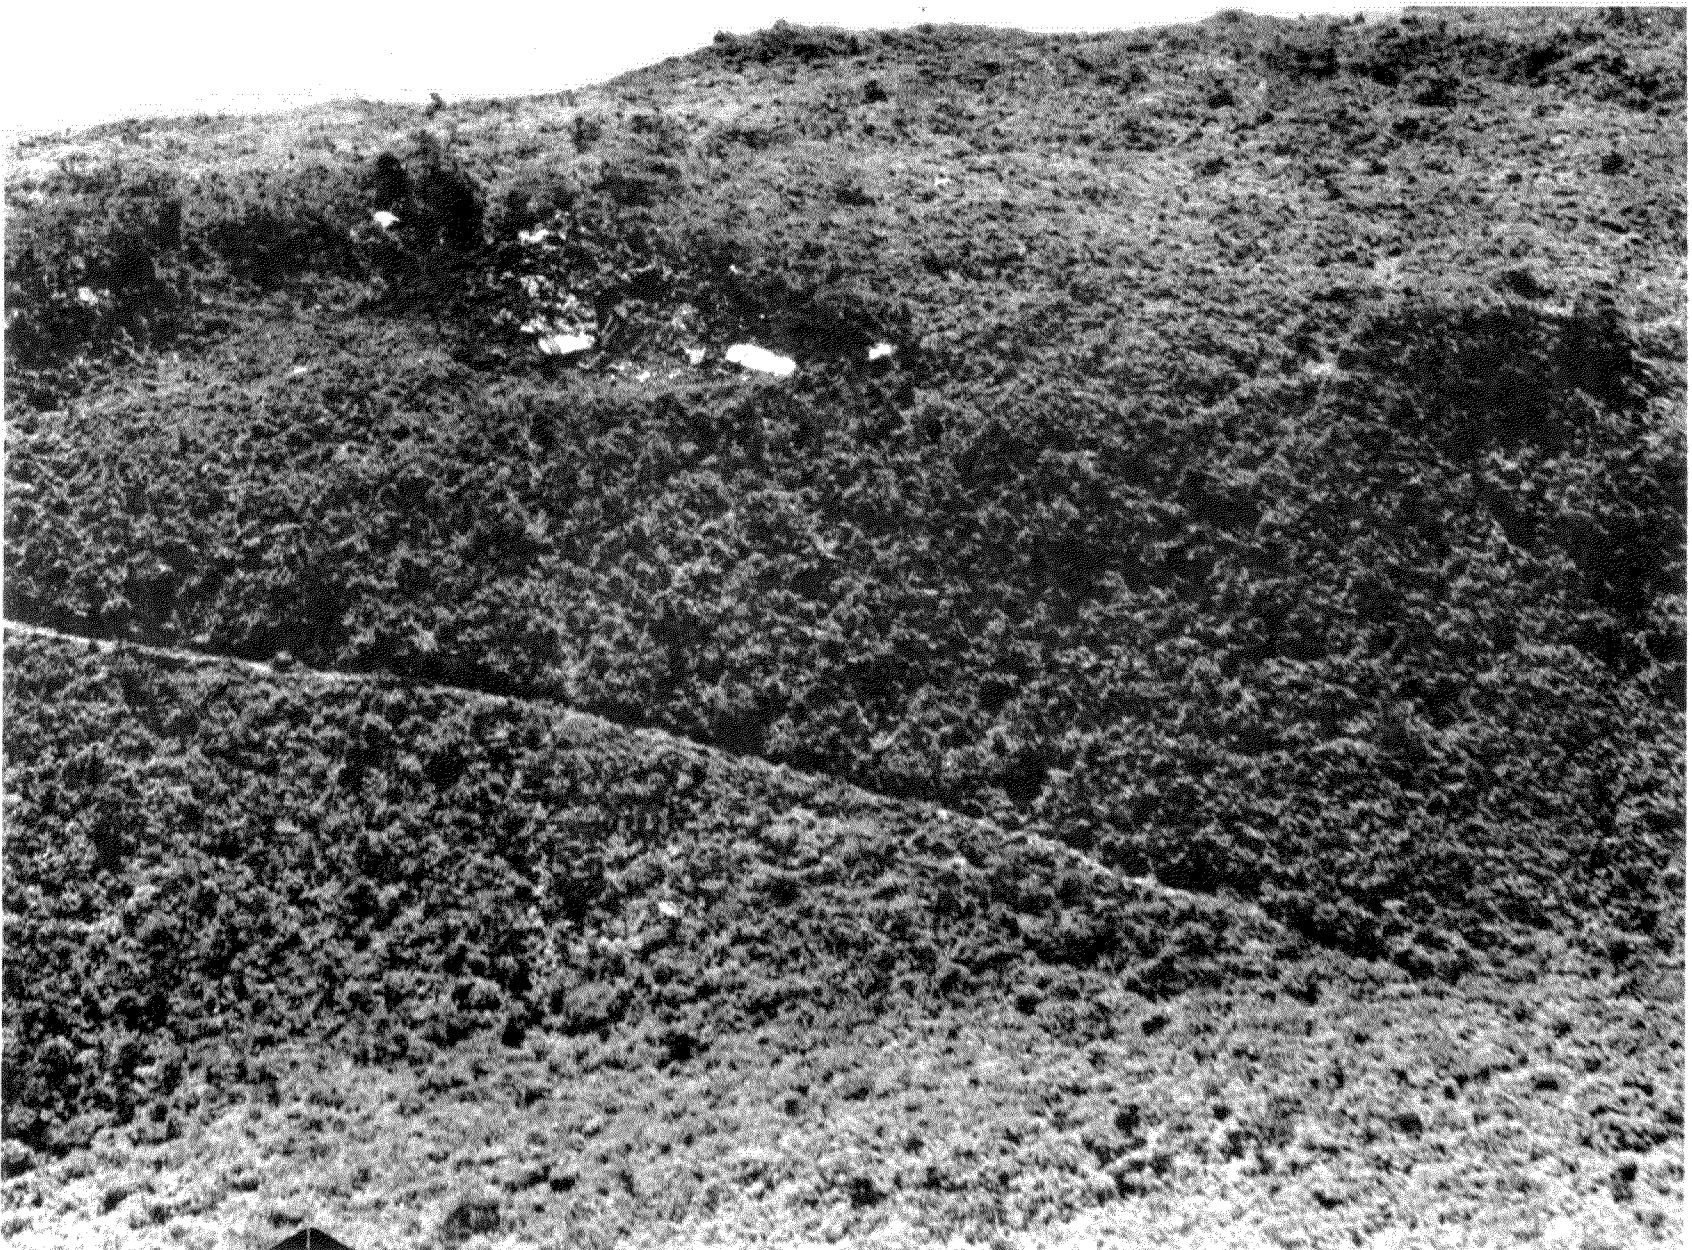
FIGURE 28

The chart at fig. 29 shows the scene of the crash and a horizontal projection of the track assumed to have been flown by the aircraft. The photograph at fig. 28 shows the scene of the accident, part of the wreckage being just distinguishable and the remainder scattered beyond the crest of the mountain. Not only did the marks on the ground indicate a violent impact, but all the evidence led to the belief that the pilot did not see the obstacle in his path.

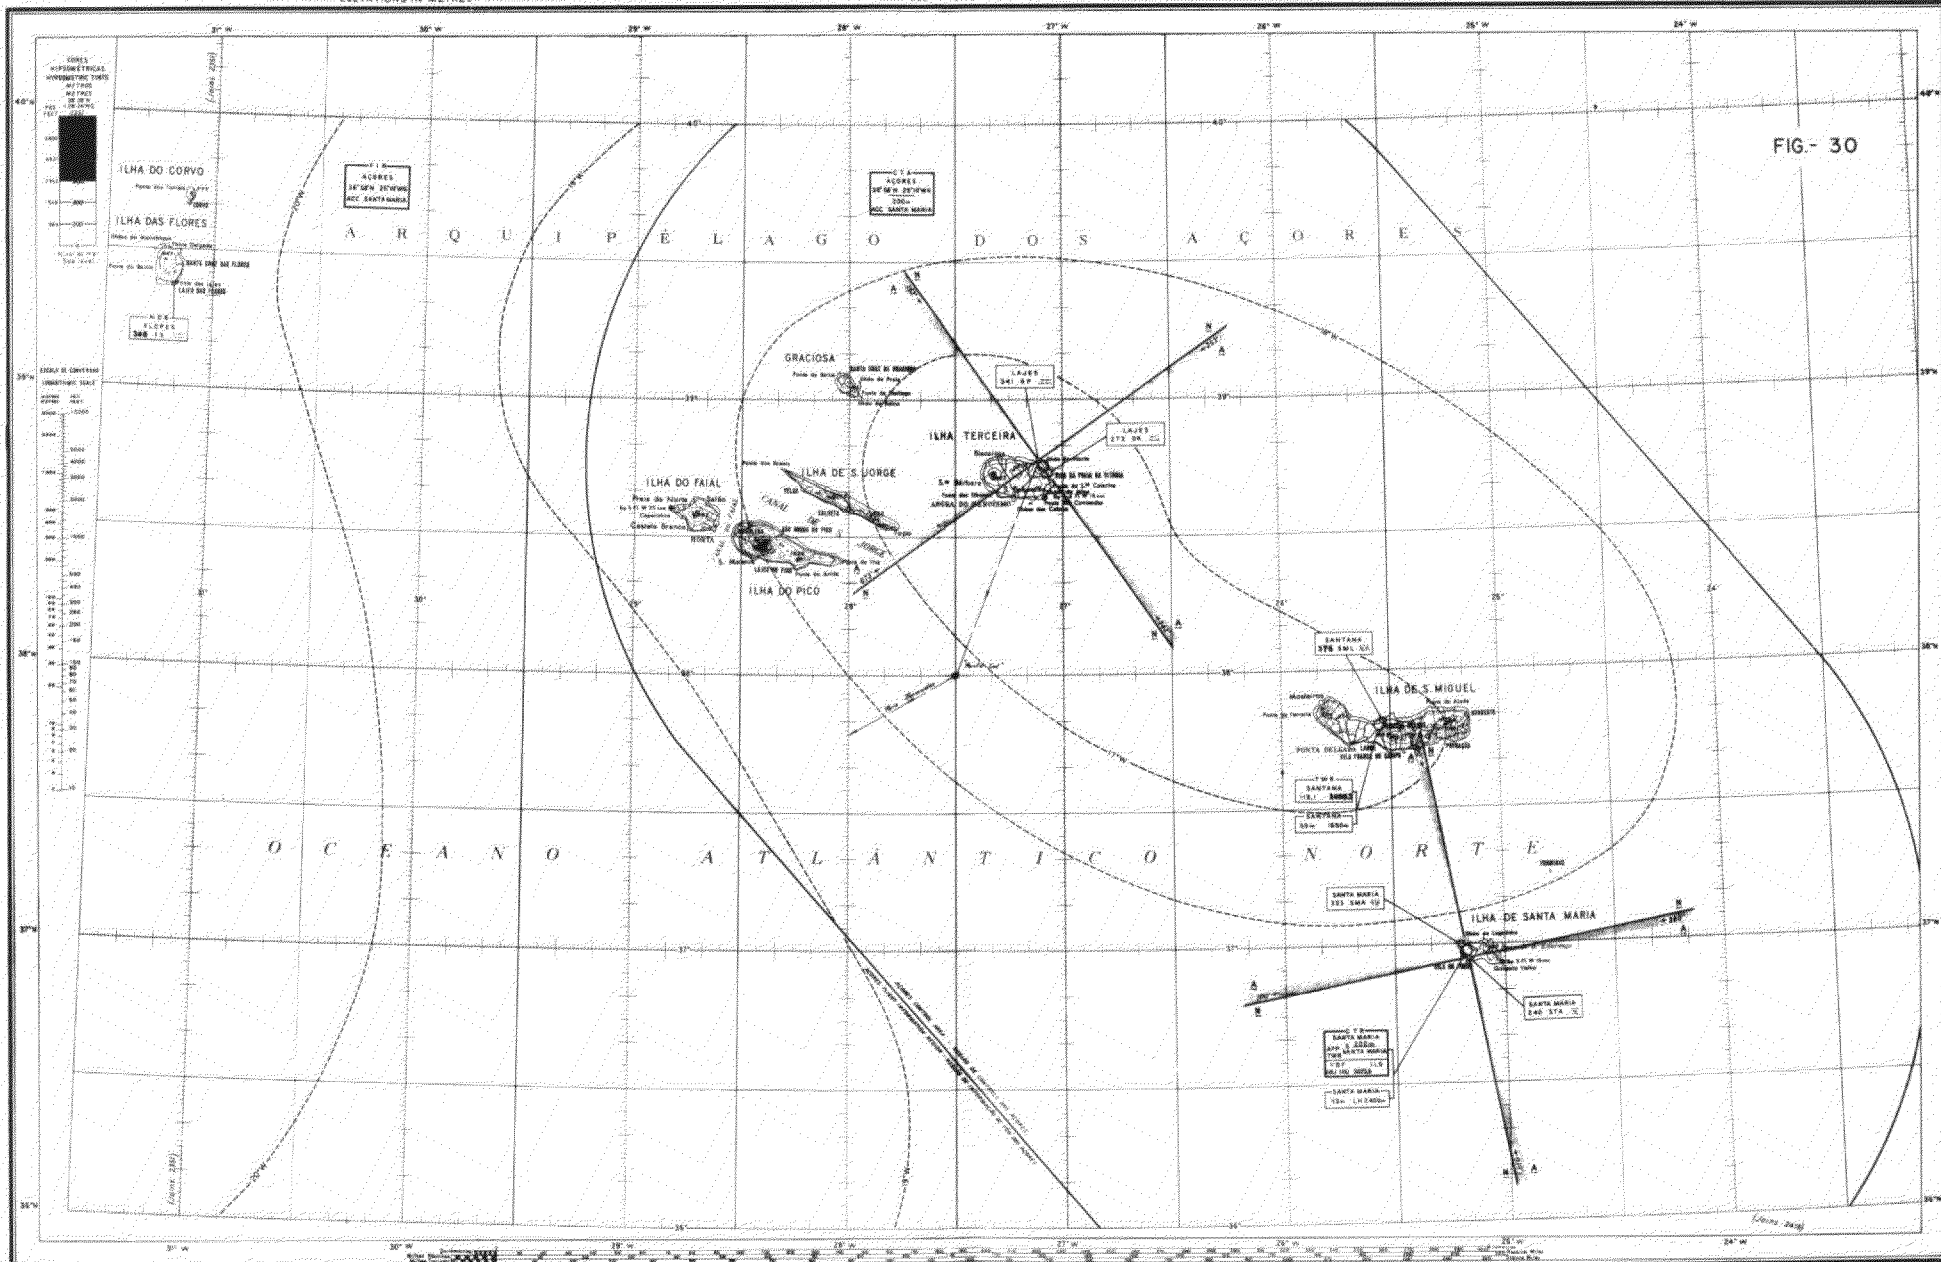
FIG- 30

The point known as "Ponto Sul" is shown on the reproduced 1:1 000 000 chart at Fig. 30. Examination of this chart will immediately explain the reason for the adoption in the Azores control area of the standard procedure whereby aircraft are required to fly over this point before proceeding towards Bermuda, in order to avoid the high ground on Terceira, S. Jorge, Pico and Faial Islands.

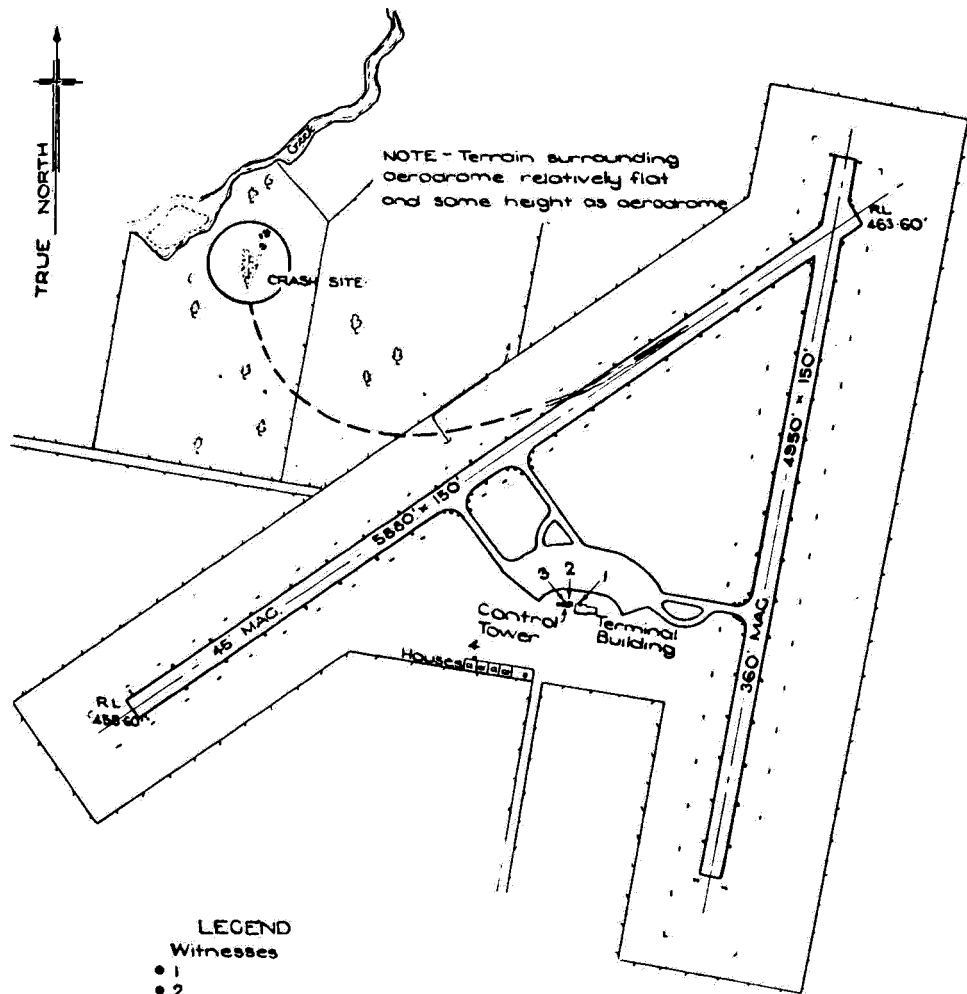
FIGURE 31

Tyre marks left on the runway during the take-off reveal that a swing to starboard occurred approximately 1 100 feet from the start of the take-off run and, as indicated by the marks on the runway, nosewheel steering was used to correct it. Marks of a second swing were in evidence 1 800 feet along the runway and it was during this swing that the aircraft left the runway at a point some 2 000 feet from the commencement of the take-off, and became airborne, 240 feet further on. There were no nosewheel steering marks during this swing. The path of the aircraft is shown in the attached plans. (Figures 31 and 32).

ACCIDENT TO VISCOUNT AIRCRAFT VH-TVA.
 AT MANGALORE VICTORIA ON 31 OCT. 1954.
LOCALITY PLAN OF CRASH SITE SHOWING
ESTIMATED FLIGHT PATH

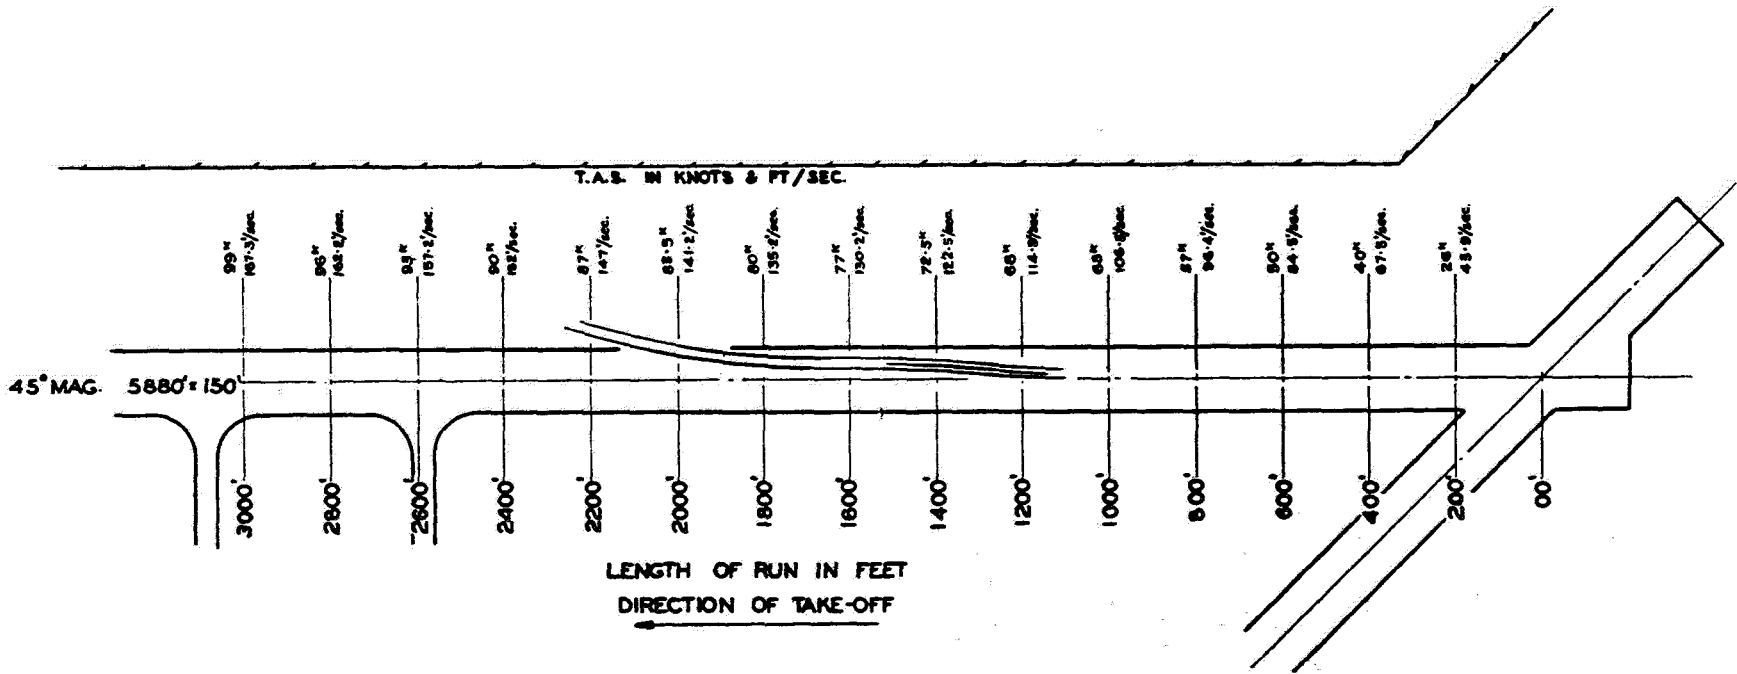
FIGURE 32

ACCIDENT TO VISCOUNT AIRCRAFT VH-TVA.
AT MANGALORE, VICTORIA ON 31 OCT. 1954.

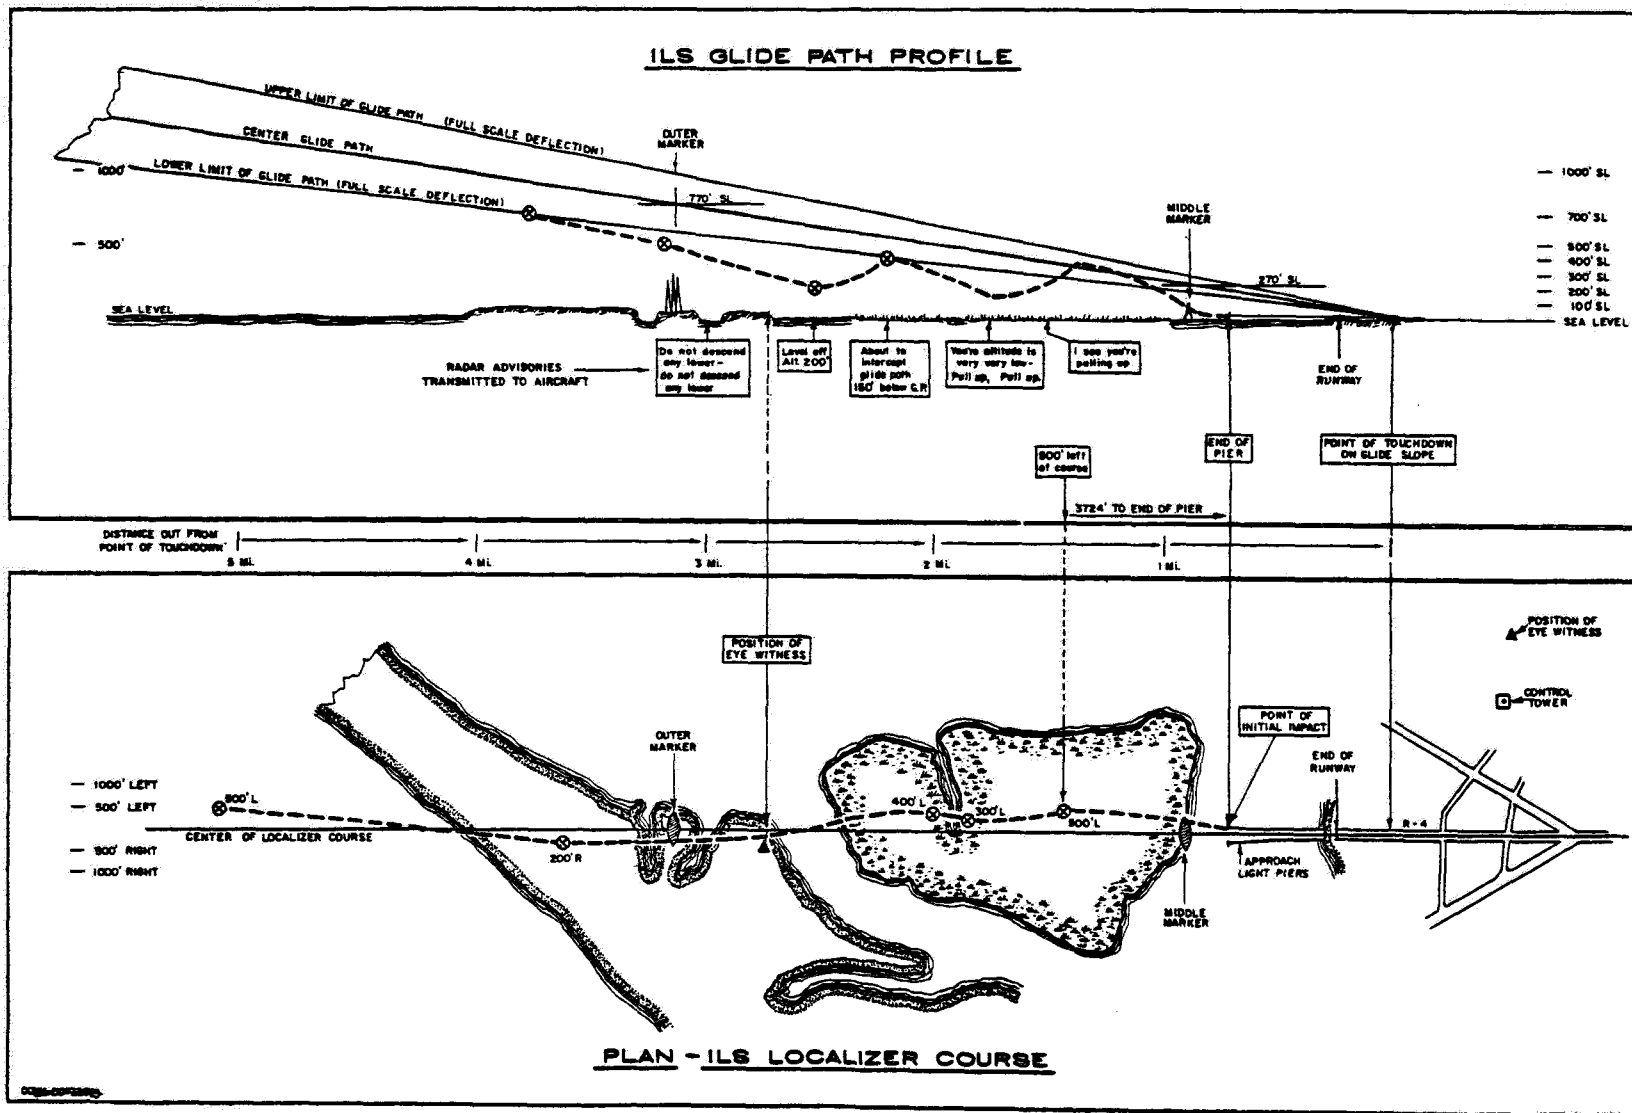
FIGURE 33
PROBABLE FLIGHT PATH AND POSITIONS OF AIRCRAFT ILINE (LAI FLIGHT 451)
DURING LAST APPROACH TO R-4 NEW YORK INTERNATIONAL AIRPORT
DECEMBER 18, 1954

Approximate Positions and Flight Path are Based on Data Obtained from Transcription of Radar Advisories

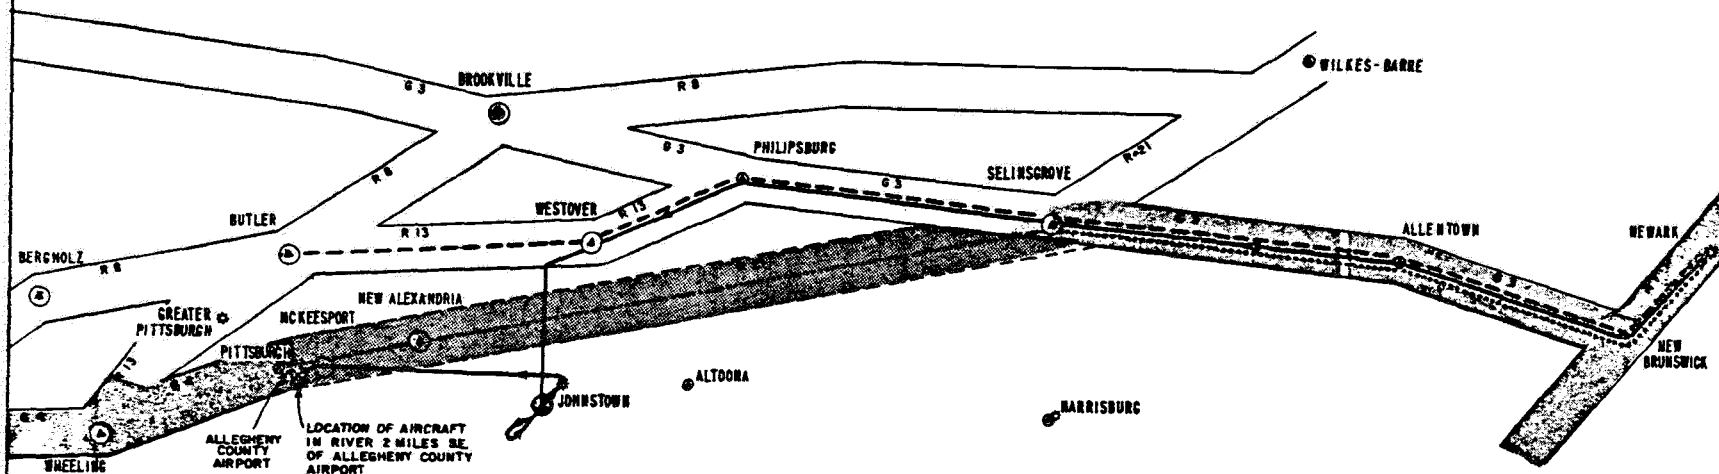
FIGURE 34
 AIRCRAFT ACCIDENT - PITTSBURGH, PENNSYLVANIA
 JOHNSON FLYING SERVICE, INC. - DC-3C N-24320
 DECEMBER 22, 1954

————— FLIGHT ROUTE ACCORDING TO CREW AND POSITION REPORTS TO CAA.
 - - - - - FLIGHT ROUTE AS SHOWN ON FLIGHT PLAN AND LOG: A 7, G 3, R 13, R 8, R 15.
 FLIGHT ROUTE FILED BY CAPTAIN POE ALONG: A 7, G 3, R 21.
