CIRCULAR 50-AN/45

AIRCRAFT ACCIDENT DIGEST No. 7

Prepared by the Secretariat and published
by authority of the Secretary General

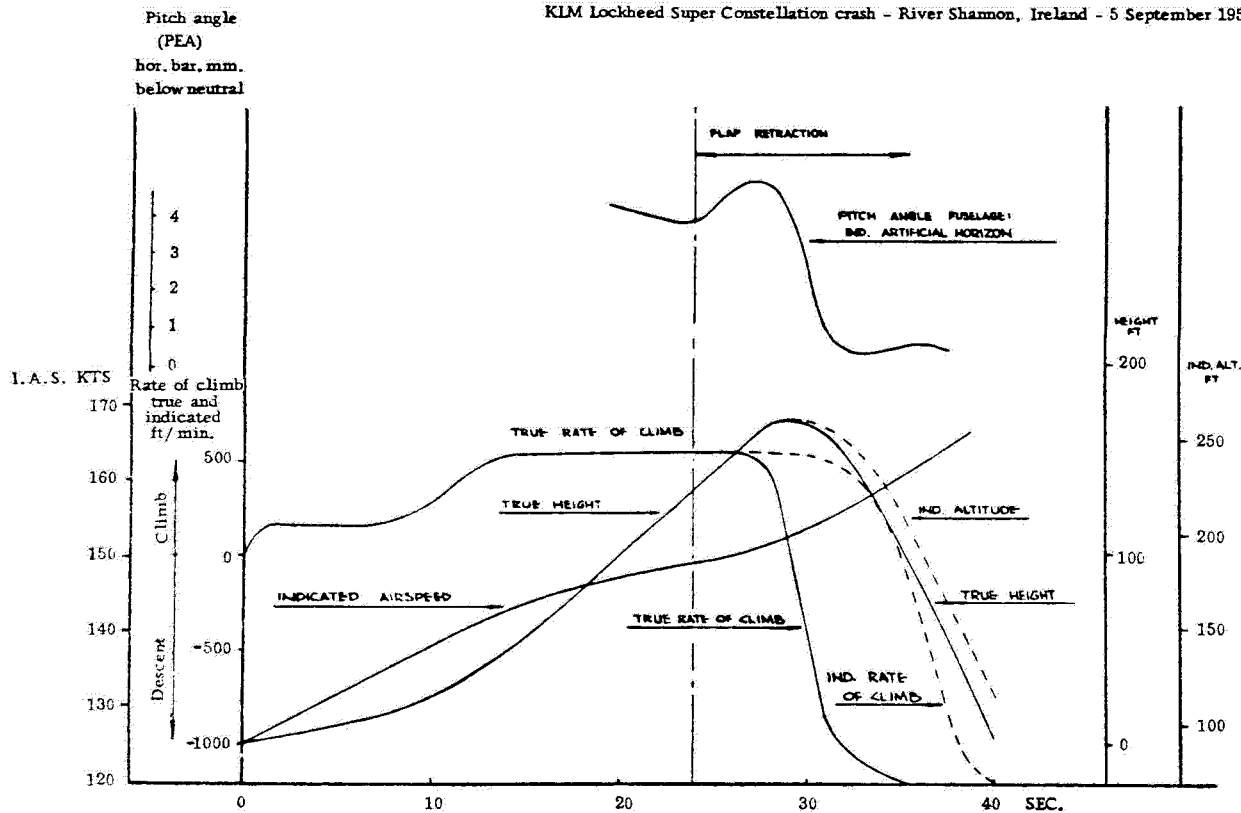
FIGURE 1
FLIGHT PATH AND
RELATED INSTRUMENT
INDICATIONS

KLM Lockheed Super Constellation crash - River Shannon, Ireland - 5 September 1954

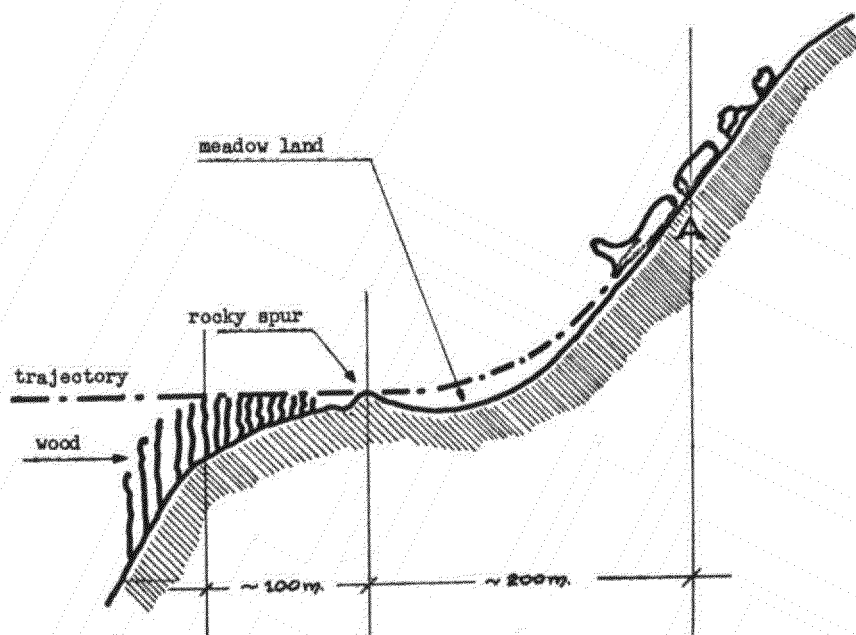
Figure 7

A large part of the wreckage was discovered in the vicinity of Point A in Figure 7. Many parts and fragments were found near the rocky spur (see Figure 7) and in the meadow, not far from the precipitous slope to the right of the fuselage (viewed from the rear).

Diagram of territory in which SABENA DC-6 aircraft crashed.
Reatini Mountains

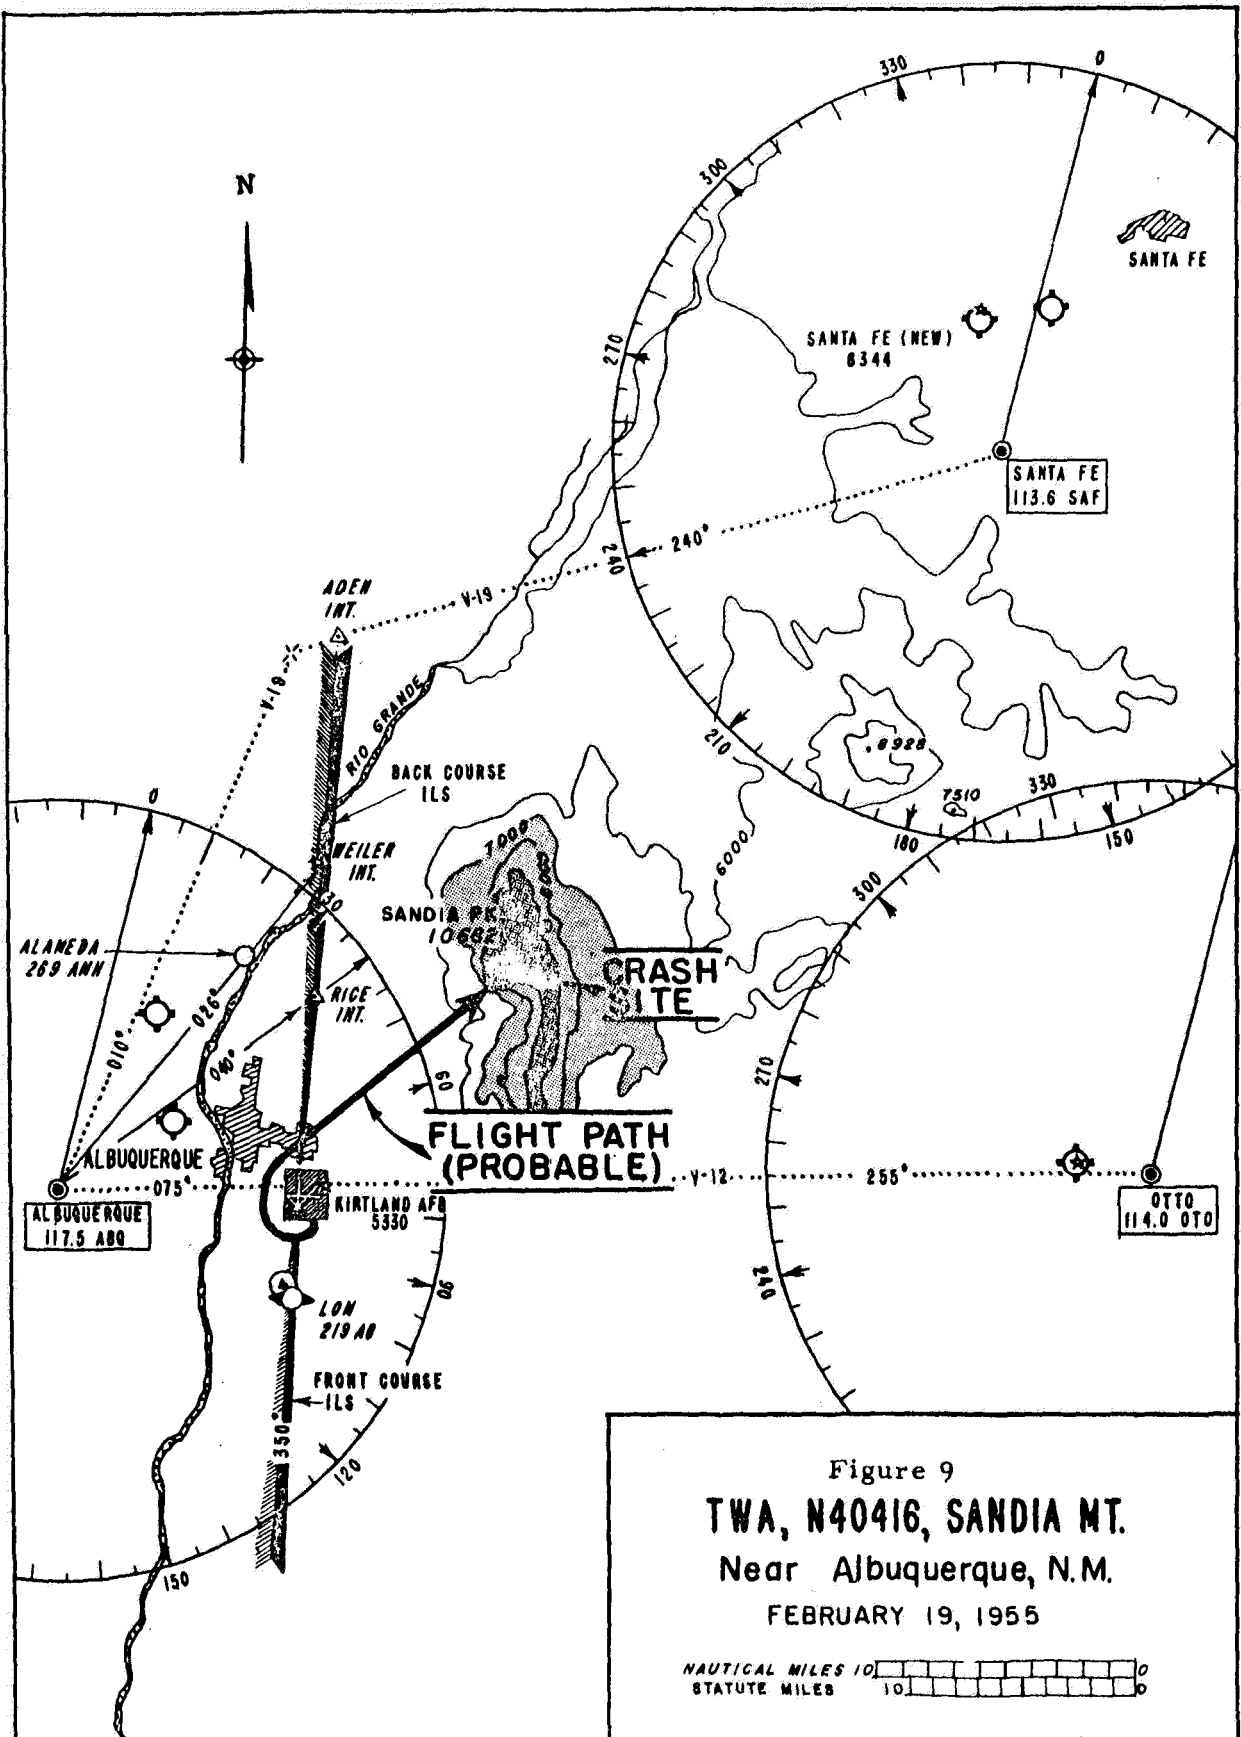
Figure 9
TWA, N40416, SANDIA MT.
 Near Albuquerque, N.M.
 FEBRUARY 19, 1955

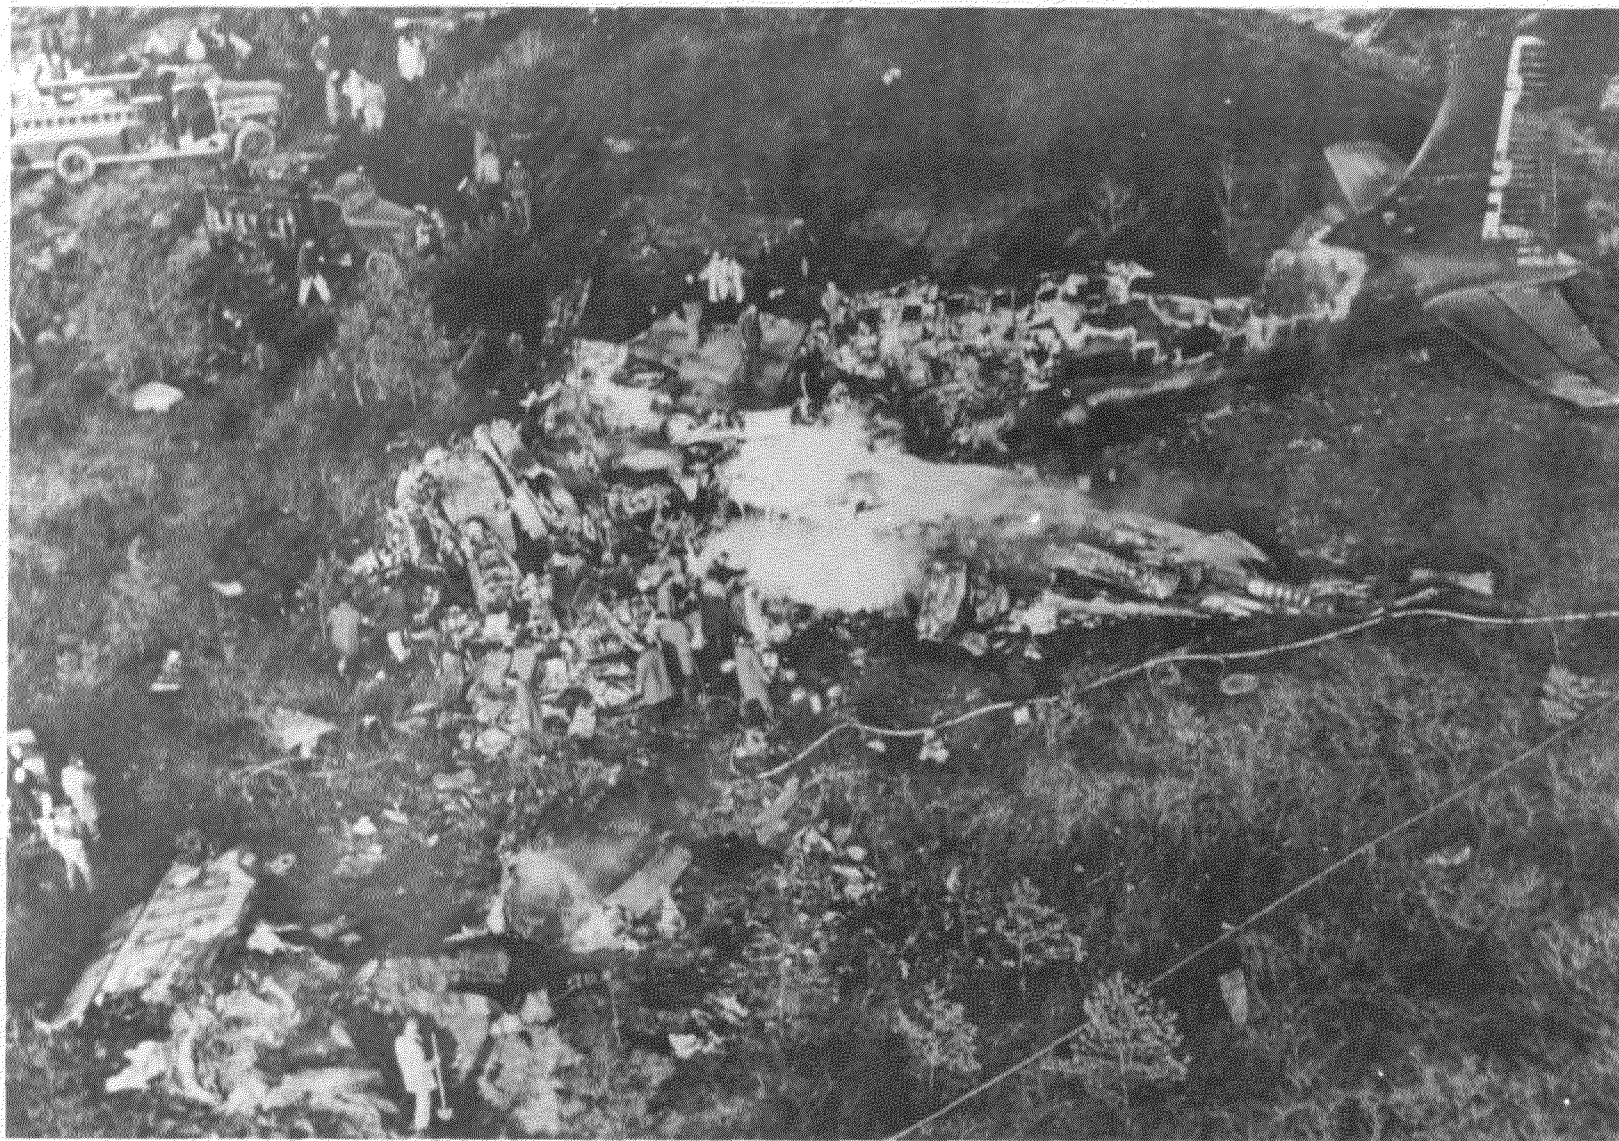
Figure 13

United Air Lines DC-6 which crashed while on a pilot qualification check flight at MacArthur Field, Islip, New York - 4 April 1955. Intense fire consumed a large portion of the wreckage in spite of prompt arrival of fire fighting equipment.

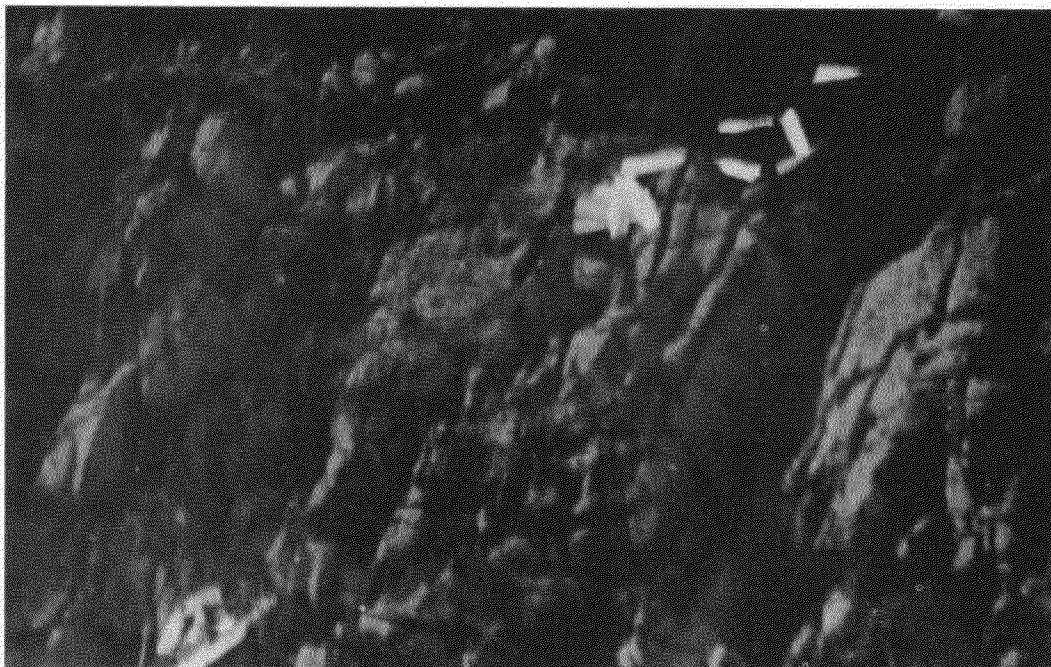
Figure 15

In view of the inaccessibility of the terrain where JZ-PTA crashed it was not possible to send a ground party to the scene of the accident.

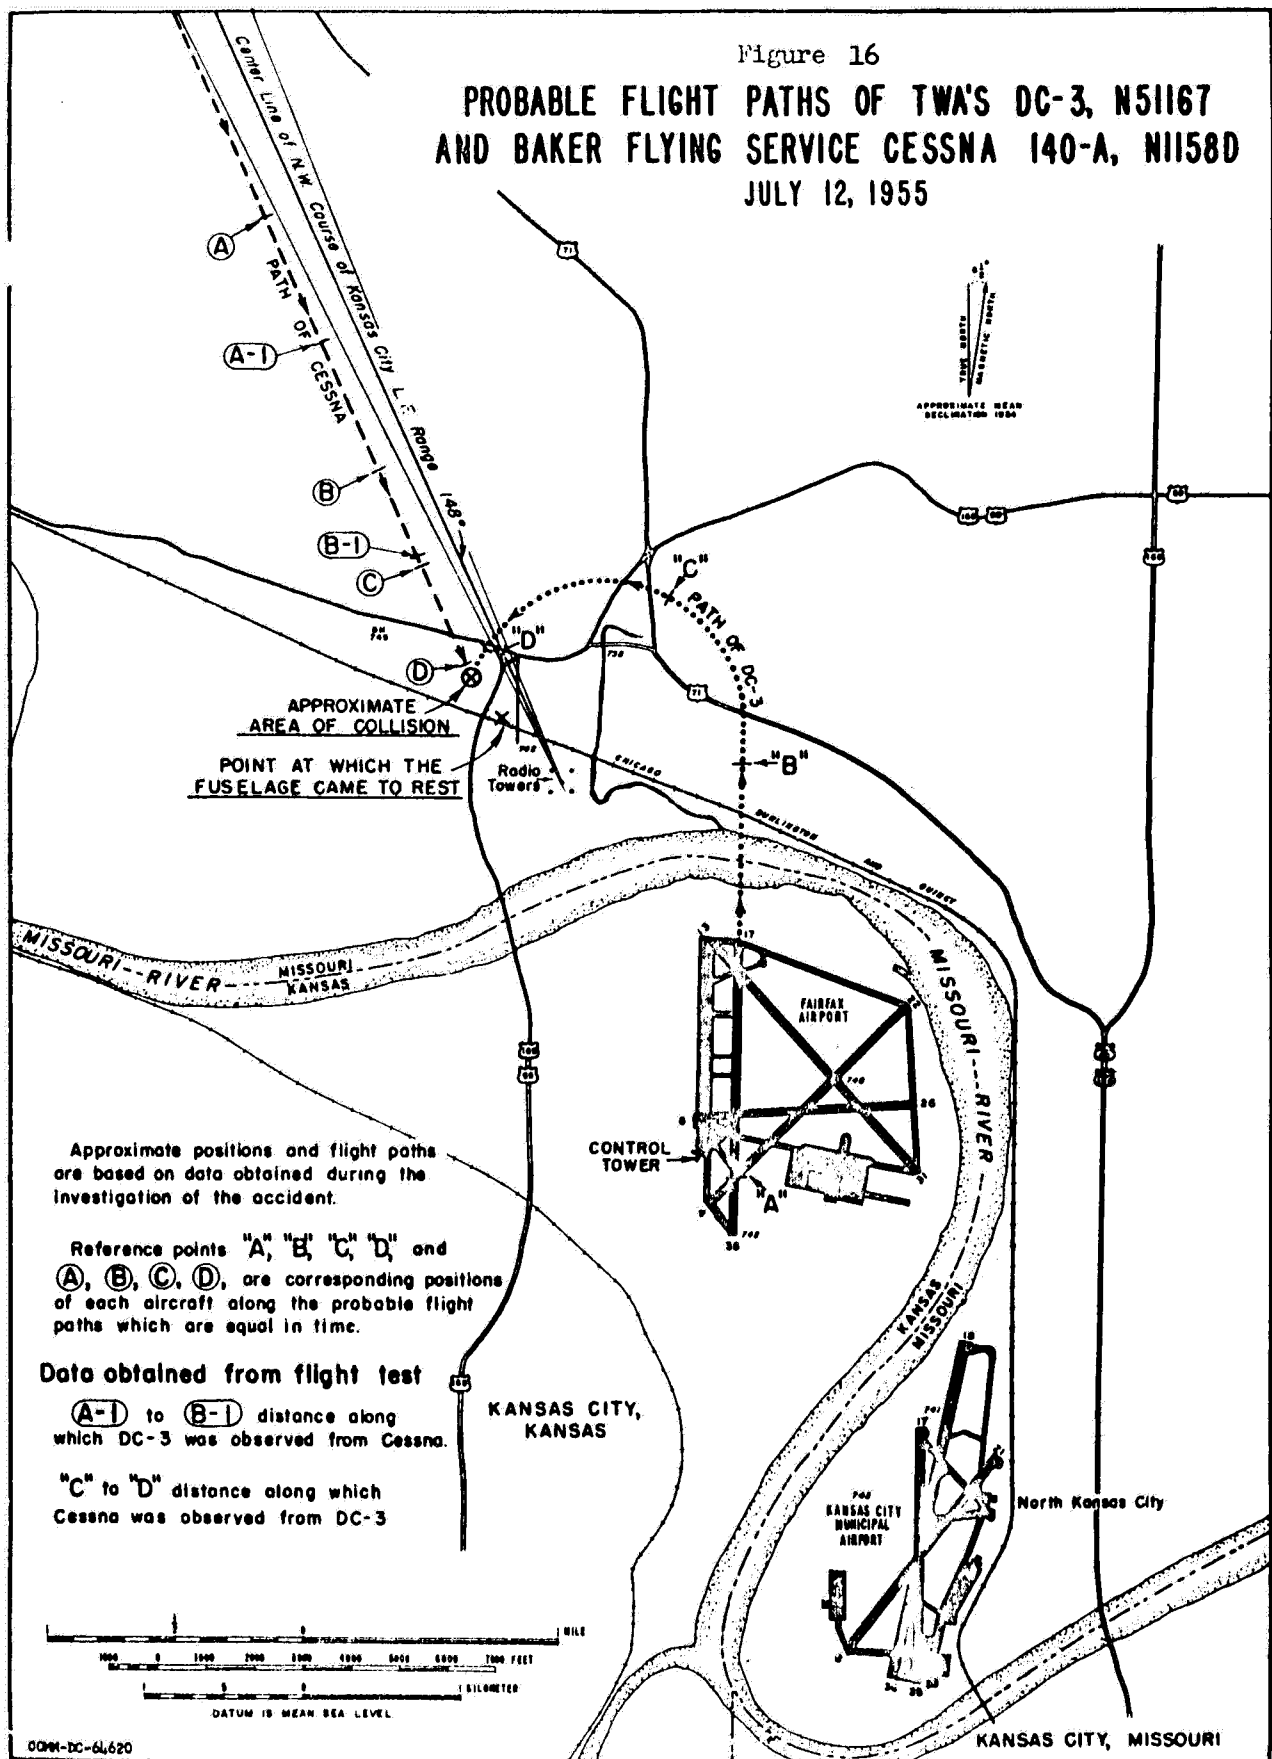
Figure 16
**PROBABLE FLIGHT PATHS OF TWA'S DC-3, N51167
 AND BAKER FLYING SERVICE CESSNA 140-A, N1158D
 JULY 12, 1955**

Approximate positions and flight paths are based on data obtained during the investigation of the accident.

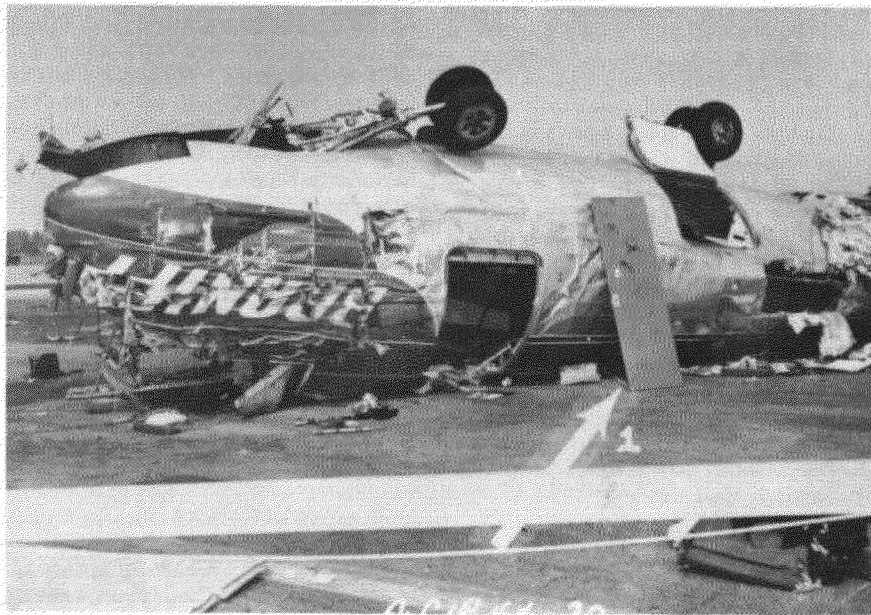
Figure 19

Braniff Airways, Inc., Convair 340 crash at Midway Airport, Chicago - 17 July 1955. View looking back along the approach path; the aircraft initially struck the 18 ft. high electric sign (1), which was approximately 90 ft. from the airport boundary fence. A portion of the line of approach lights (outside of the airport boundary) are shown at (2). The Convair was to the left, and below, the normal approach path - as indicated by the aircraft silhouette (3).

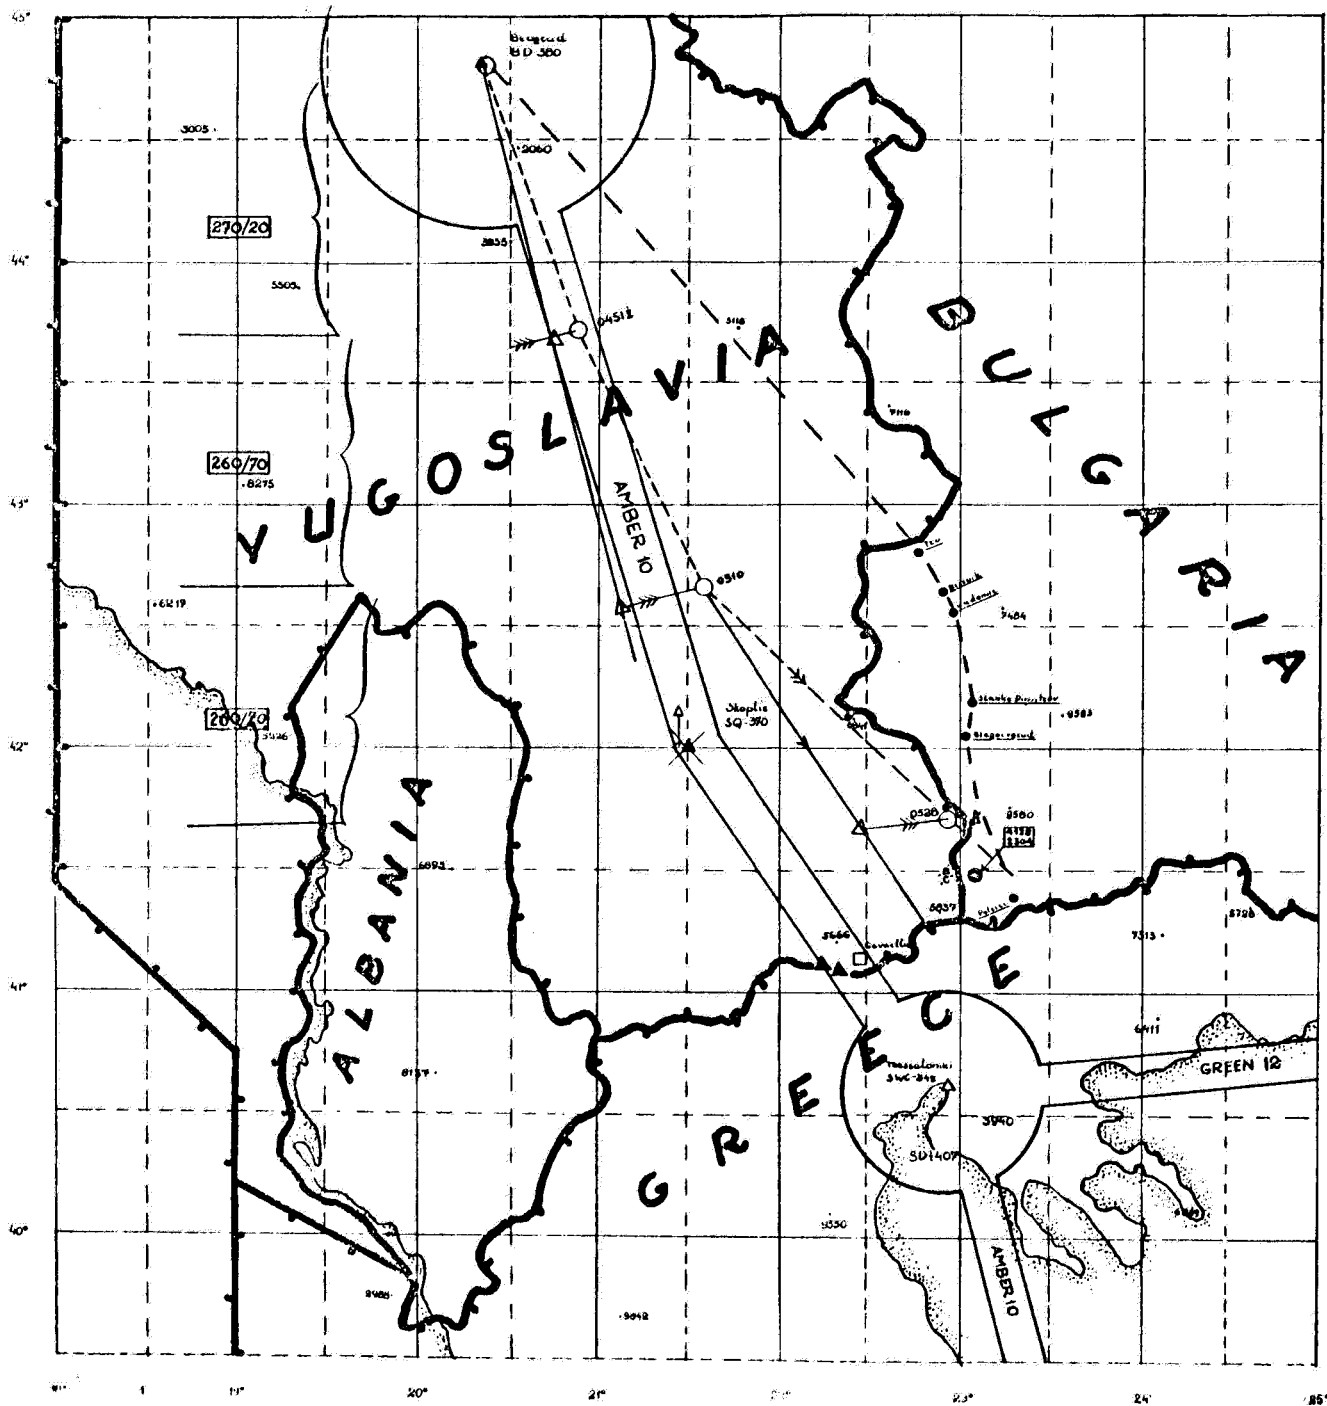
Plotting the aircraft's position after completion of the first half (70 nautical miles) of the leg on the basis of an indicated airspeed of 200 statute miles per hour at an altitude of 17 500 feet with an outside temperature of -11°C ., which gives a true airspeed of 230 knots, we arrive at the point marked 0451 1/2. (See Figure 20).

over the border at 0528. Plotting the course taken during the 18 minutes with allowance for the actual wind, we arrive at the point 0528. (See Figure 20). We conclude this was the aircraft's actual position when it reported over the Yugoslav-Greek border. It was, in fact, close to the Yugoslav-Bulgarian border at a point approximately 26 nautical miles north of the Greek border. Continuing on this course for a further few minutes, the aircraft would cross into Bulgarian territory.

The Yugoslav witnesses made their observations from points along the Yugoslav-Bulgarian border. One of the three witnesses stationed at the point marked "A" on Figure 20 saw a large aircraft flying in a southeasterly direction over Bulgaria and two fighters approaching it from the east. One of the fighters took up a position between the large aircraft and the Yugoslav-Bulgarian border. The other fighter manoeuvred around the large aircraft. All three witnesses at the point "A" heard bursts of machine-gun fire but none of them saw signs of a hit. The two witnesses stationed at the point "B" heard an aircraft to the northeast of their position and heard bursts of machine-gun fire. They then observed the aircraft moving in a southeasterly direction towards the Greek border. After this they heard more machine-gun fire. The aircraft was flying in a southeasterly direction and was about 7 kilometres distant from the observation post when it disappeared from view. A witness stationed at the point "C" also saw the aircraft to the northeast of his position and observed it flying to the southeast and losing height. He heard machine-gun fire but did not observe fighters or smoke from the plane when it disappeared over the mountain marked on Figure 20 with the co-ordinates 41°28'N 23°04'E.

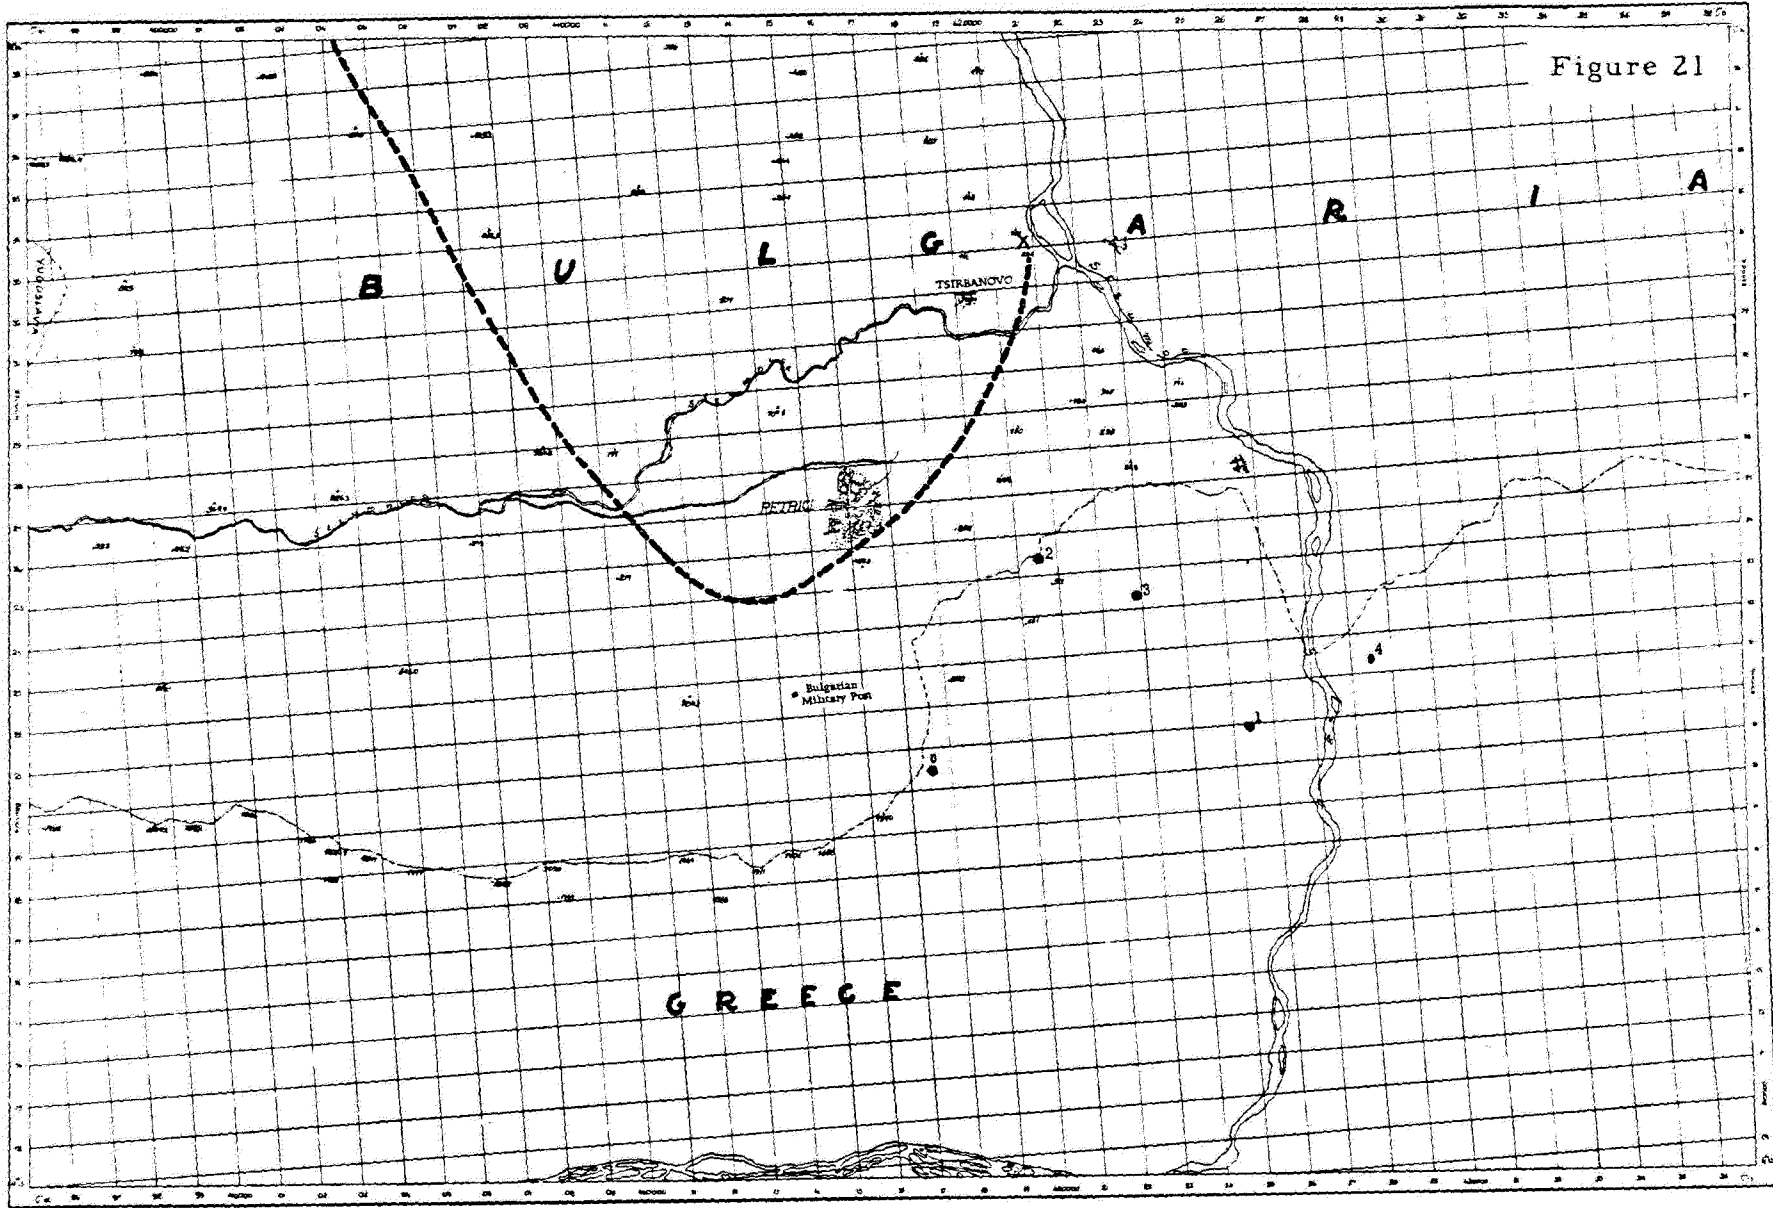
Figure 21

The next witnesses to see the aircraft were the Greek observers along the Greek-Bulgarian border. The first group of observers (3 witnesses) stationed at the point "O" (see Figure 21) saw the aircraft approach over the mountain from the northwest. When it appeared, smoke was coming from its right side. Before the aircraft came into view one witness heard what he took to be heavy gun fire and another what he thought was thunder. The aircraft was seen flying southeast losing height but under control.

Other witnesses stationed at points "2" and "3" (see Figure 21) further east along the same border heard machine-gun fire before the aircraft appeared and then saw it coming low over the mountain with fire and smoke at the root of the right wing. They generally confirmed the previous witnesses regarding the path the aircraft took. However, they saw, in addition, two jet fighters above the aircraft. One of the jets disappeared immediately after the aircraft turned north but the other accompanied it right up to the time when it broke up. After this it circled and flew to the north. These witnesses heard a loud explosion at the time the aircraft broke up.

Three other witnesses, civilians, made their observations from the vicinity of Promachonos marked 4 on Figure 21. One of them heard shots immediately before the aircraft broke up. The attention of the others was drawn to the aircraft by what they described as "noise". Of this group of witnesses two saw the fighter.

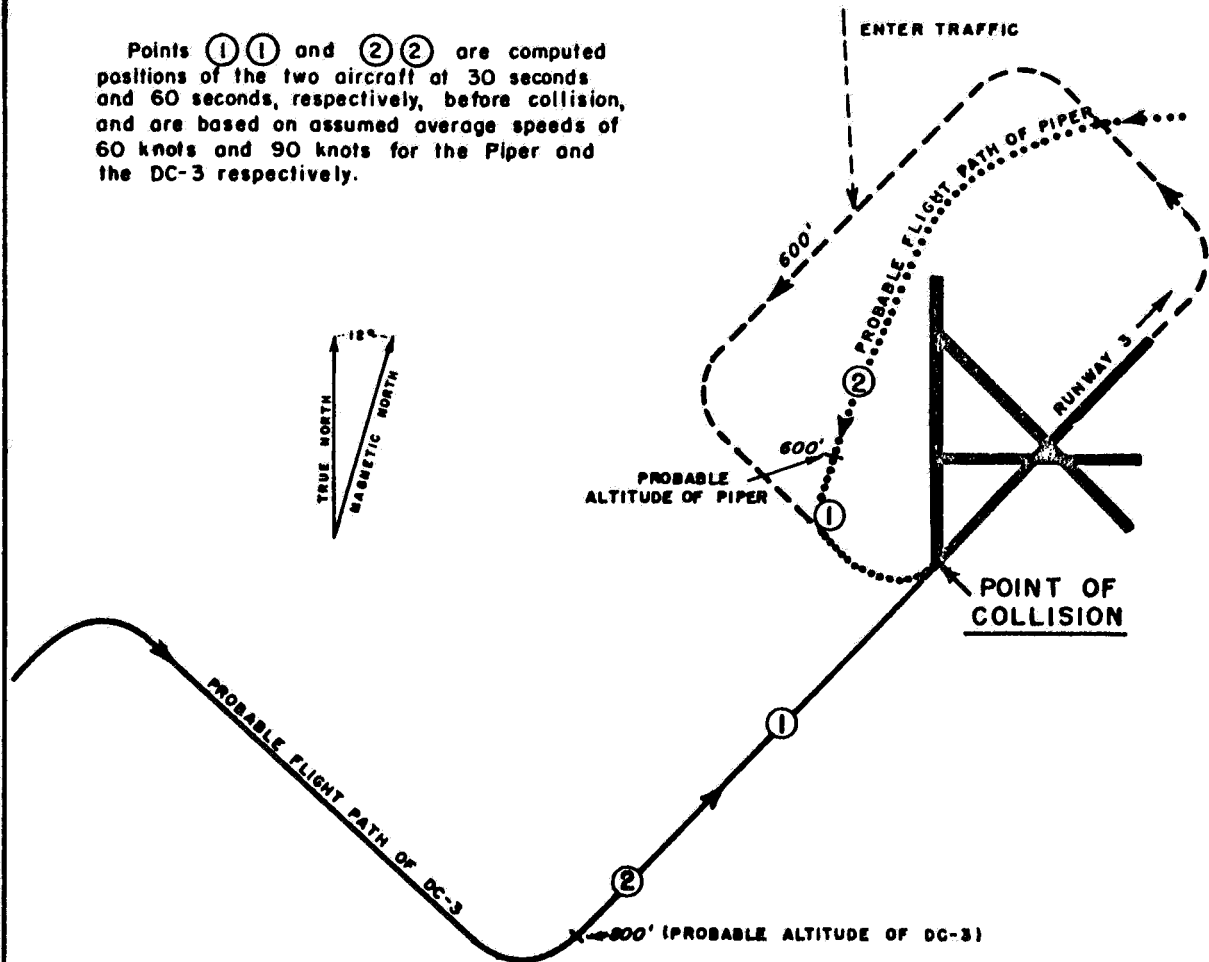
Figure 23

flown on the downwind leg in a direction approximately opposite Runway 3 to a point about abreast of its approach end. Consequently approximately 180 degrees of left turn was necessary to align with that runway. Testimony of competent ground witnesses indicates that this turn was continuous or nearly so, with the aircraft banked appreciably throughout the turn. It also indicates that the Piper was the higher of the two aircraft as both approached the runway, the DC-3 in straight descending flight and level laterally, the Piper in a rather sharp left turn merging into a left forward slip just before collision. These flight paths were confirmed shortly after the accident by ground observations of simulated approaches of two identical aircraft. (Refer to Figure 23).

Points ①① and ②② are computed positions of the two aircraft at 30 seconds and 60 seconds, respectively, before collision, and are based on assumed average speeds of 60 knots and 90 knots for the Piper and the DC-3 respectively.

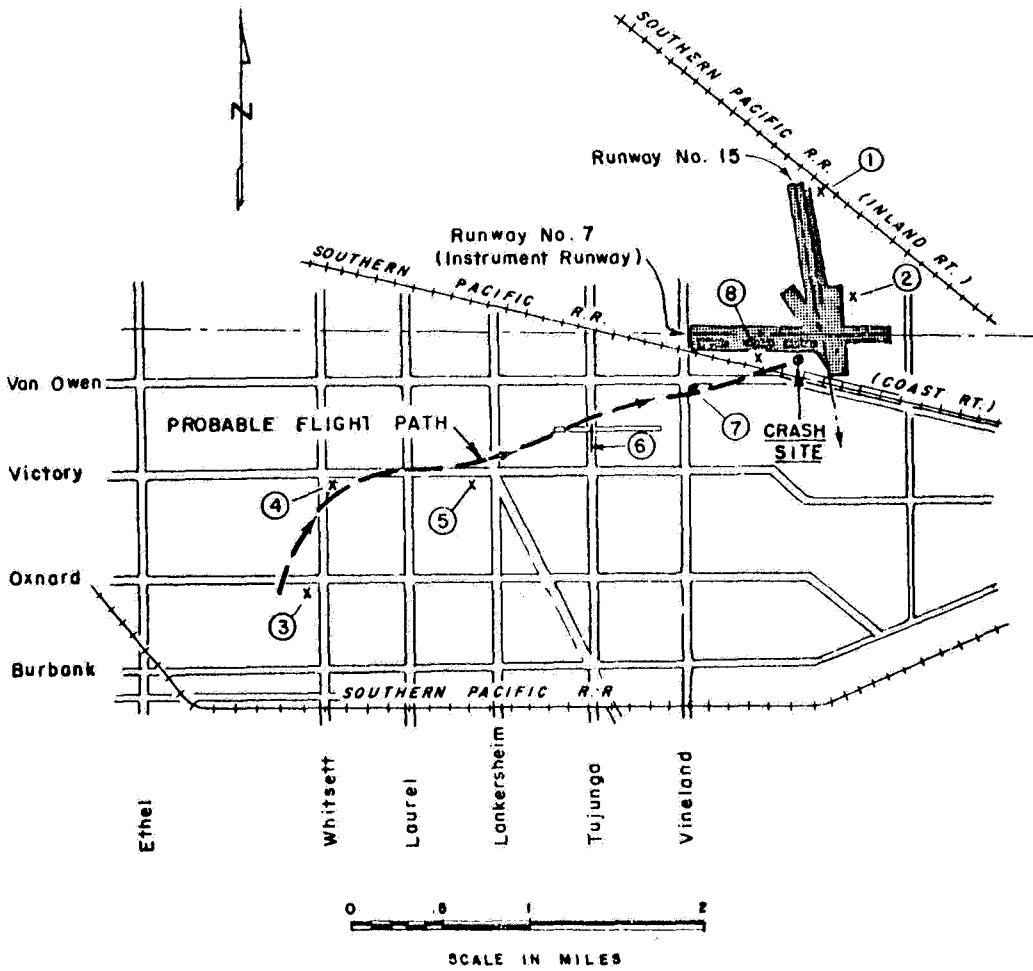
Testimony of eyewitnesses made it possible to plot the path of the aircraft back about 3-1/2 miles from the point of impact. Figure 24 shows this portion of the flight path in relation to the runways and to the take-off path. The position of the aircraft at the time the crew became aware of the emergency and immediately thereafter is not definitely known and that portion of the flight path is not shown.

The observed portion of the flight path, charted in Figure 24 does not include the base leg of the approach.

CURREY AIR TRANSPORT, LTD. - N-74663
LOCKHEED AIR TERMINAL
BURBANK, CALIF.
September 8, 1955

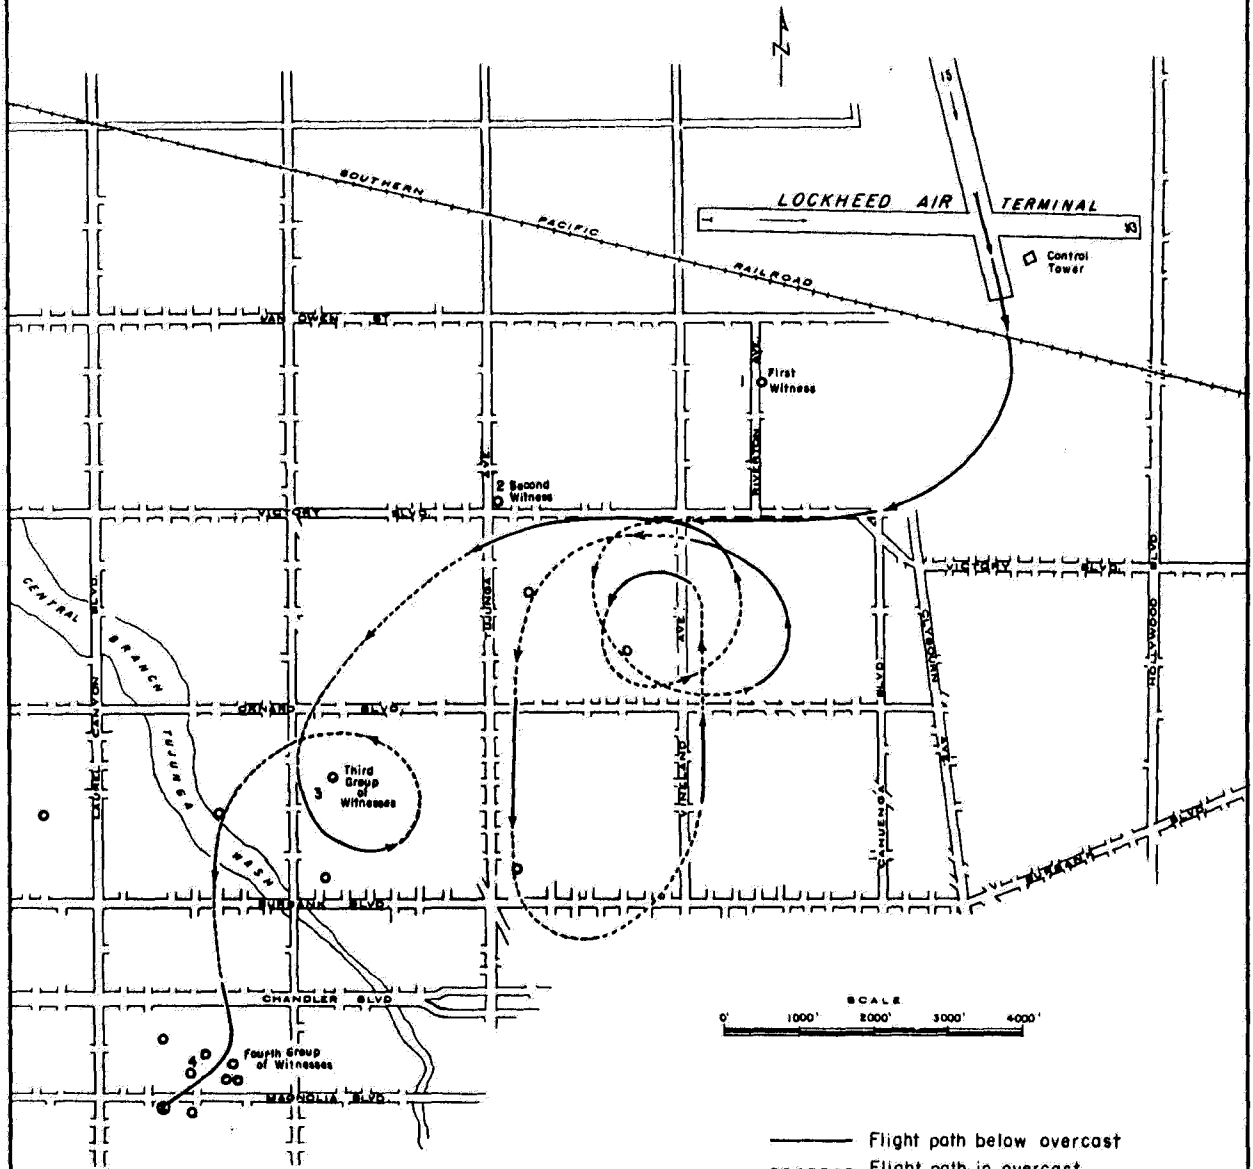
From the information provided by witnesses the probable flight path of the aircraft was reconstructed and is shown at Figure 25.

Figure 25
**PROBABLE FLIGHT PATH
 OF BEECH BONANZA N-5825C
 NORTH HOLLYWOOD, CALIFORNIA**
 OCTOBER 17, 1955

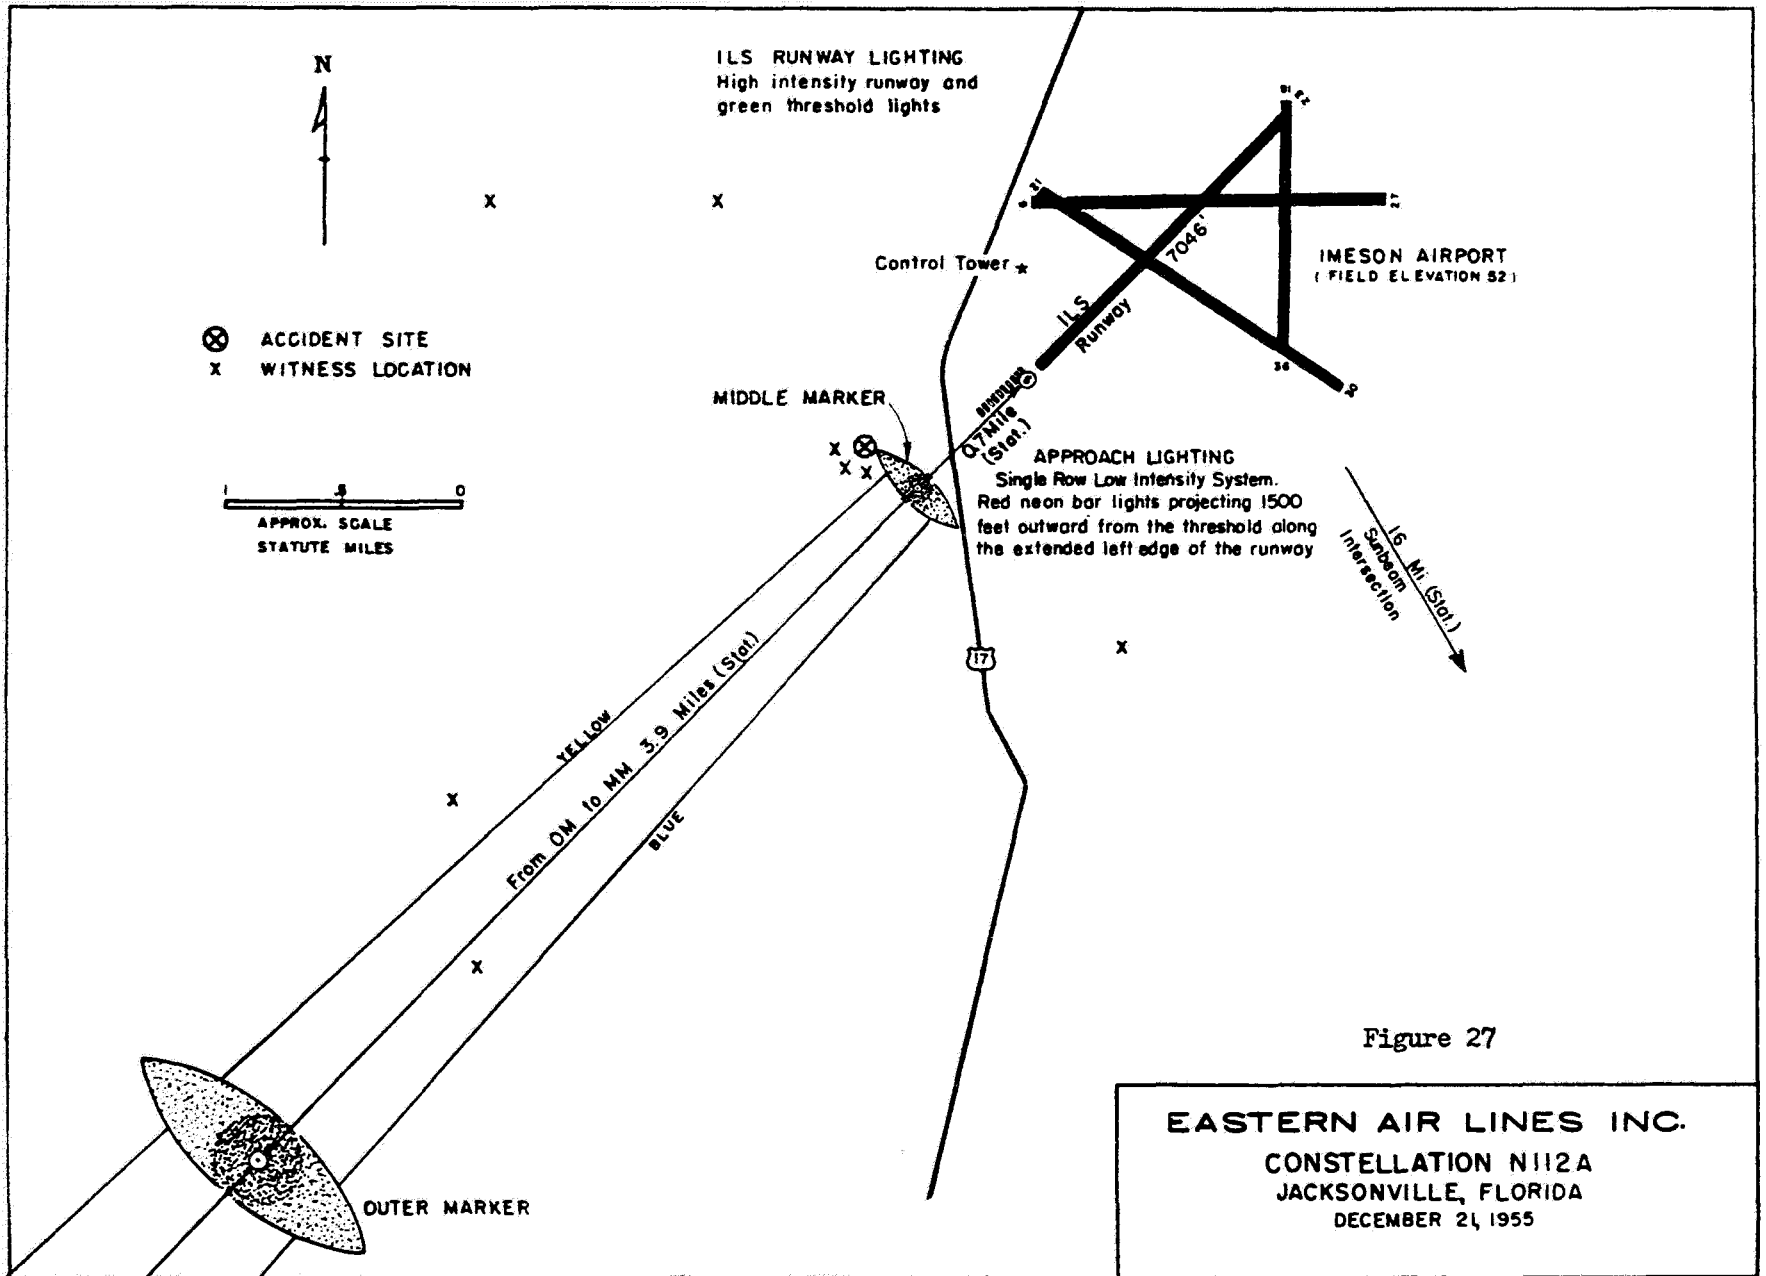
Figure 27

EASTERN AIR LINES INC.
CONSTELLATION N112A
JACKSONVILLE, FLORIDA
DECEMBER 21, 1955
