ICAO

CIRCULAR 54-AN/49

AIRCRAFT ACCIDENT DIGEST

No. 8

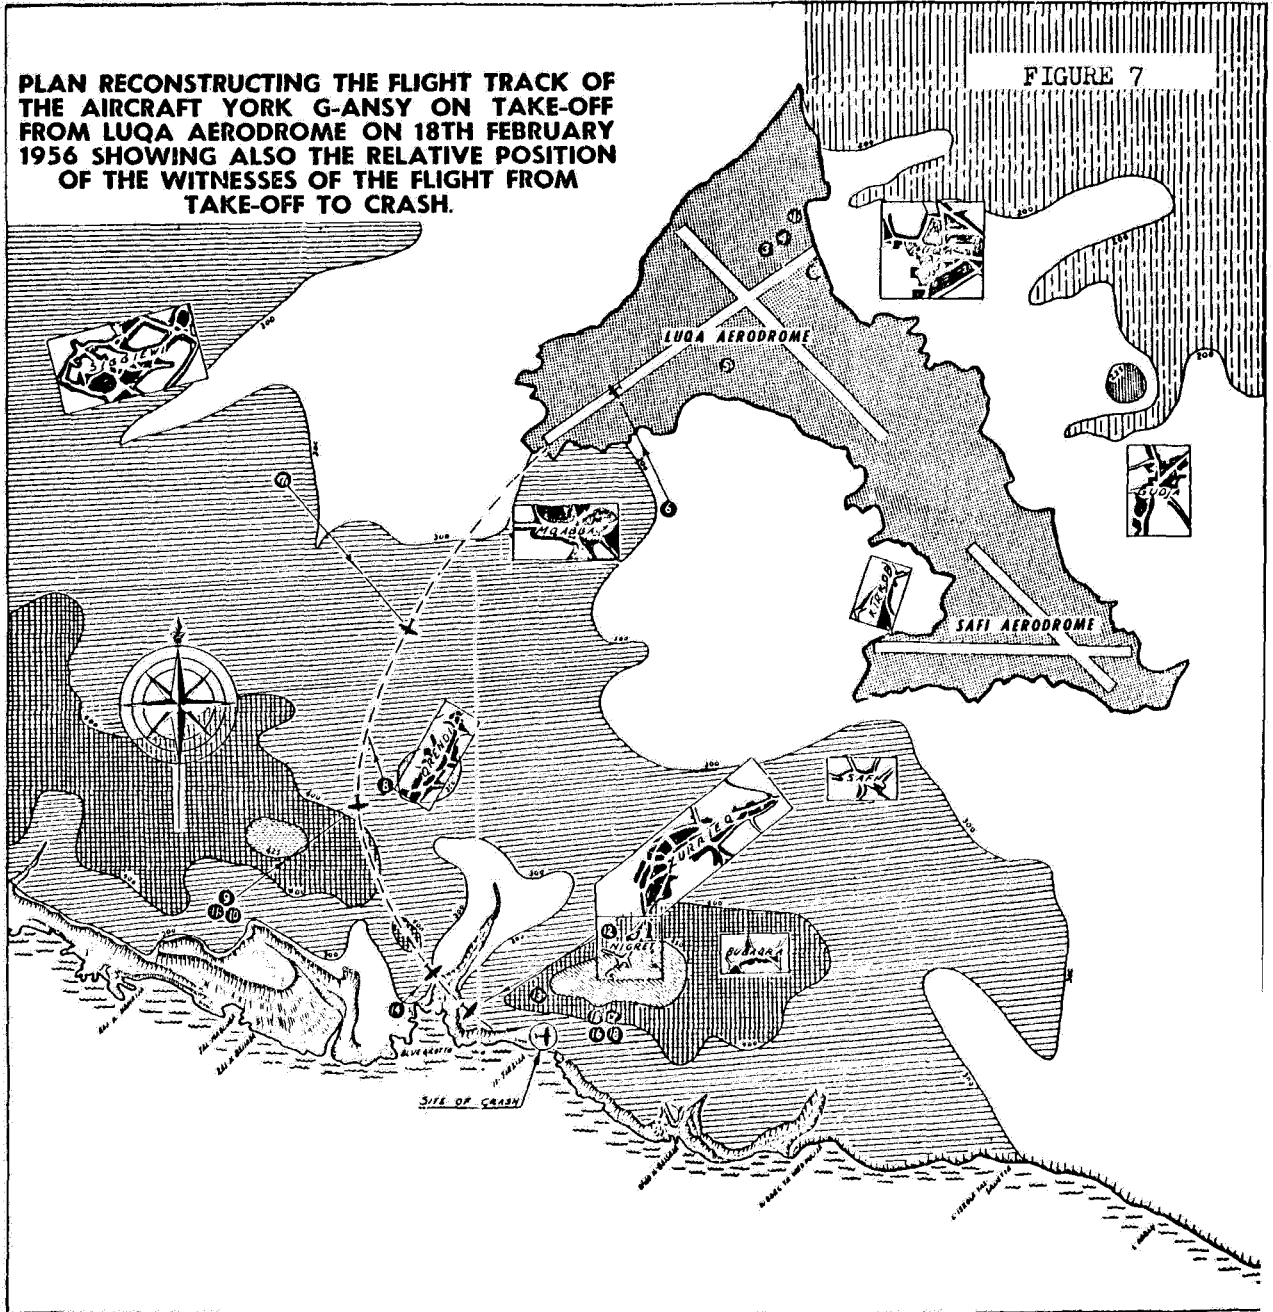
FIGURE 7

PLAN RECONSTRUCTING THE FLIGHT TRACK OF THE AIRCRAFT YORK G-ANSY ON TAKE-OFF FROM LUQA AERODROME ON 18TH FEBRUARY 1956 SHOWING ALSO THE RELATIVE POSITION OF THE WITNESSES OF THE FLIGHT FROM TAKE-OFF TO CRASH.

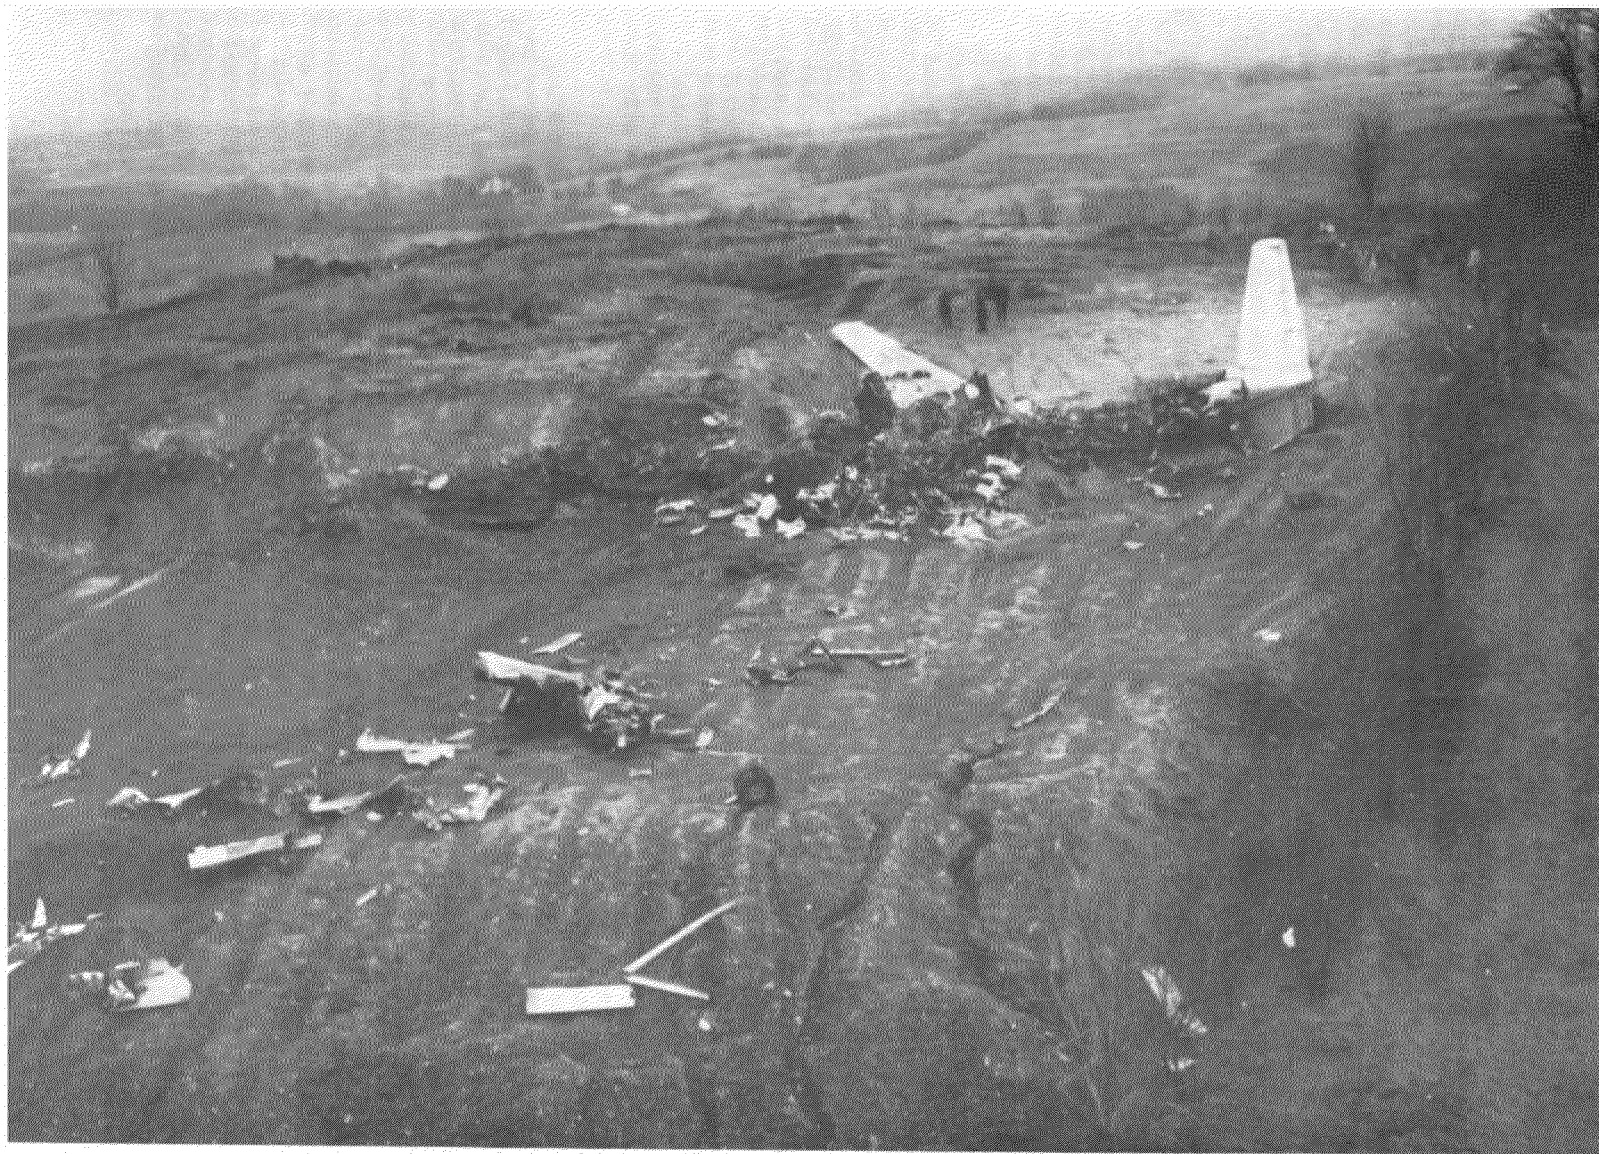
Figure 11

The accident site was about 1 690 feet from the end of the runway but because of the nature of the terrain, airport based fire fighting equipment, which was immediately dispatched, took 20 minutes to reach the scene, traversing circuitous country lanes. One fire truck, belonging to the County Department of Aviation, attempted to reach the scene by crossing the Air Field (the shortest route) but bogged down in the muddy terrain. Air Force crash trucks based at the Airport did reach the scene as indicated above, but by that time fire had nearly consumed the wreckage. (No detailed fire fighting report could be secured from the Air Base Fighter Group stationed at the Airport. The CAB report merely indicates that the remaining fire was quickly smothered once the fire equipment reached the scene.)

The 12 passengers who survived extricated themselves from the jumbled wreckage through and ahead of the fire as best they could; some helped others while a few found themselves thrown out through tears and rents in the shattered fuselage. The intensity of the fire must have had a decided influence on the deaths which resulted.

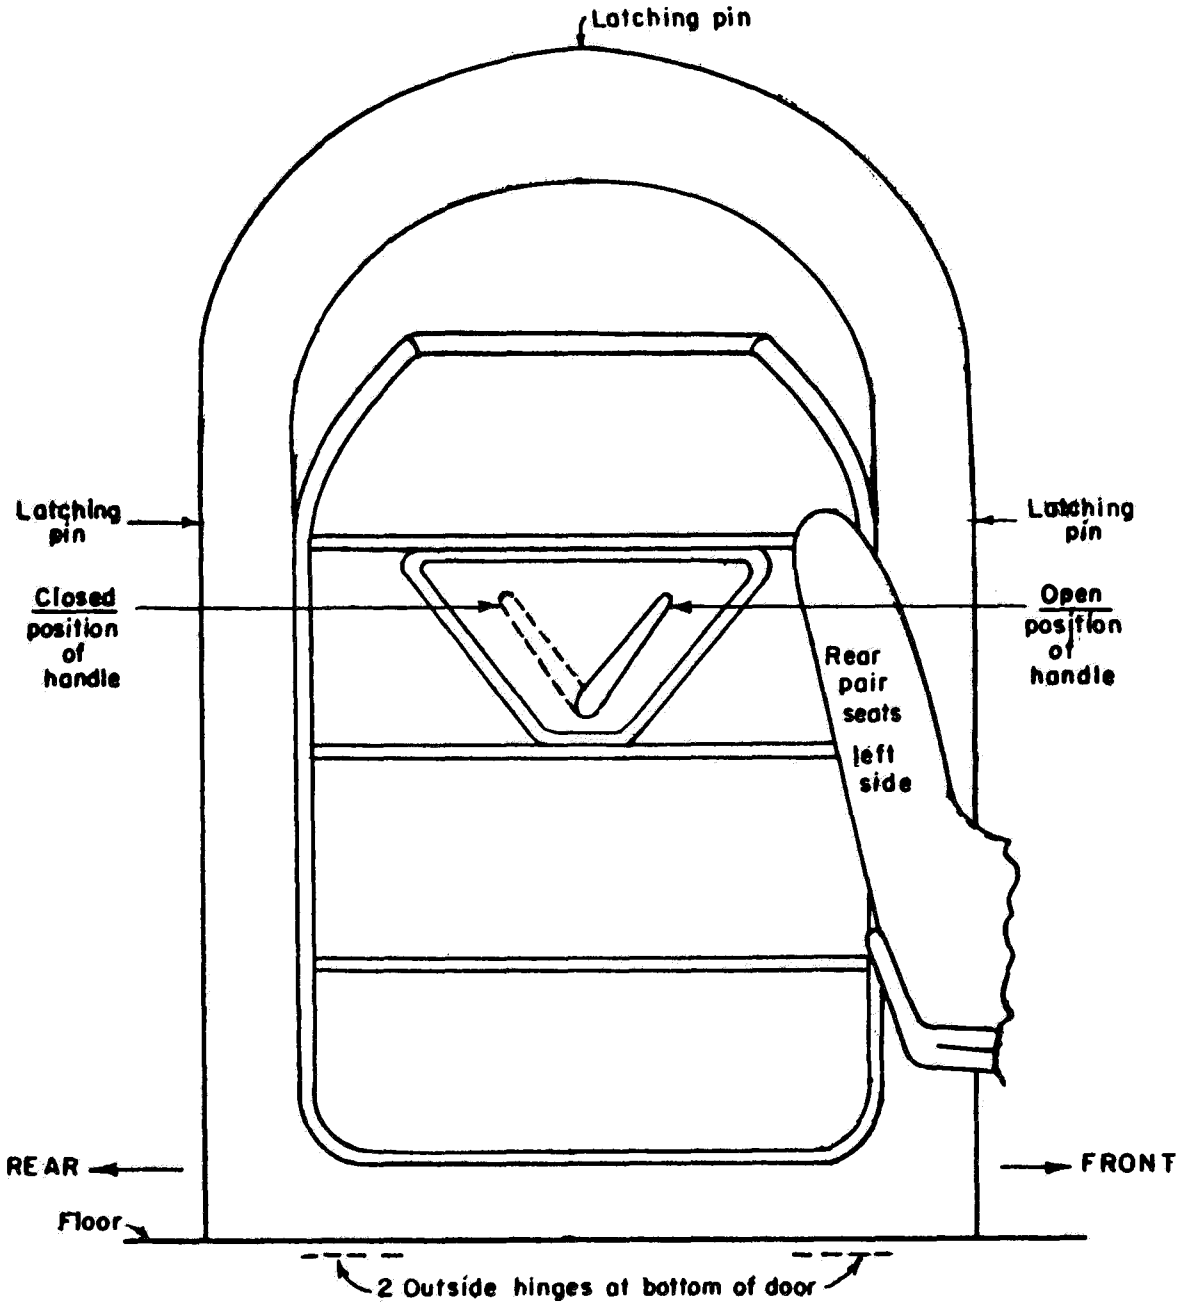
Figure 12
PIEDMONT AIRLINES DC-3C, N45V
NEAR SHELBY, NORTH CAROLINA, JUNE 13, 1956

The probable cause of this accident was a passenger's accidental opening of the main cabin door in flight.

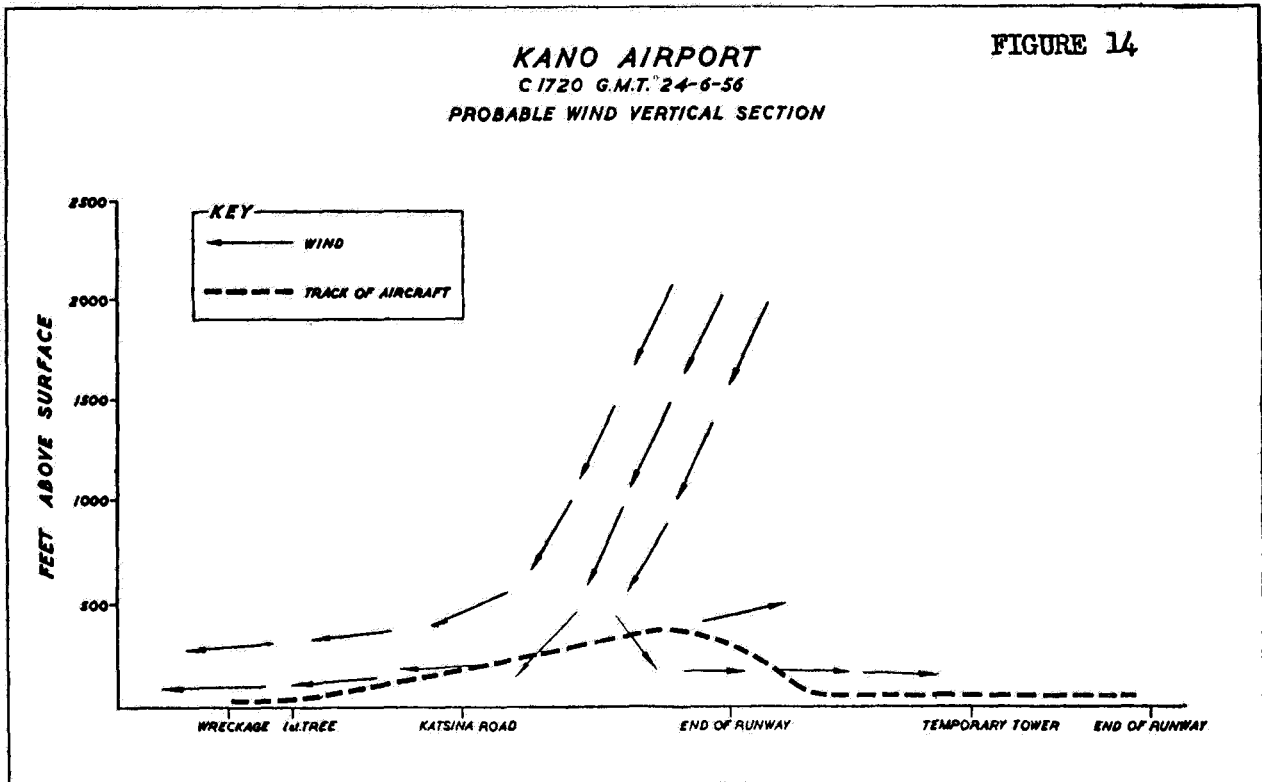
FIGURE 14

of the airport and the other about six miles to the southwest. Both were moving slowly towards the southwest and by 1700 GMT the former lay a mile or two to the northeast with an associated cloud overhang extending over the airport itself. Moderate rain from this overhang started to fall at the Terminal Building at 1714 GMT and ended at 1722 GMT. The main centre of the thunderstorm passed a little to the north of the airport but a new cell appears to have developed in the overhang which gave heavy rain and squalls over the western half of the airport at about 1720 GMT and moved westwards. A probable synoptic map of the wind and rain at and near the airport, based upon official observations at the Terminal Building and Temporary Tower and upon lay evidence elsewhere, is given as Figure 13. The evidence of witnesses in the area south and west of the end of the runway establishes beyond reasonable doubt that a strong easterly squall with associated heavy rain was experienced there, though instrumental evidence is lacking. A probable vertical cross section through the runway-line of the wind is given as Figure 14."

KANO AIRPORT
 C. 1720 G.M.T. 24-6-56
 PROBABLE WIND VERTICAL SECTION

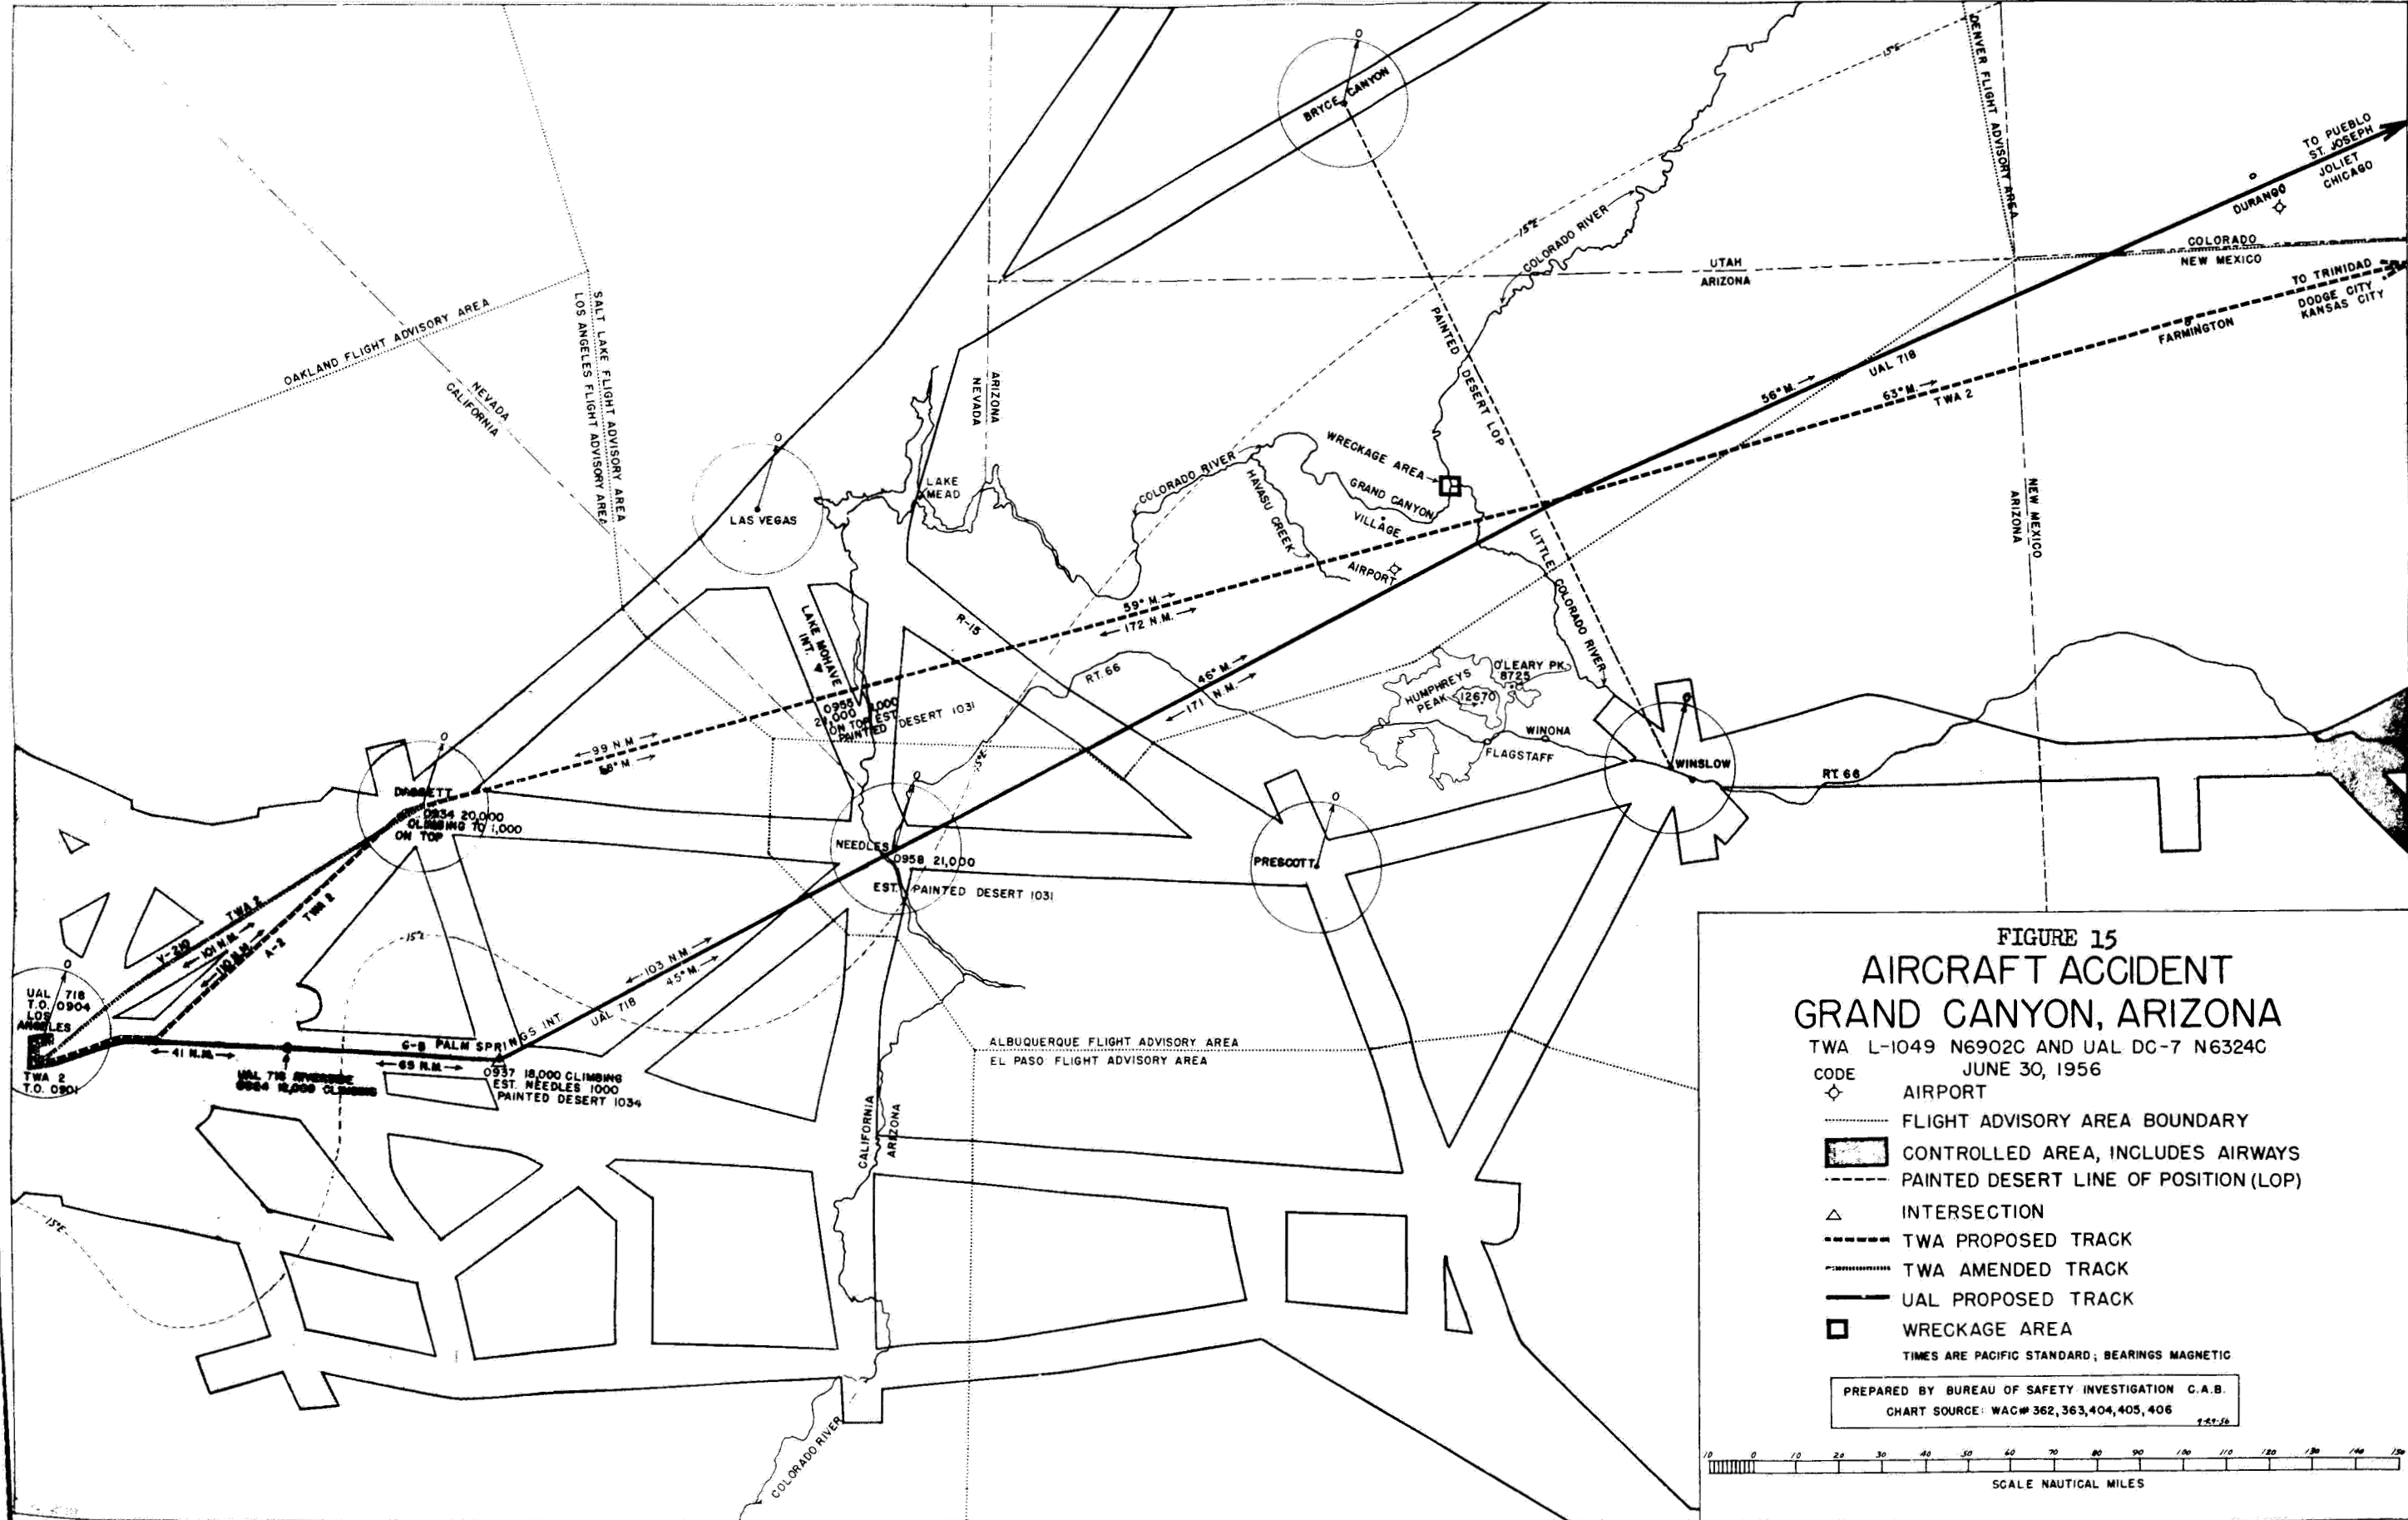
FIGURE 15
AIRCRAFT ACCIDENT
GRAND CANYON, ARIZONA

The probable cause of this mid-air collision was that the pilots did not see each other in time to avoid the collision. It is not possible to determine why the pilots did not see each other, but the evidence suggests that it resulted from any one or a combination of the following factors:

TWA L-1049 N6902C AND UAL DC-7 N6324C
 CODE JUNE 30, 1956

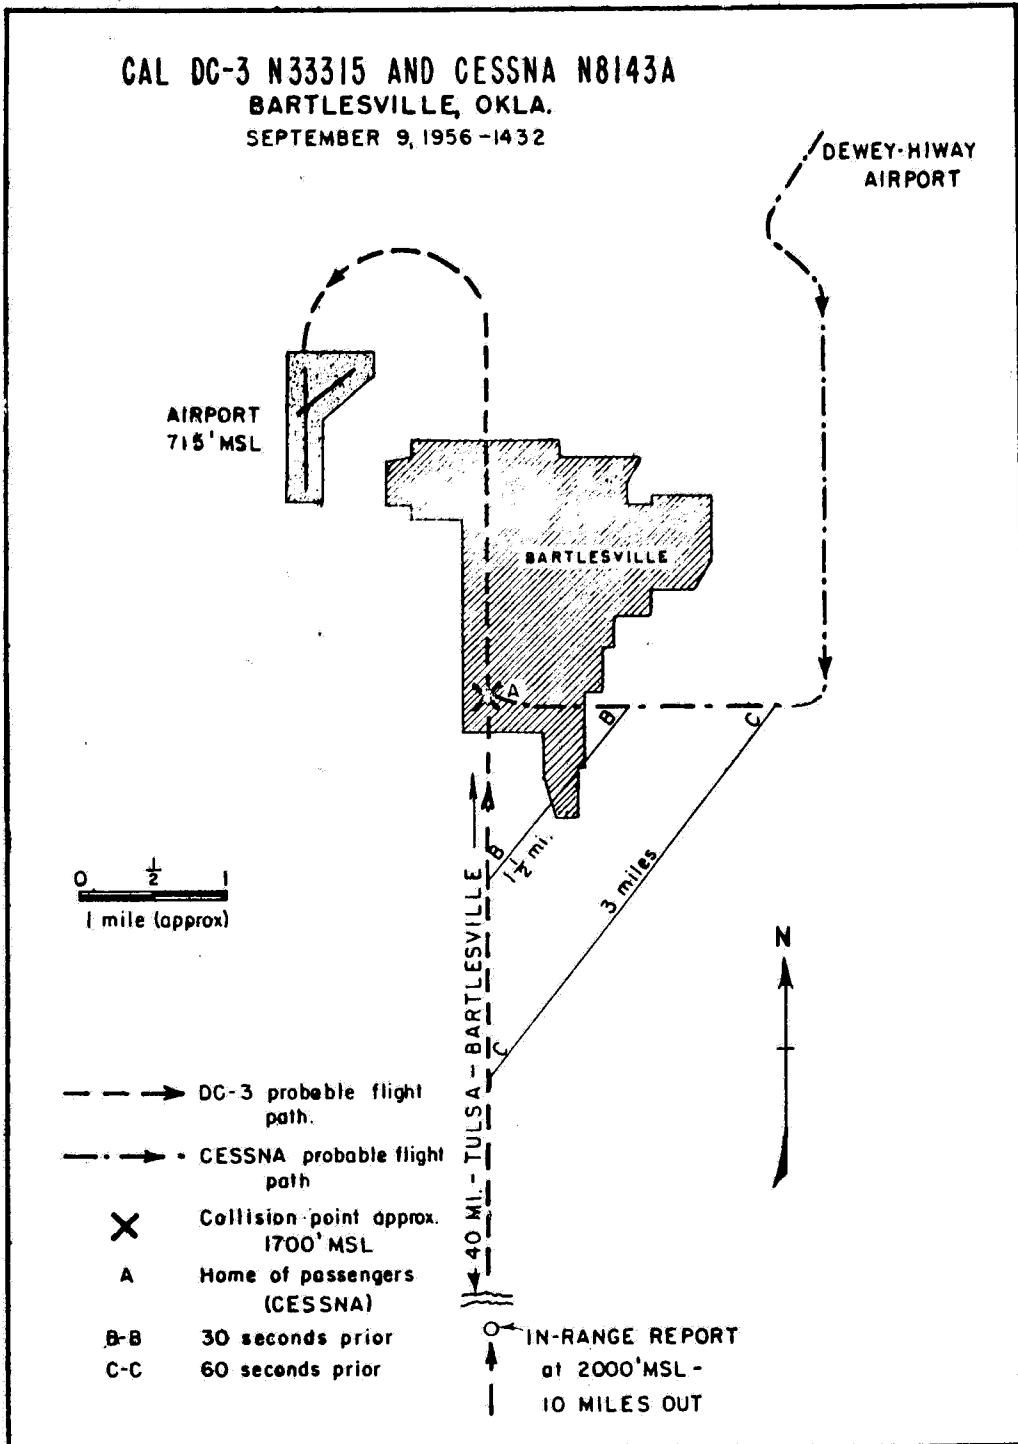
FIGURE 20

Flight 190 (the DC-3A) was scheduled between El Paso, Texas and Kansas City, Missouri, with planned stops including Tulsa and Bartlesville, Oklahoma. The flight departed Tulsa at 1418 hours central standard time and the trip to Bartlesville was planned and operated in accordance with visual flight rules at an altitude of 2 000 feet. Ten minutes after leaving Tulsa and in the vicinity of Ochelata, Oklahoma, the captain advised his company that the aircraft was in range of Bartlesville and then changed to Bartlesville Radio Frequency as advised. Some time after the captain initiated his first radio call, the first officer began the "in-range" cockpit check, which took approximately 30 seconds. Just as it was completed the collision occurred. At the time of collision, the DC-3 was continuing north and about to enter the downwind leg of the airport traffic pattern on a reciprocal heading to the intended landing on runway 17. (See Figure 20)

The probable cause of this accident was the failure of the pilots of both aircraft to observe and avoid the other aircraft.
