ICAO

CIRCULAR 59-AN/54

AIRCRAFT ACCIDENT DIGEST

No. 10

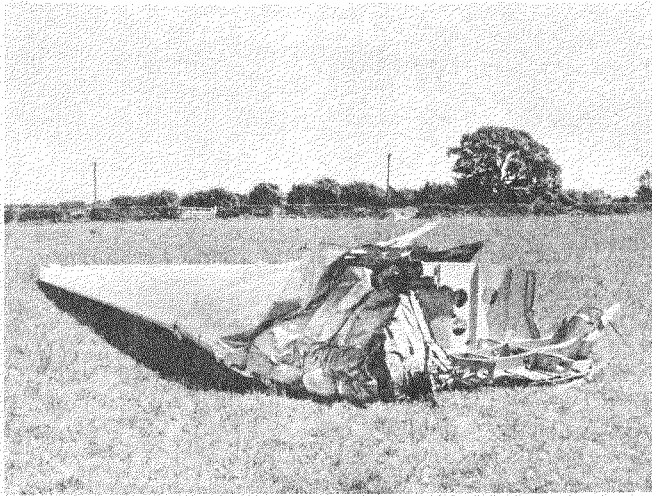
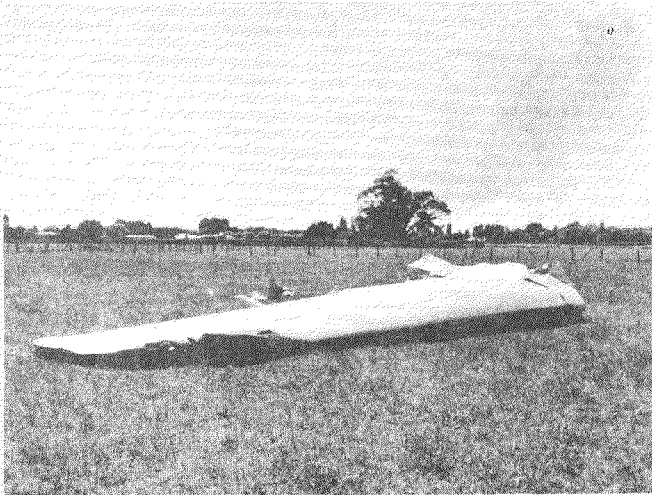
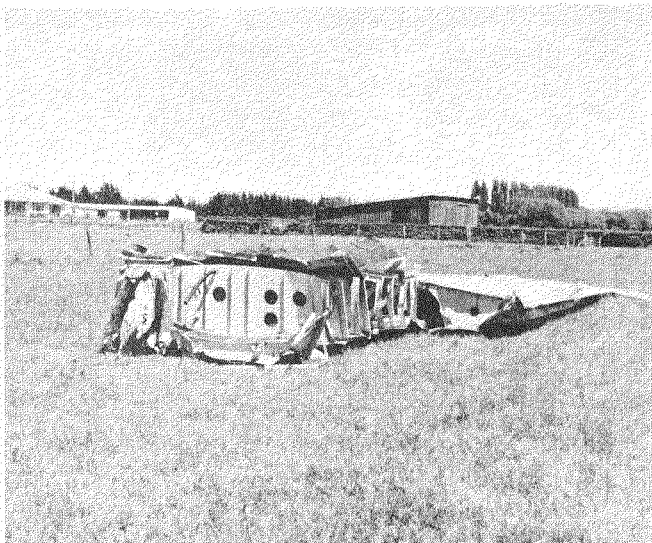
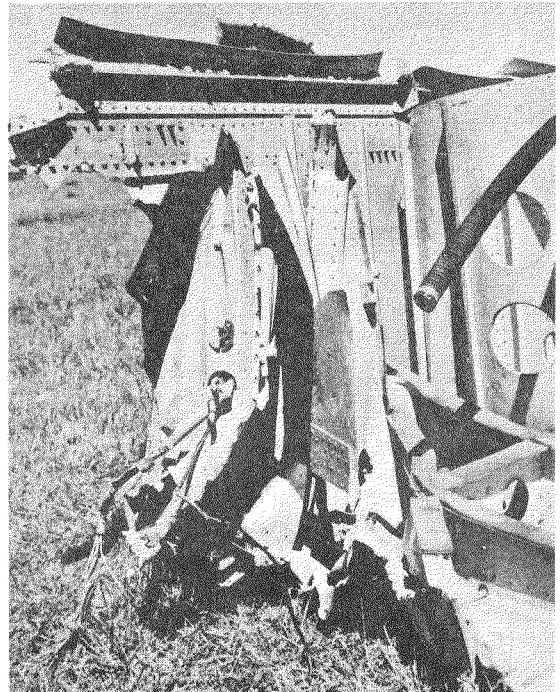
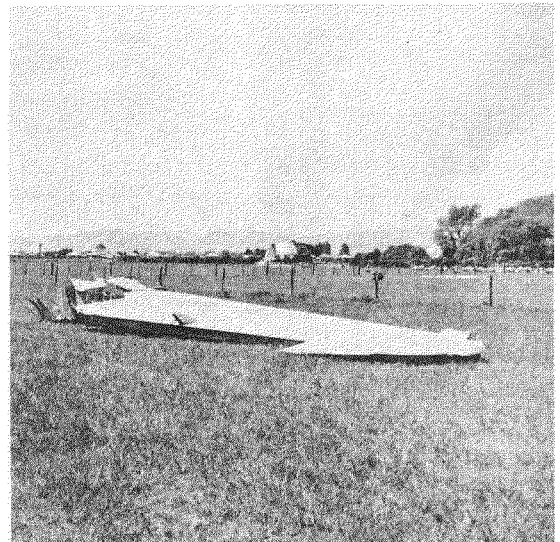
FIGURE 7
STARBOARD OUTER WING

THESE ILLUSTRATIONS WERE
CONTAINED IN THE REPORT OF
THE DOMINION LABORATORY,
DEPT. OF SCIENTIFIC AND
INDUSTRIAL RESEARCH, N. Z.,
WHICH WAS ATTACHED TO THE
ACCIDENT REPORT

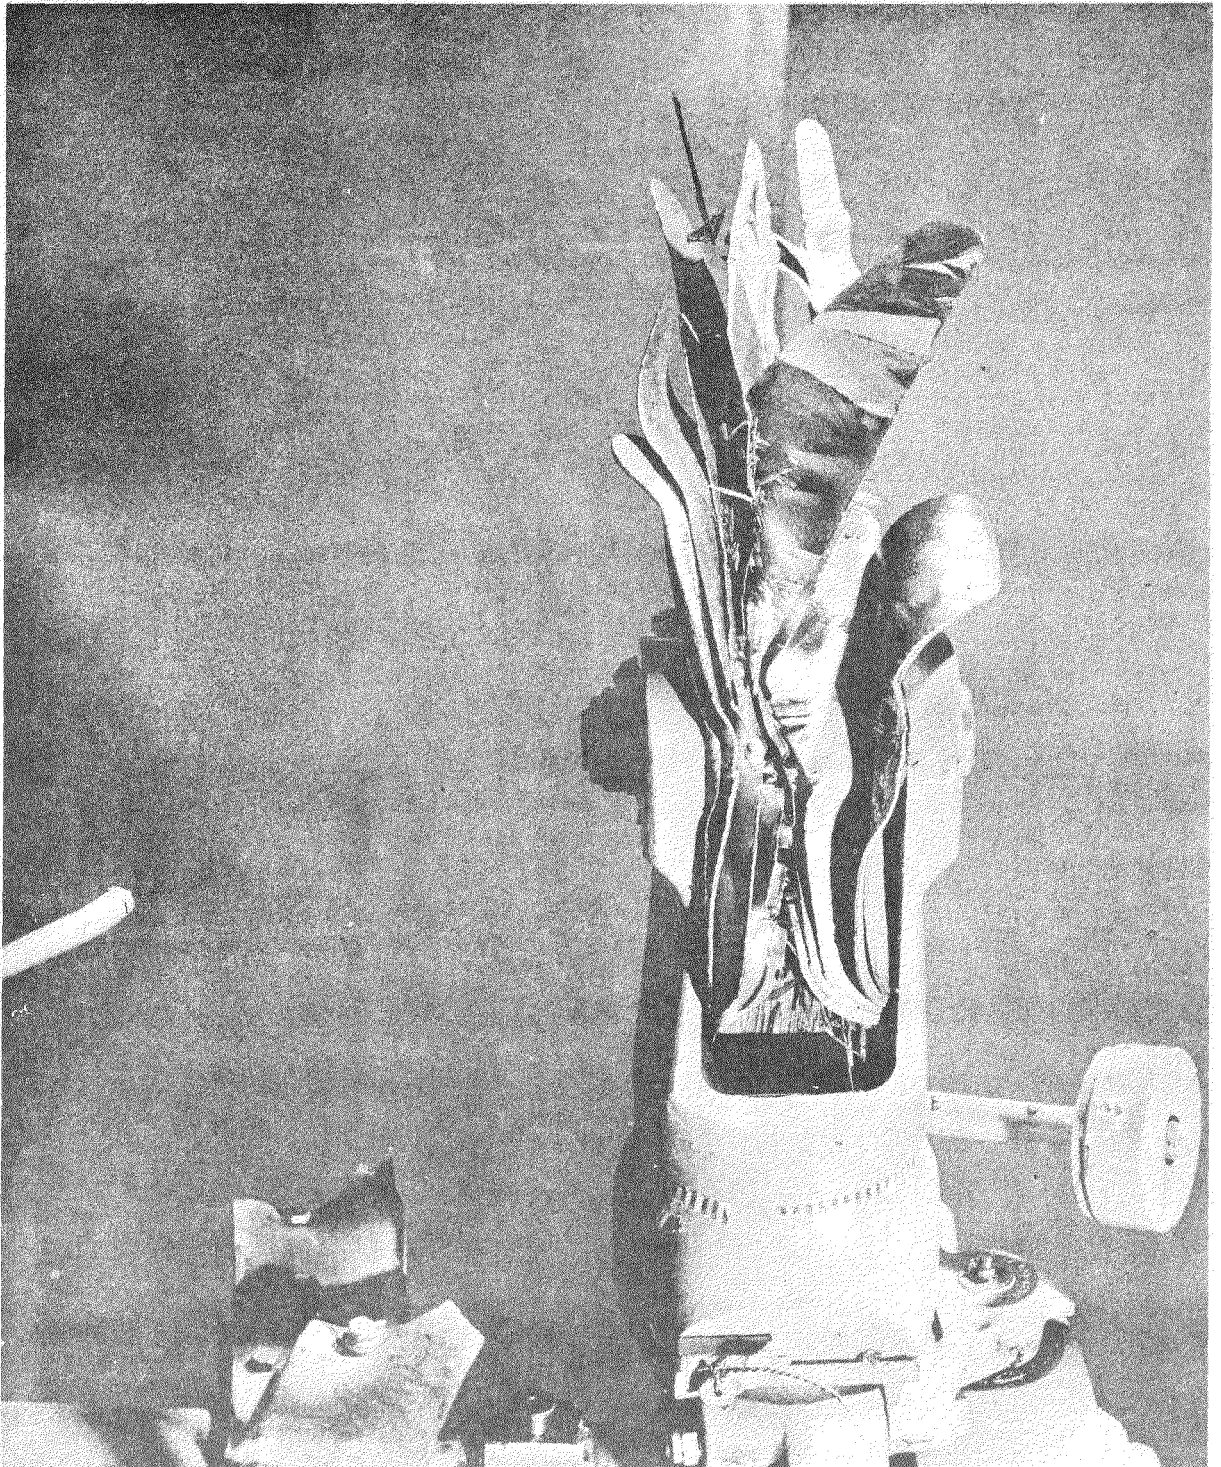
FIGURE 9

Laminates of blade No. PI-259. Arrow points to screw remaining in laminate which was repaired.

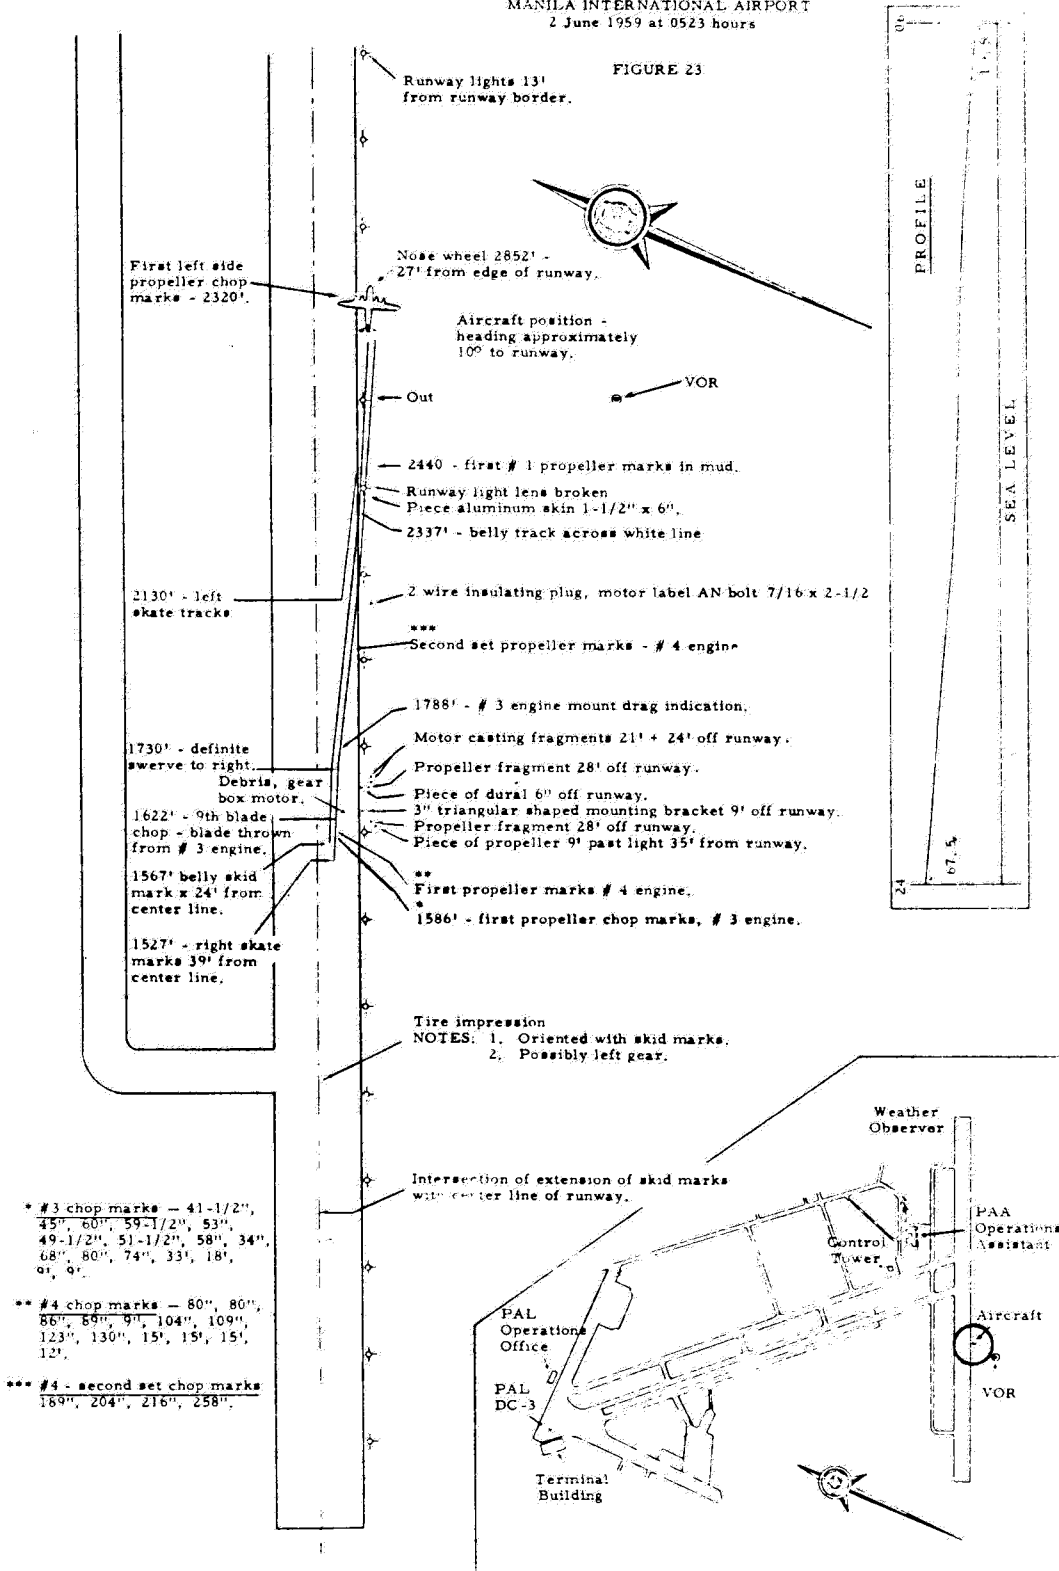
FIGURE 23

- * # 3 chop marks - 41-1/2", 45", 60", 59-1/2", 53", 49-1/2", 51-1/2", 58", 34", 68", 80", 74", 33', 18', 0', 0'
- ** # 4 chop marks - 80", 80", 86", 89", 9", 104", 109", 123", 130", 15', 15', 15', 12'
- *** # 4 - second set chop marks 169", 204", 216", 258"

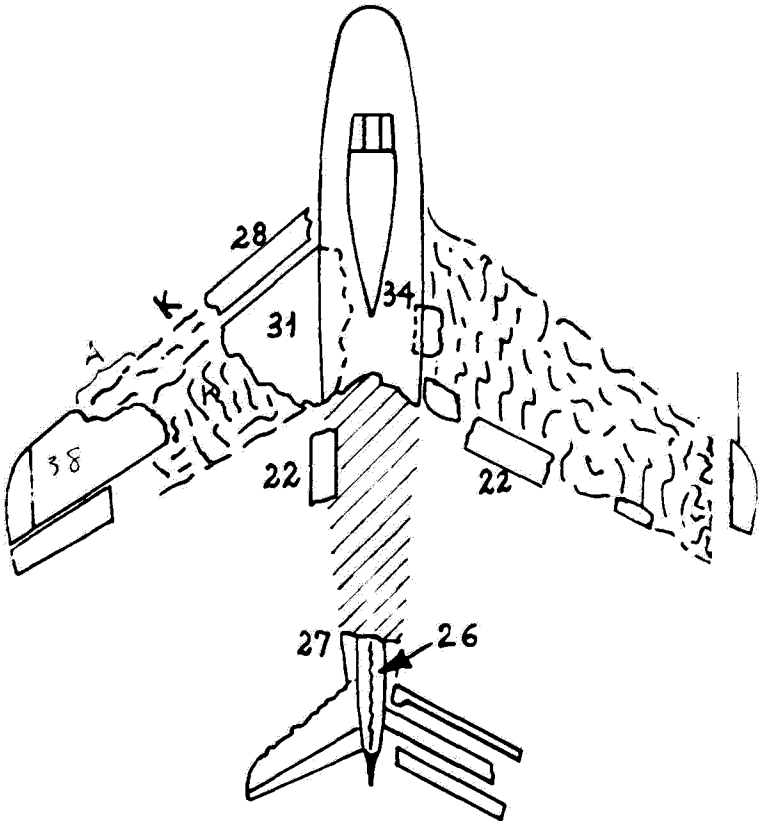
RECONSTRUCTION OF IN-FLIGHT COLLISION DAMAGE

Broken parts

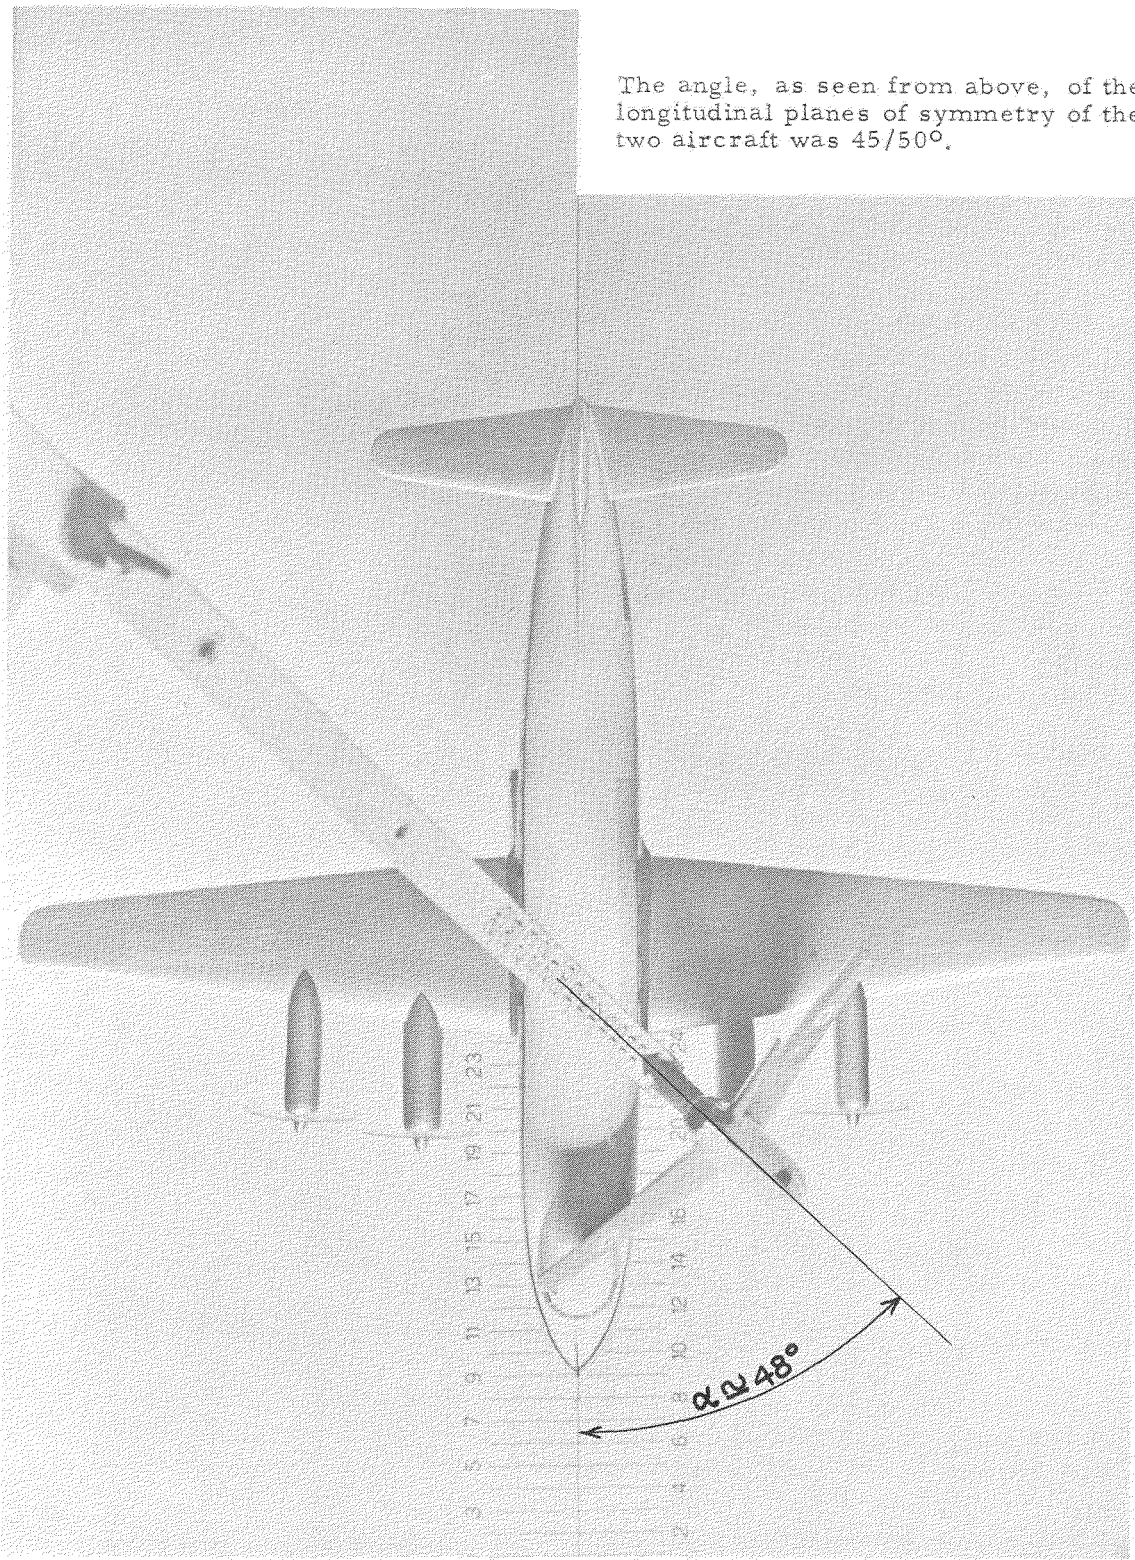
FIGURE 30

The angle, as seen from above, of the longitudinal planes of symmetry of the two aircraft was $45/50^{\circ}$. (See Figure 30)

The angle, as seen from above, of the longitudinal planes of symmetry of the two aircraft was $45/50^\circ$.

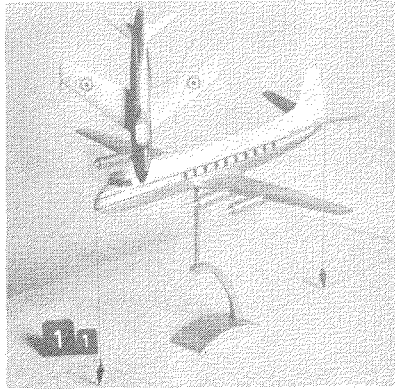
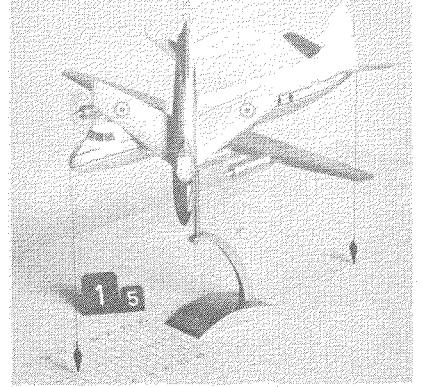
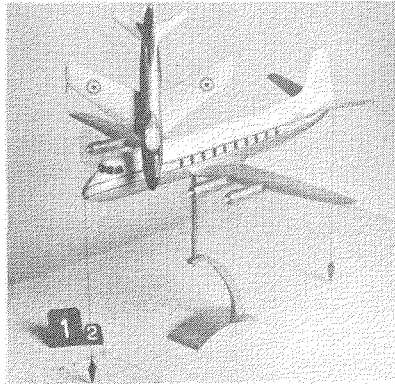
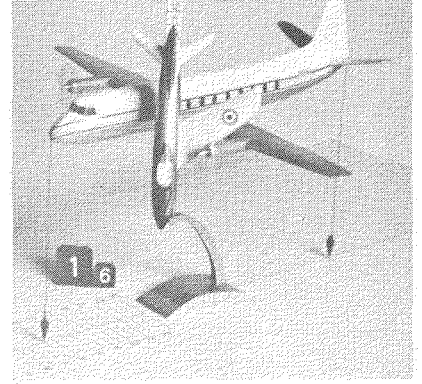
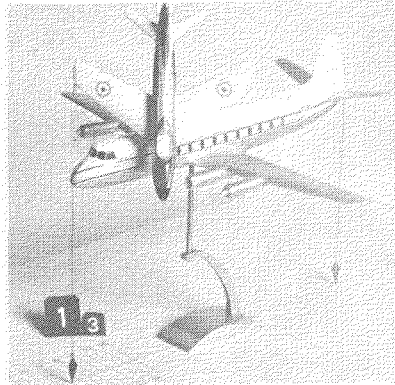
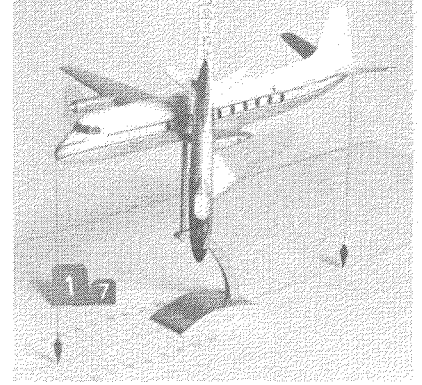
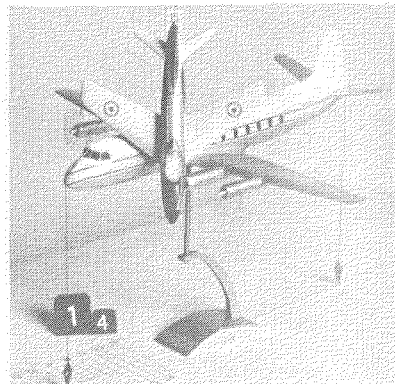
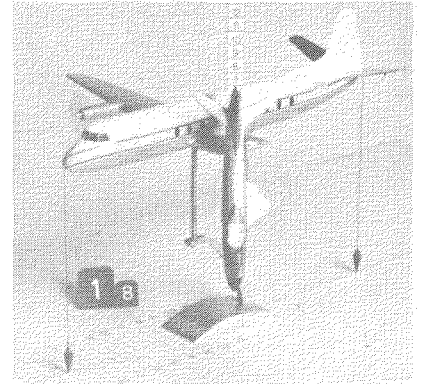
FIGURE 31

The figures in Figure 31 attempt to reconstruct the likely sequence of the collision.

Reconstruction
of the likely
sequence of the
collision.
