CIRCULAR 62-AN/57

AIRCRAFT ACCIDENT DIGEST

No. 11

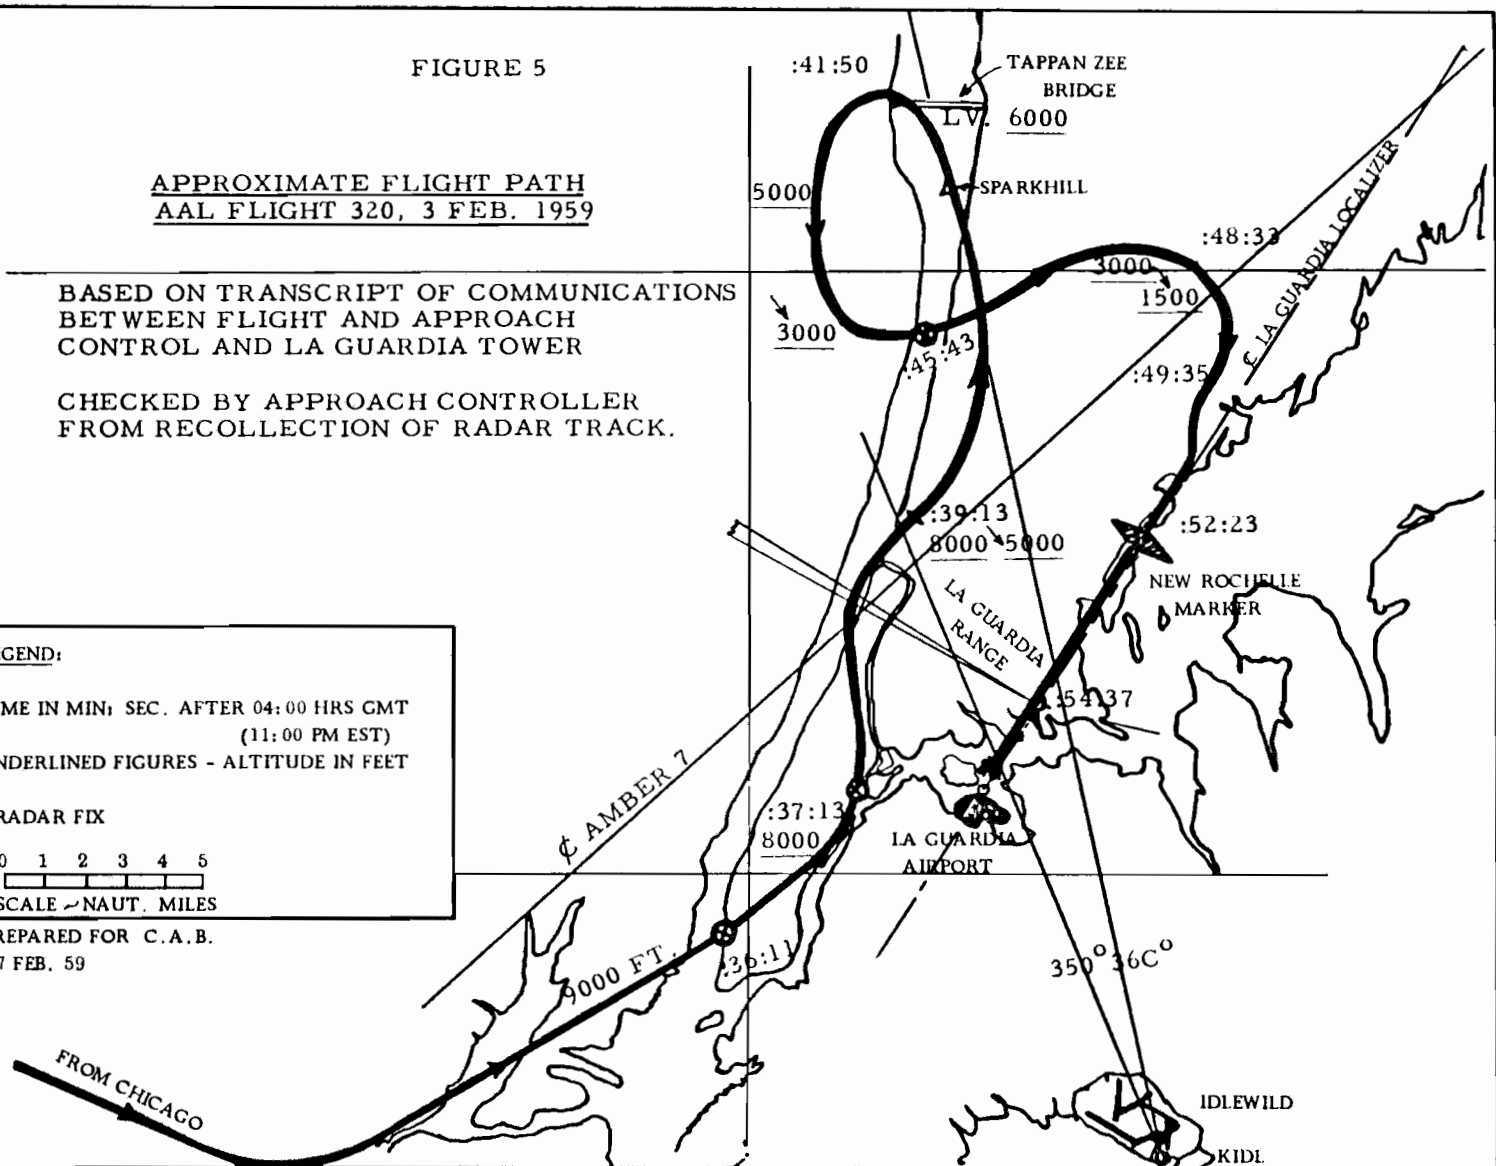
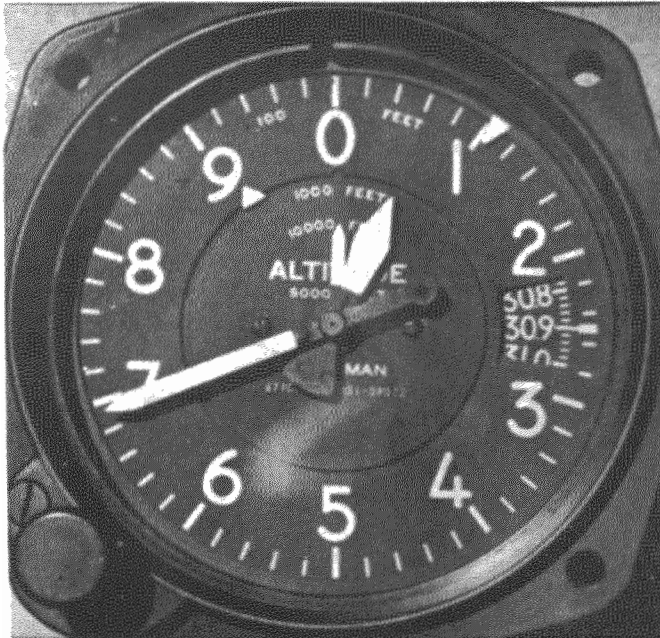
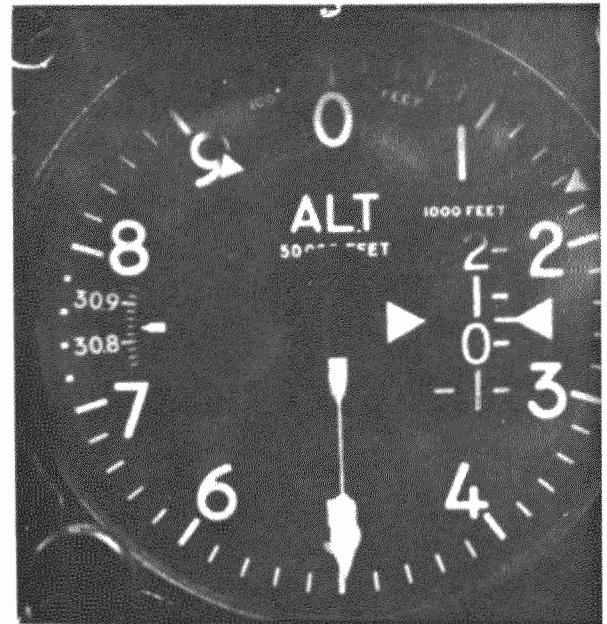
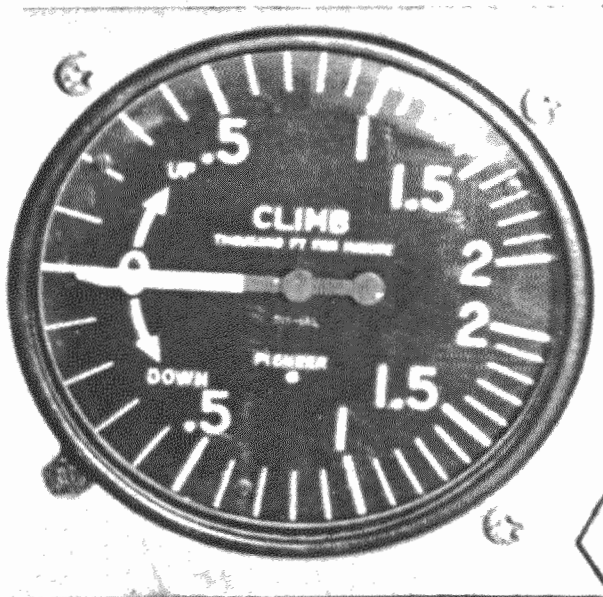
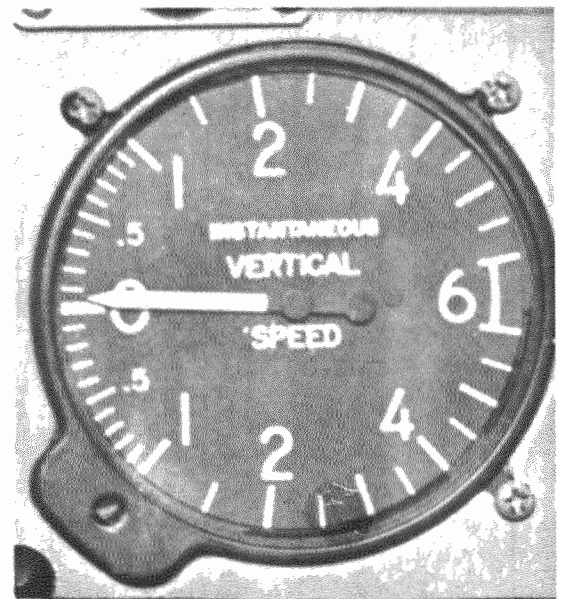
FIGURE 6

CONVENTIONAL THREE POINTER
TYPE SENSITIVE ALTIMETER

PRECISION DRUM TYPE ALTIMETER

RATE OF CLIMB INDICATOR

INSTANTANEOUS VERTICAL
SPEED INDICATOR

(ACCIDENT TO AMERICAN AIRLINES,
LOCKHEED ELECTRA, 3/2/59)

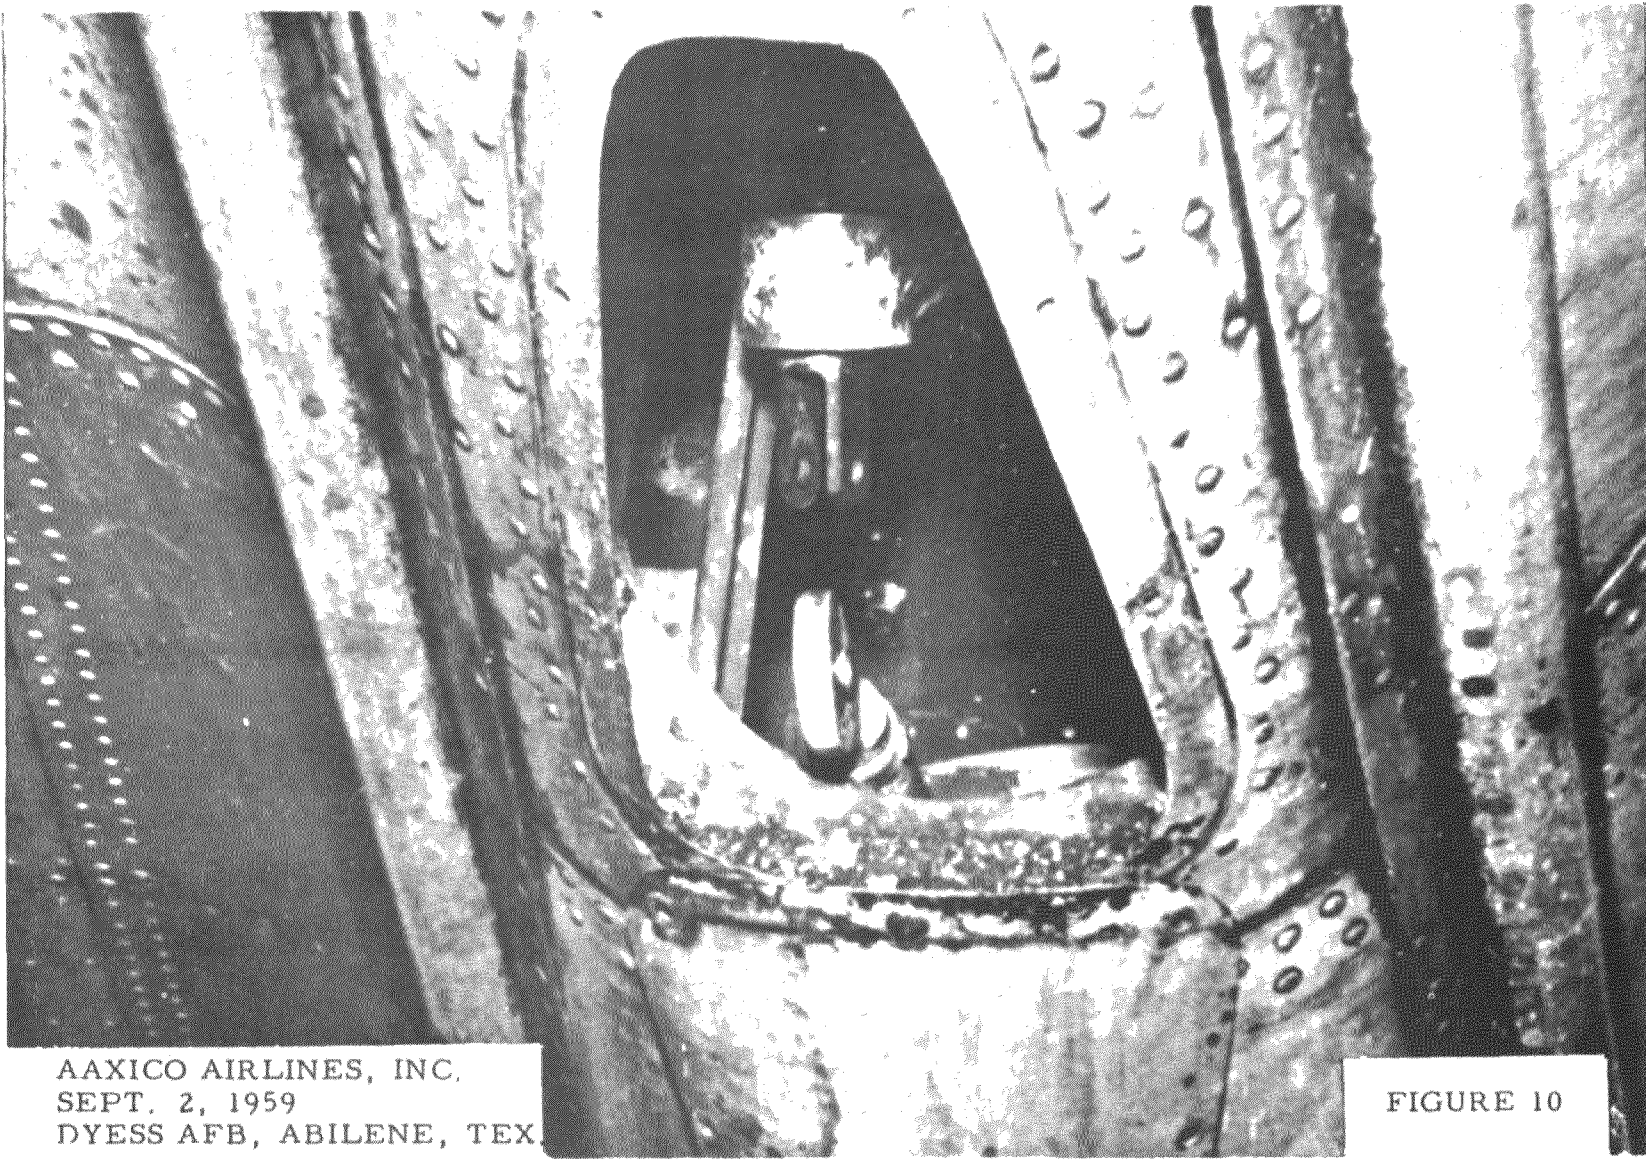
FIGURE 10

The probable cause of the accident was loss of elevator control because of an improperly secured bolt, a condition which was undetected because of an inadequate inspection.

AAXICO AIRLINES, INC.
SEPT. 2, 1959
DYESS AFB, ABILENE, TEX.

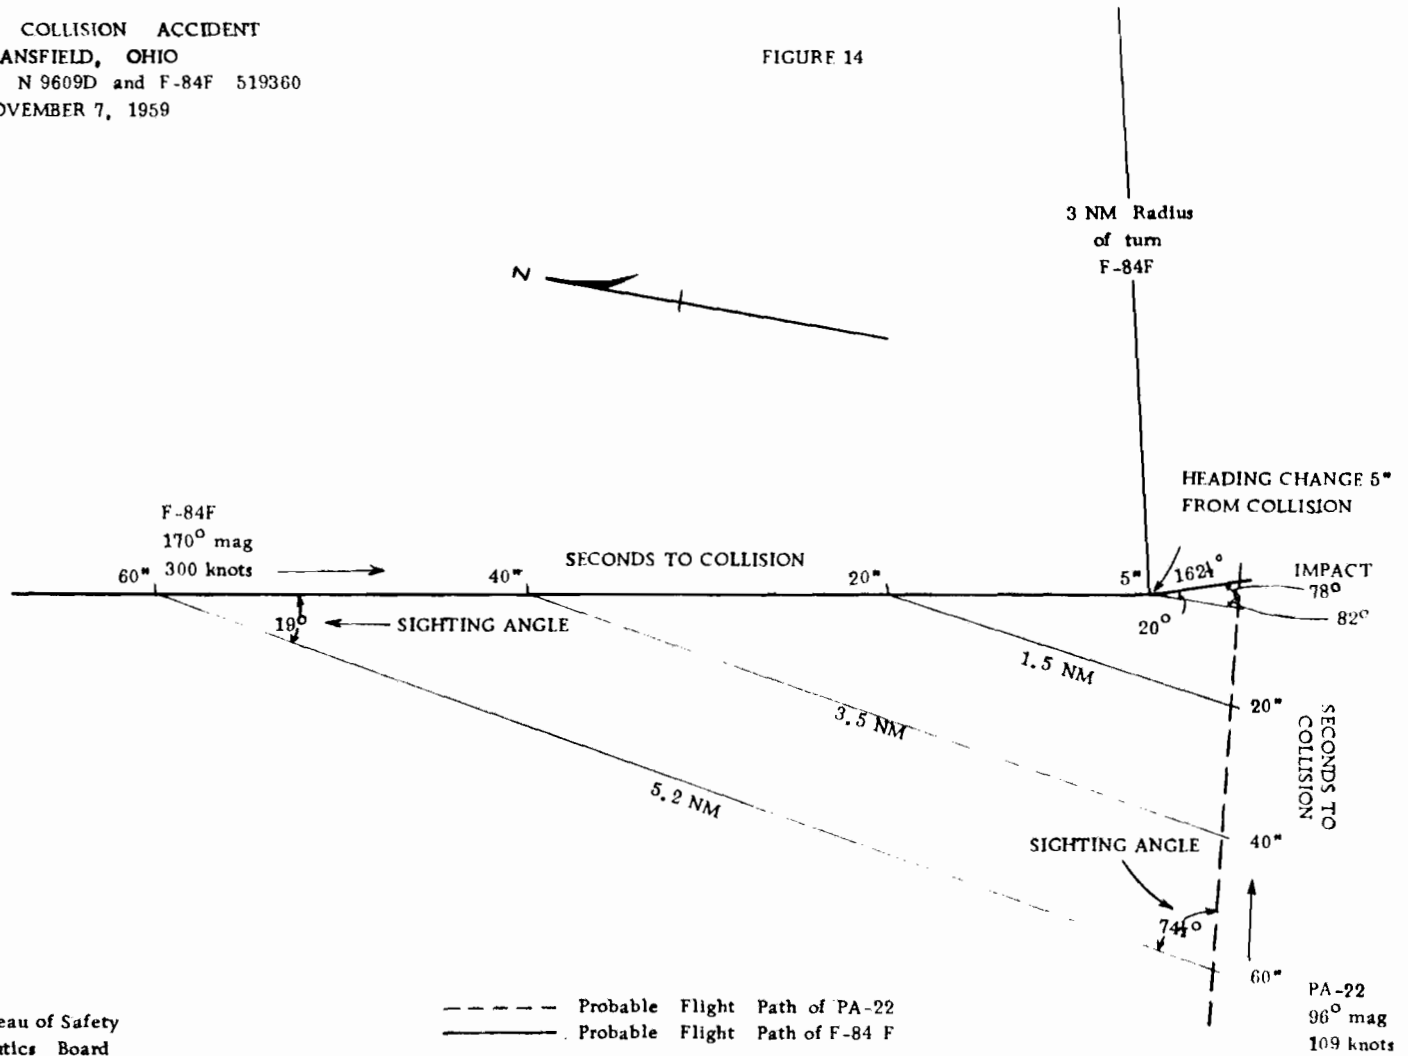
FIGURE 14

AIRCRAFT COLLISION ACCIDENT
 MANSFIELD, OHIO
 PIPFR PA 22, N 9609D and F-84F 519360
 NOVEMBER 7, 1959

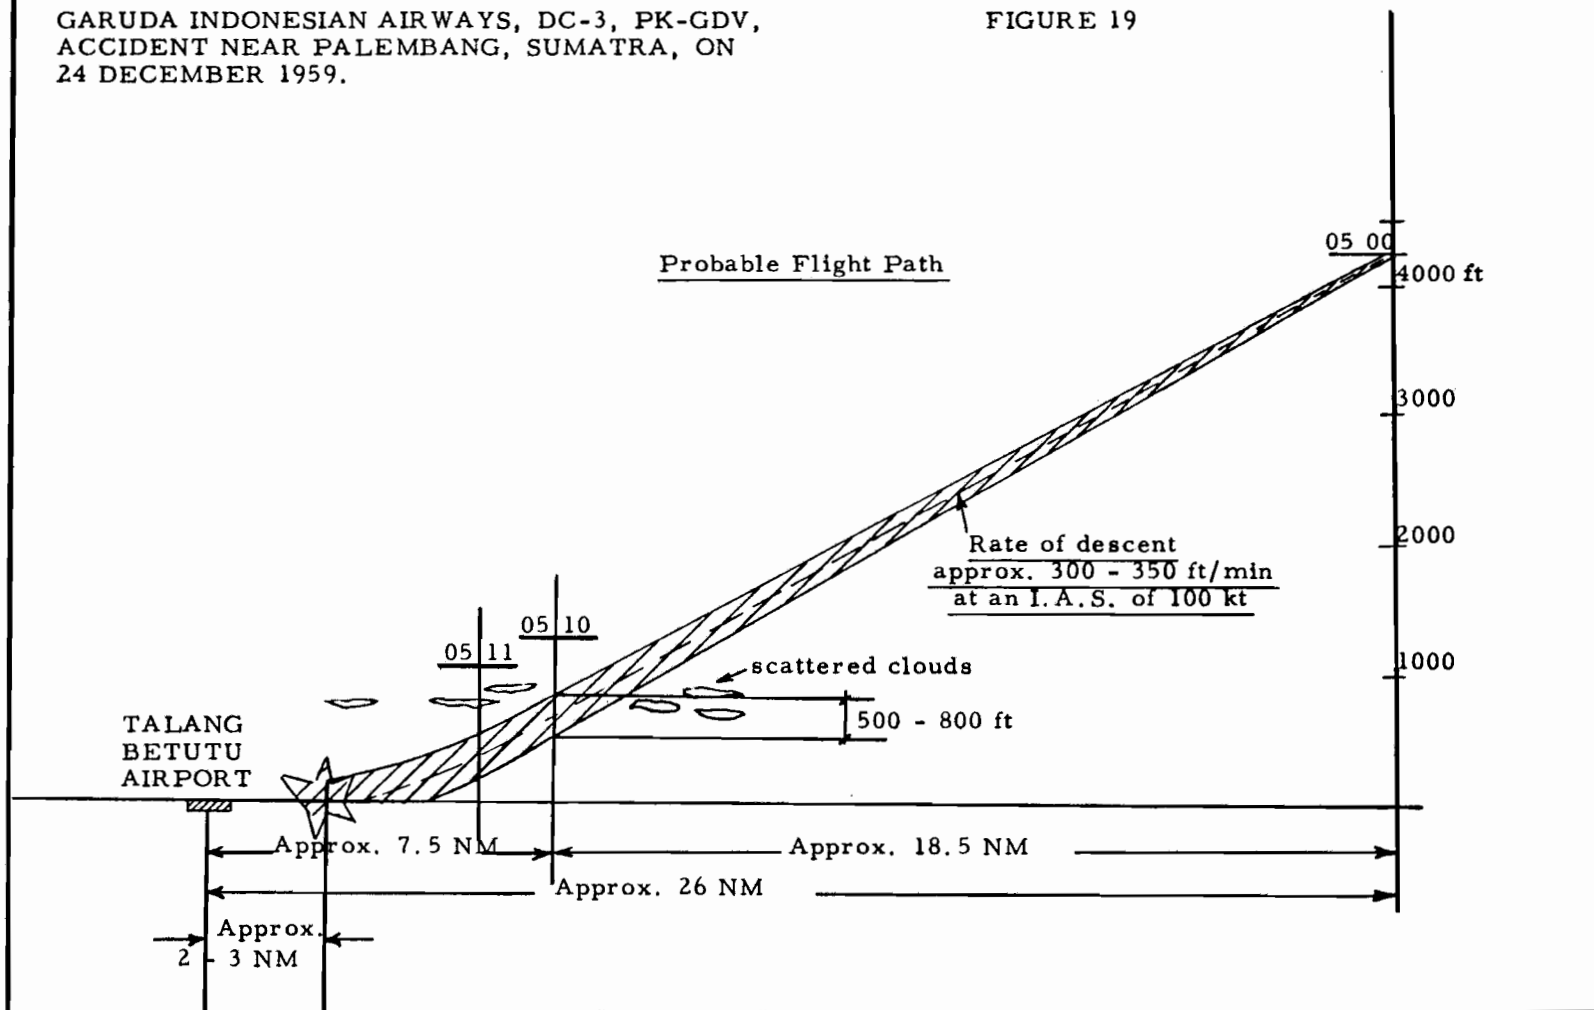
FIGURE 19

Several possible flight paths were considered by the Committee, but the most likely is shown in Figure 19.

GARUDA INDONESIAN AIRWAYS, DC-3, PK-GDV,
ACCIDENT NEAR PALEMBANG, SUMATRA, ON
24 DECEMBER 1959.
