ICAO

CIRCULAR 64-AN/58

AIRCRAFT ACCIDENT DIGEST

No. 12

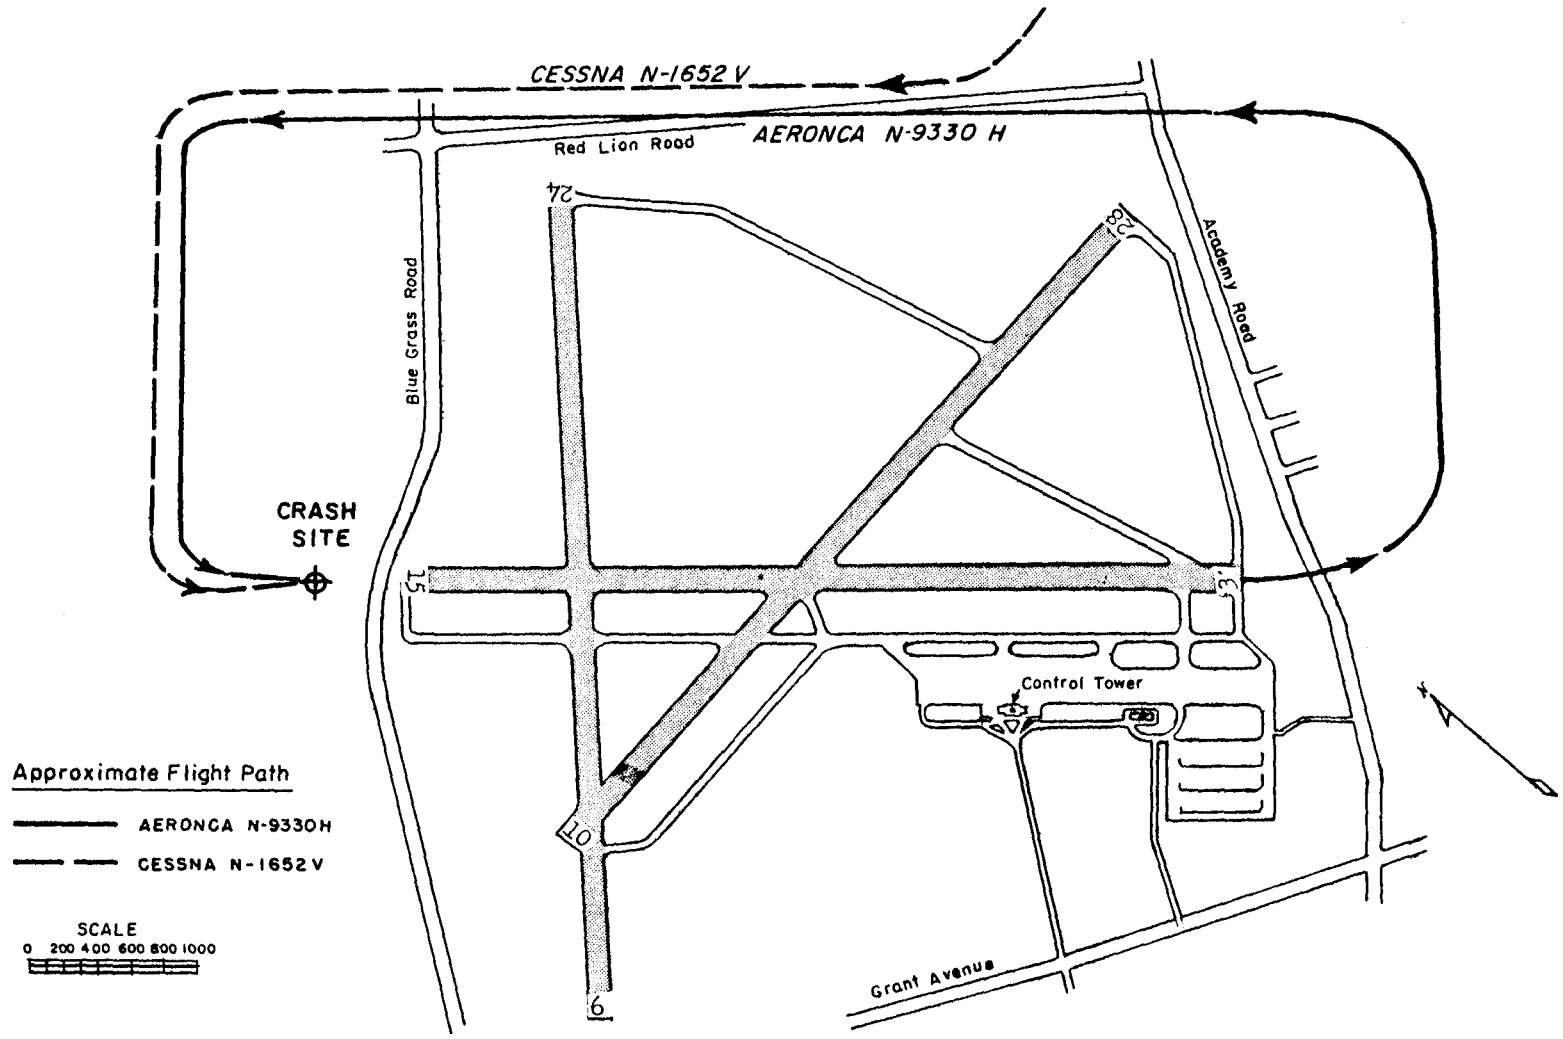
FIGURE 1

COLLISION OF CESSNA 140, N-1652 V, AND AERONCA L-16, N-9330 H NEAR NORTH PHILADELPHIA AIRPORT September 30, 1959

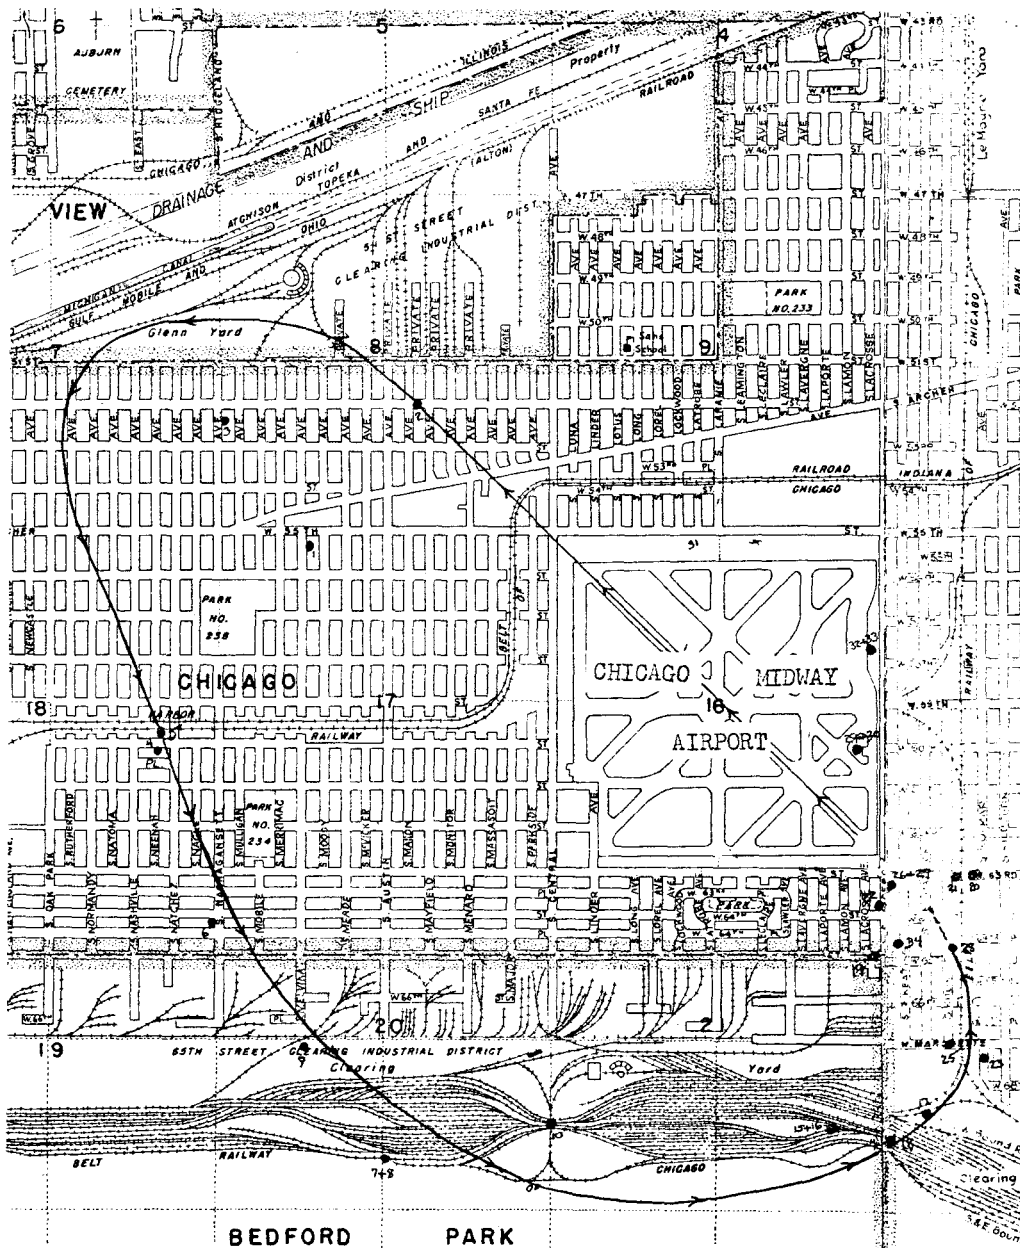
FIGURE 3

APPROXIMATION OF PROBABLE FLIGHT PATH AS DERIVED FROM WITNESS STATEMENTS

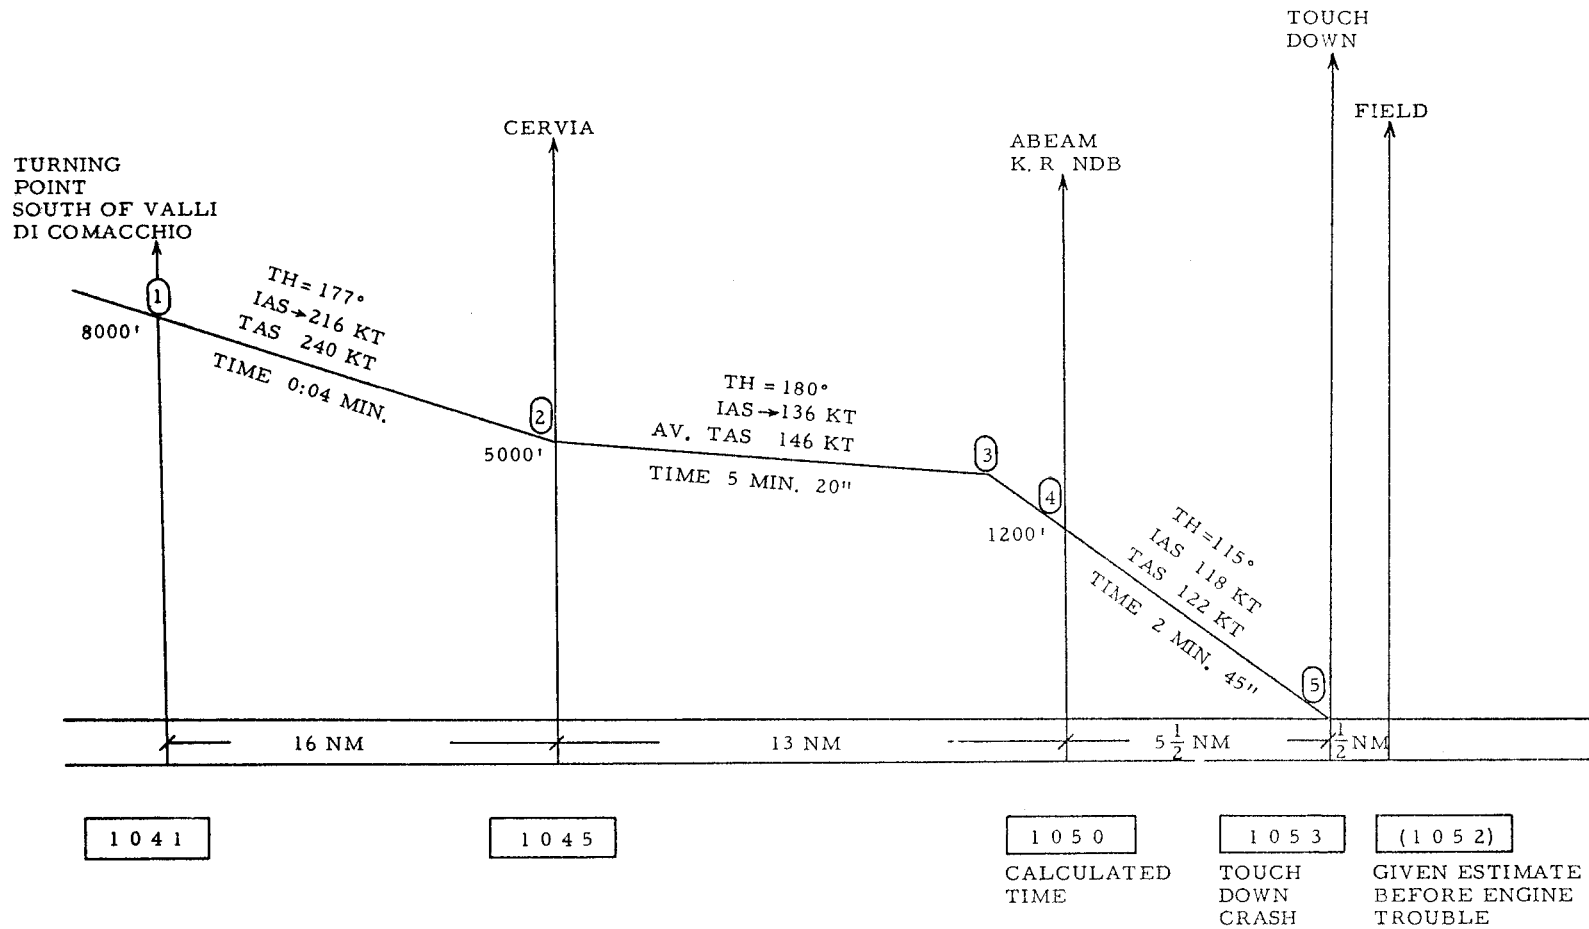
FIGURE 12

ROUTE CHIOGGIA - RIMINI

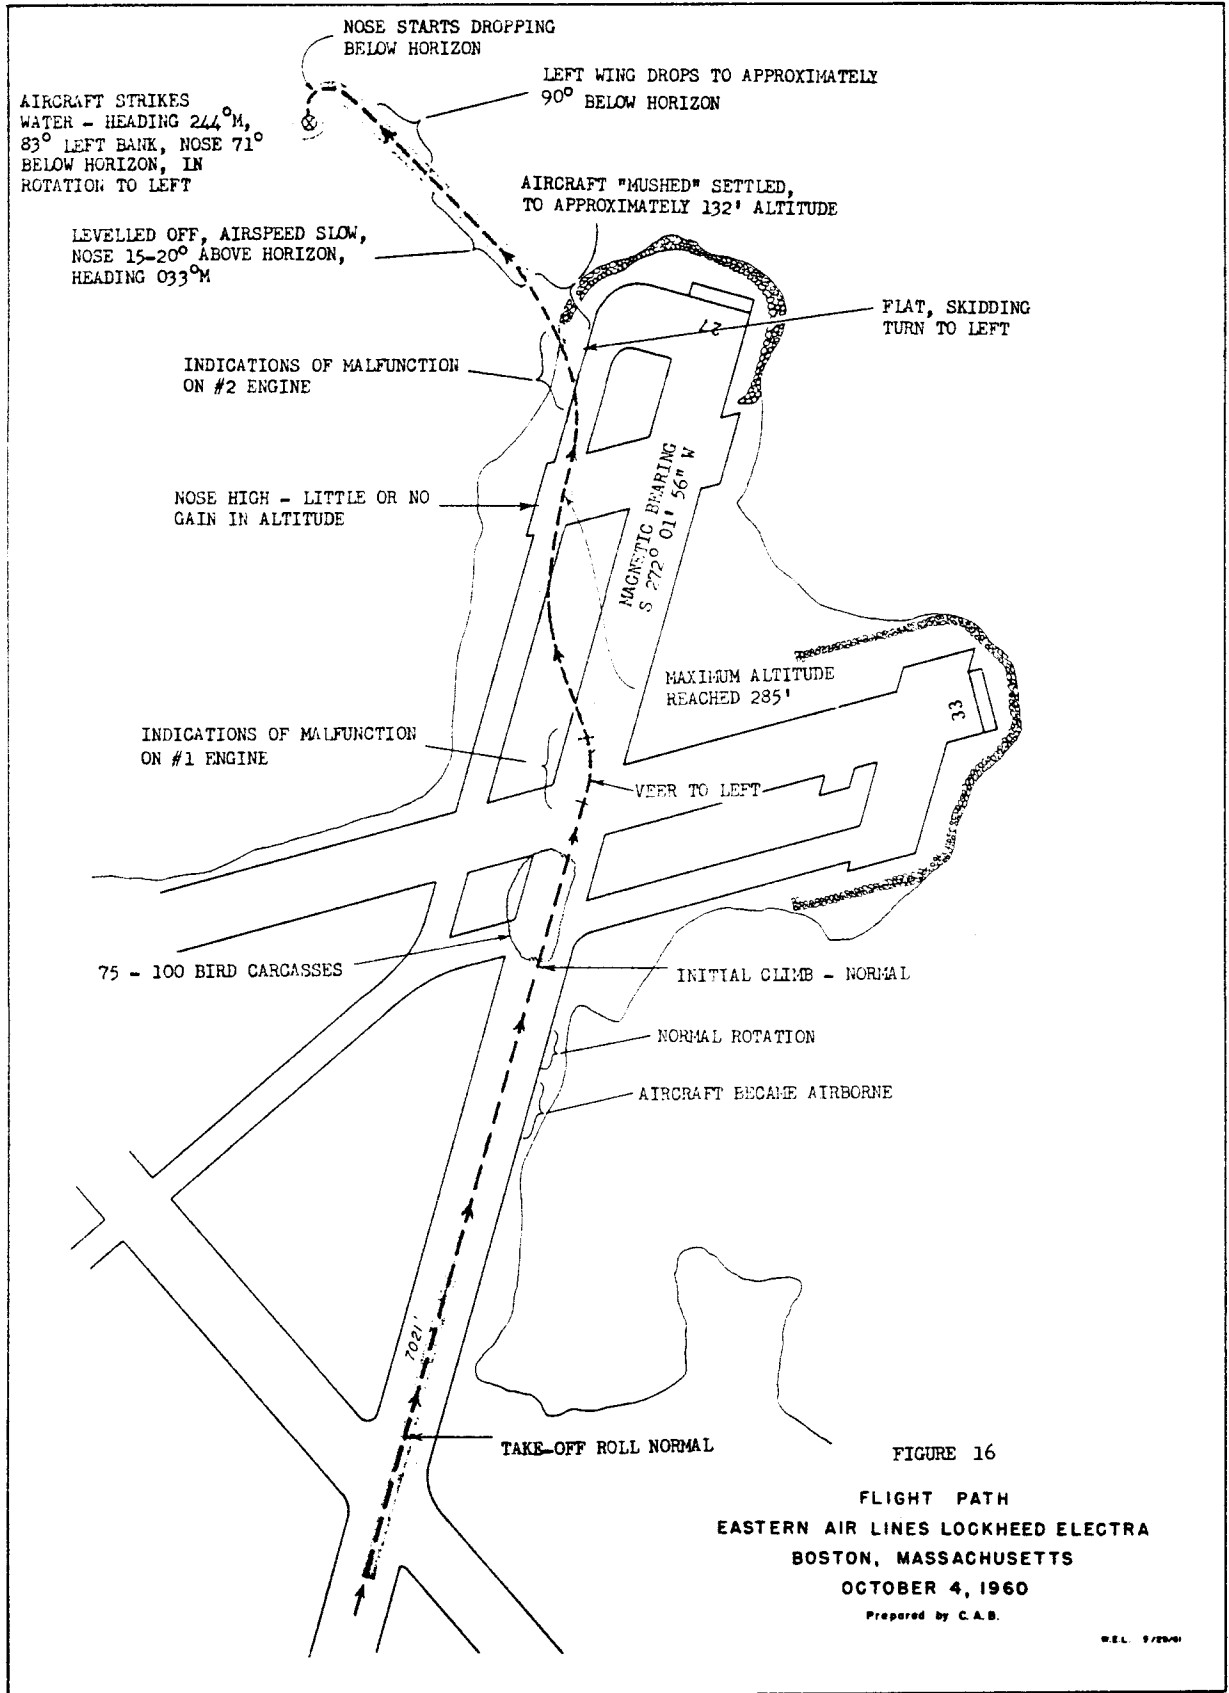
FIGURE 16
 FLIGHT PATH
 EASTERN AIR LINES LOCKHEED ELECTRA
 BOSTON, MASSACHUSETTS
 OCTOBER 4, 1960
 Prepared by C.A.B.

Description of take-off based on eyewitnesses' statements (See Figure 16)

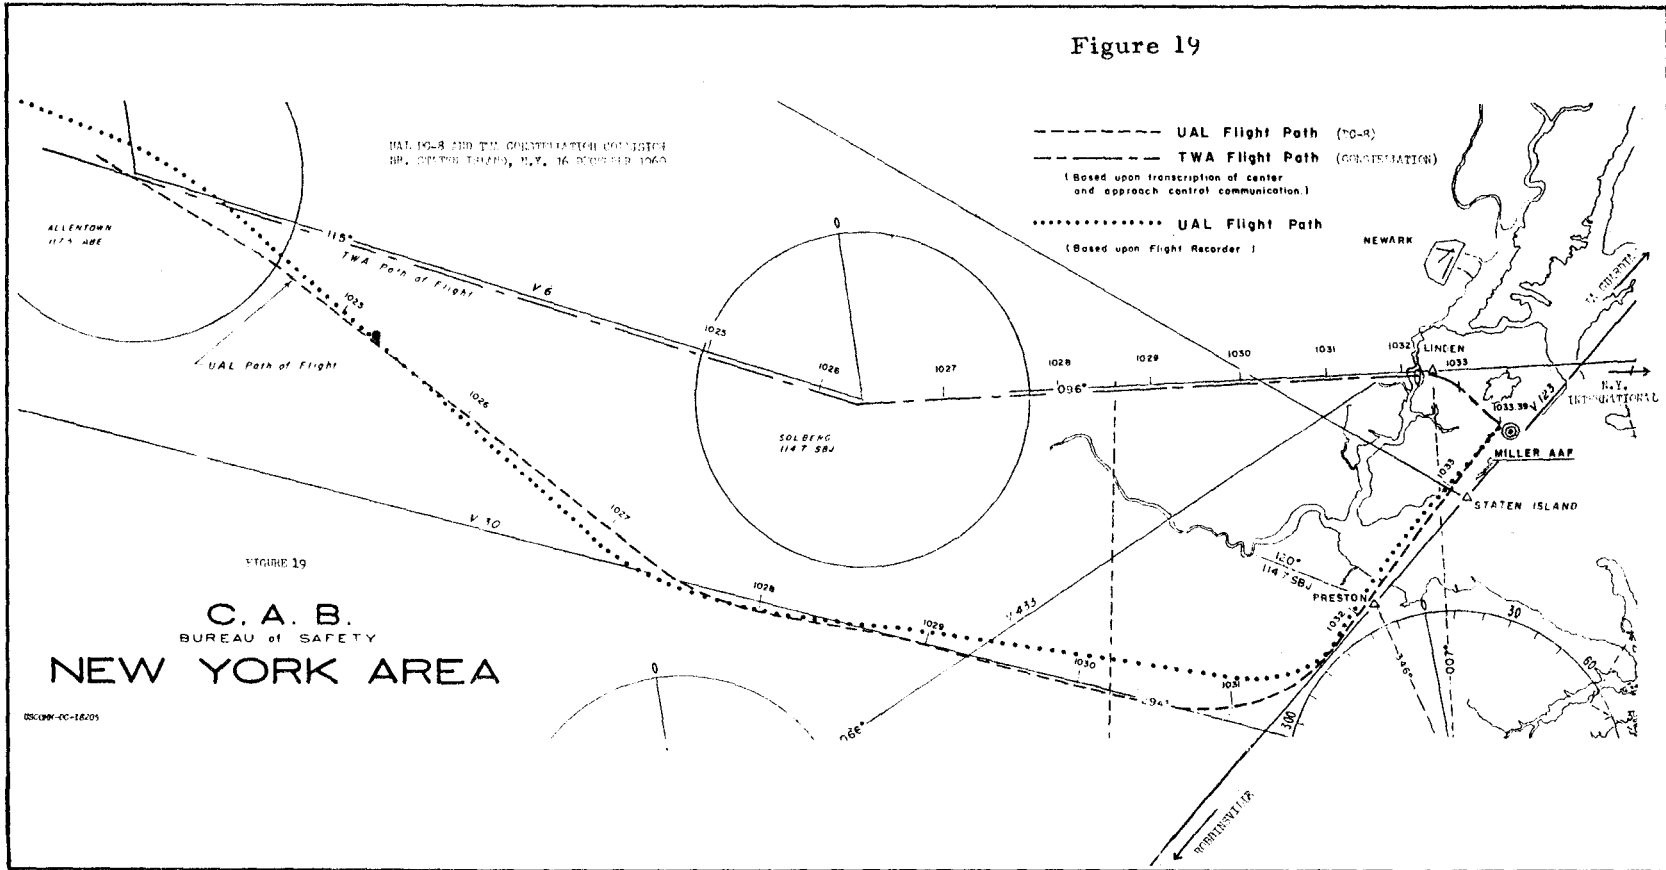
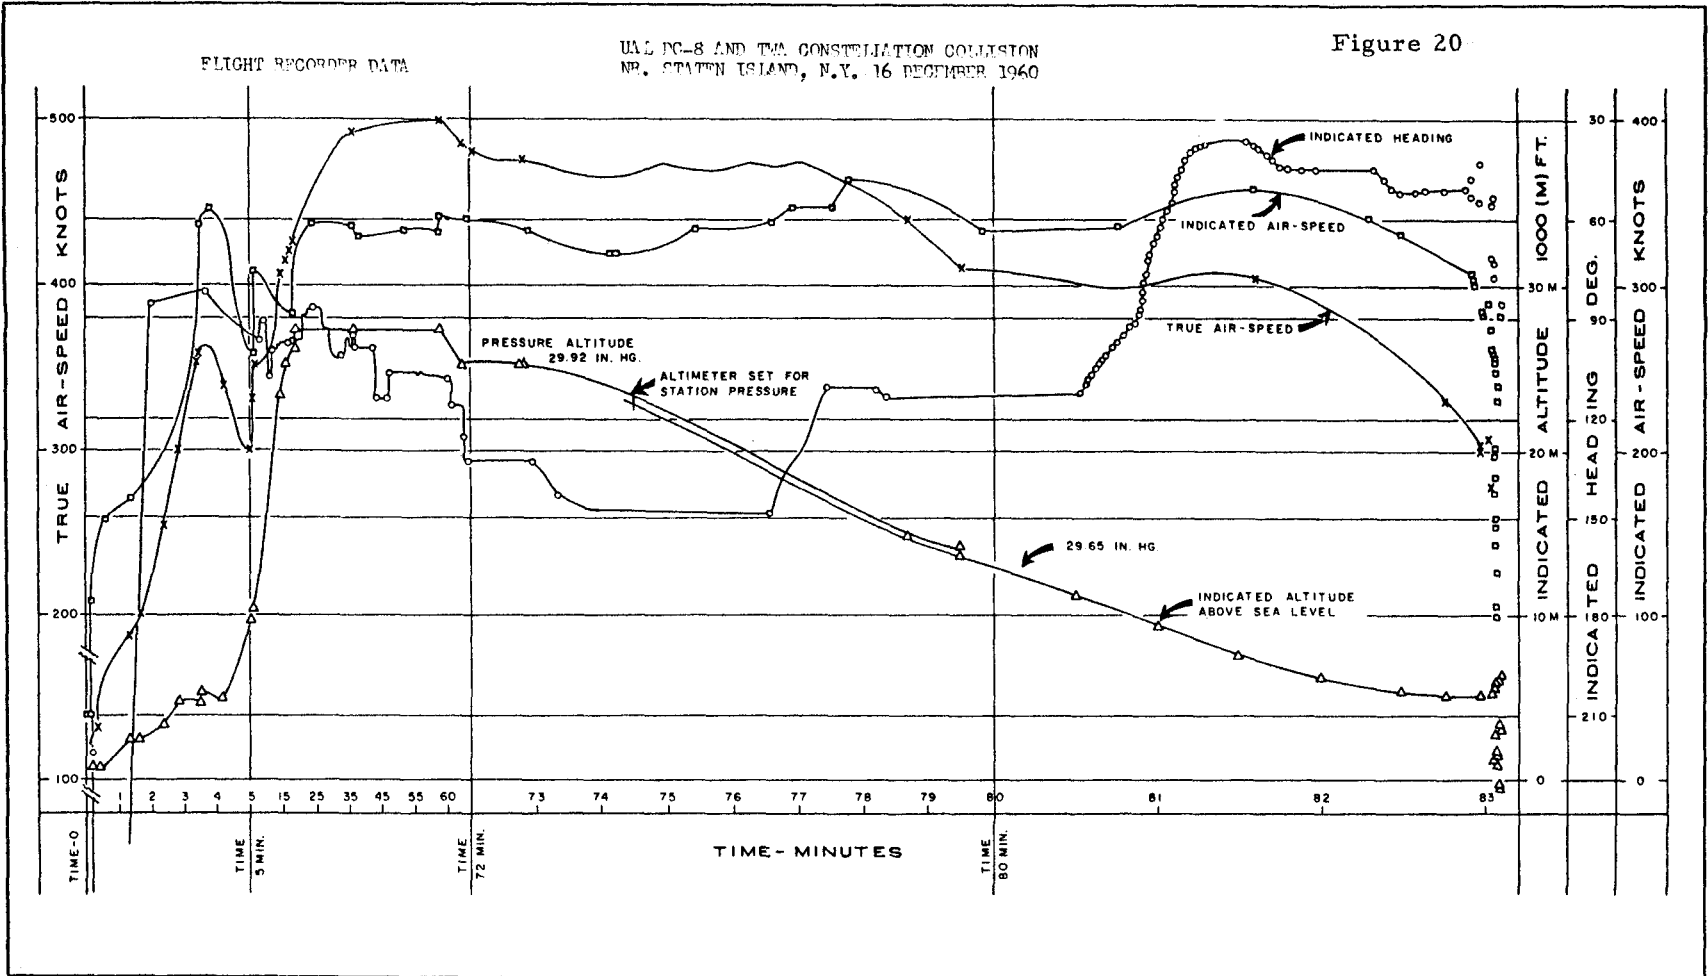
The data obtained relative to altitudes, indicated airspeeds, and headings are shown in Figure 20. The flight recorder values between 72 minutes after take-off and the time of collision are plotted as a track profile in Figure 19. This track was plotted in reverse from the point of collision determined by a trajectory study of the DC-8 No. 4 engine and the TWA Constellation No. 3 engine.

The flightpath of United 826 as derived from the flight recorder readout was plotted independently of the information obtained from the communications tapes. The two tracks depicted in Figure 19 are similar. The starting point of each track was the point of collision as determined by the trajectory study. The flightpath was then worked out in reverse from this point using the information obtained from the flight recorder readout. The successive points were determined and plotted back along the flight path to Allentown. The data points were then joined in a faired curve.

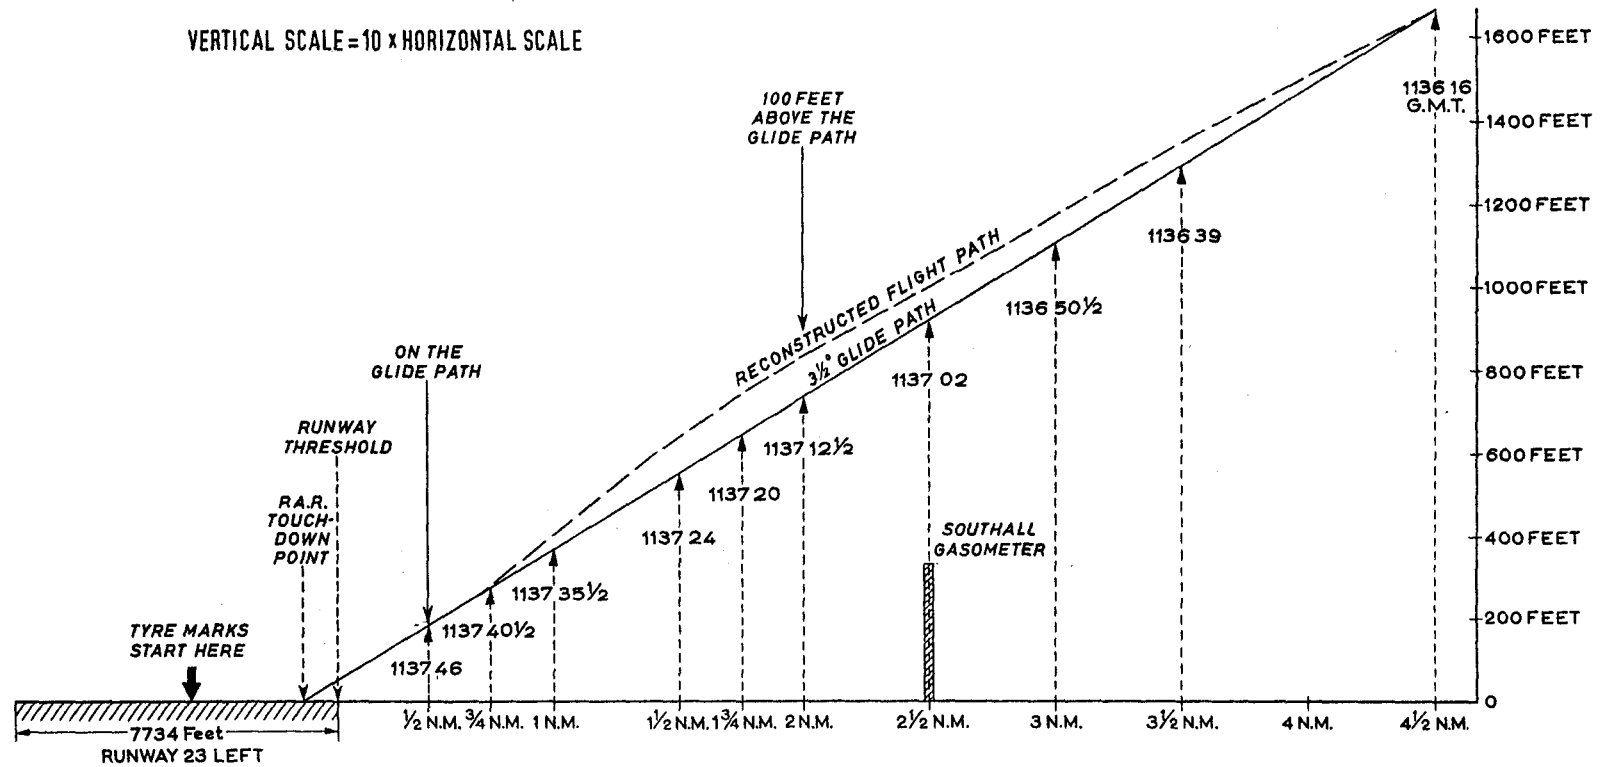
FIGURE 21

A profile reconstruction of the aircraft's descent during the precision approach radar is shown at Figure 21. Calculations made on a basis of the time taken between the radar ranges show that the average groundspeed of the aircraft between the 4-1/2 and 1/2 mile ranges was approximately 160 kt. Bearing in mind that the wind at 2 000 ft and 1 000 ft was 230°/10 kt and the surface wind was 240°/4 kt it would appear likely that the aircraft's airspeed was about 10 kt higher than the groundspeed during most of the approach.

RECONSTRUCTION OF P.A.R. TALKDOWN OF BOEING 707 G-APFN
 (Side Elevation)

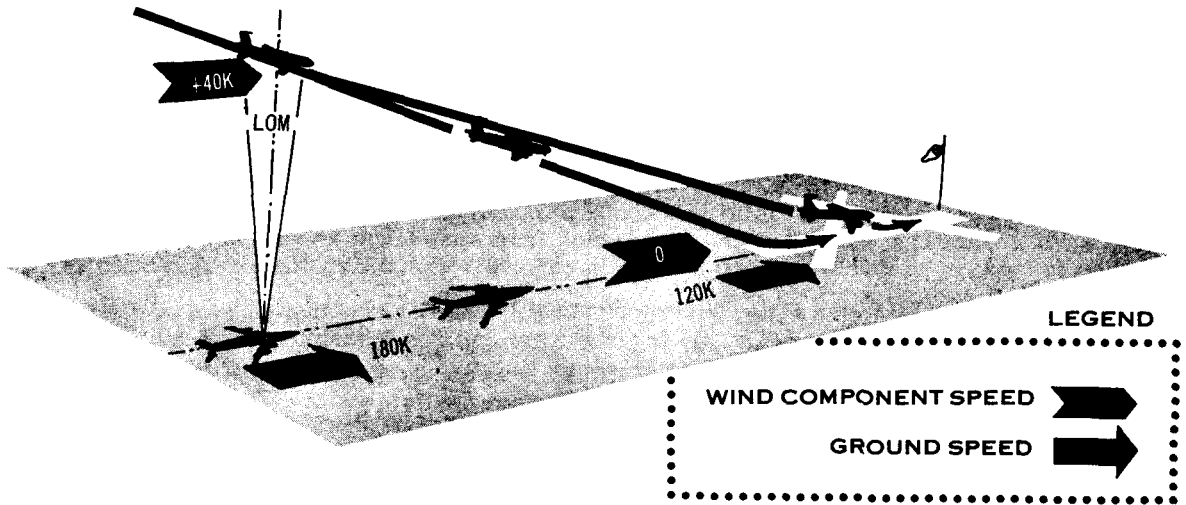
FIGURE TWO

"In Figure 2 we consider an abnormal tailwind approach in which a 40-knot tailwind exists at the outer marker with a zero surface wind. As can be computed in this case, the average ground speed from the outer marker to touchdown is 150 knots, which results in an elapsed time of 1.24 minutes and an average rate of descent of 800 feet per minute for a precisely executed approach. Comparing this example with Figure 1, we see that while the airspeed is decelerated 20 knots in both cases the ground speed in the latter case must be decelerated 60 knots in a faster time than the 20 knot deceleration in the normal approach of Figure 1. This is the root of the problem, for whenever the wind environment changes faster than the aircraft mass can be accelerated or decelerated, the wind variations must be reflected by changes in airspeed. In the tailwind situation depicted in Figure 2, should the pilot be unable to decelerate his

aircraft in the faster time required, he would find his airspeed had increased, very likely he would have gone above glide path in an effort to hold desired airspeed, and he would have to go around. (Assuming, of course, he wisely resists the temptation to land long.) One more point, the more gradual the shear the more likely the pilot is to be able to decelerate to remain on glide path and at desired indicated airspeed. "

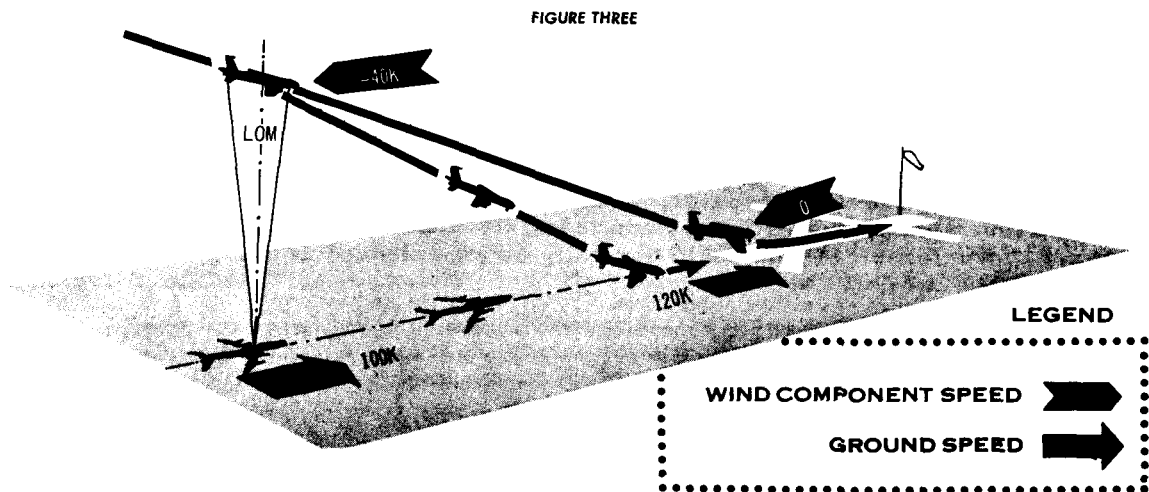
FIGURE THREE

"In Figure 3 we take up the strong headwind-aloft condition. In this case we have a 40-knot headwind over the outer marker and a zero component on the ground. In this case we find that the average ground speed from outer marker to touchdown is 110 knots, which results in an elapsed time of 1.7 minutes and an average rate of descent

of 580 feet per minute for a precisely executed approach. In comparing this situation with the normal profile approach depicted in Figure 1, we see that in the headwind shear approach the aircraft ground speed must be accelerated by 20 knots during the final approach instead of the normal 10 knot deceleration. Unless this acceleration is accomplished, the aircraft will sink below the glide slope and land short of the runway. Occasionally the shear will not be gradual, but will occur rapidly. If the speed falls below stall speed the aircraft will lose altitude until it crashes or flying speed is recovered. Time required for acceleration to flying speed may exceed that available. To illustrate, following are calculations for a particular aircraft. Conditions are: altitude 1 000 millibars, power setting constant, air speed 100 knots, headwind 20 knots. When the aircraft is instantaneously placed in calm air the times to accelerate to the indicated ground speeds are:

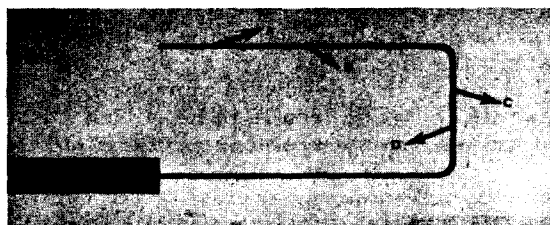
FIGURE FOUR

"Figure 4 provides an indication of clues to wind shear that the pilot can pick up in the pattern. Assuming a calm, or near calm surface wind, if crabbing as depicted in A or B is necessary, lateral shear can be expected on final. If crabbing is required as depicted in C, a tailwind component is present at pattern altitude and over-shoot problems, as discussed in the section on TAILWIND APPROACH, should be anticipated. If crabbing is required as depicted in D, a headwind component is present and a short touchdown potential exists if the gradient is large enough and occurs rapidly during the final approach path. "

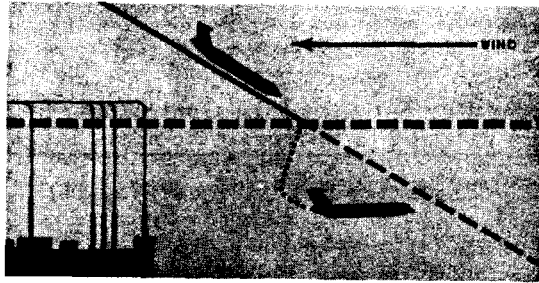
FIGURE FIVE

"Shear can be anticipated whenever there is an inversion (Figure 5). Shear is also a hazard potential with frontal passage and in and near thunderstorms. Severe down drafts associated with thunderstorms warrant delaying take-off or landing when such storms are over or adjacent to the airfield. Shear should be anticipated when taking off or landing over cliffs, water, in hilly terrain and with large buildings or trees adjacent to the runway. Normally, the severity of such low altitude wind shear bears a direct relationship to the surface wind speed. Don't overlook the help you can obtain from the weather forecaster. Check with him before take-off and, when you suspect shear, call him before making your final approach. "
