CIRCULAR 69-AN/61

AIRCRAFT ACCIDENT DIGEST

No. 13

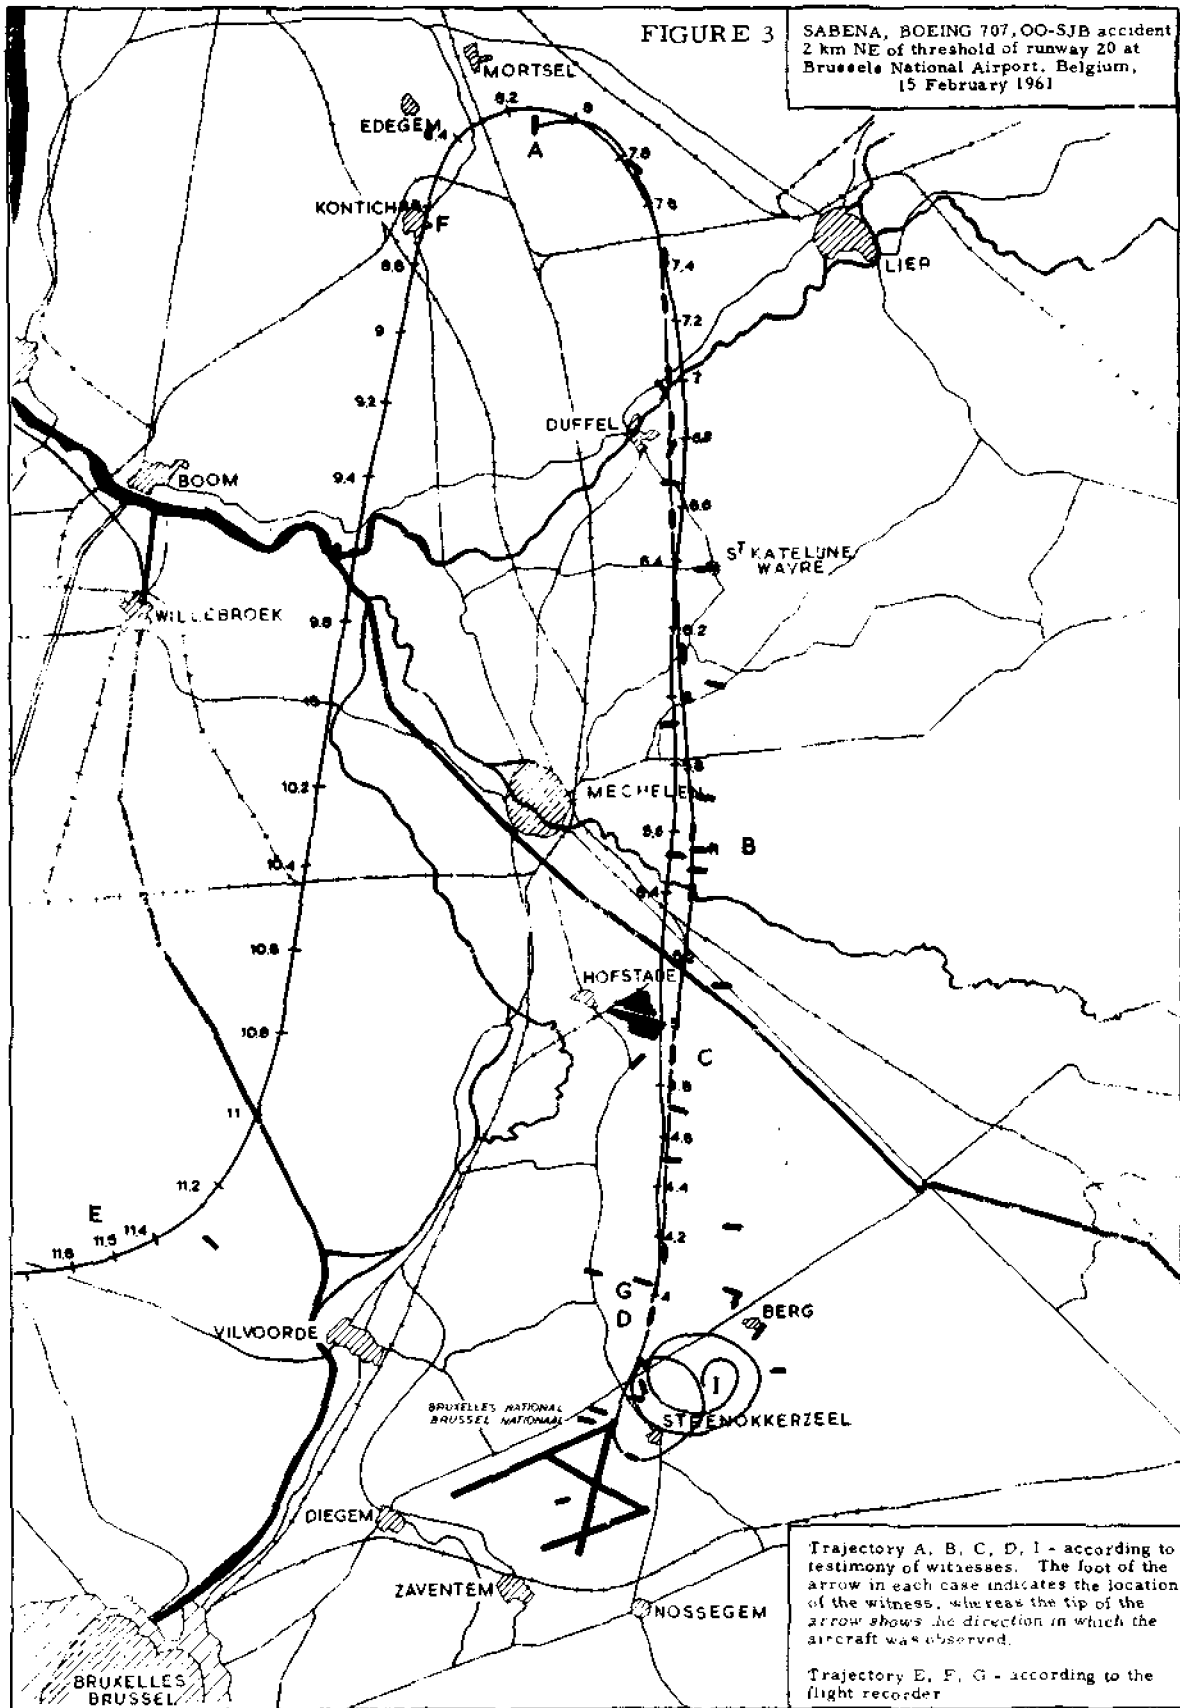
FIGURE 3

The trajectory was also reconstructed from the turn onto a long final approach until impact. The trace of this trajectory figures as Points A, B, C, D and I on Figure 3. These witnesses included persons spaced along the trajectory, Air Force personnel stationed at the airport, personnel of the Air Traffic Control Services and aircrew and technical personnel of Sabena.

The trajectory is shown as Points E, F and G on Figure 3. It is based on information extracted every 12 or 15 seconds on the time scale of a graph. It is to be noted that the flight recorder was an experimental model and, moreover, it was found in an area where the fire was particularly intense. For this reason, the value of the information furnished by the graph during the last 4 or 5 minutes of flight is uncertain or worthless. The recorder does not give points of the trajectory directly. It provides for the airspeed and heading of the aircraft at each instant. From these observations and supposing that the speed vector has the same direction as the heading, a series of tangents can be traced for which the envelope constitutes the trajectory. There is no correlation between the times of the testimonies and the times of the recorder, however, one may attempt to place the curve established according to the witnesses' testimony over the curve established according to the elements of the flight recorder by displacing the latter and by taking into account its orientation, which is determined by the indications of successive headings.

Trajectory A, B, C, D, I - according to testimony of witnesses. The foot of the arrow in each case indicates the location of the witness, whereas the tip of the arrow shows the direction in which the aircraft was observed.

Trajectory E, F, G - according to the flight recorder

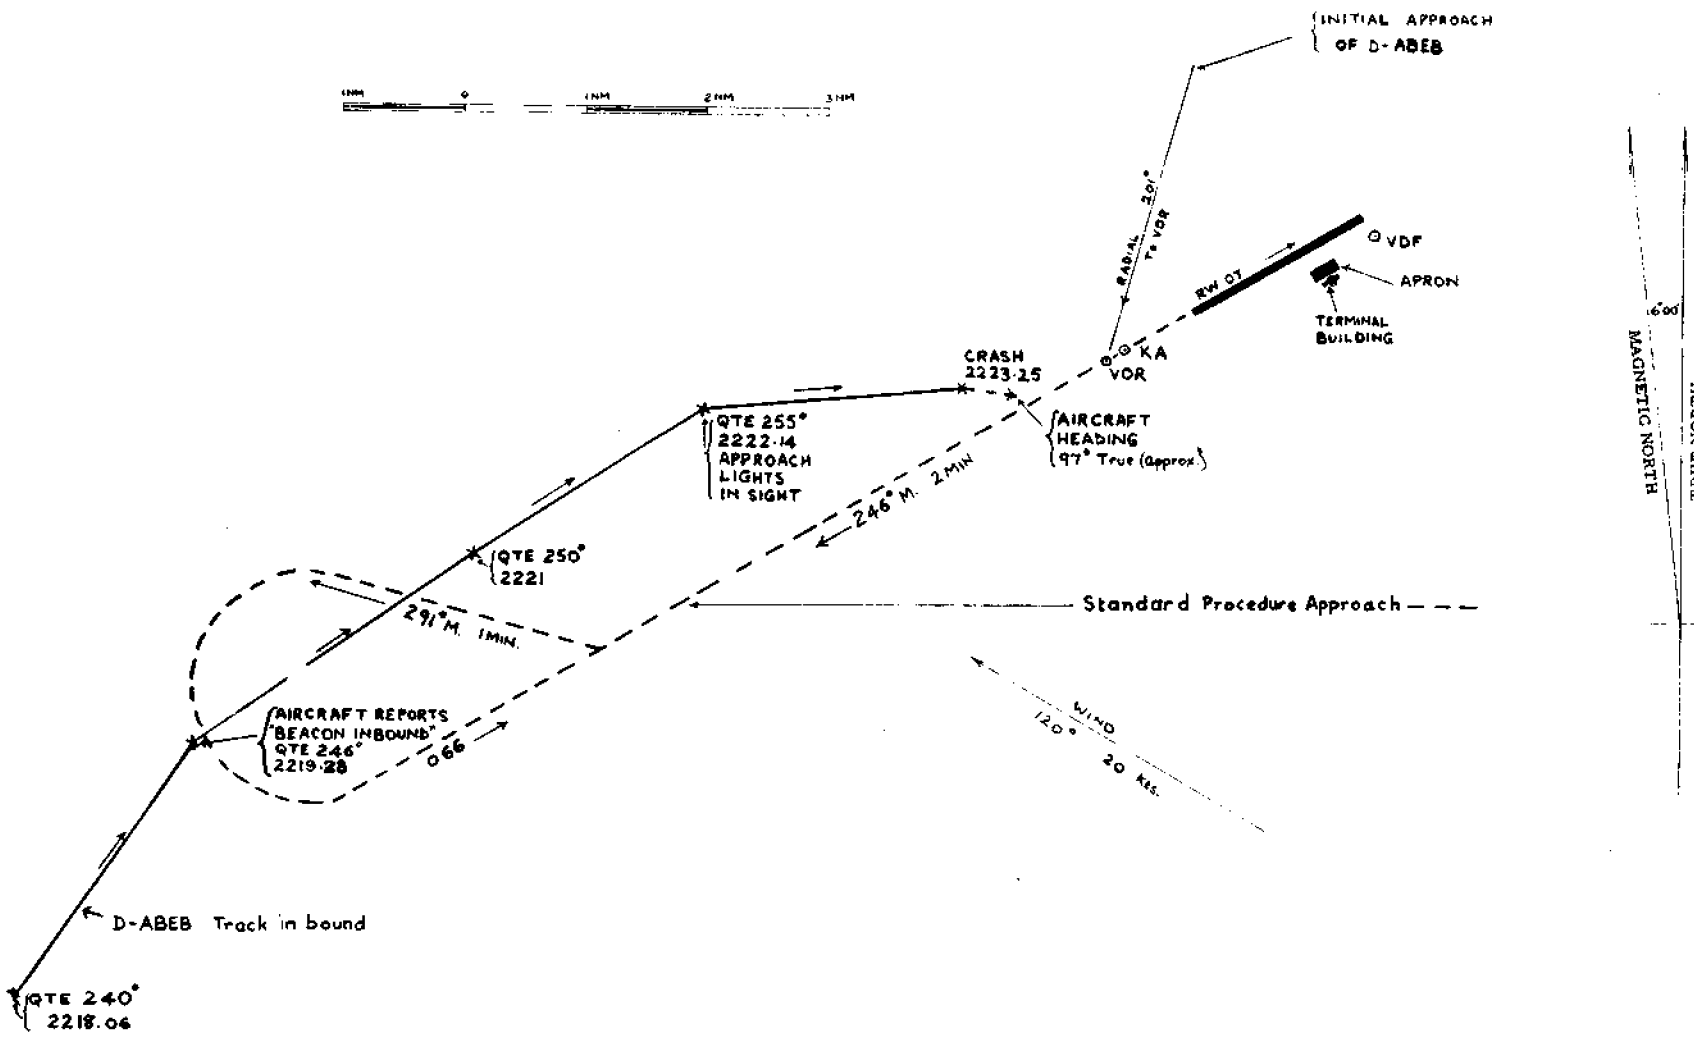
FIGURE 9

It has been found impossible to plot the outbound track of the aircraft with any reasonable accuracy. At the time it completed its procedure turn, it should have been 7-1/2 NM from the KA beacon; in actuality, at the time it reported "beacon inbound" at 2219:28 hours it was approximately 8-1/2 NM from the KA beacon and 1 mile north of the extended centreline of runway 07; but before this, at 2218:06 hours, when it obtained a bearing of 240°T it was approximately 10-1/2 NM from the KA beacon and just south of the extended centreline. (See Figure 9).

Due to the bearings that the aircraft obtained during its final approach it has been possible to plot its inbound track. (See Figure 9). It will be seen that the aircraft tracked away from the centreline until it was about 1-1/2 NM north of the centreline at a distance of 4-3/4 NM from the threshold of runway 07. It later appears that the aircraft did not turn in towards runway 07 until just after the last bearing 255°T, when it reported it had the runway lights in sight. This evidence is in accord with that of eyewitnesses of its final approach, and with the heading of the aircraft when it first impacted.

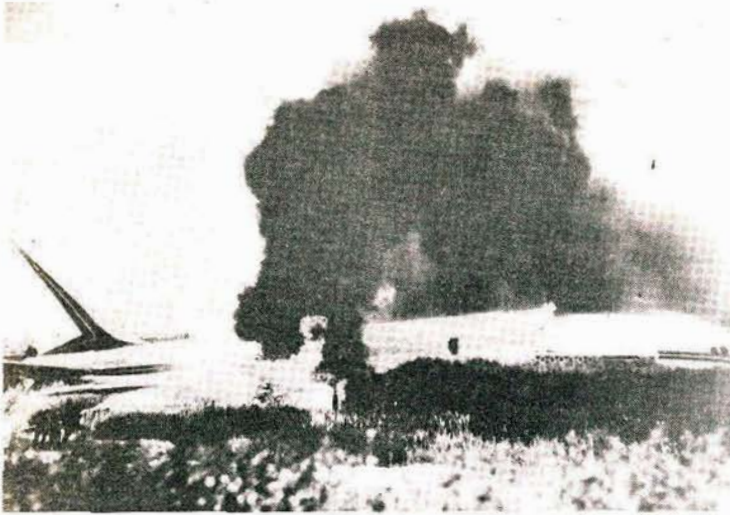
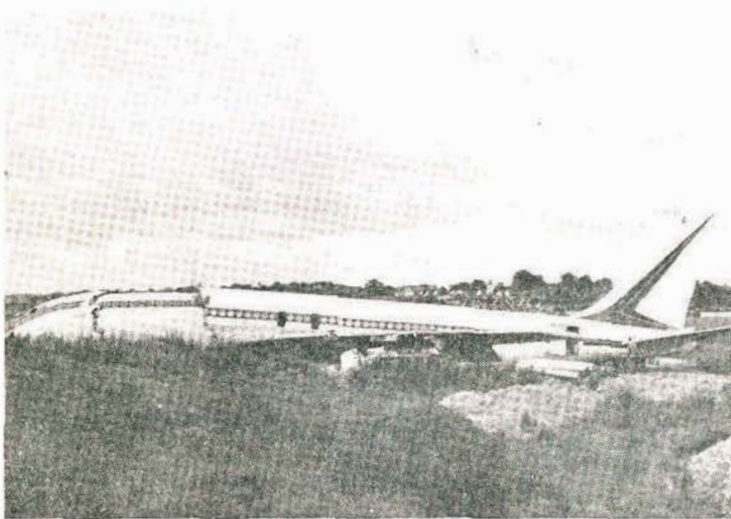
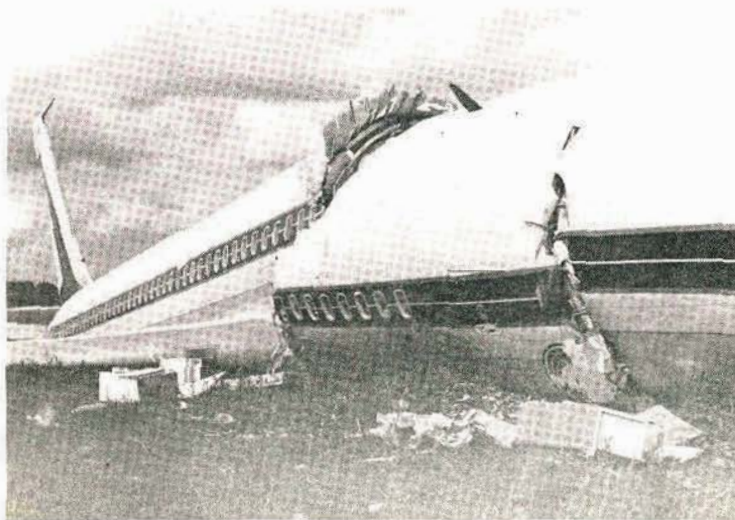
FIGURE 10

Having rolled 2 360 m, the aircraft ran off the runway in a gentle curve to the left. In turn, the nose gear assembly, the port undercarriage and finally the starboard undercarriage broke off. Finally the aircraft came to rest in a depression 1.5 m deep and 30 m wide with its fuselage broken into three parts. (See Figures 10, 11 and 12).

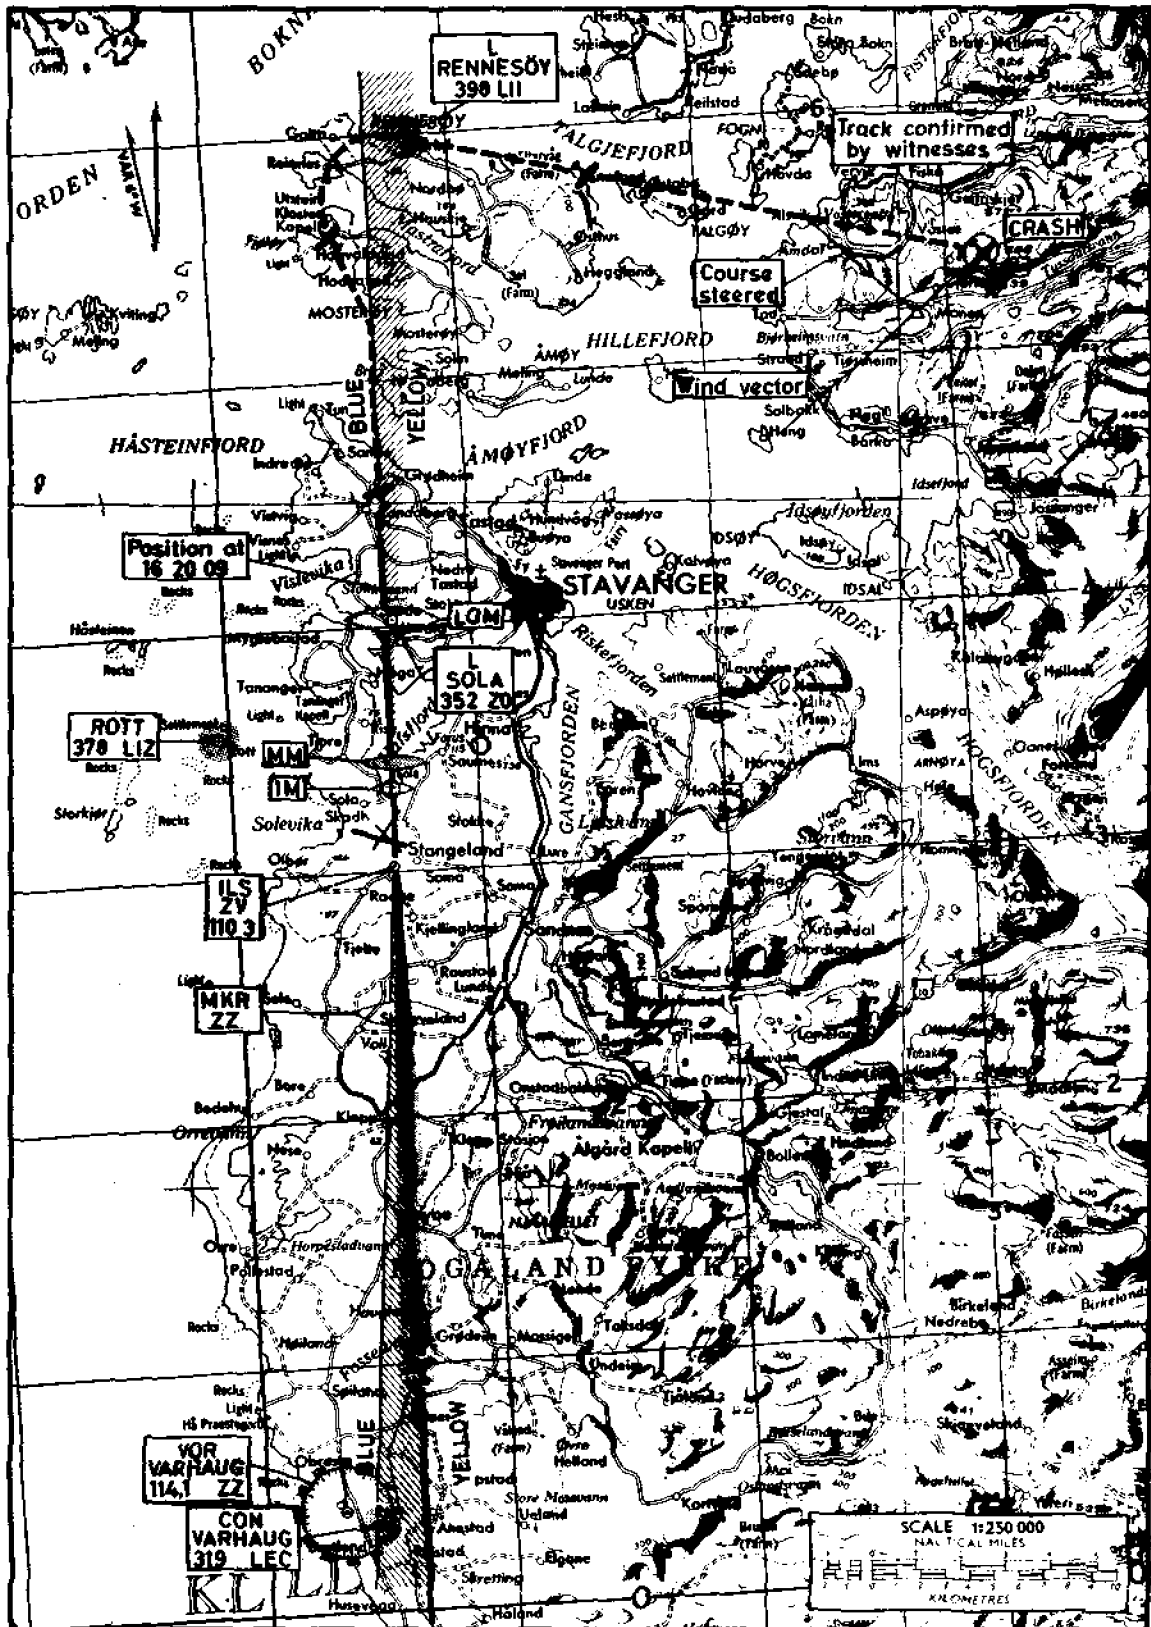
FIGURE 14

Unbroken line: Aircrafts initial approach
Dotted line: Possible flight path last minutes

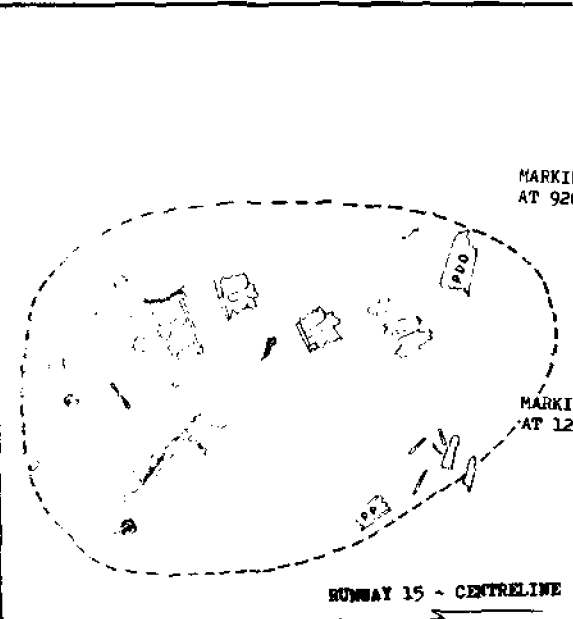
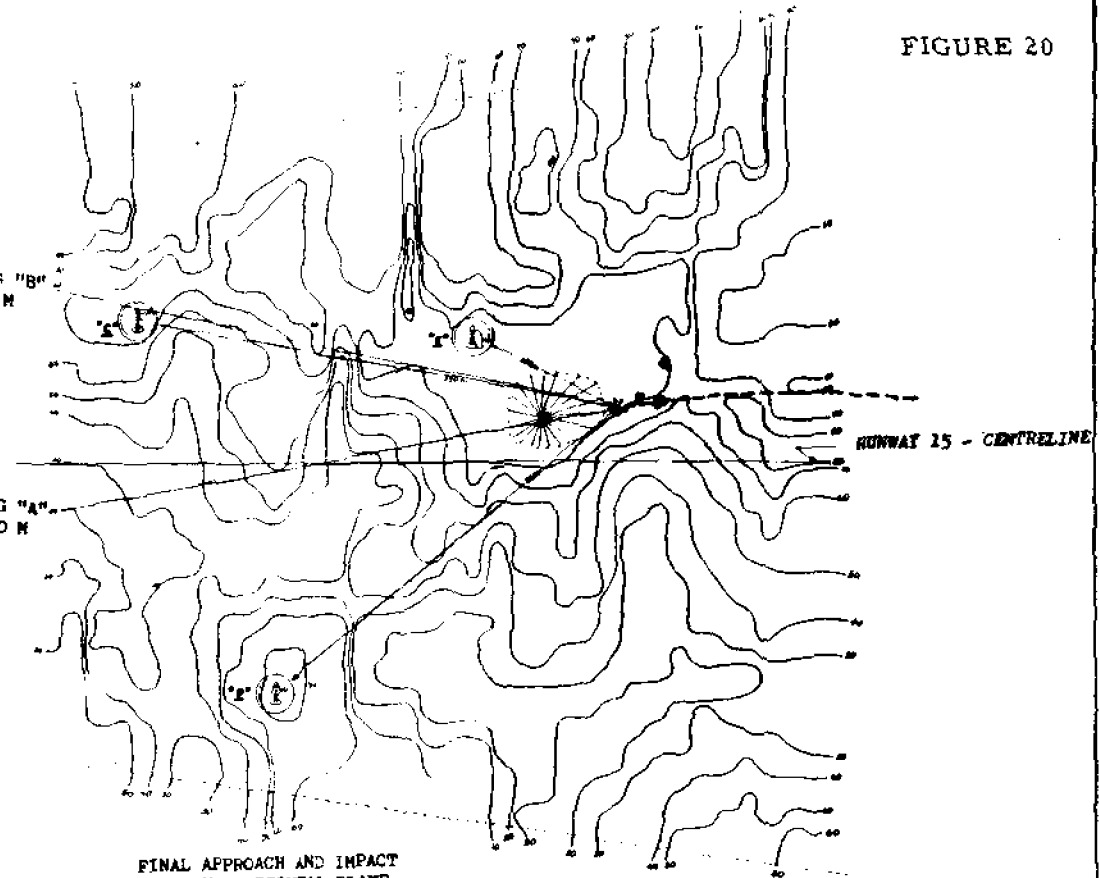
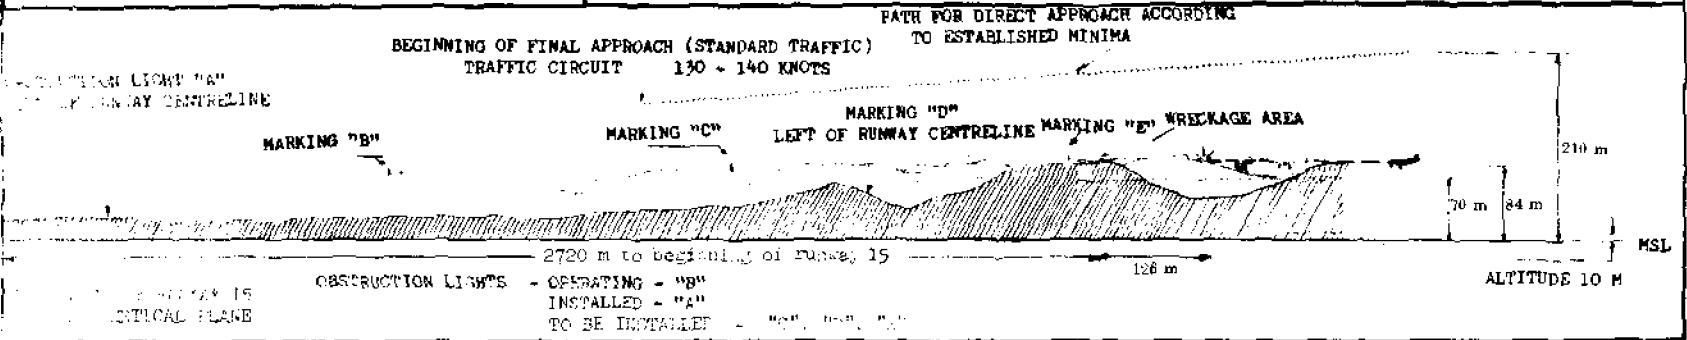
FIGURE 20

Referring to the elevations of the approach area to Runway 15, as shown in Figure 20, it is noted that there are five points above that area (A, B, C, D, E), which measure 16, 10 m, 24, 40 m, 22, 90 m, 26, 00 m and 29, 80 m, respectively. In accordance with Annex 14, Part IV, paragraph 3.1.1, these five points should be marked. However, only two points (A and B) have obstruction lights installed, and on the night of the accident only the light in B was operating.
