CIRCULAR 78-AN/66
Volume I

AIRCRAFT ACCIDENT DIGEST No. 15

Volume I

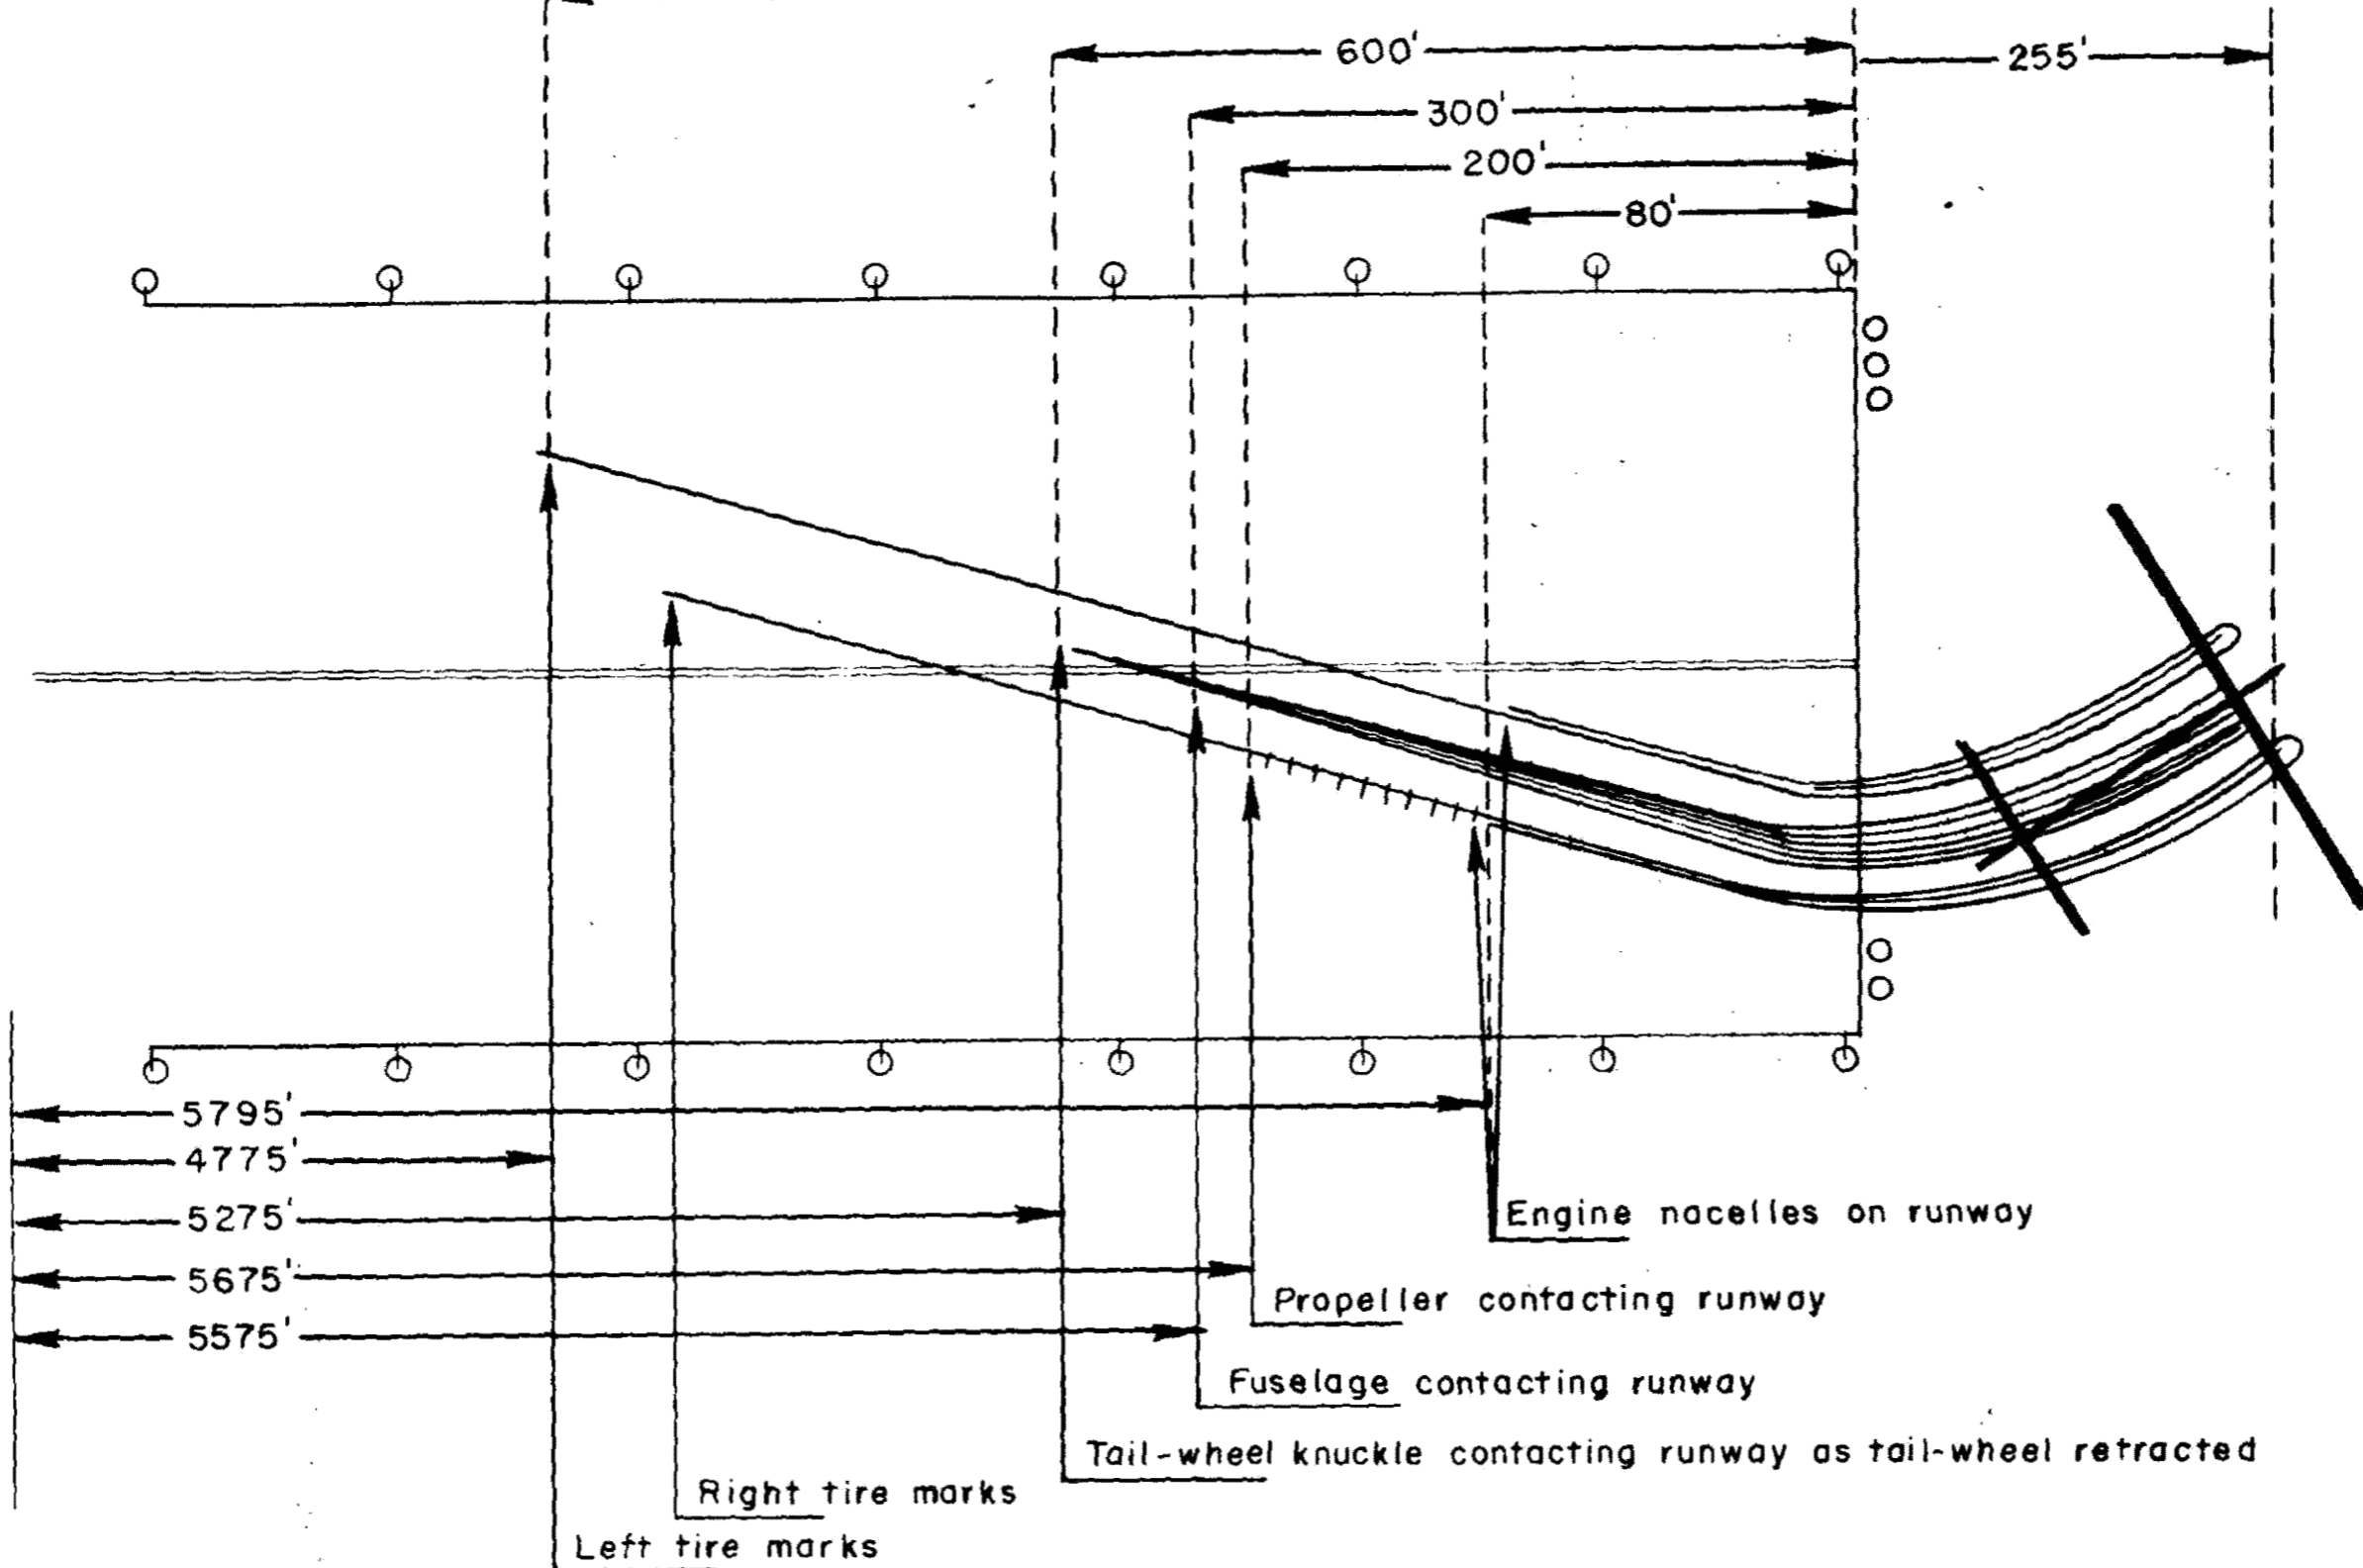
Runway length is 5875' for night operations

Area of Runway covered from touch-down until aircraft came to rest - App 1300'

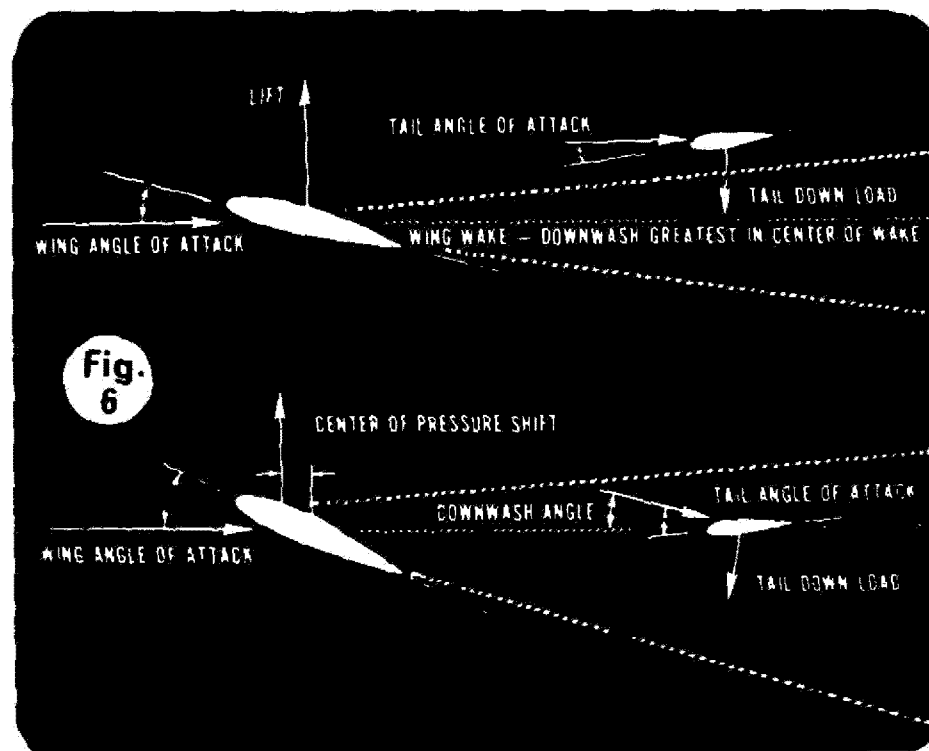
By placing the tail high enough it can be kept out of this region of downwash and it will not show a decrease in effectiveness with angle of attack. But if it moves from an area of no interference to an area of strong downwash (Fig 6), then a sudden and significant loss in stability can occur. The angle of attack at which the tail enters the downwash

area is determined by the height of the horizontal stabilizer. However, since the vertical distance is limited by the structure of the vertical stabilizer it is practically impossible to get the tail high enough to avoid the pitch-up region completely.
