CIRCULAR 78-AN/66
Volume II

AIRCRAFT ACCIDENT DIGEST No. 15

Volume II

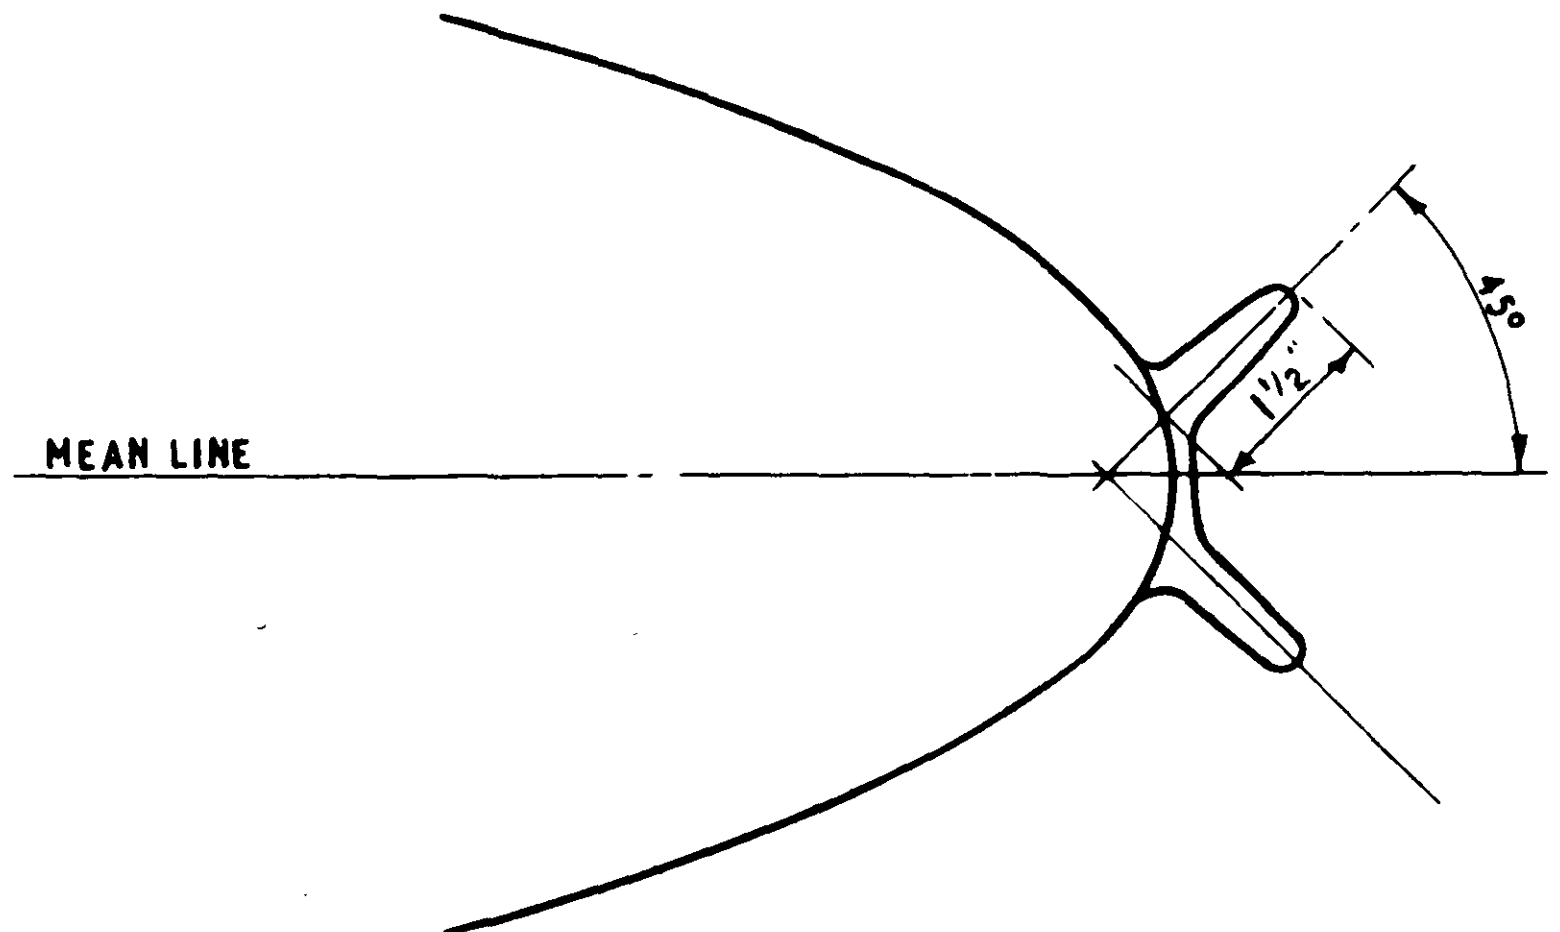
FIGURE 3

After landing, the aircraft was examined and light rime ice was found on the wings and radome, the propellers were clean and dry, and the horizontal stabilizer and vertical stabilizer had a concave, cup-shaped buildup of rough rime ice, approximately one inch thick with horns extending diagonally upward and downward approximately one and one half inches into the airstream (see Figure 3).

A TYPICAL PILOT SKETCH OF
HORN TYPE ICING

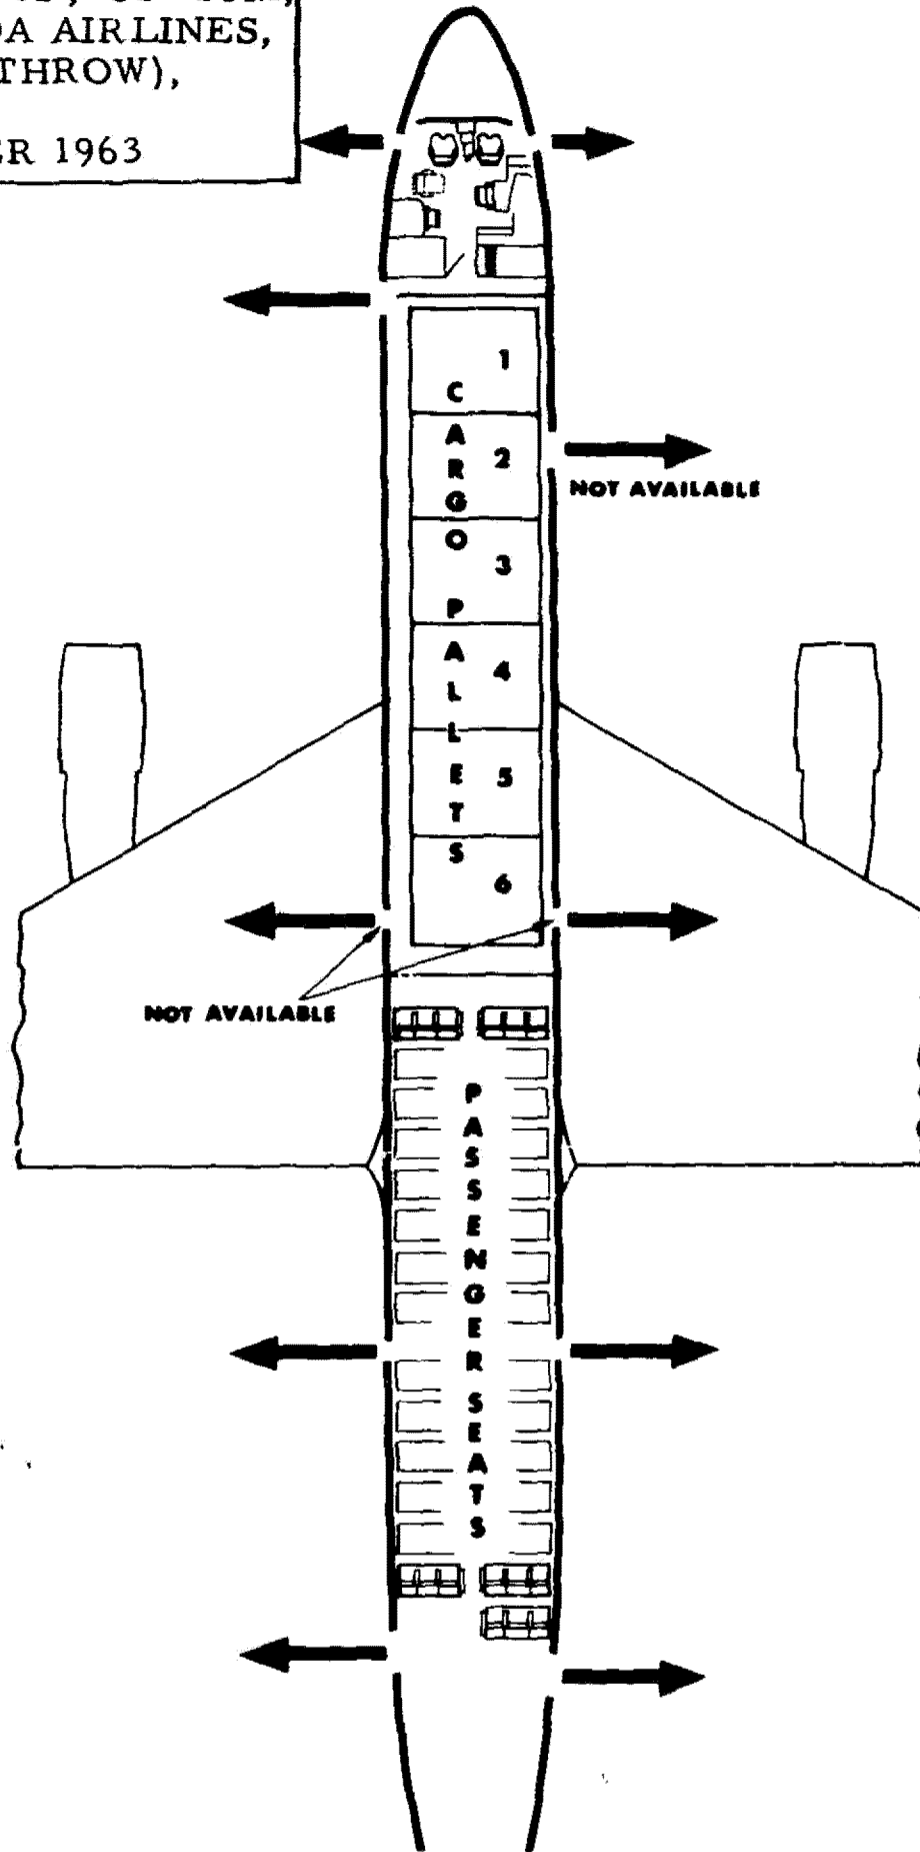
FIGURE 4

An unnecessary waste of time resulted for some passengers from an attempt to push out an emergency exit designed to be pulled in. The addition in bold letters of the directions "PULL IN" visible in emergency lighting could help to prevent a repetition of such a delay. It was fortuitous that it was on the left wing that two engines were on fire for over 20 minutes, particularly as there were over 16 000 gal of JP-4 fuel on board. It is in the knowledge of these facts that it must be considered whether there were enough exits. No injury was sustained as a result of a shortage of emergency exits, but if the fire had developed rapidly it might well have been otherwise (See Figure 4).

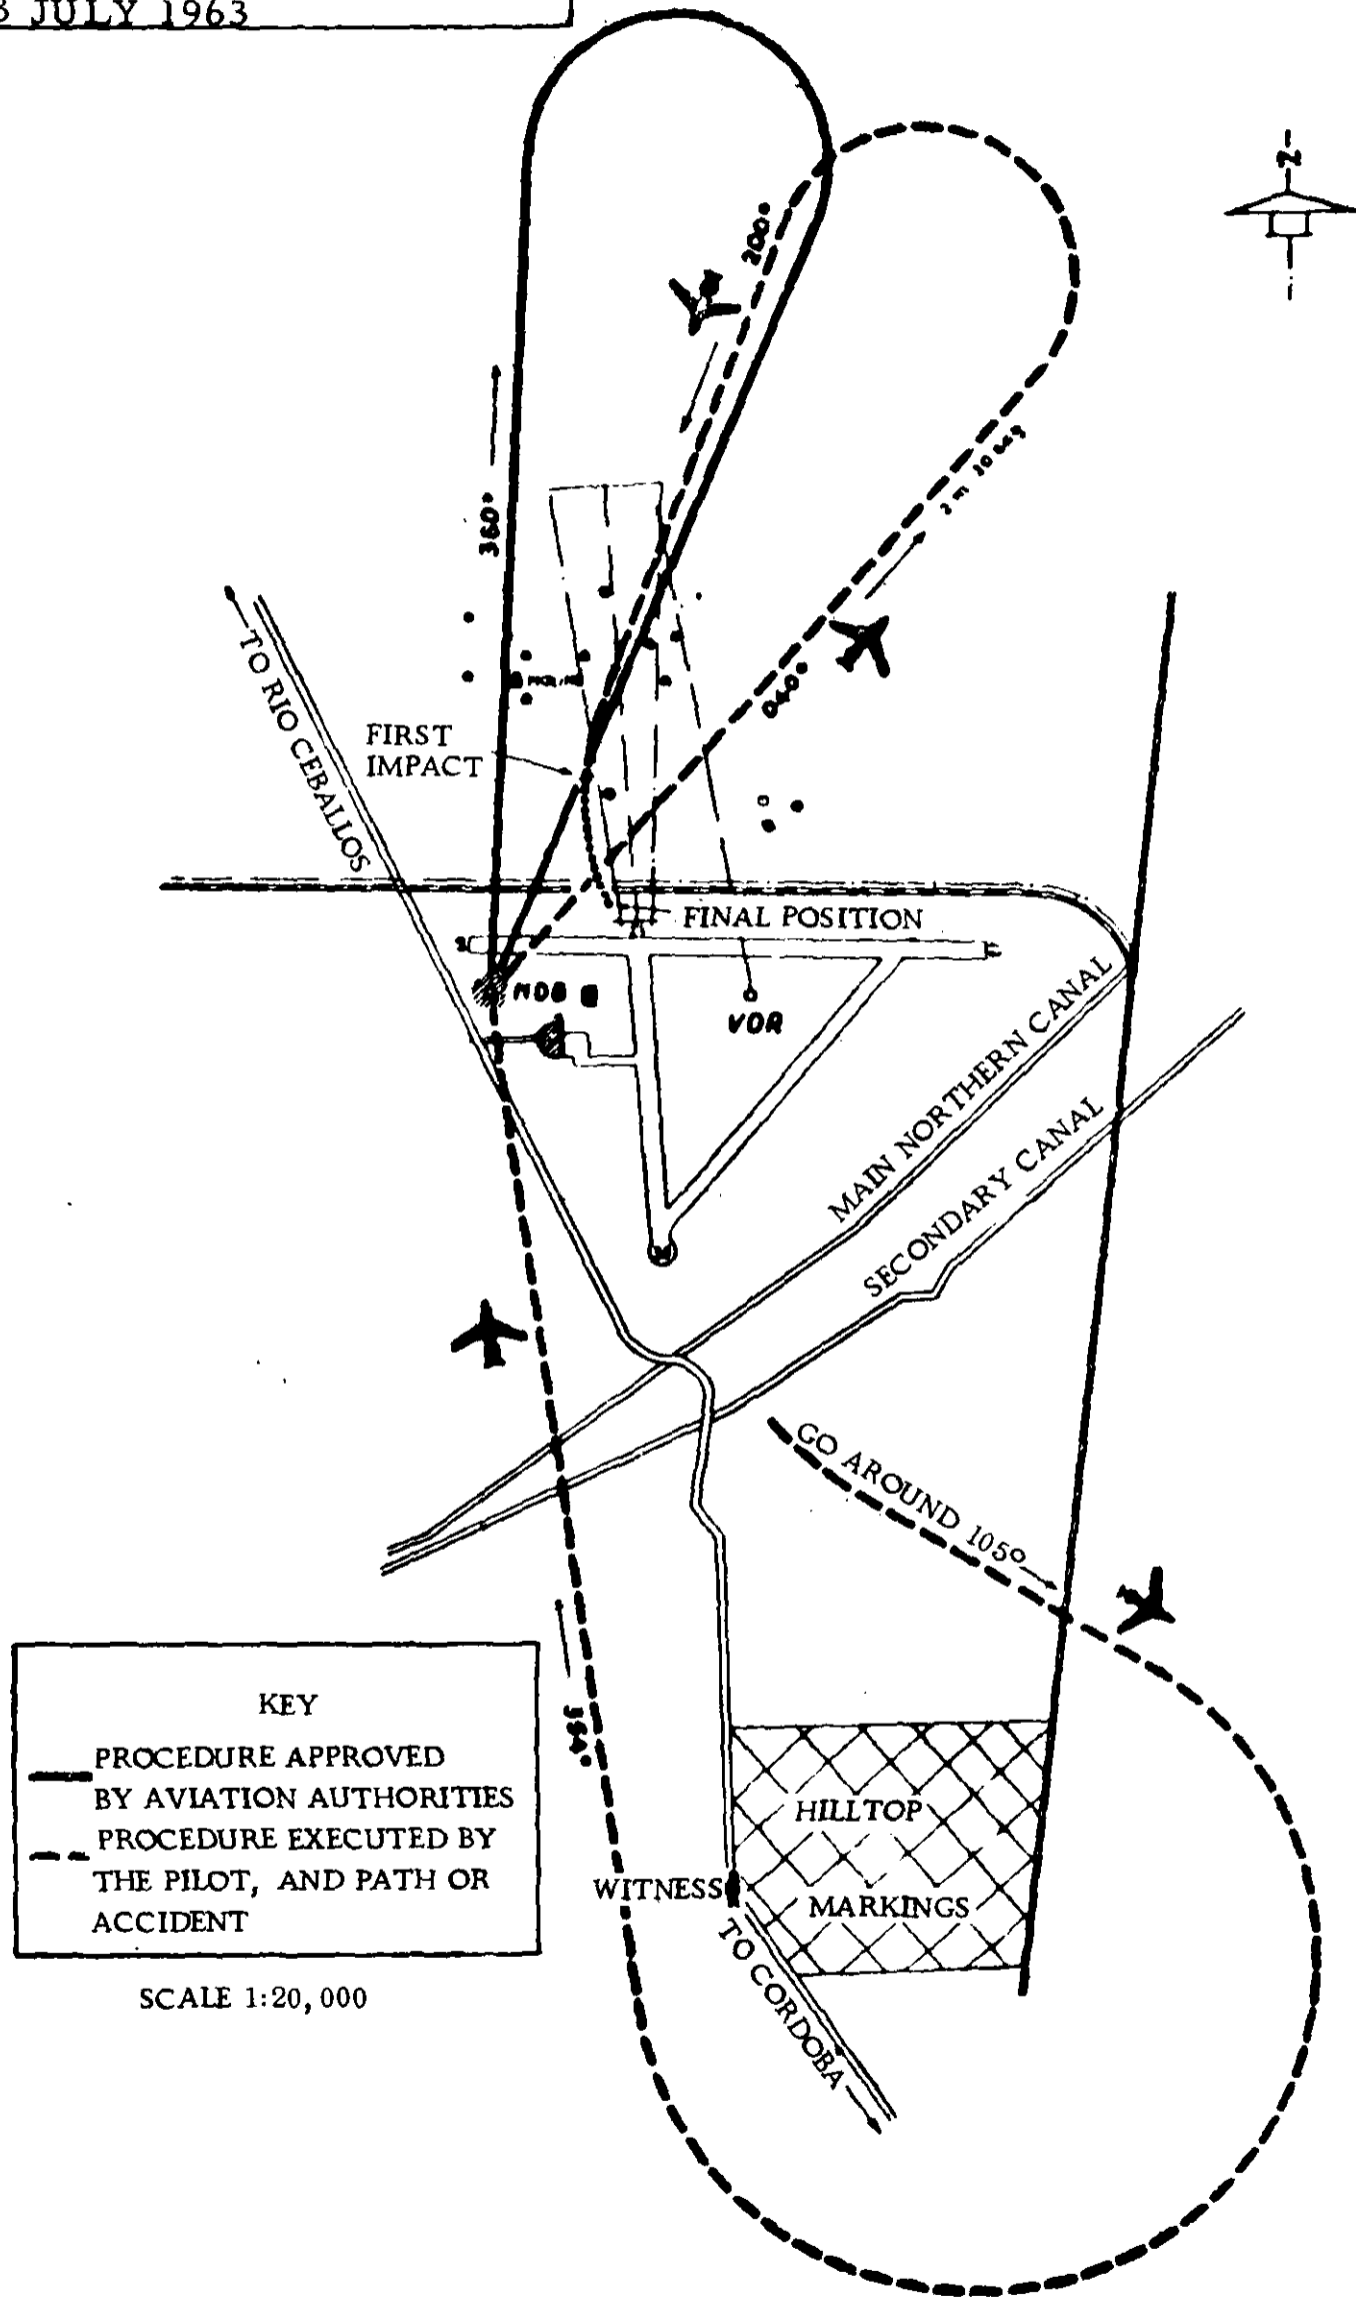
FIGURE 10

At 390 m from initial impact the port wing struck some other trees, the fuel tanks bursted out and fire broke out. The aircraft then came into contact with the General Belgrano Railway tracks, broke its undercarriage, tearing away 25 m of railway rails and finally came to rest 280 m before the threshold of runway 17 (See Figure 10). The accident occurred at 1906 hours.

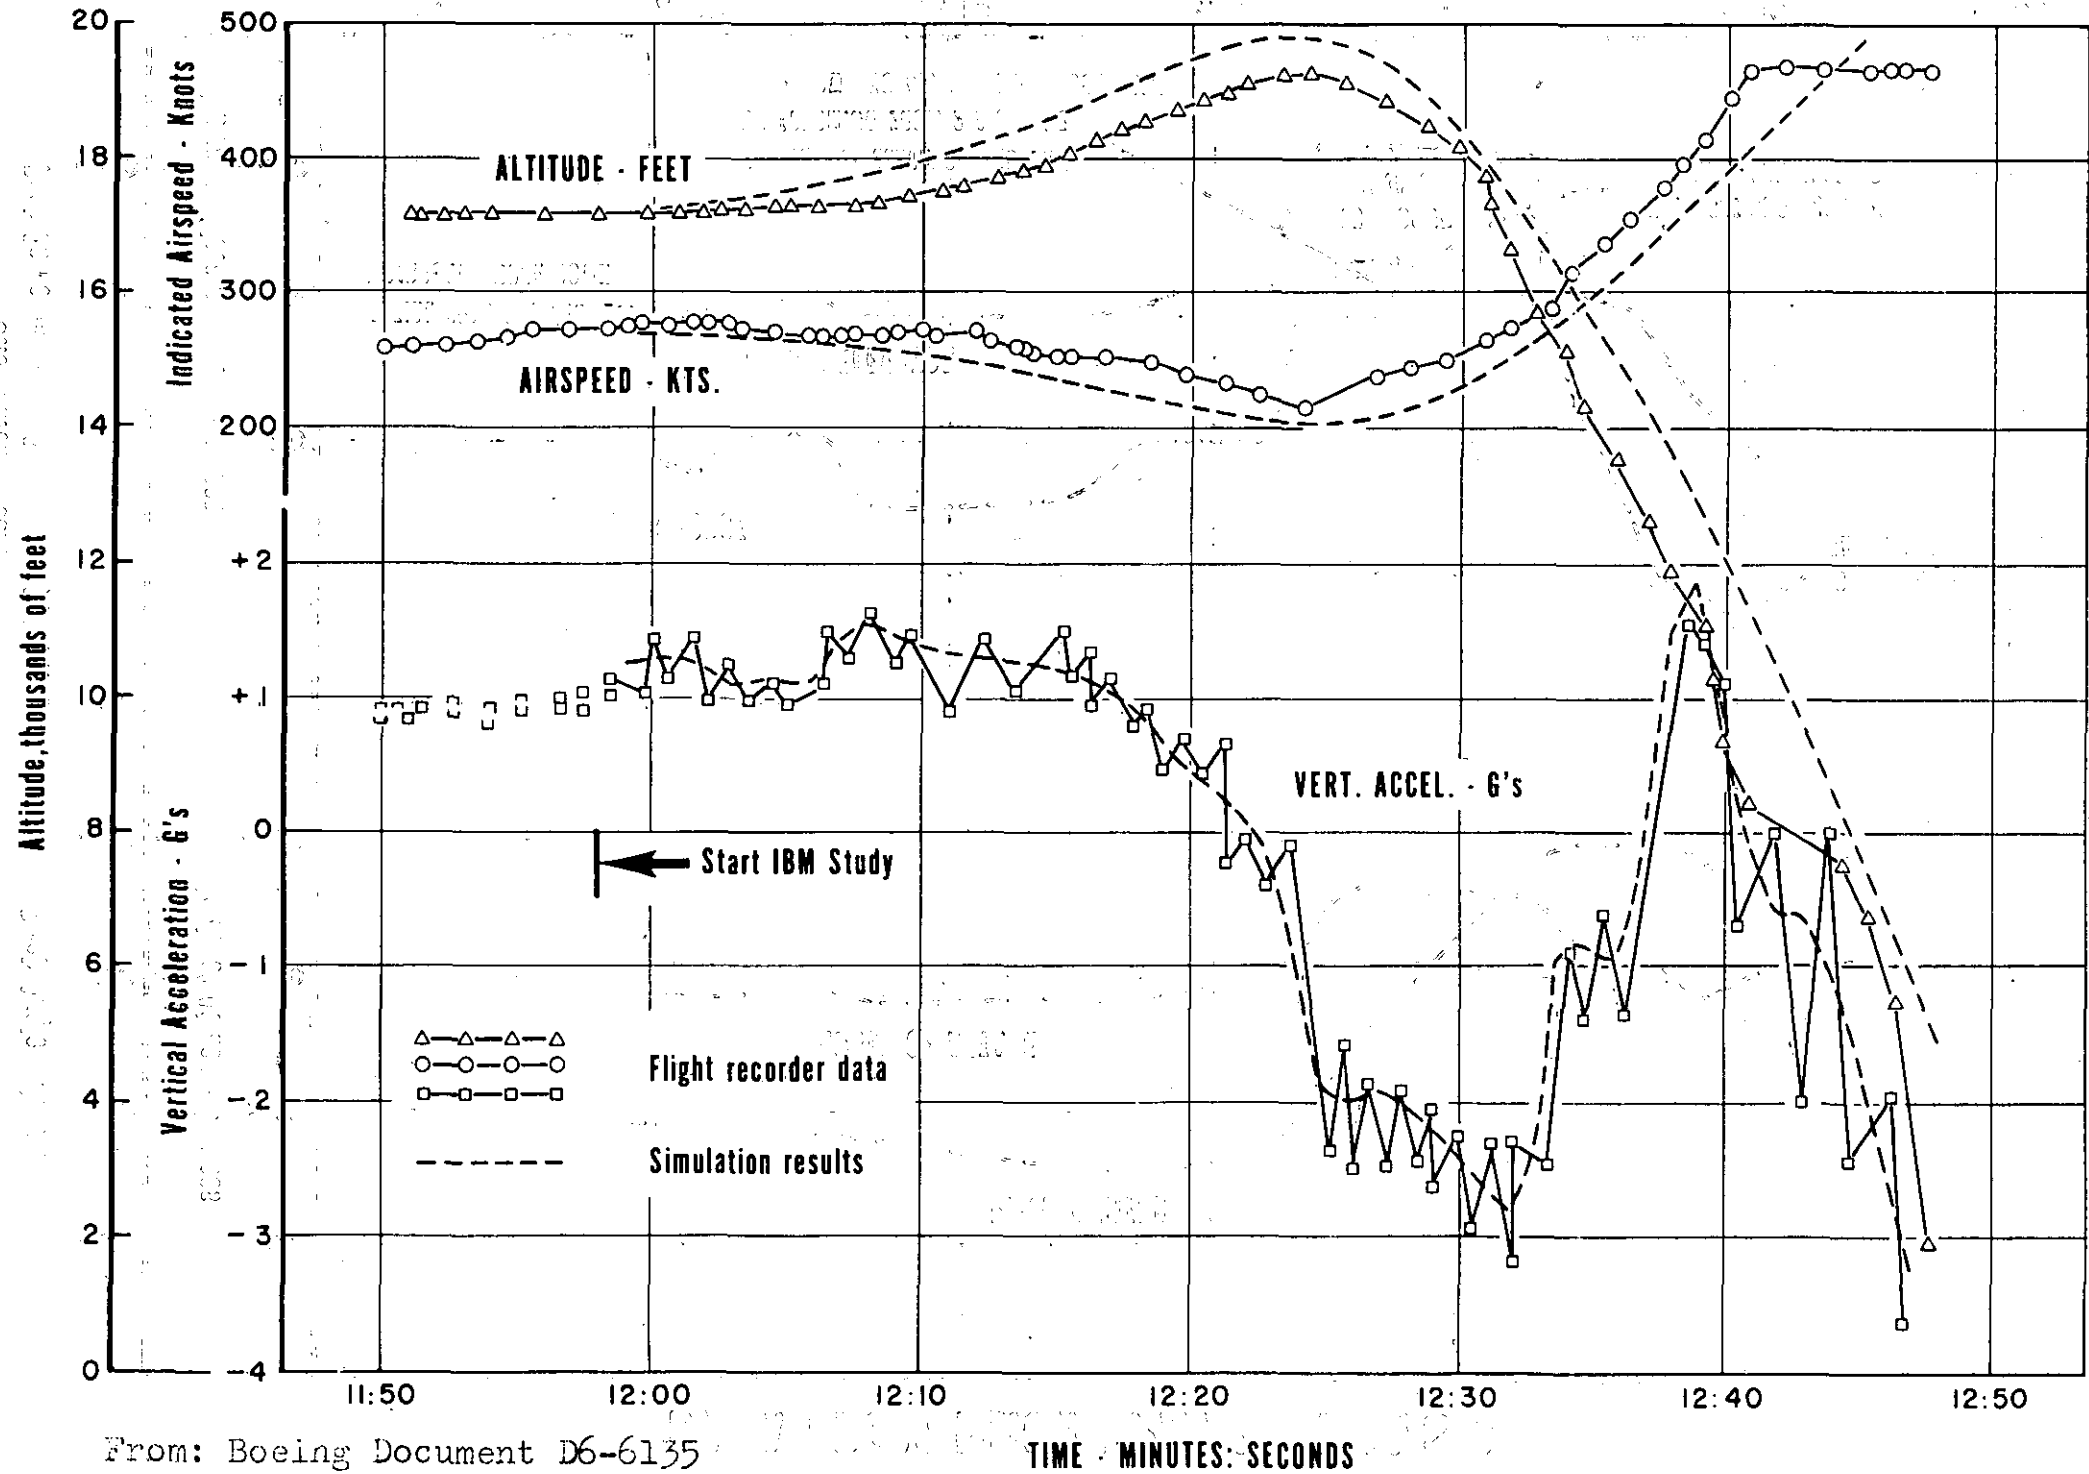
FIGURE 14

The early analogue and digital recorder readout studies by Boeing (See Figures 14 and 15) showed that the aircraft was intact during the initial steep climb, the noseover, and during at least most of the dive. The most significant and initially puzzling finding was that the final manoeuvre required -

COMPARISON OF TRACES FROM FLIGHT RECORDER AND FLIGHT PATH ANALYSIS

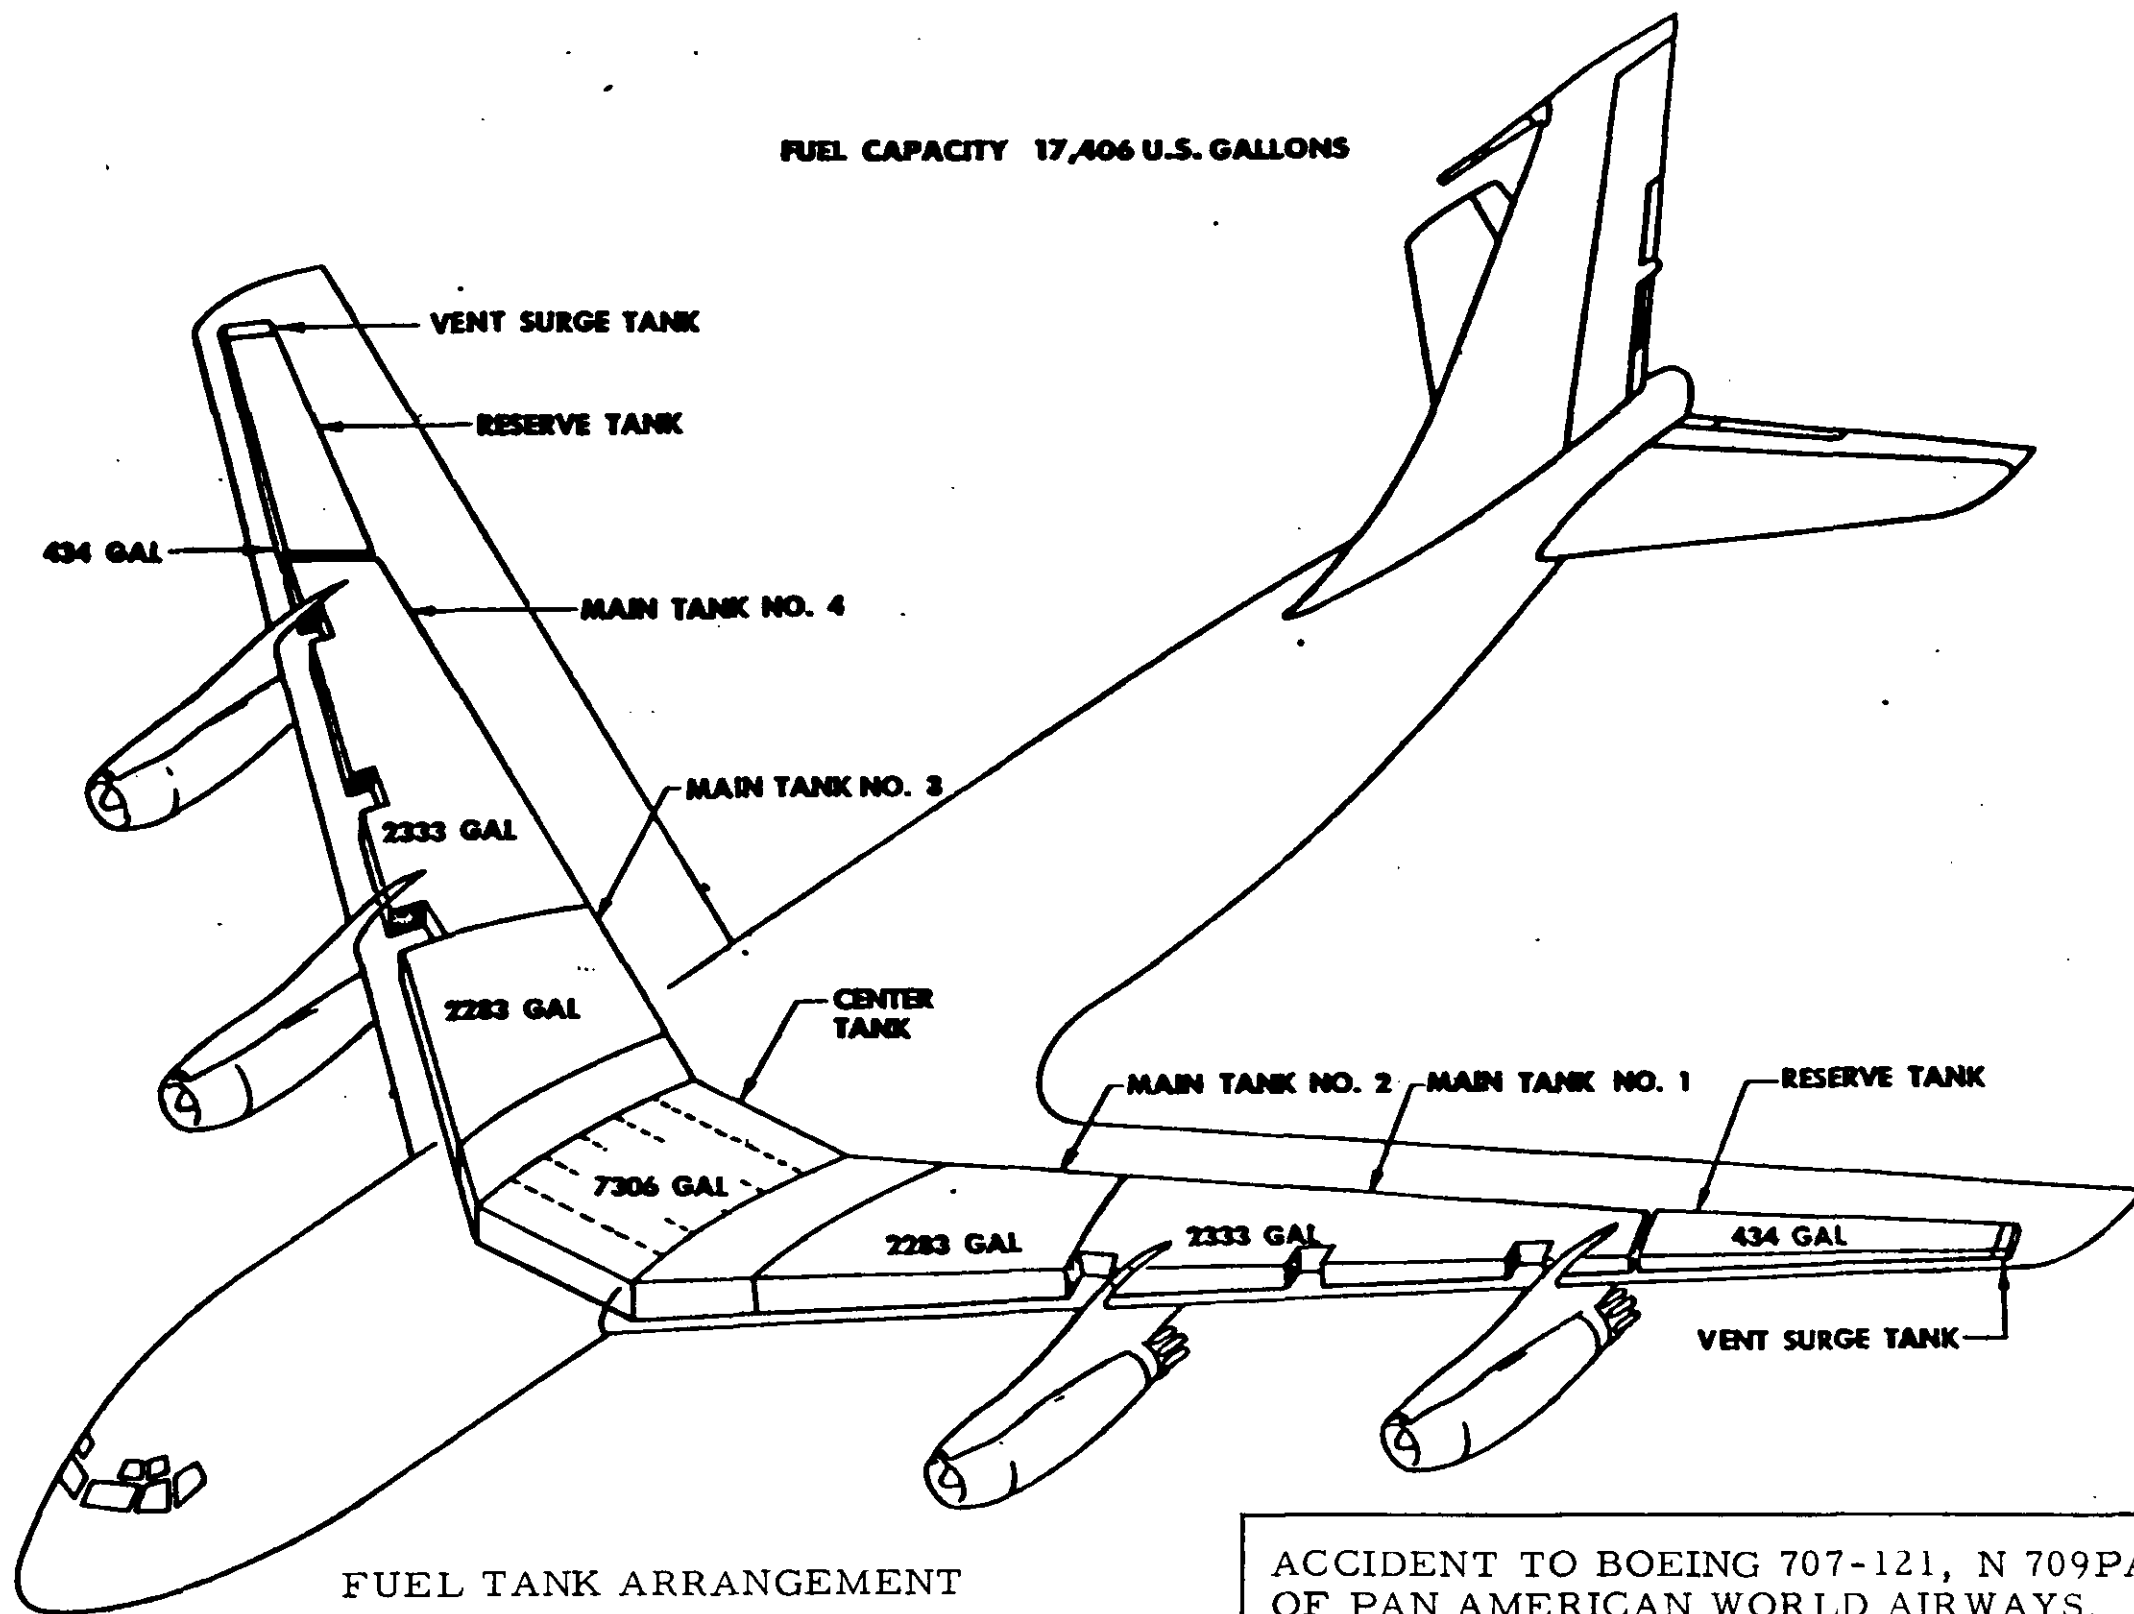
FIGURE 16

Pan American World Airways conducted a flight test in a Boeing 707 to determine if fuel would discharge through the tank vent system ram air inlet, in flight conditions simulating moderate to rough air turbulence with skidding two minutes turns. There was no visible discharge of fuel at any time during the test. There was evidence that fuel entered the vent system, collected in the surge tanks, and returned to the proper fuel tanks (See Figure 16).

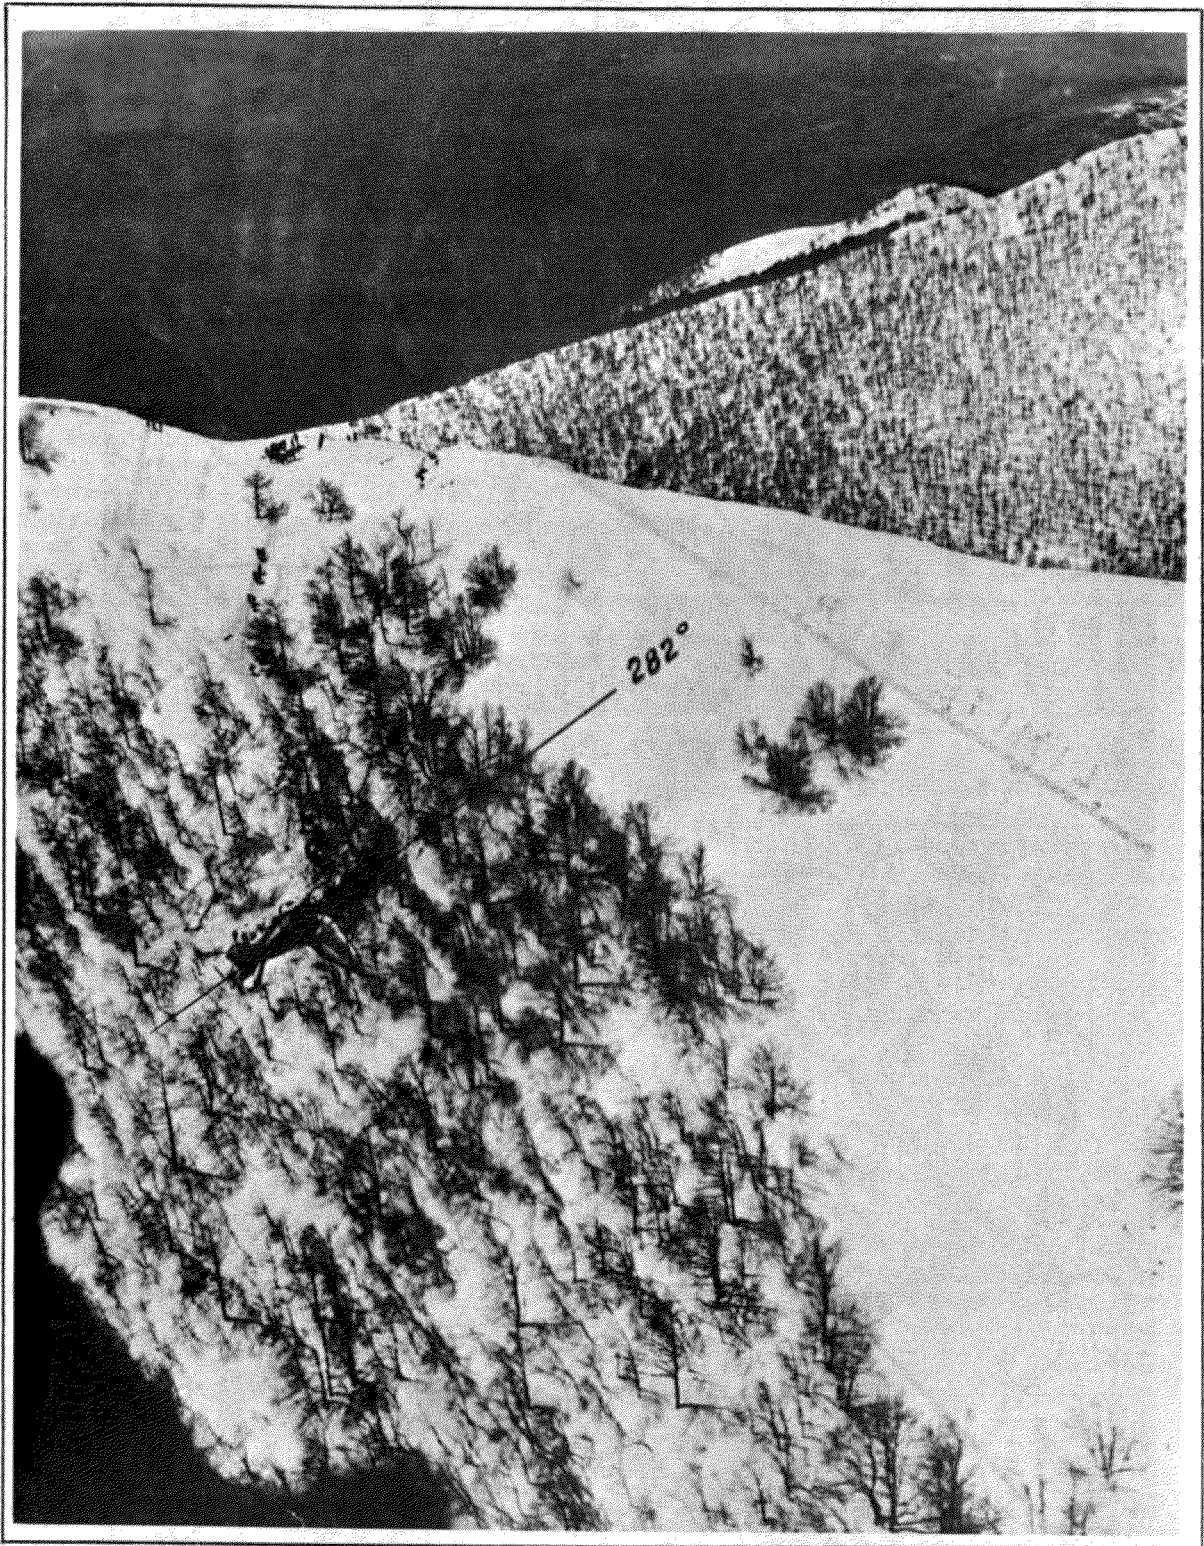
FIGURE 17

The accident site was located at 70 m from the mountain crest, which at this point reached an altitude of 1670 m. The wreckage was lying on the snow in a limited area with the axis of the fuselage oriented 282° and the nose of the aircraft pointing towards the mountain crest (See Figure 17).

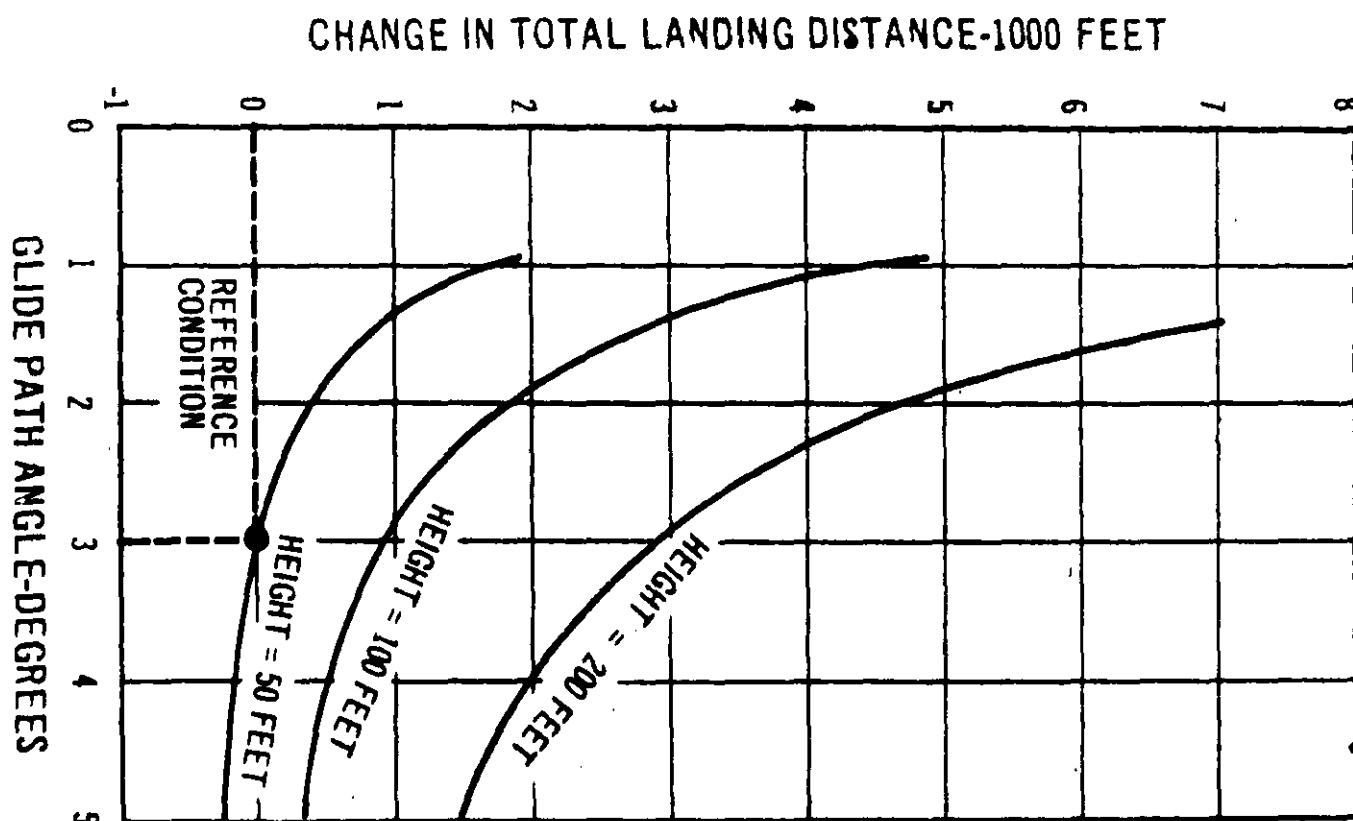
Height of the aeroplane over the end of the runway also has a very significant effect on total landing distance. The relatively steep trend lines of Fig. 5 show this effect for a range of glide slope paths. This chart indicates a change in total landing distance directly. For example, flying over the end of the runway at 100 feet altitude rather than 50 feet could increase the total landing distance by 950 feet on a 3-degree glide path. This change in total landing distance, results primarily because of the length of runway used up before the aeroplane actually touches down. Glide path angle also affects total landing distance as shown in Fig. 5.

FIG. 5—Flat glide slope path and excessive height over end of runway combine to extend landing distance required due to runway used before touchdown. Reference conditions call for 50 feet over threshold while on 3-degree glide slope path.

Even while maintaining the 50-foot height over the end of the runway, total landing distance is increased as the approach path becomes flatter. A combination of excess height over the end of the runway and a flat approach uses up runway in a hurry. Glide path angle is a function of pilot technique and best results will be obtained at a normal ILS glide slope angle.

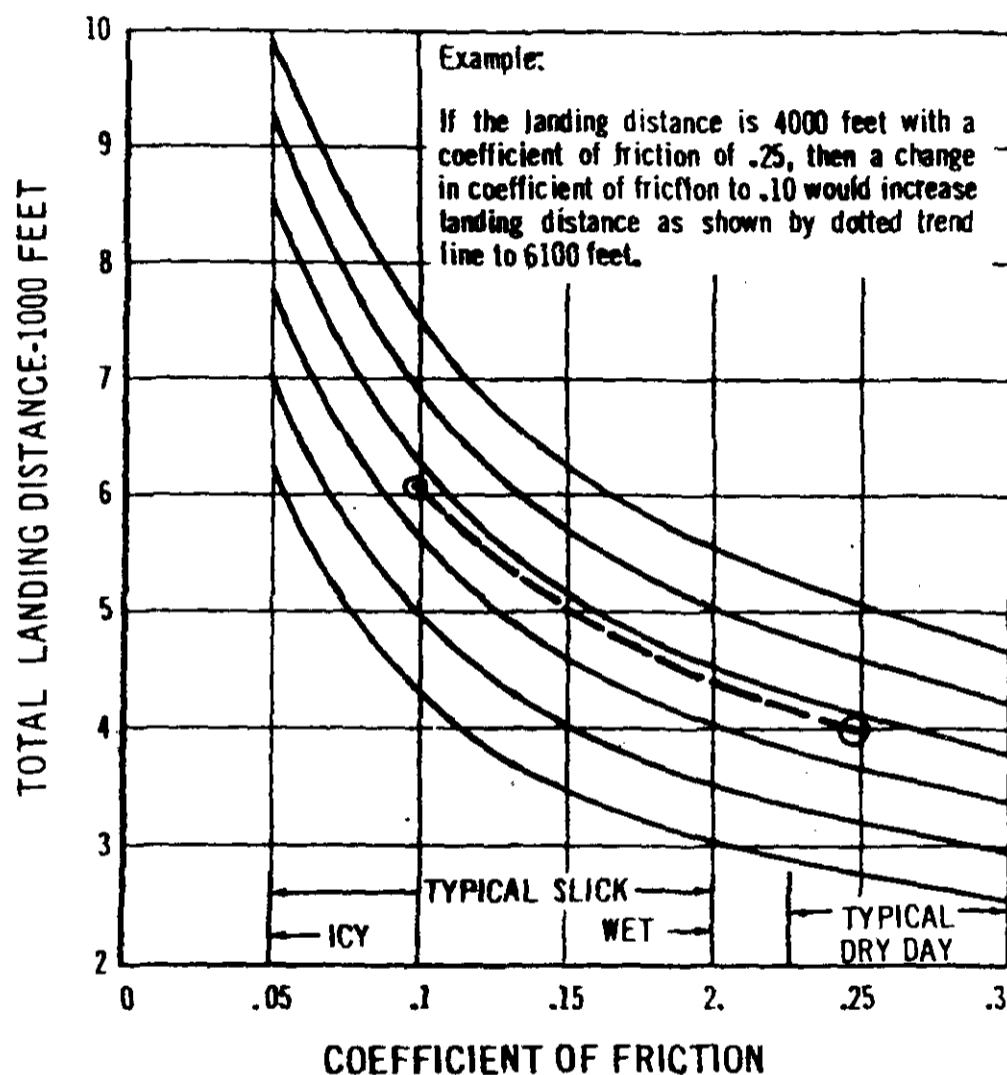
Probably the most important factor that affects total landing distance is the coefficient of friction between tires and runway surface. This coefficient is a result of many variables, such as tire tread design, runway material, water or ice cover on the runway, air temperature, and rolling speed of tires. A normal effective coefficient of friction on dry concrete may be expected to vary between .25 and .30. On icy runways at temperatures near 32°F, tire friction may drop as low as .05. The range can be considerable, and the effects of these variations are shown in Fig. 6. It can be seen from this chart that landing distance can be significantly increased when a runway is covered with water and/or ice with other conditions constant.

FIG. 6—Trend lines for coefficient of friction show increase in stopping distance on wet or icy runway surfaces. Trend lines show only effect of friction. Which trend line used must be determined from length of runway required by variation of all other factors that affect distance.

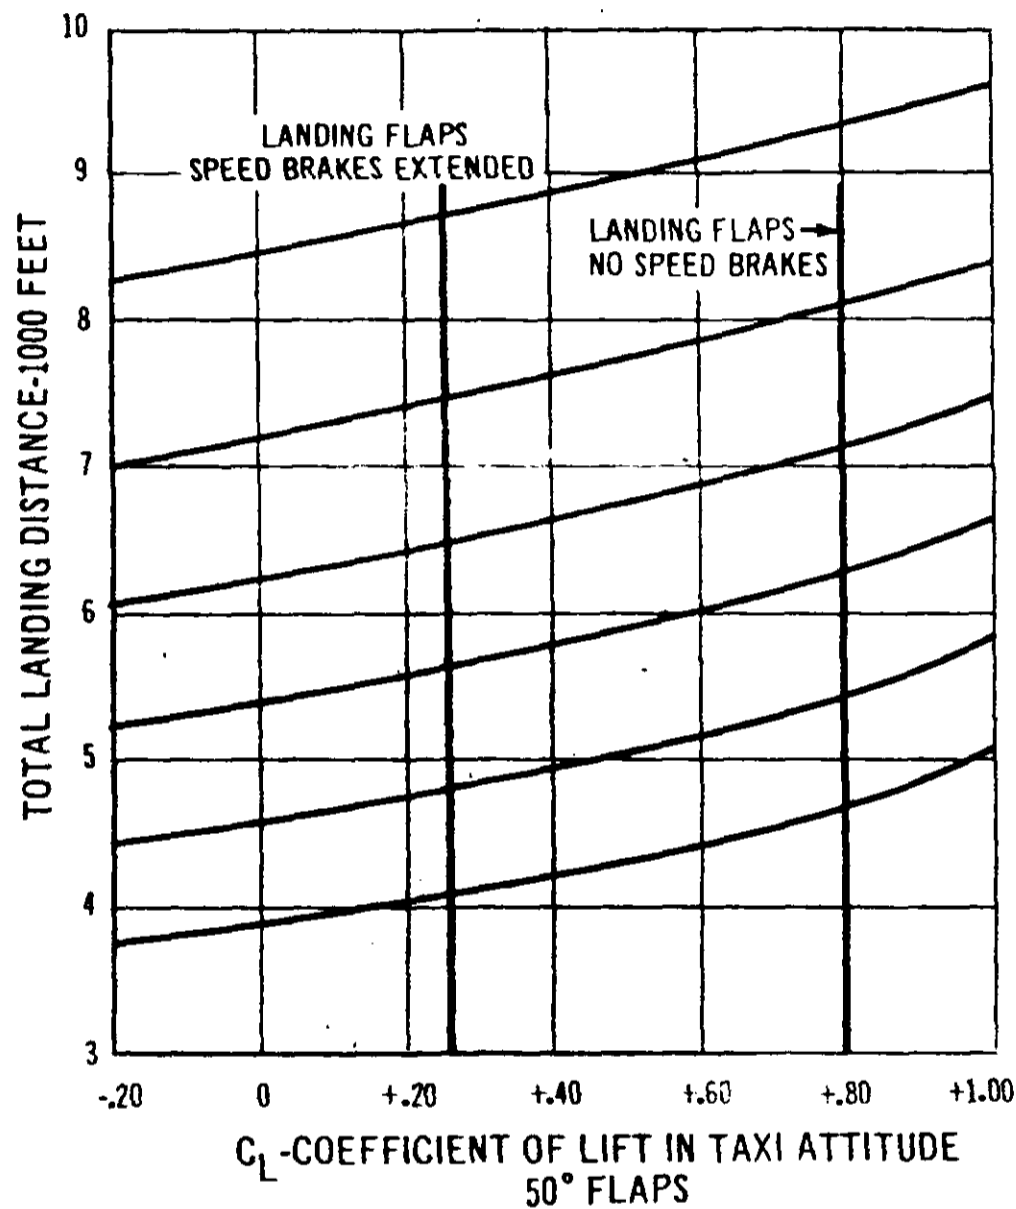
Basically, the C_L is constant for any specific aeroplane at the same configuration. However, aeroplane attitude and speed brake deflection affect C_L . Keeping the nose wheel off the ground, for example, produces a higher angle of attack for the wing than if the nose gear is rolling on the runway. This higher angle of attack develops lift and prevents the brakes from working to their full capacity, regardless of the condition of the runway. Therefore, immediately after touchdown, the nose wheels should be lowered to the runway and held there positively until taxi speed is reached. Speed brakes increase drag and lessen or "spoil" wing lift and, therefore, affect C_L during landing. The chart in Fig. 7 shows how a variation of C_L affects total landing distance. Aeroplane drag is not increased by keeping a nose-high attitude on the ground during landing roll.

FIG. 7—Trend lines show variations in coefficient of lift. Difference in lift with speed brakes deflected and not deflected are shown between lines. Flaps are extended to 50 degrees.

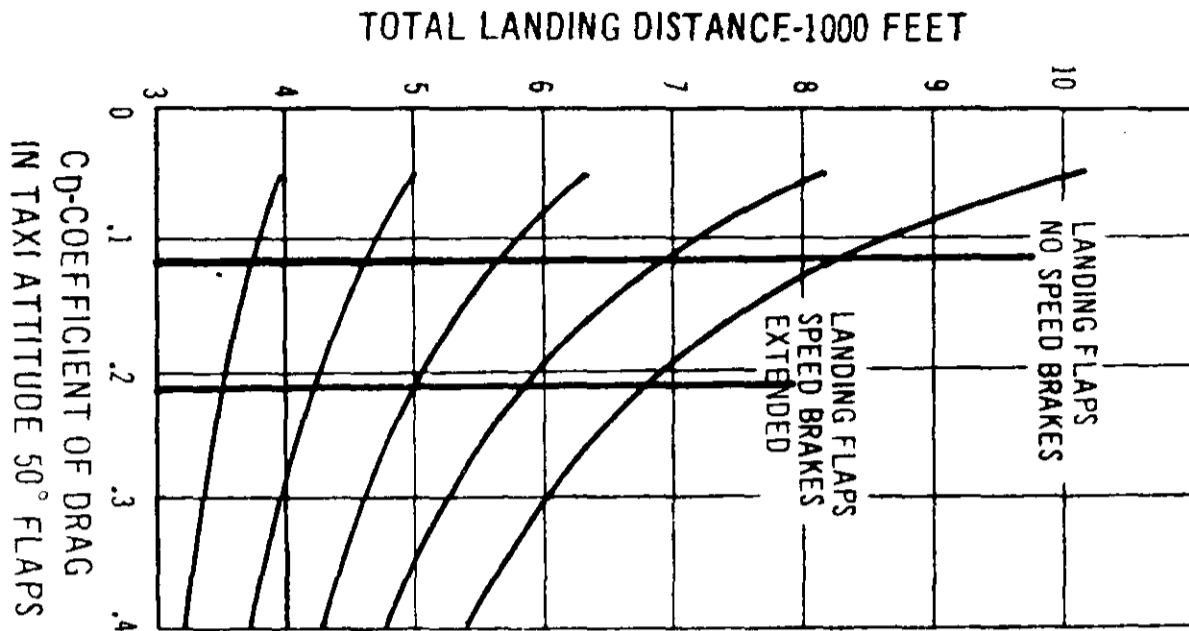
FIG. 8—Trend lines show effects of drag. As landing distance increases due to other factors, effect of speed brakes becomes progressively greater. Flaps are assumed at 50 degrees for both example lines.

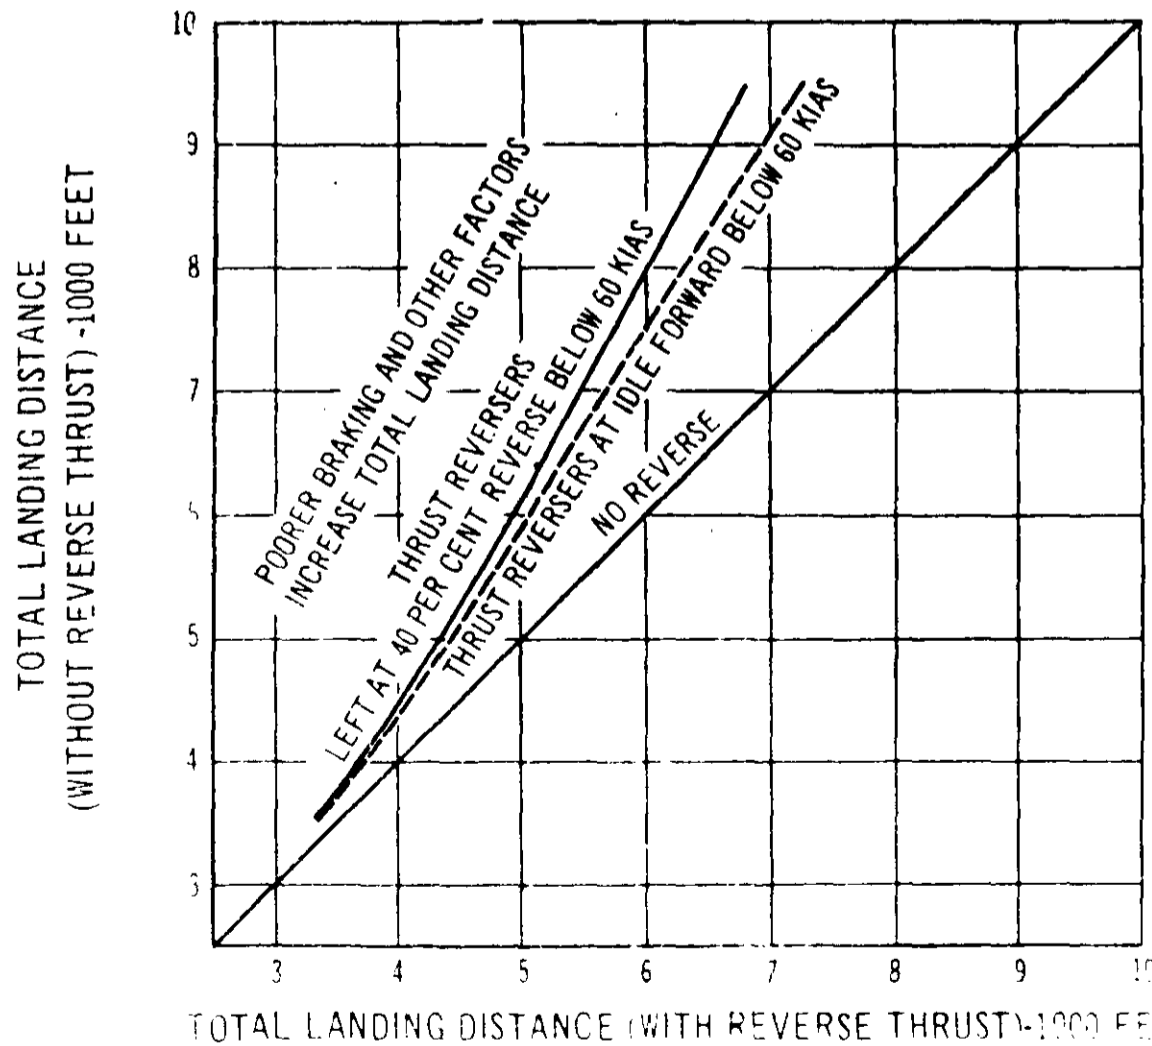
Thrust reversers can be used to shorten the stopping distance once the aeroplane is on the ground and, thereby, shorten the total landing distance. By operating the thrust reversers at published limits during normal operation from touchdown to 60 knots indicated air speed, significant reductions in landing distance can be achieved. Fig. 9 (based on 60 knots cutoff) indicates how much of a reduction in landing distance is possible under the stated conditions. Normally, ingestion of exhaust gases may cause engine surging if thrust reversers are continued in full use at speeds below 60 knots. Partial reverse thrust can be used until taxi speed without ingestion.

FIG. 9 - During normal landings, thrust reversers can reduce landing distance by different amounts depending on whether thrust reversers are left in reverse or in idle when cut off below 60 knots. During emergency conditions, thrust reversers can be used below 60 knots, but effect on landing distance varies according to usage.

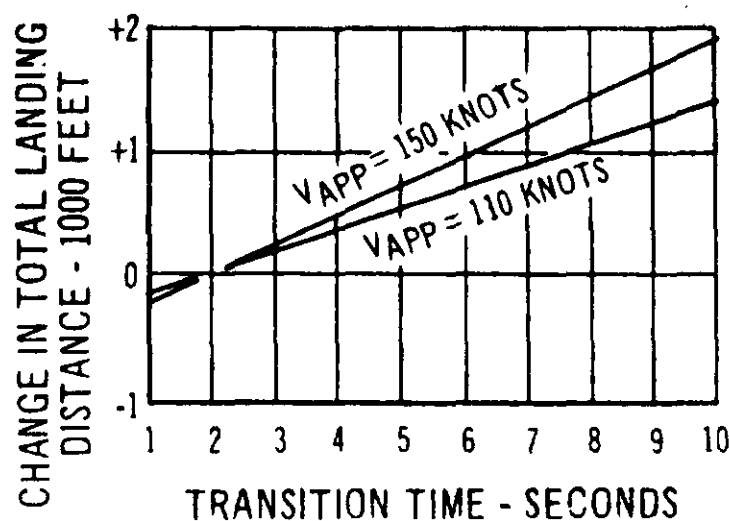
Transition time between touchdown and brake application affects total landing distance in accordance with the chart in Fig. 10.

FIG. 10—Delay in applying brakes increases landing distance as shown for different speeds at touchdown. Normal time between wheels rolling on runway and brake application is two seconds.
