CIRCULAR 78-AN/66
Volume II

AIRCRAFT ACCIDENT DIGEST No. 15

Volume II

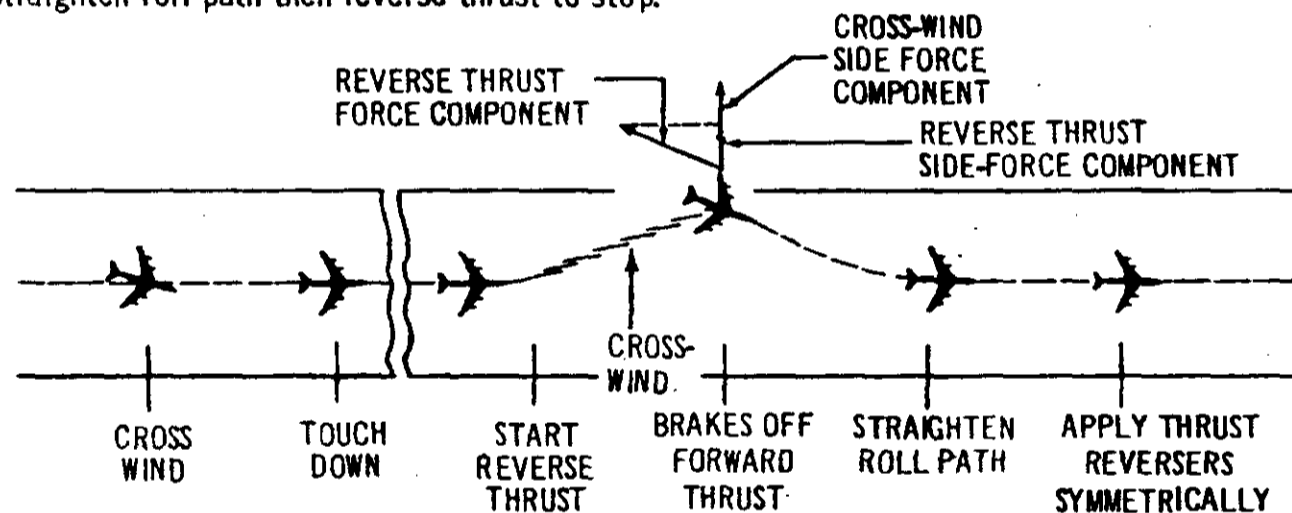
FIG. 11-During cross-wind landing side thrust from thrust reversers, once airplane is canted to centerline, plus cross-wind can drive airplane off runway. To correct path, return all engines to forward thrust at low power to return to center, use differential braking to straighten roll path then reverse thrust to stop.

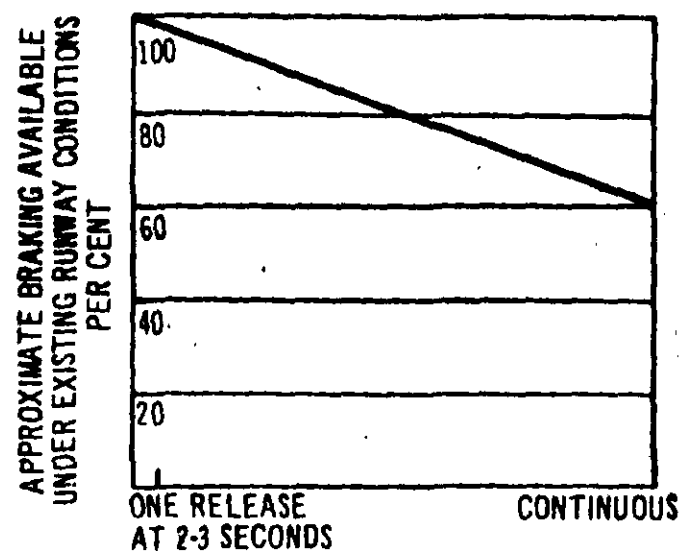
The 707 anti-skid system prevents excessive skidding or a locked wheel condition under all runway and operating conditions. During a landing, a sensor in each tandem pair of wheels senses a wheel skid and automatically relieves hydraulic pressure to those wheels until they begin rolling again. The rate of anti-skid cycling during a landing roll depends on how much brake pressure is being applied and the coefficient of friction between tire and runway surface. During a portion of every skid cycle, a wheel is producing considerably less braking effort than when it is rolling but being braked to the point just before starting to skid. During cycling when brake pressure is being relieved and later reapplied, tires produce little braking. Therefore, excessive cycling of the anti-skid system reduces total braking effort roughly in proportion to the cycling rate (Fig. 12).

FIG. 12- Braking effectiveness drops as rapidity of anti-skid cycling increases. One release about every 2 to 3 seconds develops near the maximum braking possible under existing conditions.

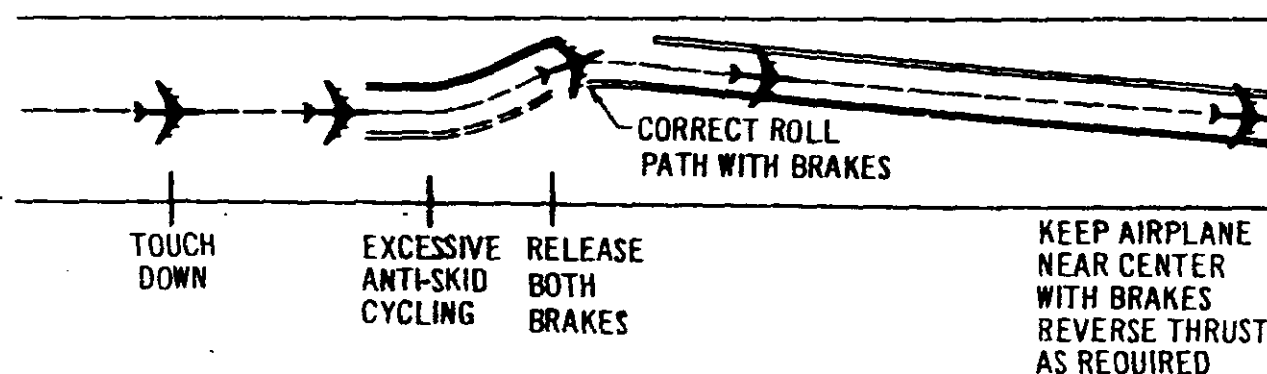
Maximum braking effort from wheels occurs when only enough brake pedal pressure is used to produce an occasional anti-skid brake release; that is, approximately one release every 2 to 3 seconds. A pilot can feel anti-skid cycling from a "kick" in the brake pedals. Large differences in cycling rates, due to the difference in brake pressure to left and right landing gear, a cross-wind, or runway conditions could cause an airplane to veer off to one side or the other (Fig. 13).

FIG. 13—Reduced braking effectiveness due to anti-skid cycling on one side may cause airplane to veer toward one side of the runway. Corrective action for this is to release pressure to both brakes, then apply brakes to one side. When airplane is again headed toward center of runway, apply all brakes to slow airplane. Reducing pressure to rapidly cycling brakes increases braking capability.
