CIRCULAR 82-AN/69
Volume I

AIRCRAFT ACCIDENT DIGEST No. 16

Prepared by the Secretariat and published
by authority of the Secretary General

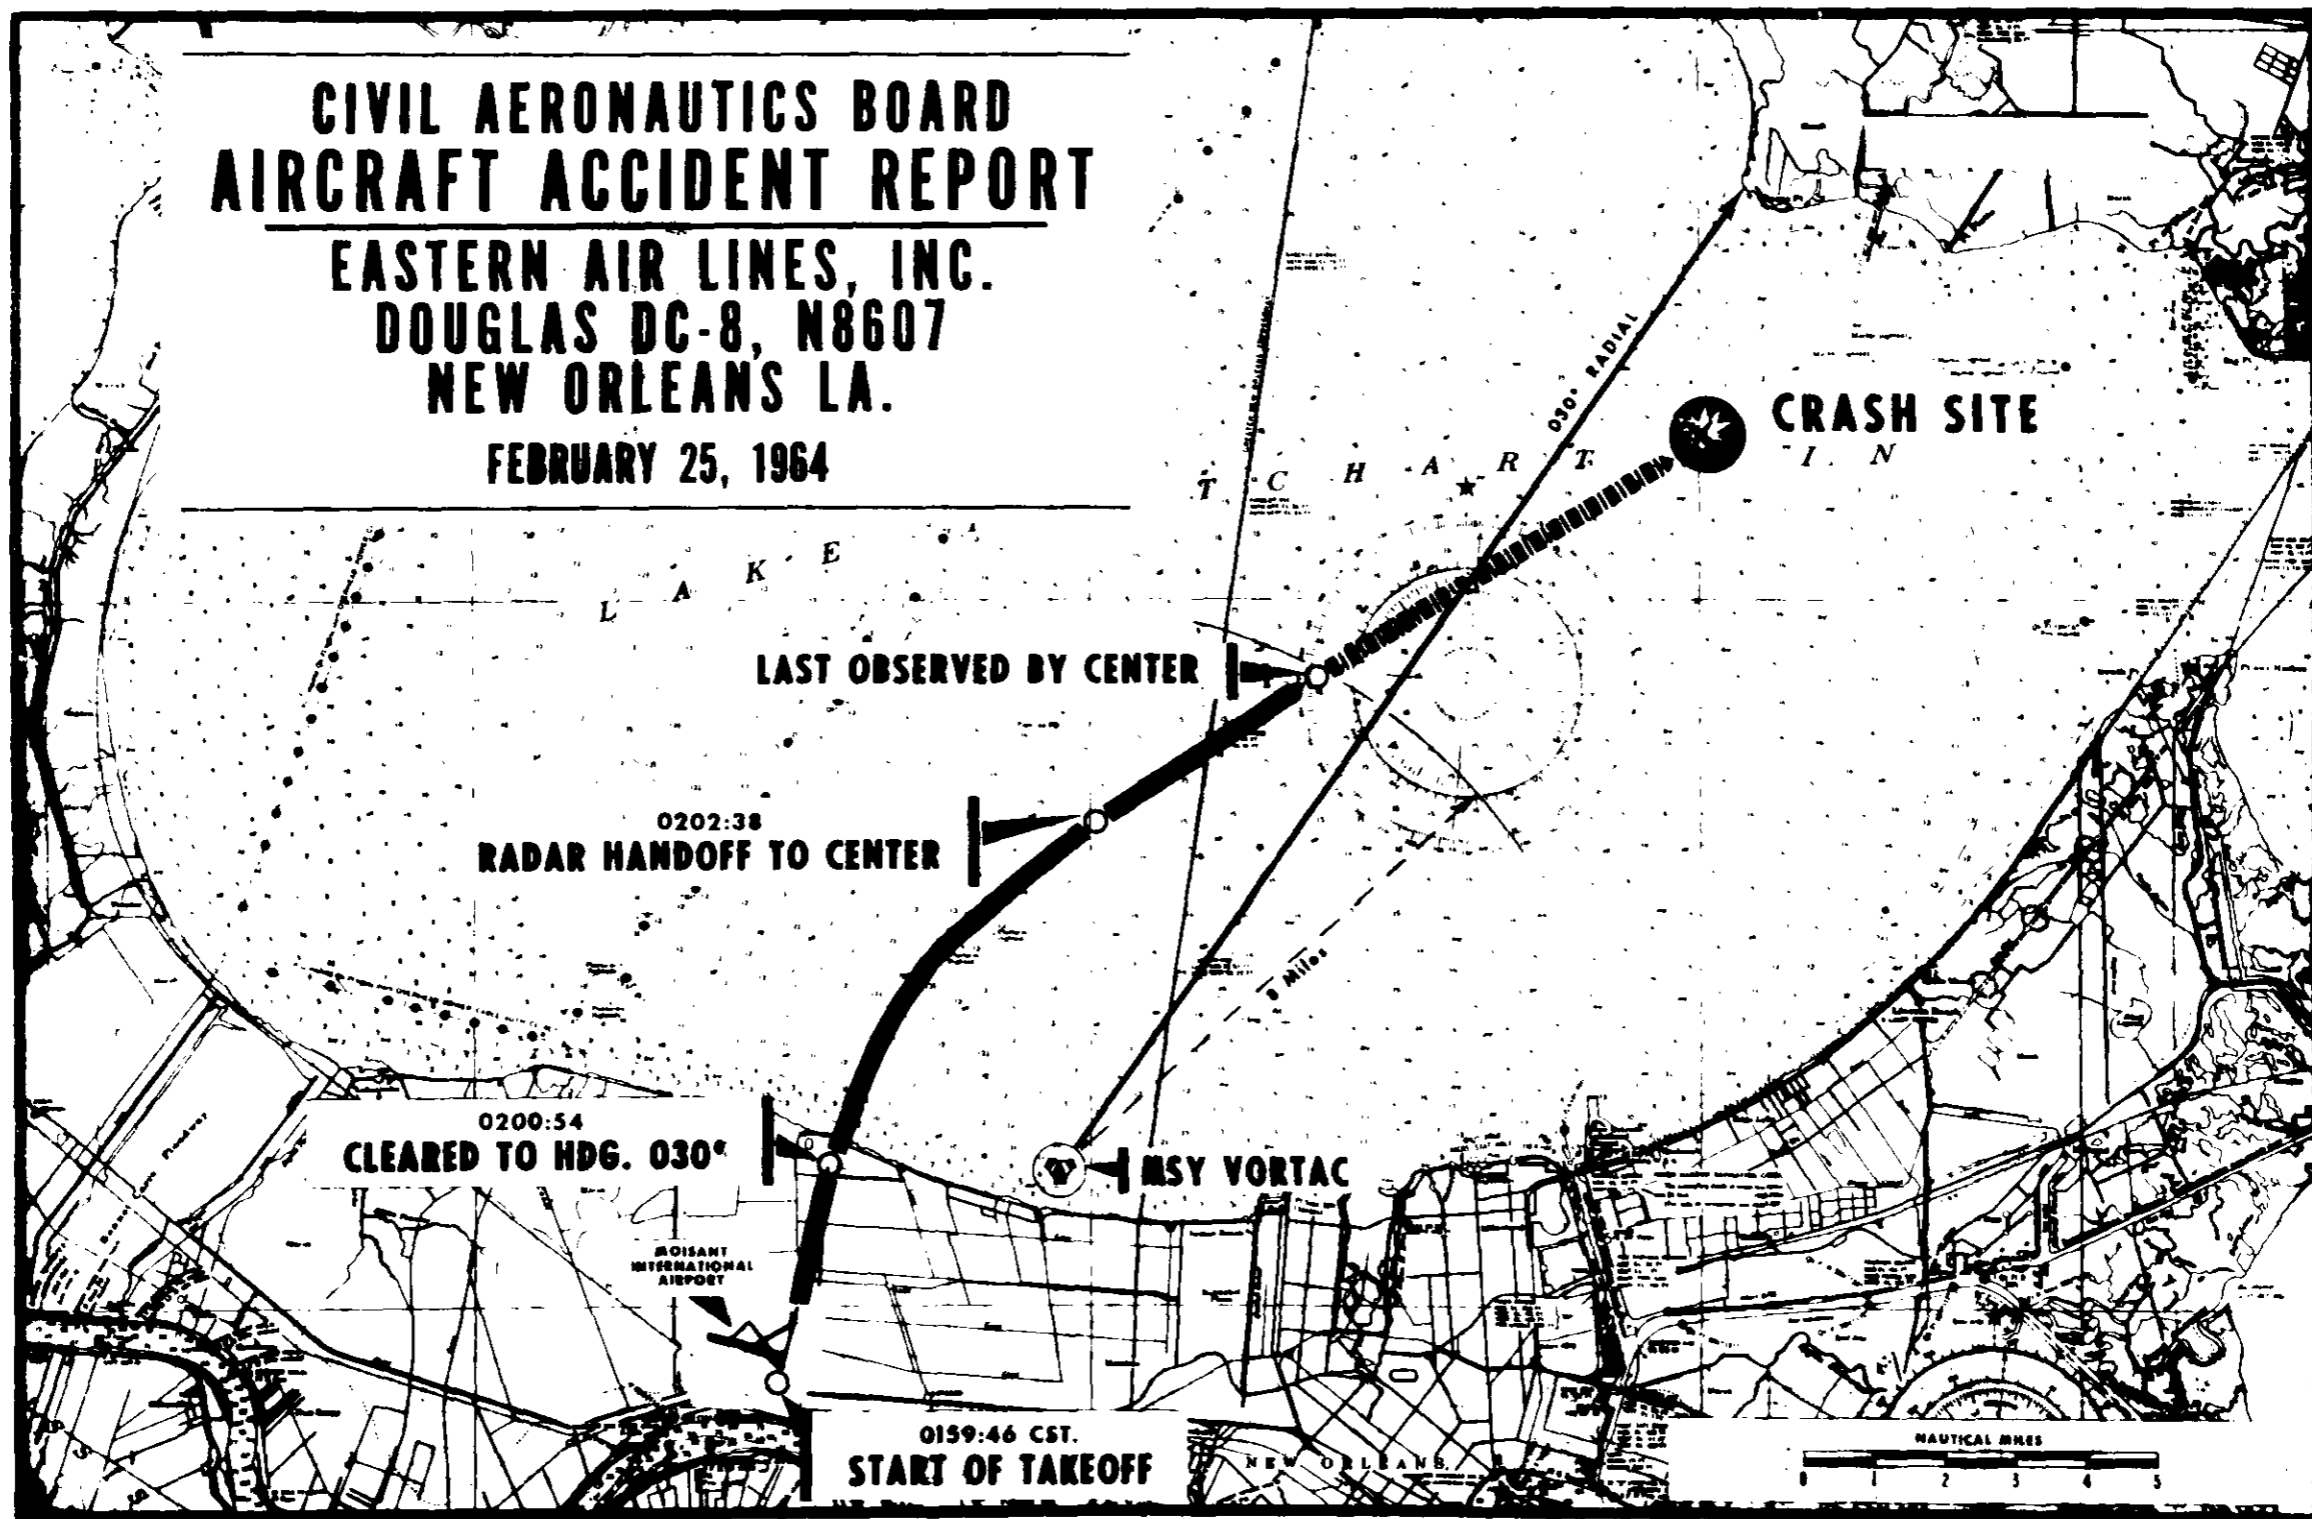
FIGURE 10-1

During this conversation, both controllers confirmed that the radar target associated with the flight had disappeared from both scopes, and emergency procedures were initiated shortly thereafter. The last position noted by the controllers was approximately 8 miles from the New Orleans VORTAC on the 030-degree radial. The aircraft crashed at 14.5 miles on the 034 degree radial in Lake Pontchartrain. The accident occurred at about 0205 hours. (Fig. 10-1)

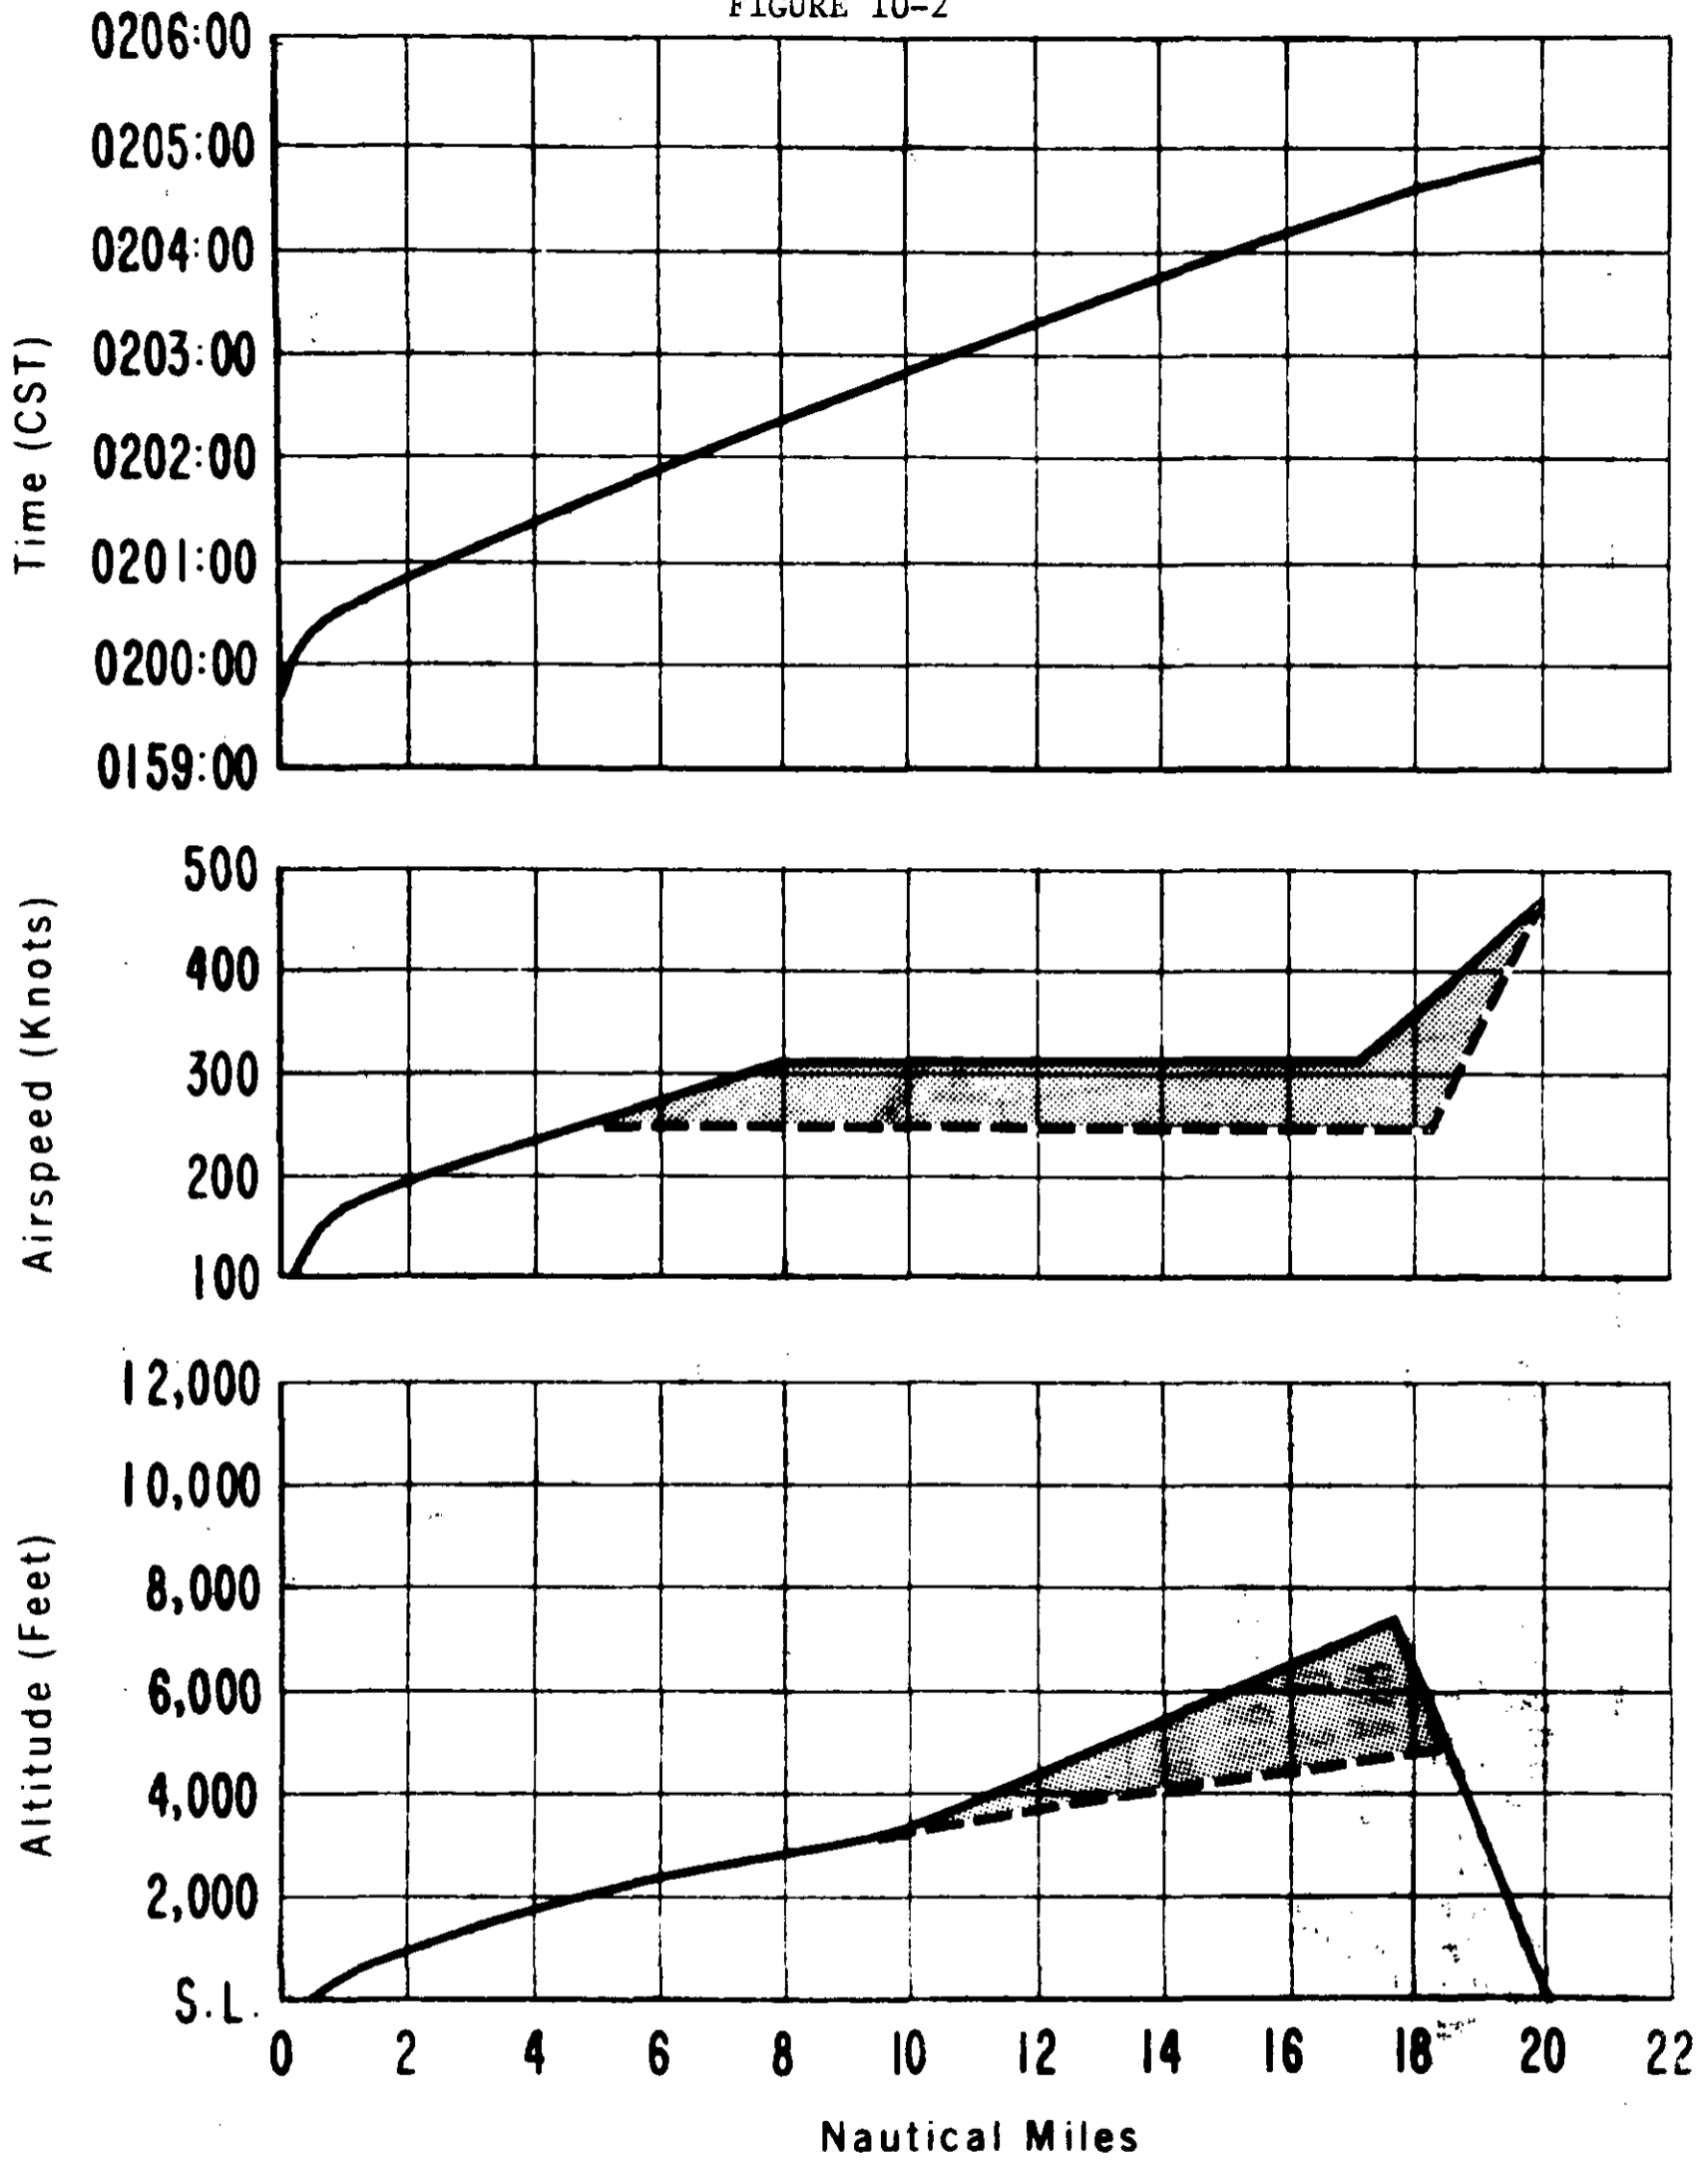
FIGURE 10-2

To assess properly the evidence at hand, the Board found it necessary to construct by analytical methods a facsimile of the type of plot normally gained from the flight recorder. This was done by utilizing a DC-8 flight simulator programmed to duplicate the weight and c.g. of the aircraft and the take-off conditions at Moisant Airport. The simulated accelerations and climb data were corroborated by observations of actual DC-8 take-offs. Integration of the data produced the plot shown at Figure 10-2, which gives an envelope within which this flight operated.

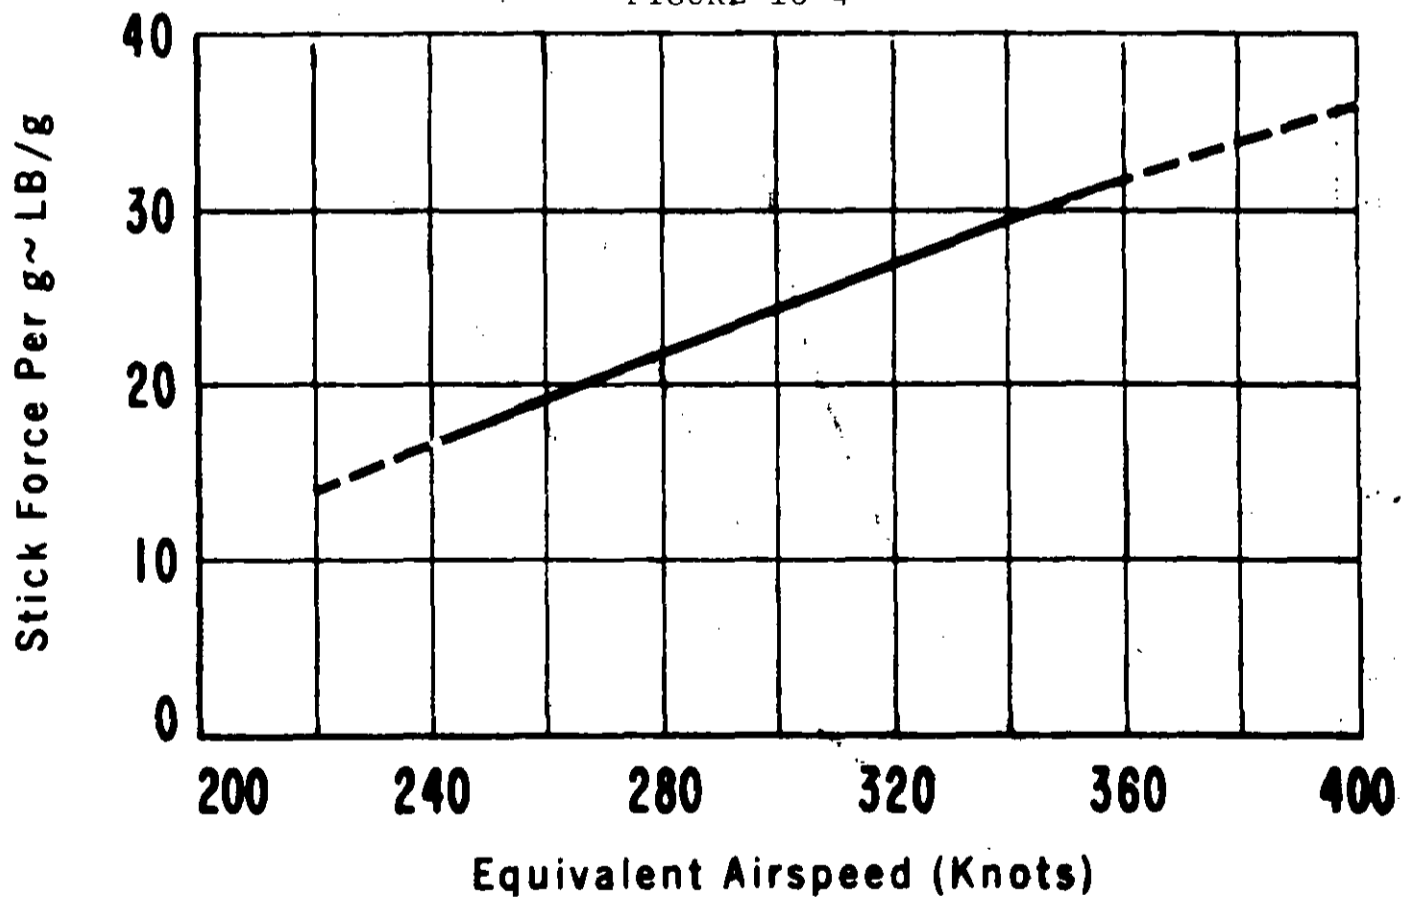
FIGURE 10-4

The variation of stick force per g versus speed for the 2-degree AND case, shown in Figure 10-4, is also significant; while the stick force per g is light but at a reasonable level at 310 knots, it degenerates to about 13 pounds at 220 knots. This level of force gradient is extremely light* and is to a large extent masked by the friction forces of the system, which are about ± 5 to 6 pounds. Thus, at 220 knots a pilot could maintain a 1.5-g manoeuvre without feeling any resistive force, or he could hold limit load (2.5-g) by feeling out only about 14 pounds, considerably less than required for a similar manoeuvre in a military fighter aircraft.

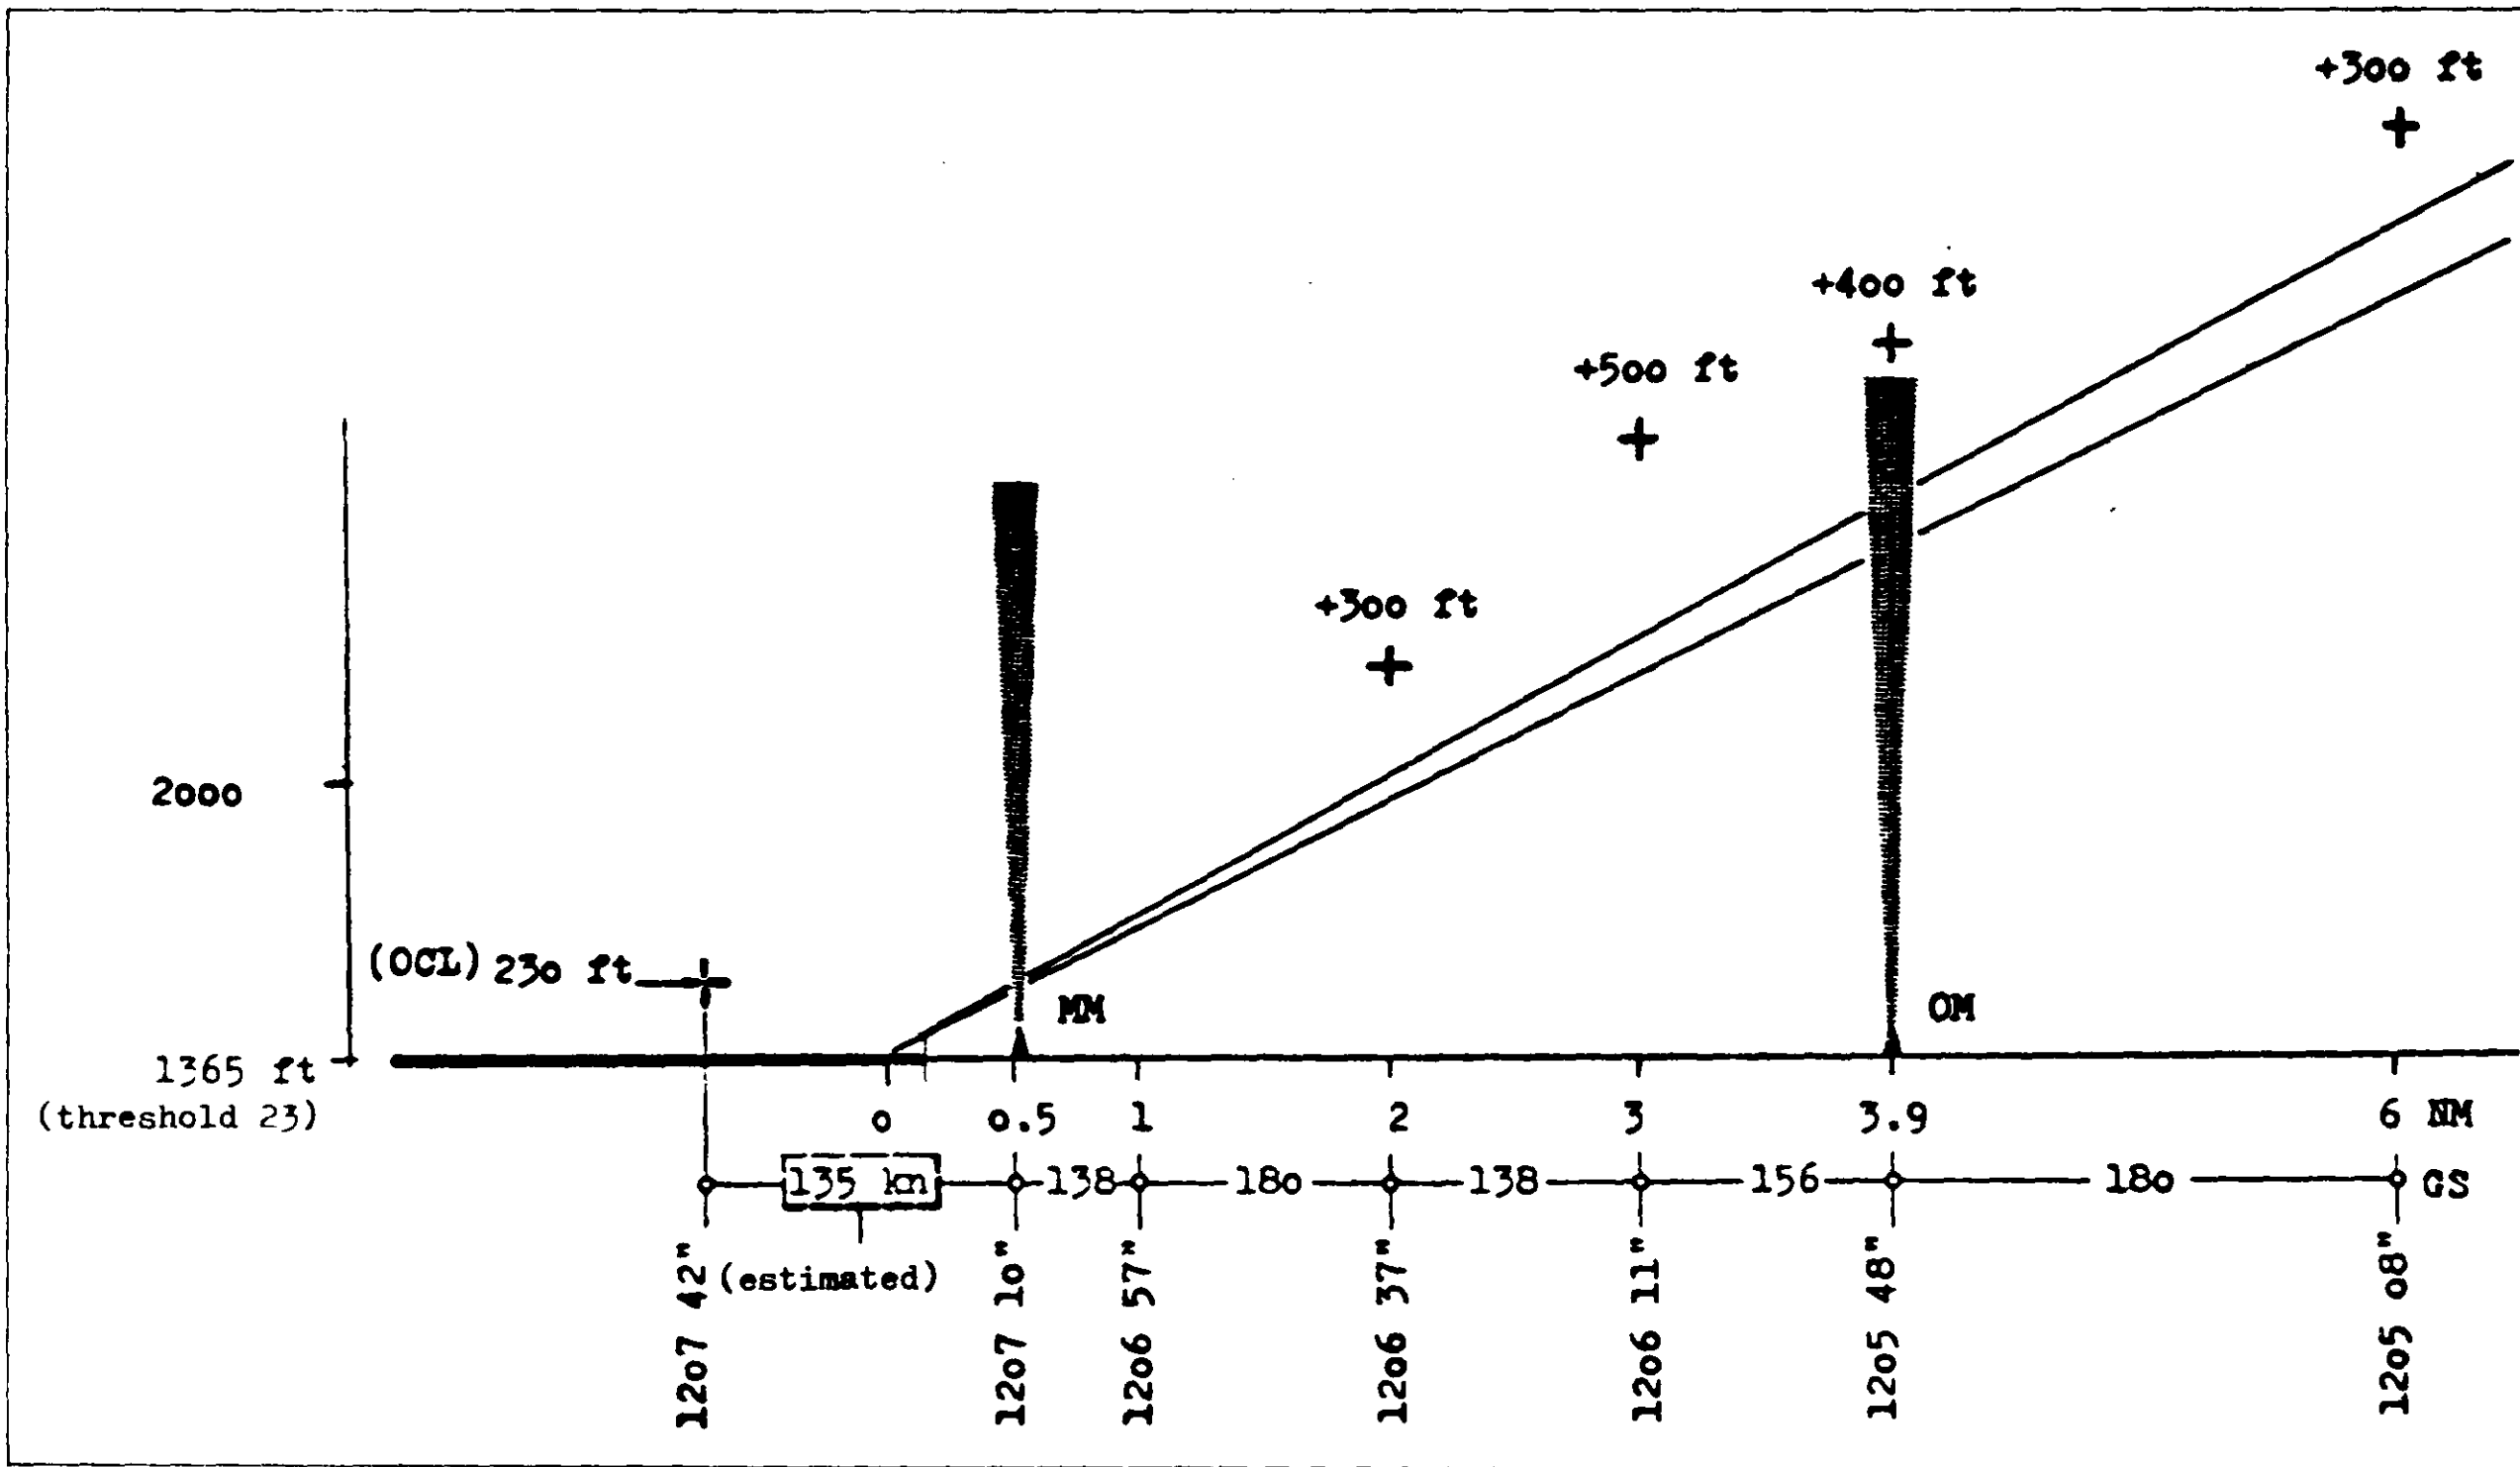
FIGURE 17-1

GRAPH RECONSTRUCTION OF THE APPROACH OF PH-DSN BASED ON THE PRECISION APPROACH RADAR TAPE RECORDING (PAR - KLM 331)

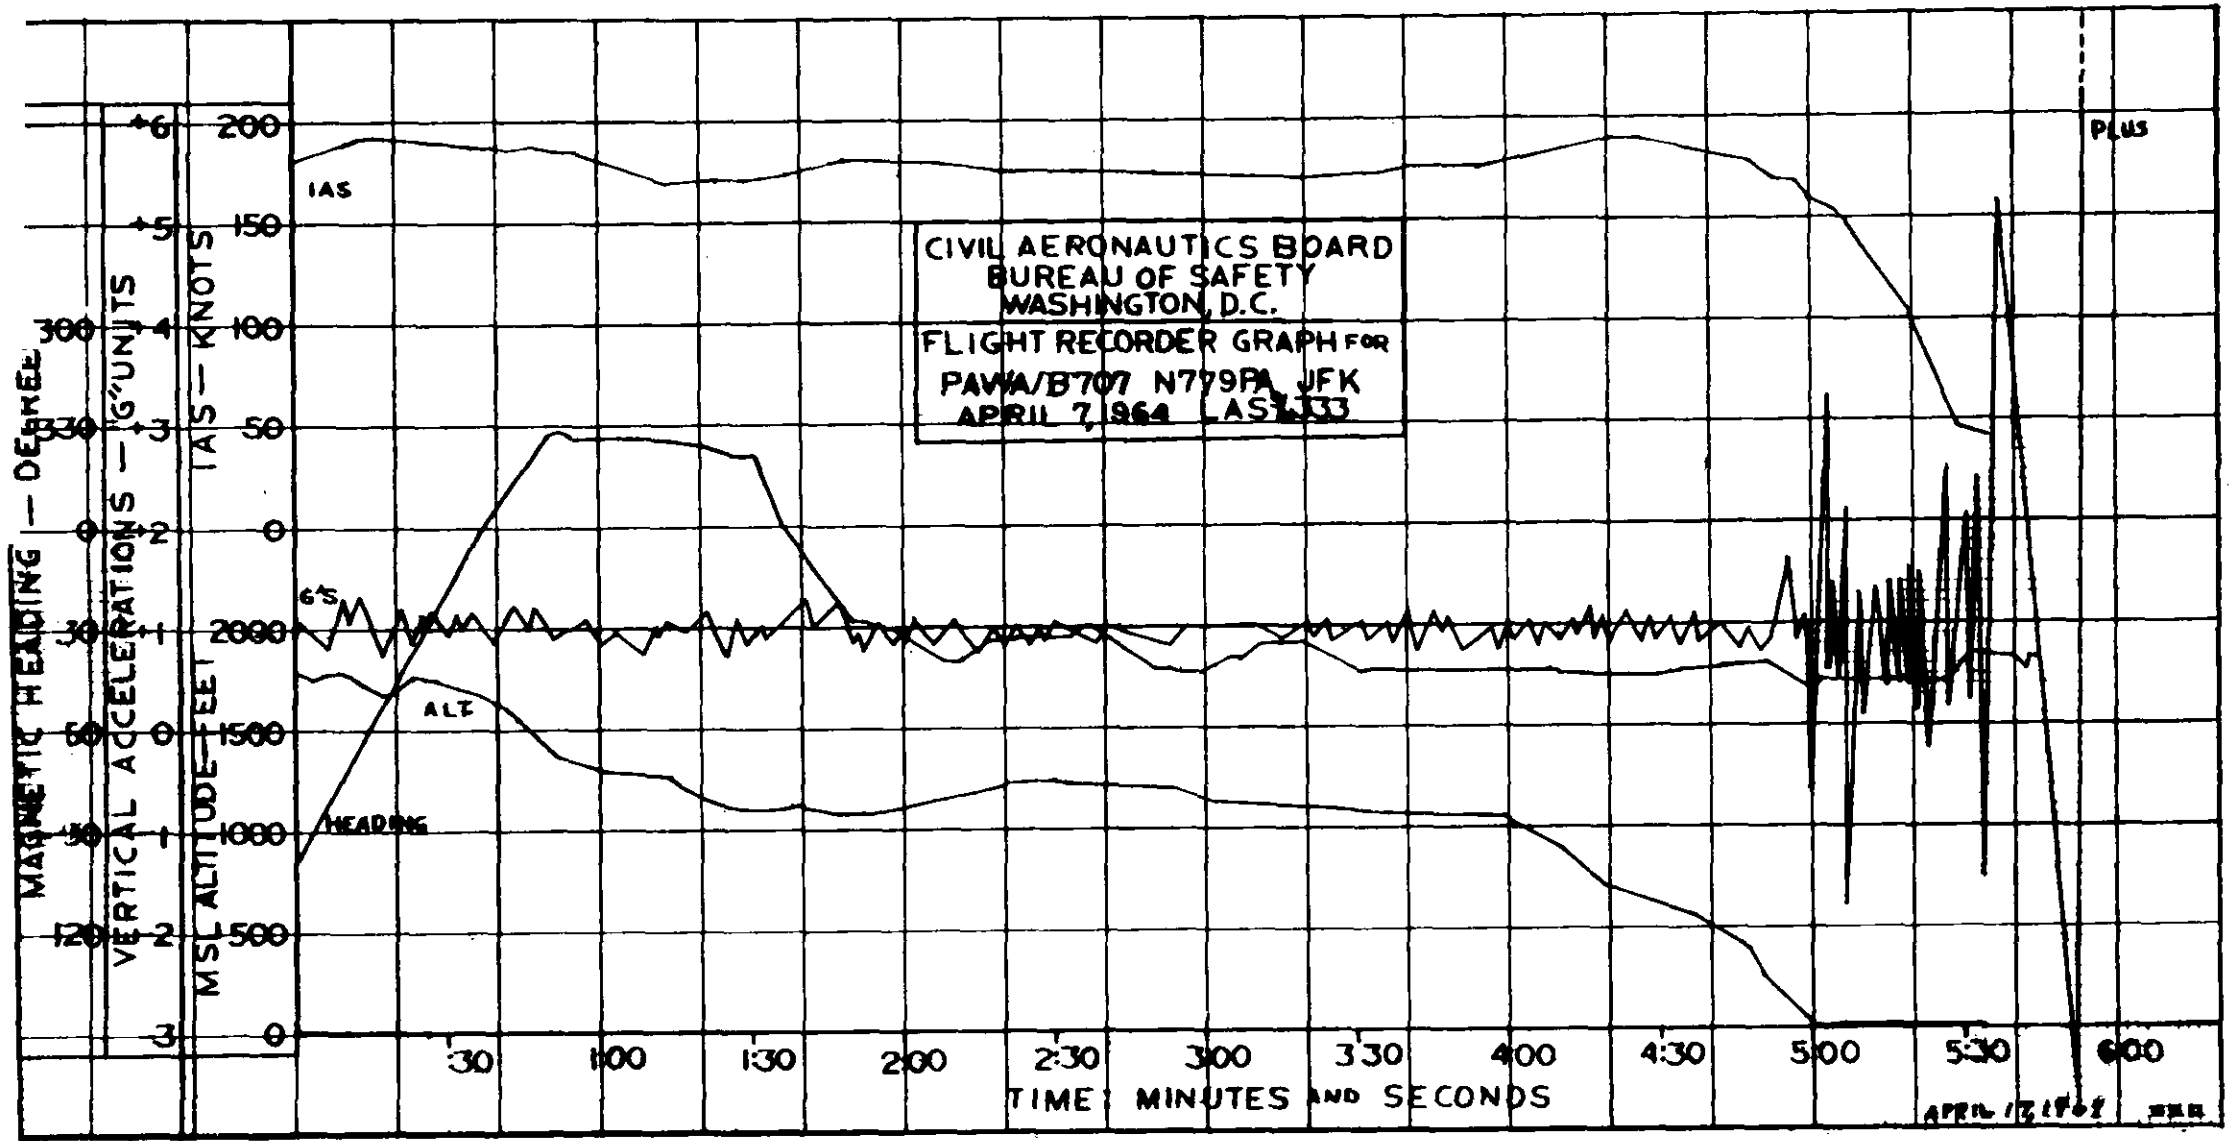
FIGURE 23-1

1.11 Flight recorders (See Figure 23-1)

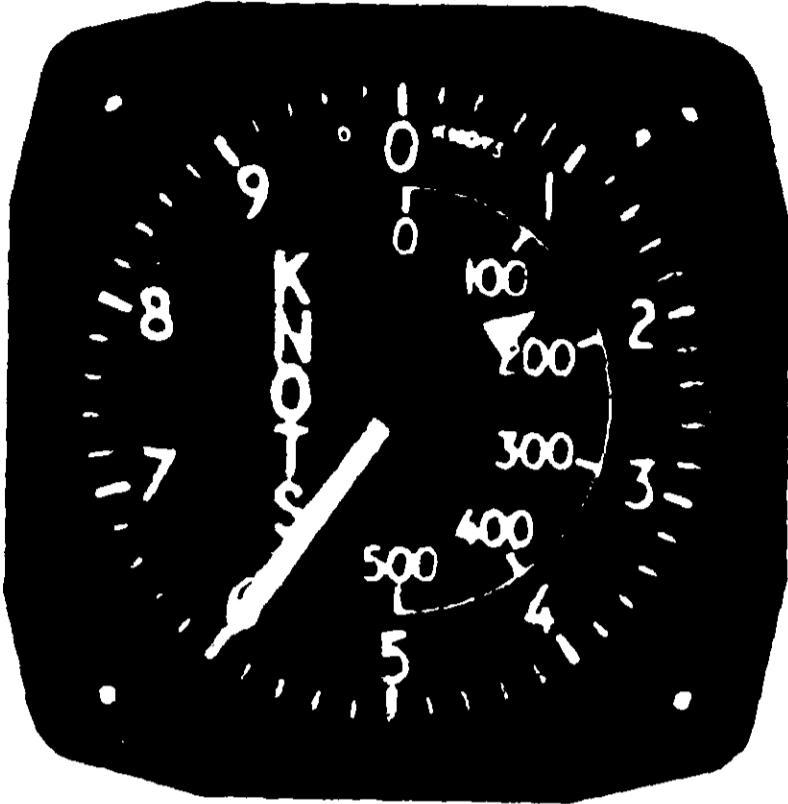
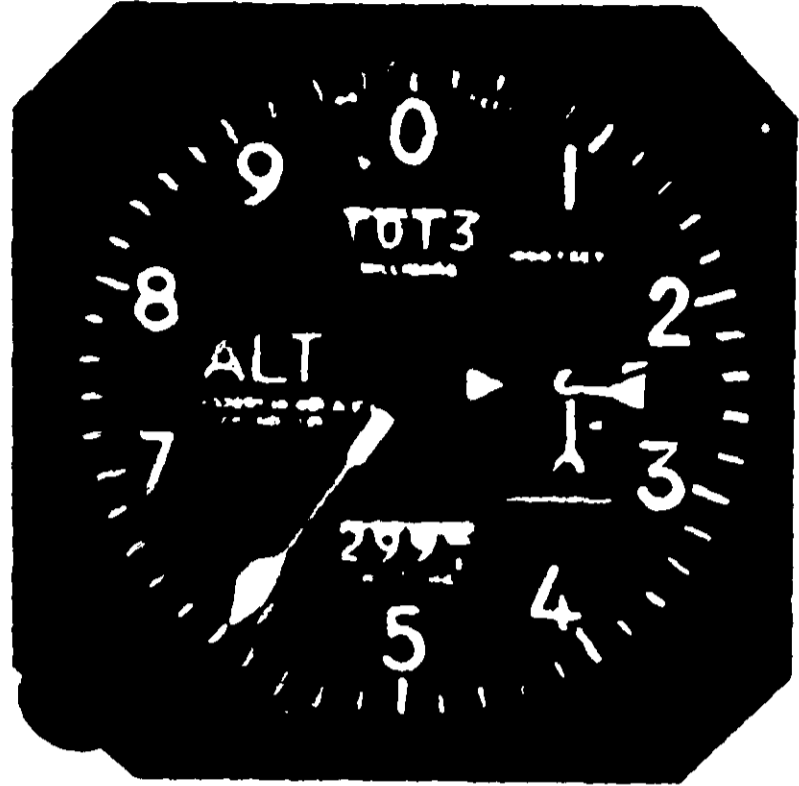
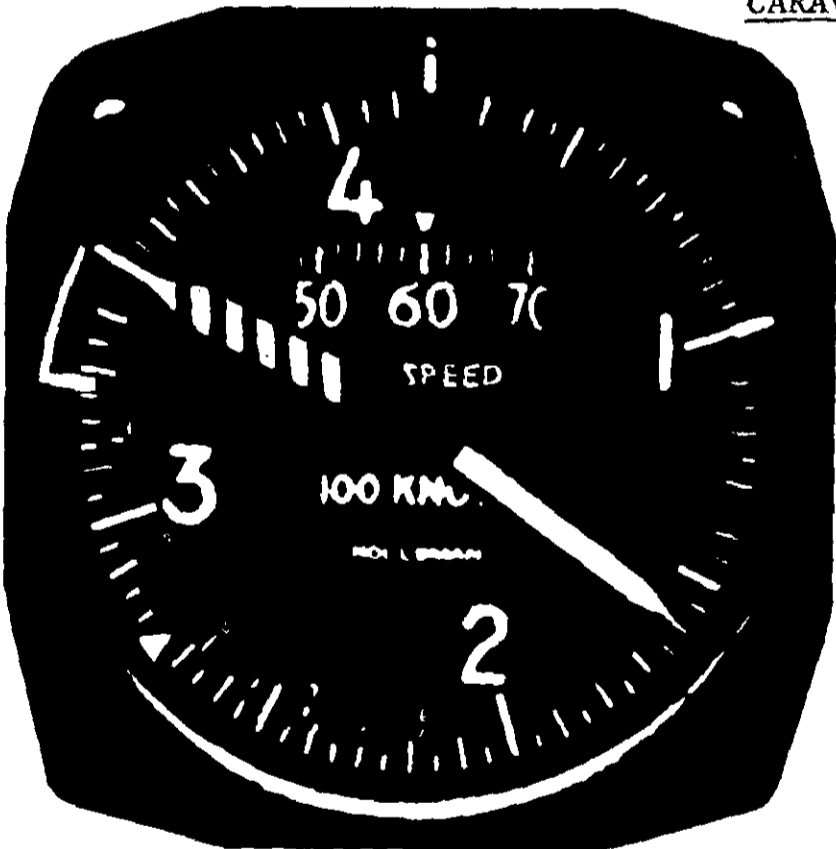
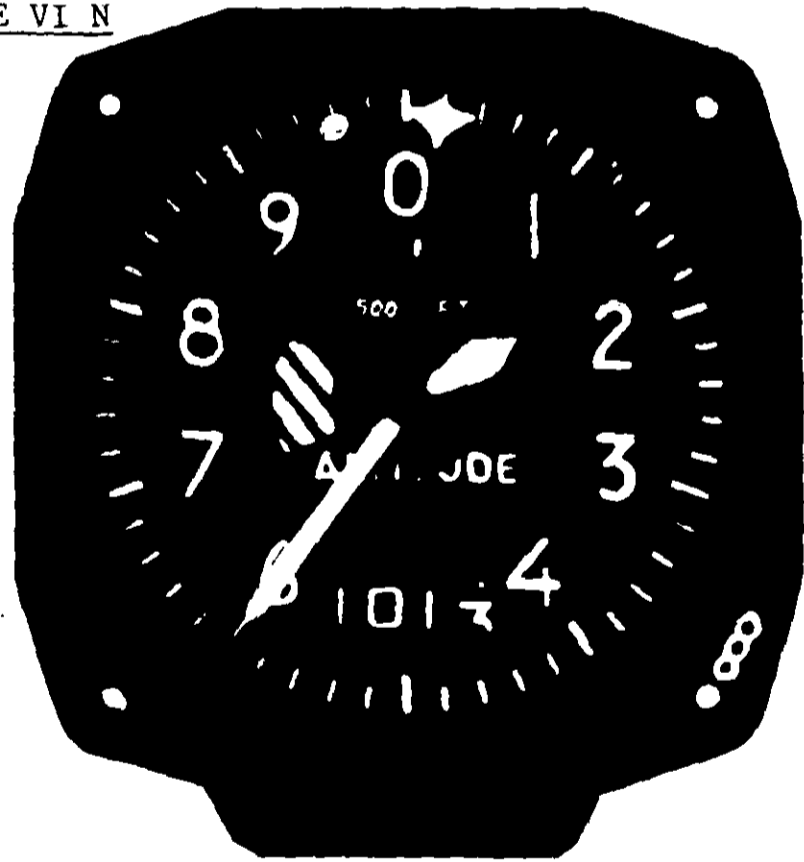
FIGURE 24-2

The Committee then considered the possibility that the pilot-in-command mistook the ASI for the altimeter. It was noted that his experience on the subject aircraft (Caravelle III) was only about 10 hours compared with approximately 225 hours on the Caravelle VI N. The VI N is equipped with double-pointer altimeters and single-pointer ASIs, whereas the Caravelle III had single-pointer altimeters and double-pointer ASIs (see Figure 24-2). Thus, when the pointers of the altimeter in the VI N are (say) indicating 1 600 ft, they are in the same positions as the pointers of the ASI in a III.
