# ICAO

CIRCULAR 82-AN/69  
Volume II

### AIRCRAFT ACCIDENT DIGEST No. 16

### Volume II

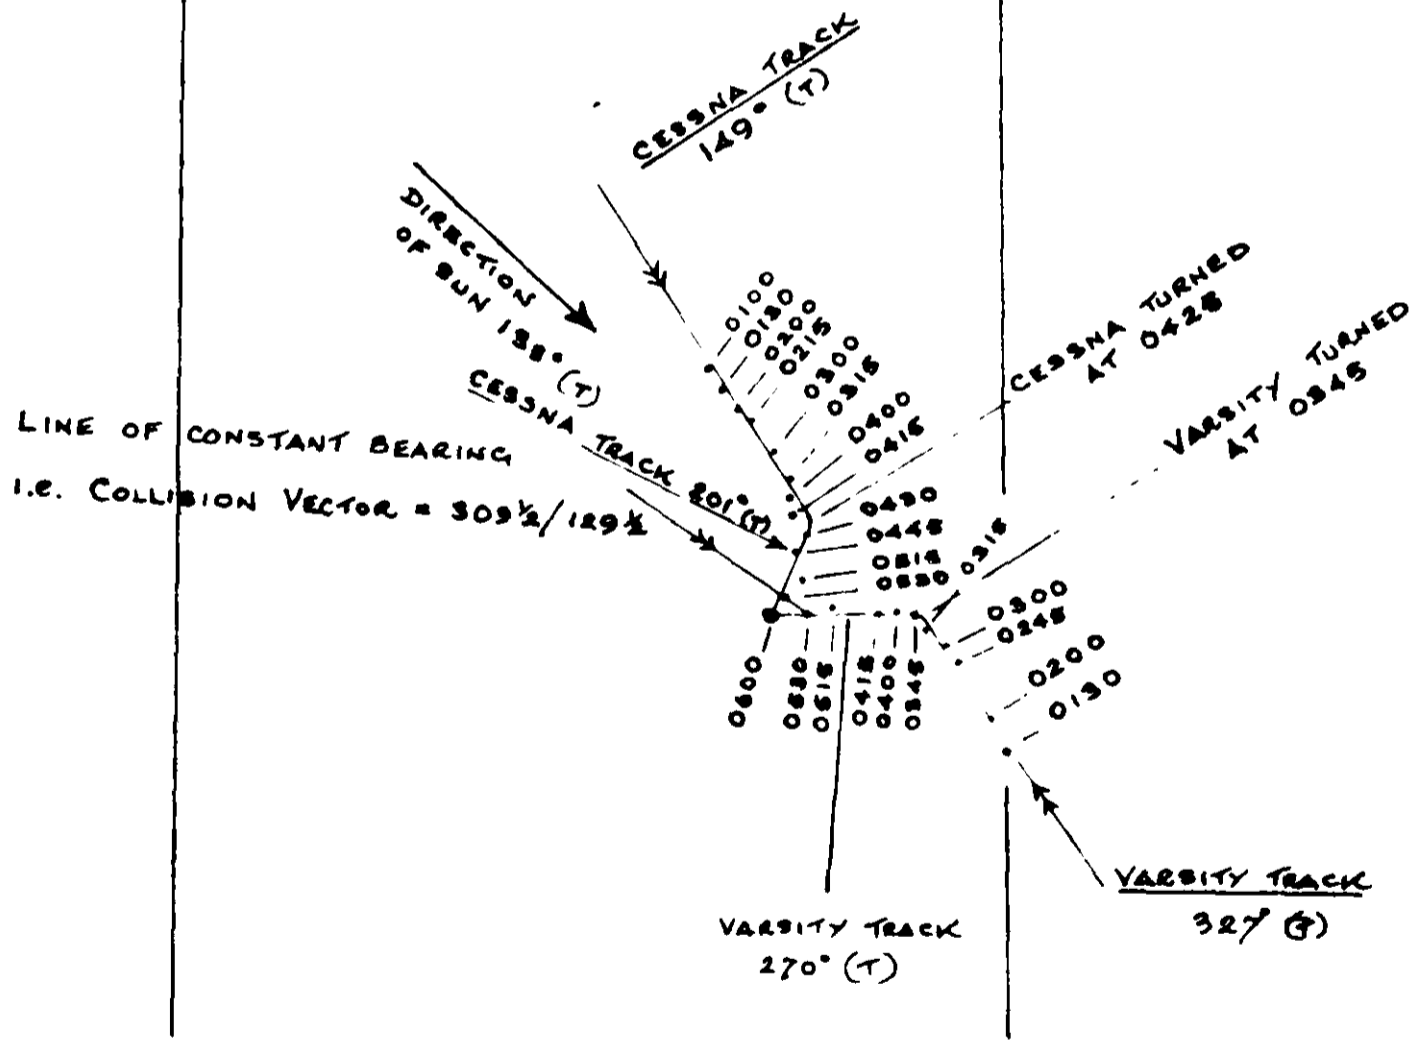
FIGURE 9-1

(Times shown are minutes and seconds after 1000 hrs.)
