ICAO CIRCULAR

CIRCULAR 82-AN/69
Volume III

AIRCRAFT ACCIDENT DIGEST No. 16

Volume III

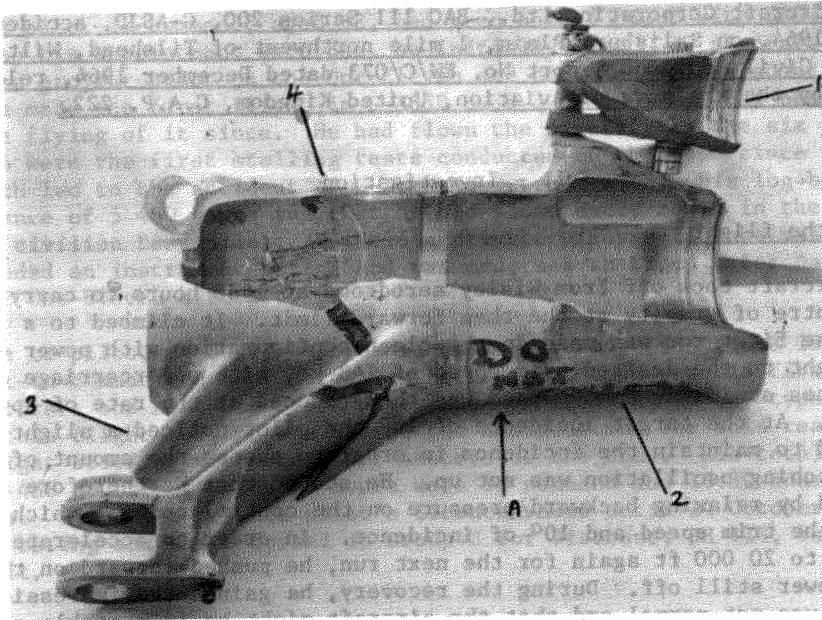
FIGURE 8-1

Examination of the fractures suggested that these had progressed upwards from the lower portions of the forging and, at a point in the blend radius between the outer torque link lug and the main barrel of the casing, a nucleus was apparent (see Figures 8-1 and 8-2).

ACCIDENT TO BRITANNIA 312, G-AOVF, OF
BRITISH EAGLE INTERNATIONAL AIRLINES LTD.,
AT KARACHI, PAKISTAN. 31 JULY 1964

- that more frequent ultrasonic inspections be carried out to all legs, sound or reworked, to detect cracks before they propagate too far;
 - that aircraft on which a repair had previously been carried out should have an additional special inspection after each ten landings;
 - that while removing material to eliminate ultrasonic signals more material be removed than the minimum required for the purpose.
-

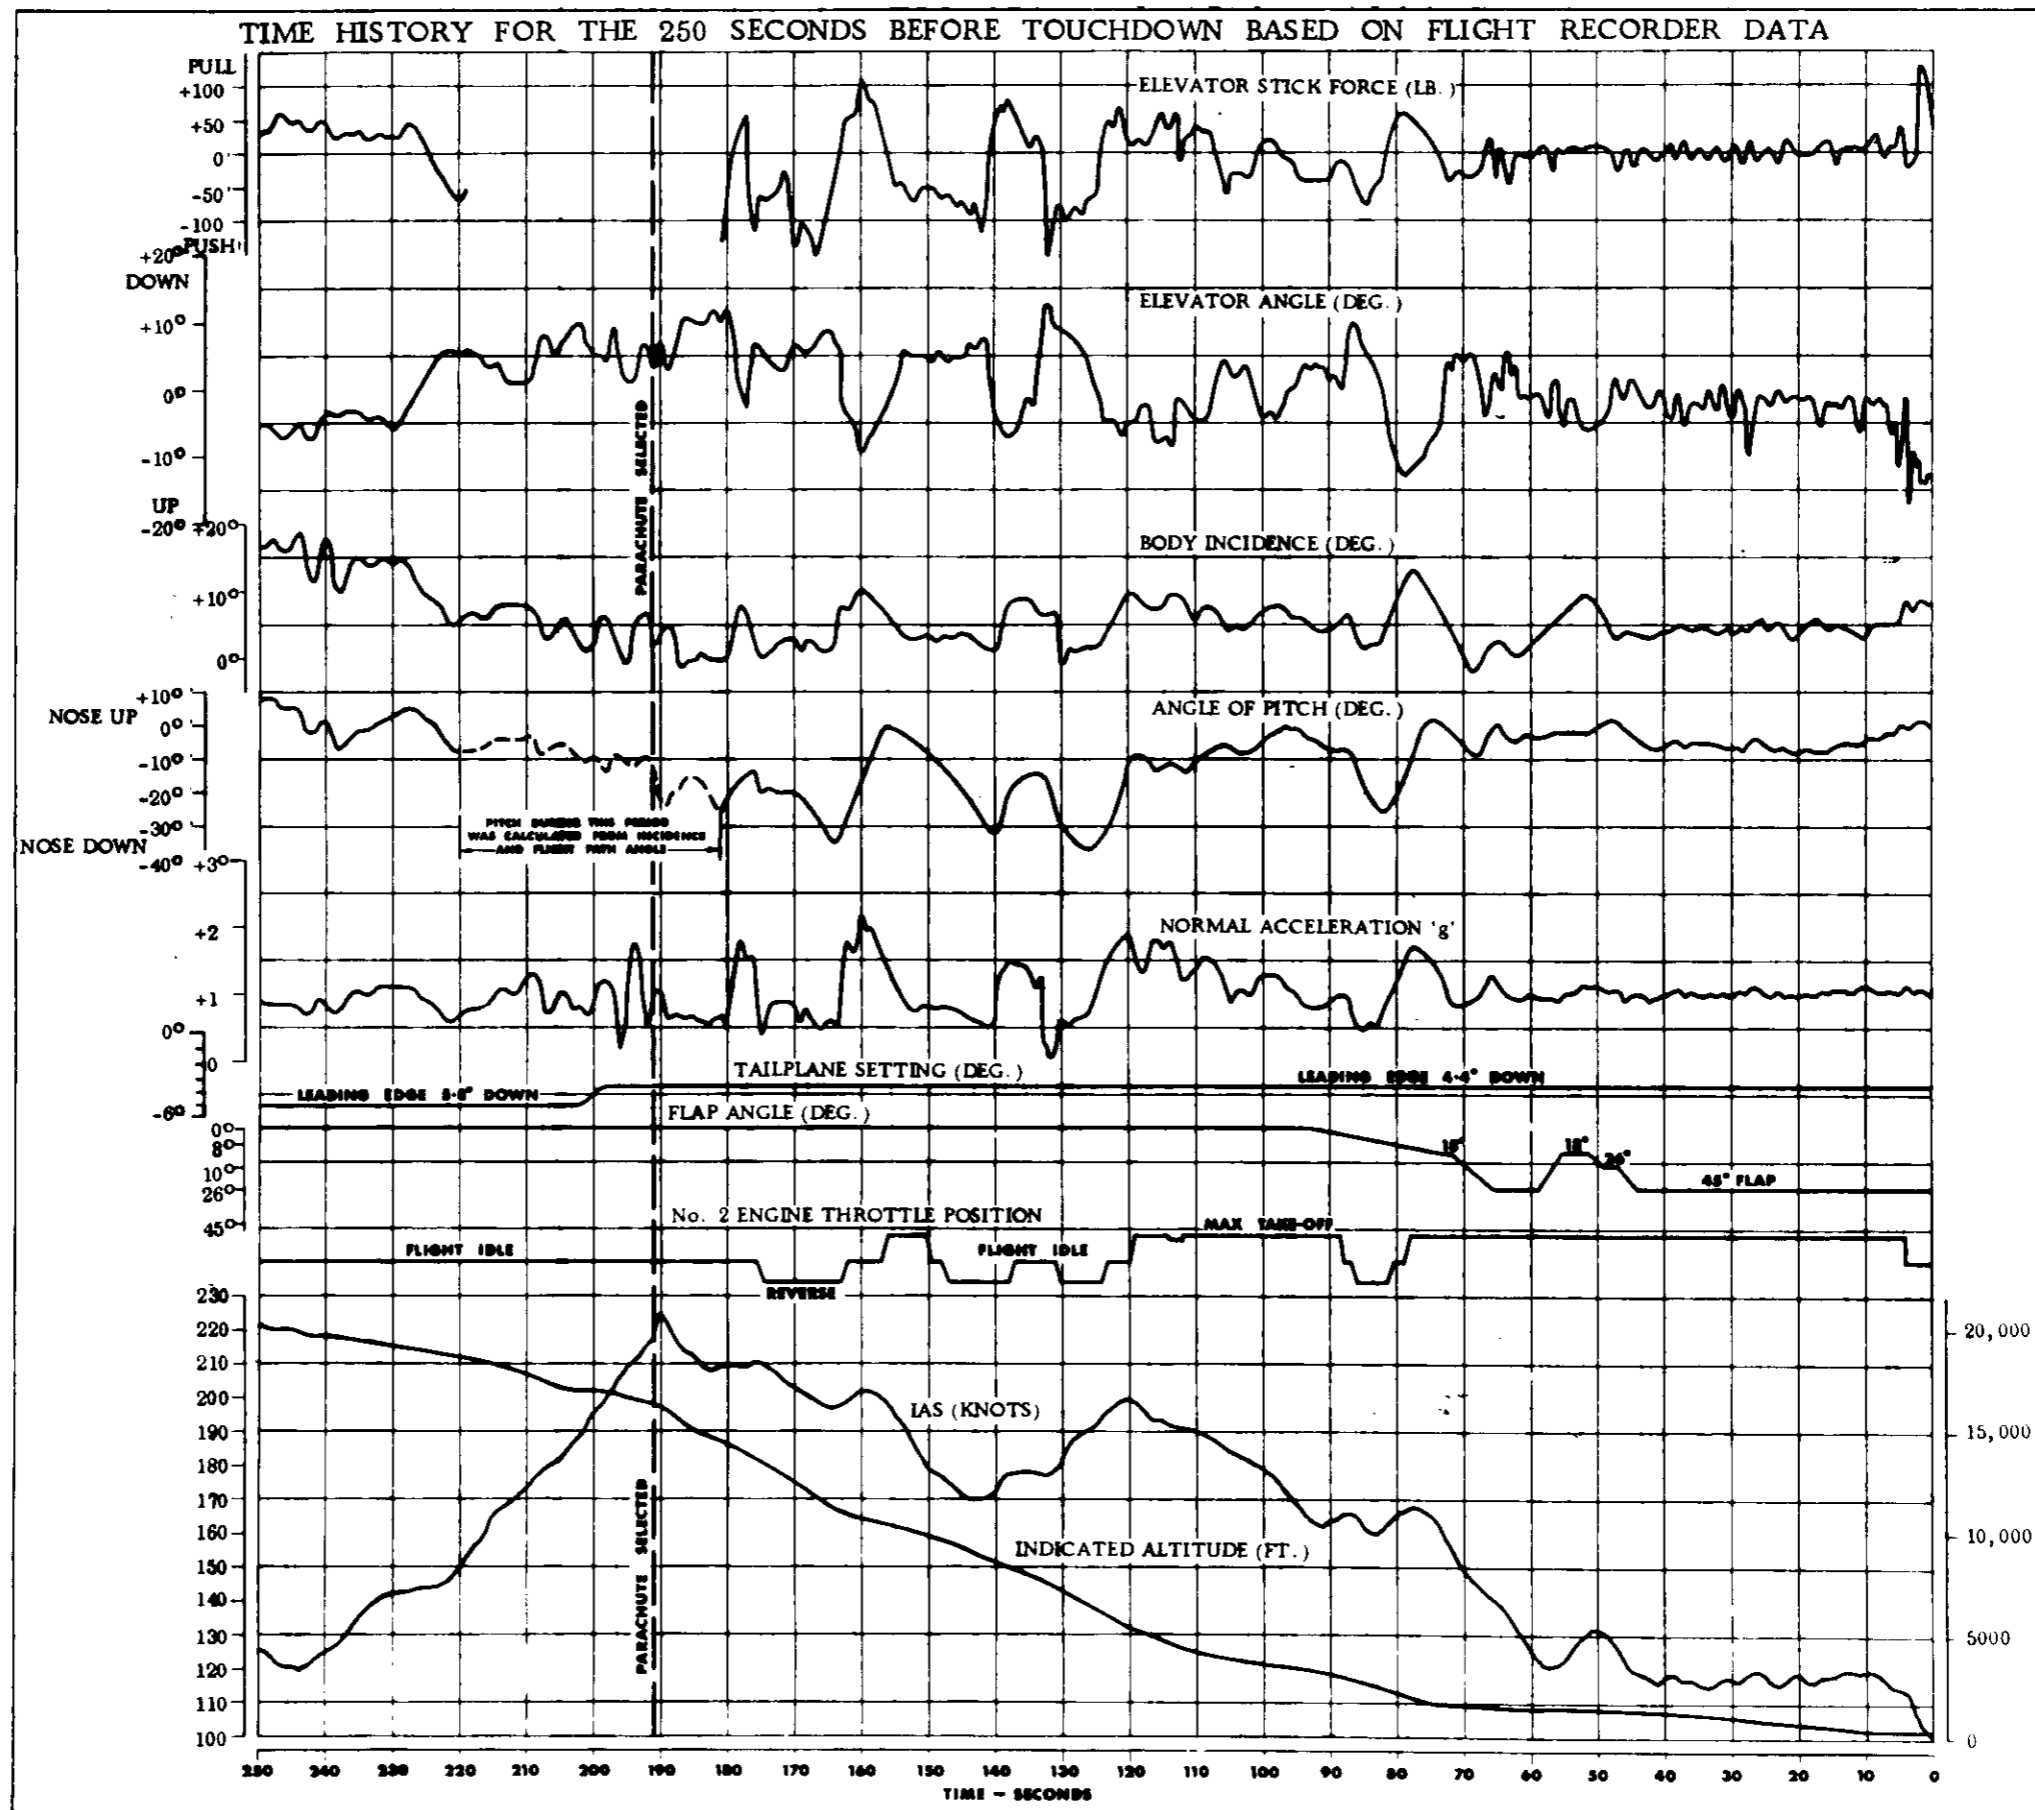
FIGURE 9-1

the recording was garbled in many places due to the incomplete erasure of the record of a previous flight and added only a little to the information available from other sources. A time history of the more significant recorder data for the 250-second period before touchdown is given in Figure 9-1 and has been completed by reference to all the recorders. The record of pitch and elevator stick force for the period during which the normal test recorders were switched off was unreadable; the gap in the pitch record has been filled from calculation, but this could not be done in respect of elevator stick force.

ACCIDENT TO BAC 111, G-HSJD, OF BRITISH AIRCRAFT CORP. LTD., NEAR TILSHEAD, ENGLAND.
20 AUGUST 1964

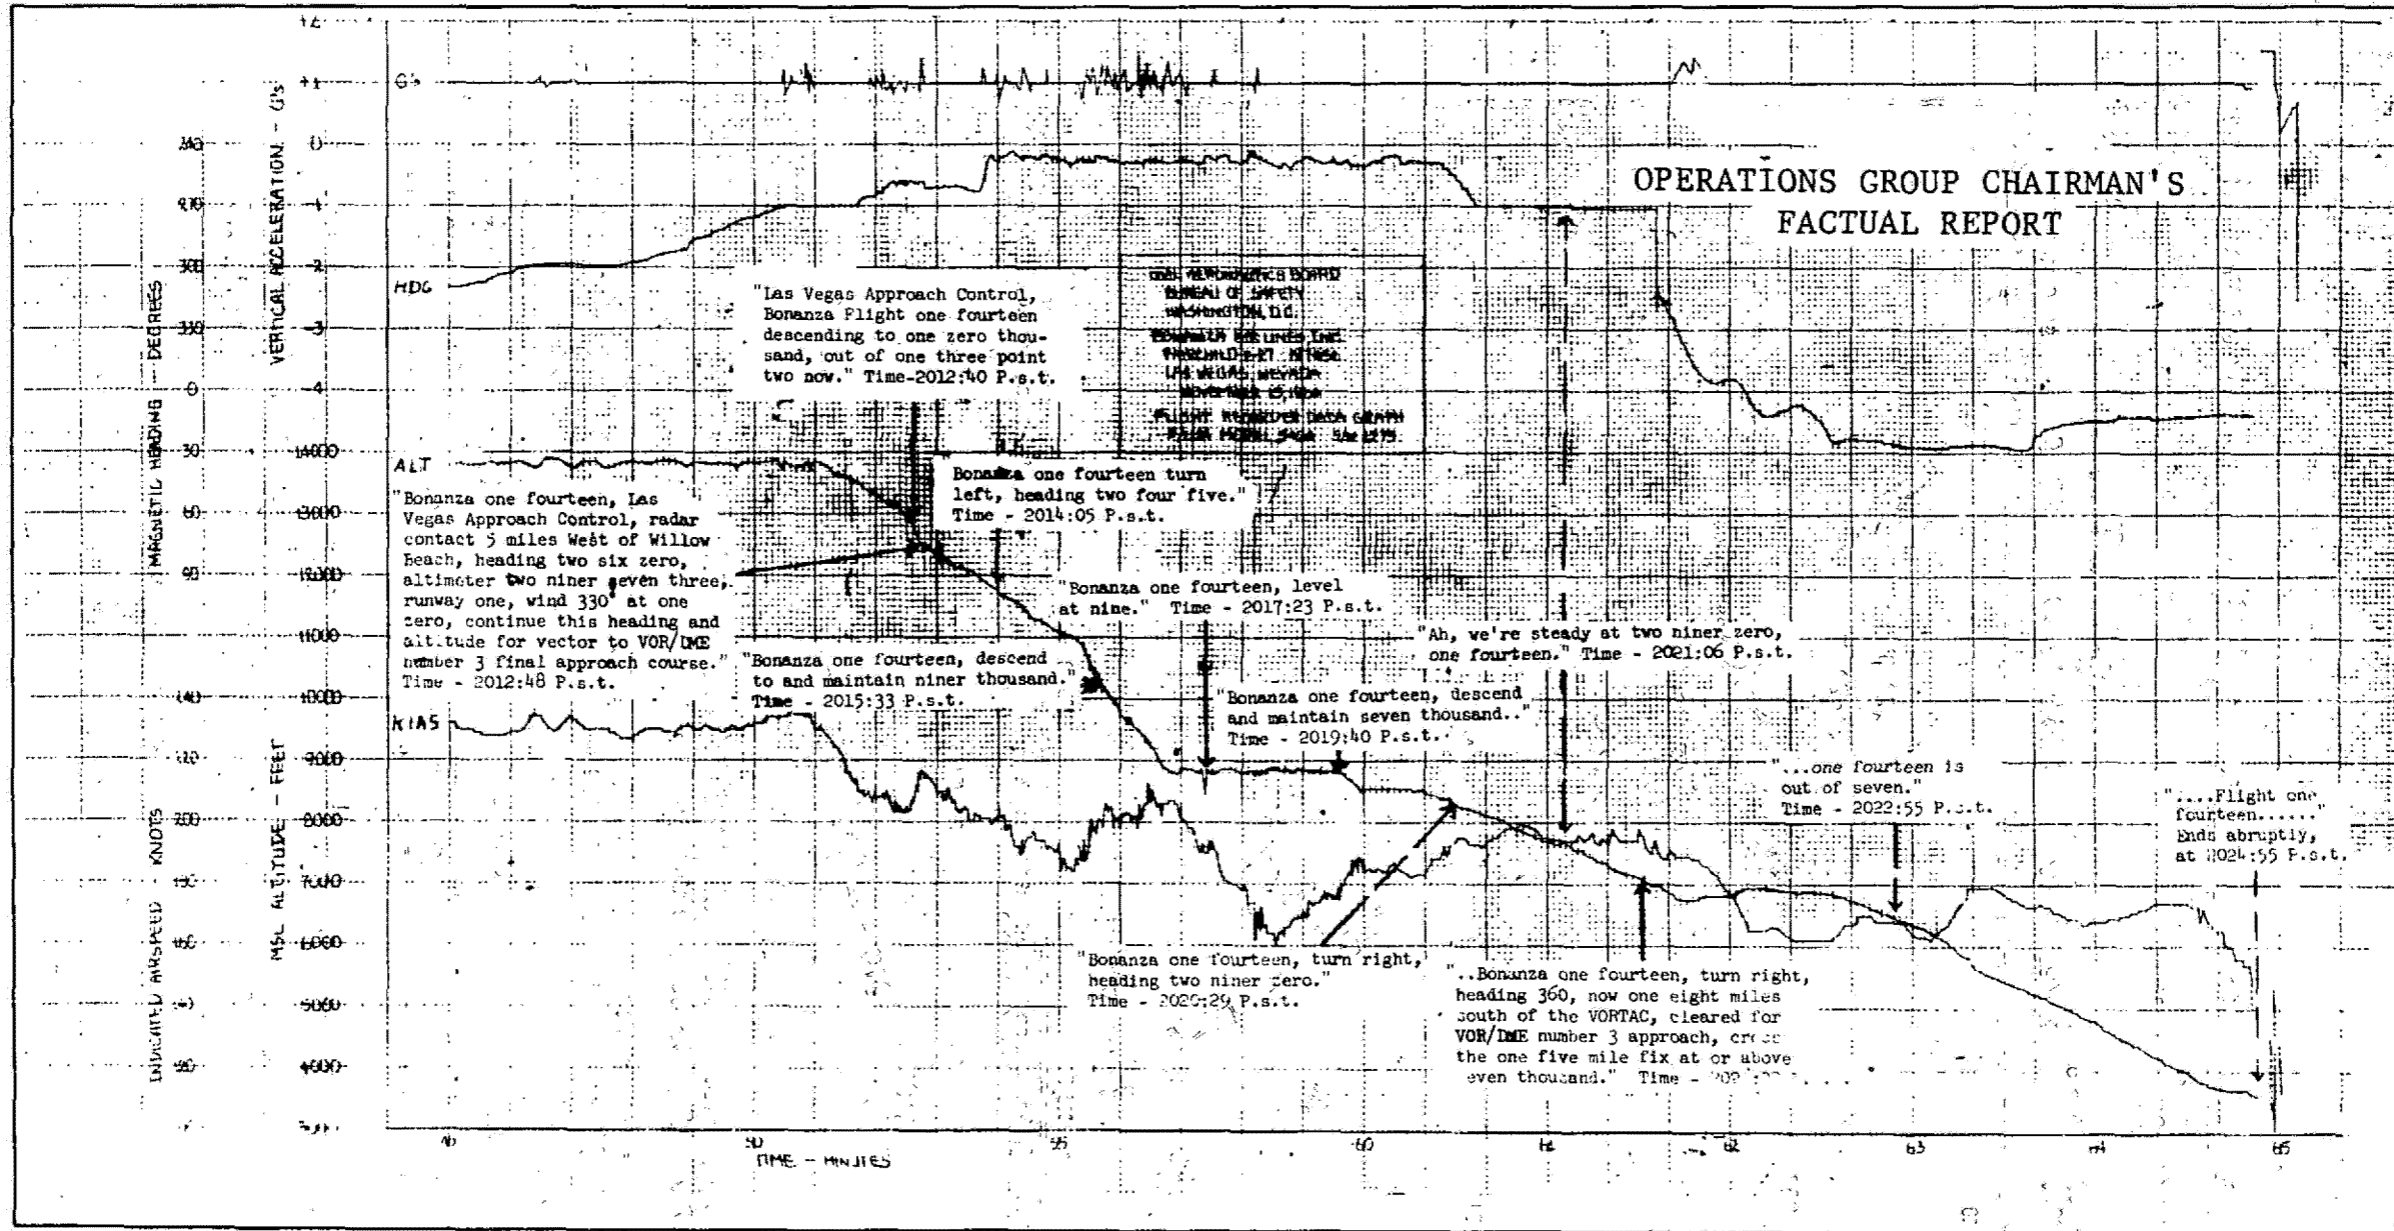
FIGURE 18-1

A Fairchild flight recorder was installed in the aircraft. The static ports for the flight recorder, altitude and airspeed instruments were located on the same panel. The recorder tape was recovered intact. Readout indicated compatibility with the clearances and instructions to the 15 mile DME fix. At approximately the 15 mile DME fix, the flight commenced a descent from approximately 7 000 ft AMSL which continued with no indication of level-off except for a few seconds at 3 700 ft AMSL. After this momentary level-off, the aircraft continued its descent until it crashed at approximately 3 575 ft AMSL. (See figure 18-1).

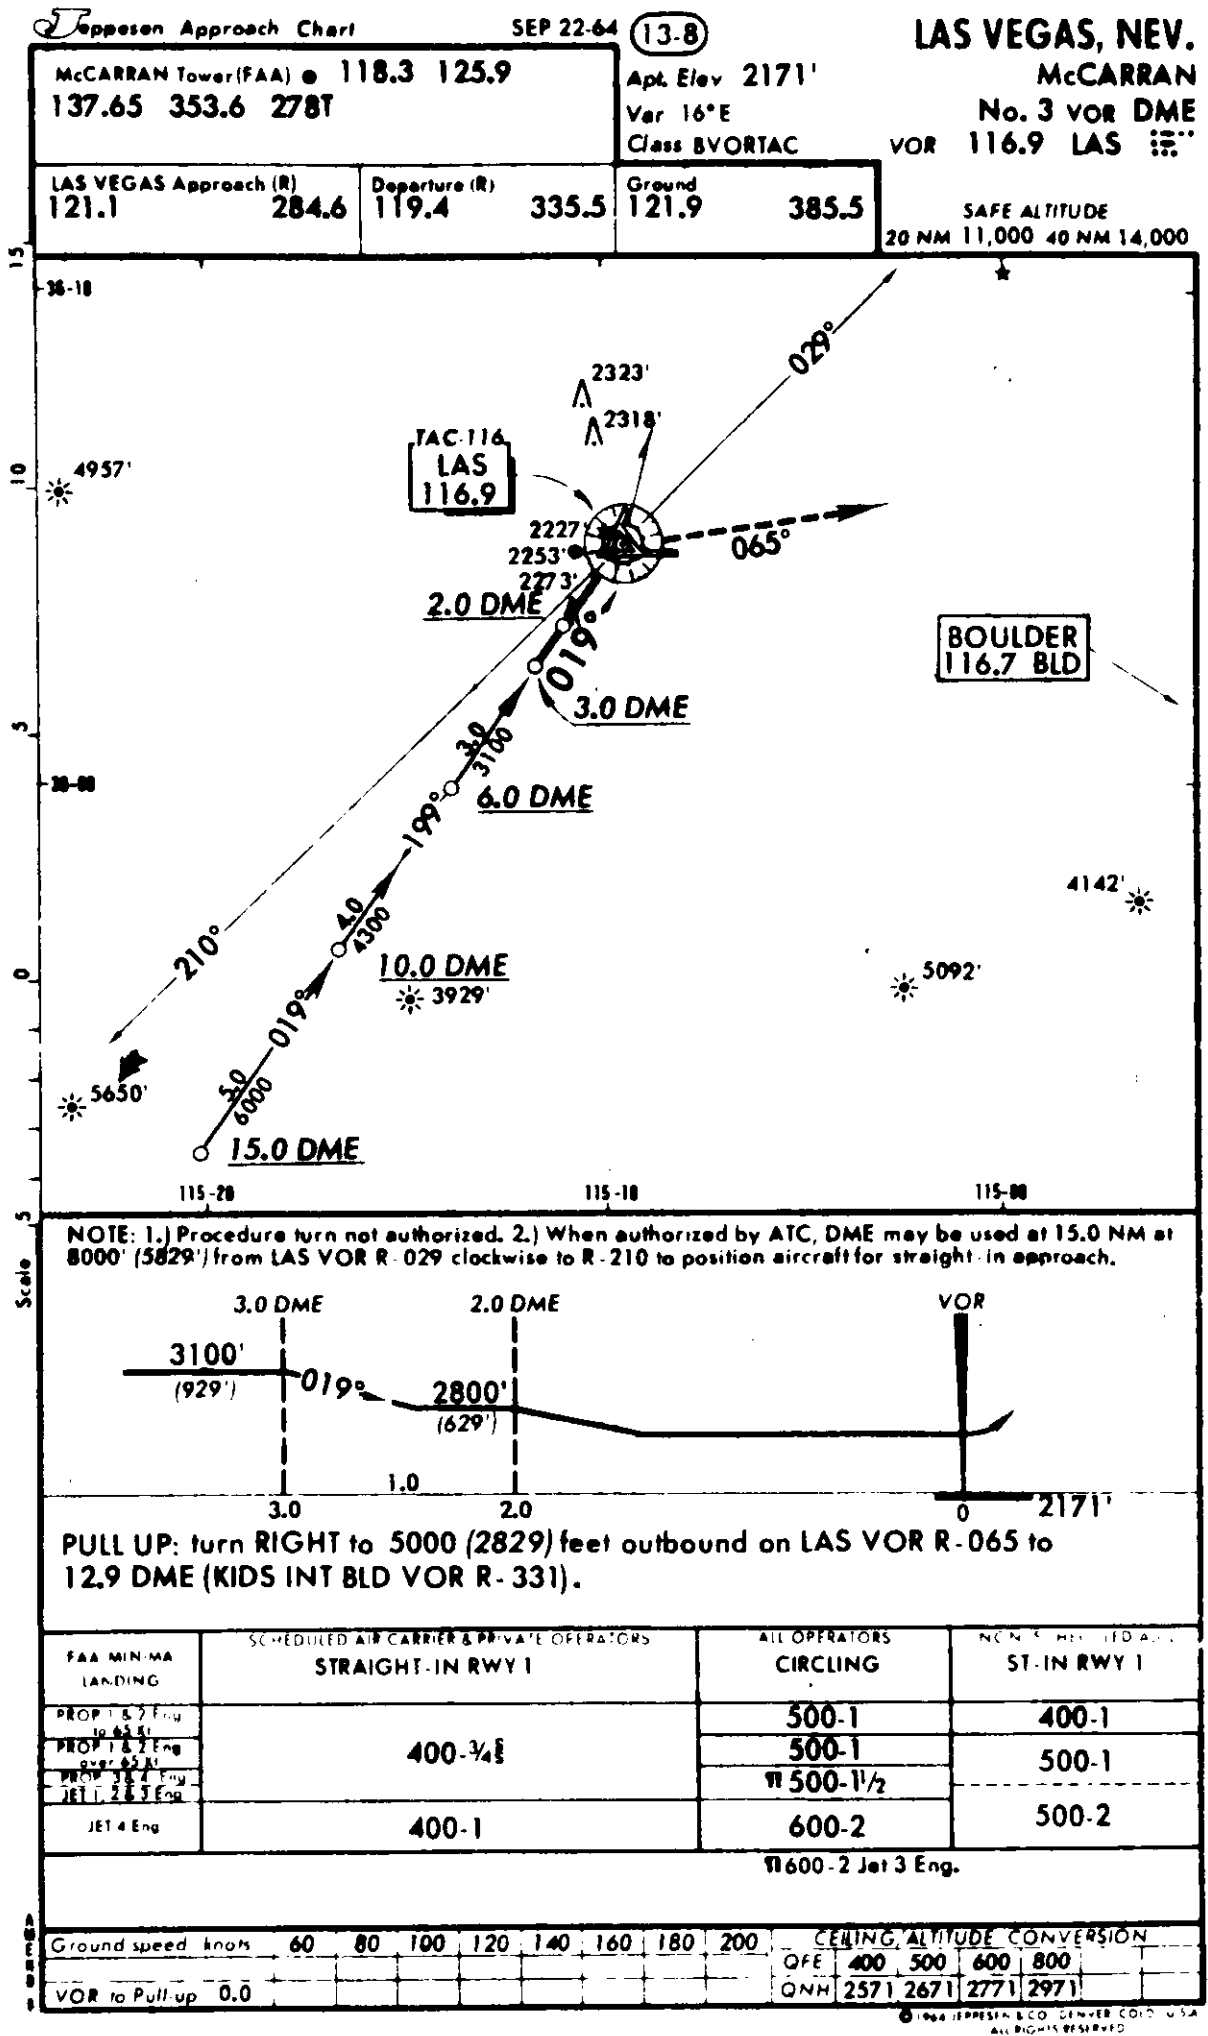
FIGURE 18-2

In accomplishing a DME-3 approach to Las Vegas the crew would have referred to a Jeppesen approach chart (see figure 18-2) which was used by the airline. The upper portion of the chart - the plan view - listed a series of fixes at 15, 10, 6 and 3 miles and the minimum altitudes between these fixes. The minimum altitude limitations were portrayed as 6 000 ft between the 15 and 10 mile DME fix, 4 300 ft between the 10 and 6 mile fix, and 3 100 ft between the 6 and 3 mile fix.

The letter also indicated that the FAA had a standing committee on charting and an invitation was extended to the Civil Aeronautics Board to have a representative sit with this committee. The Civil Aeronautics Board accepted the invitation and was represented at several meetings of the Subcommittee on Instrument Approach Charts of the FAA Flight Information Advisory Committee. A unanimous recommendation of the subcommittee was to extend the approach track in the profile to at least ten miles. The work of the Committee is continuing.

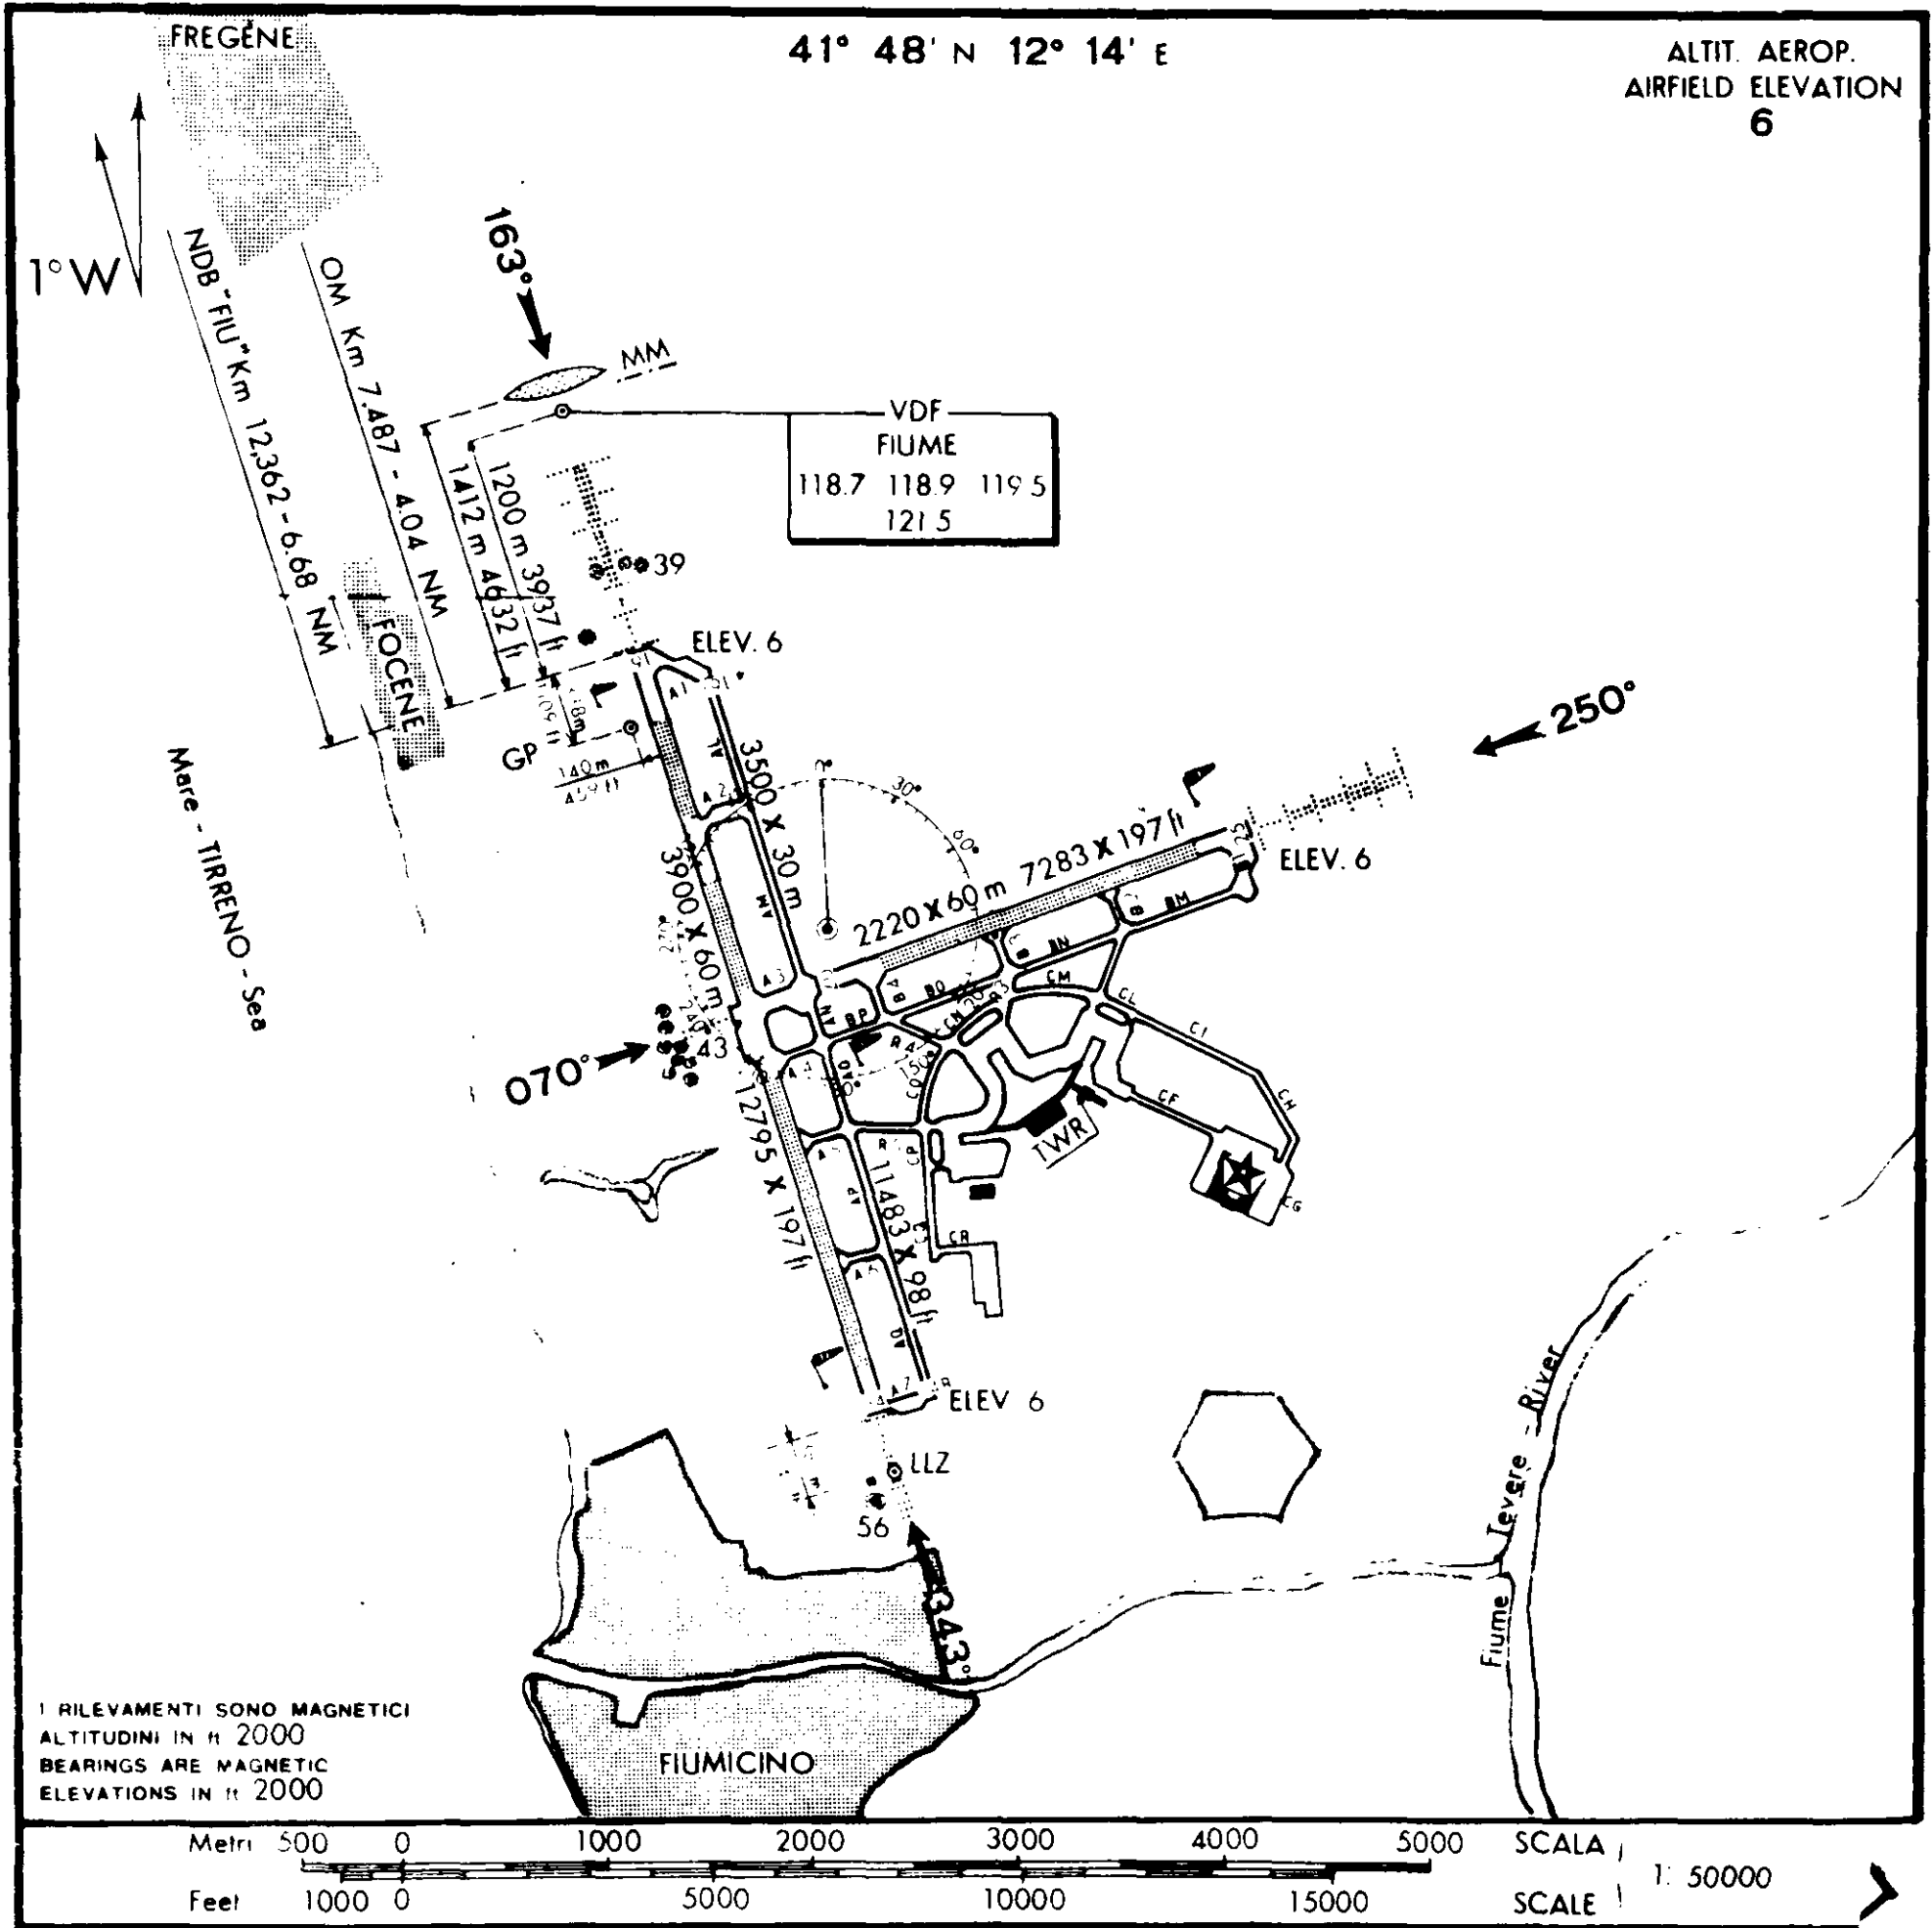
FIGURE 19-1

Runway 16/34 was usable over its entire length but taxiway 16/34 was not usable because of construction work (see Figure 19-1).

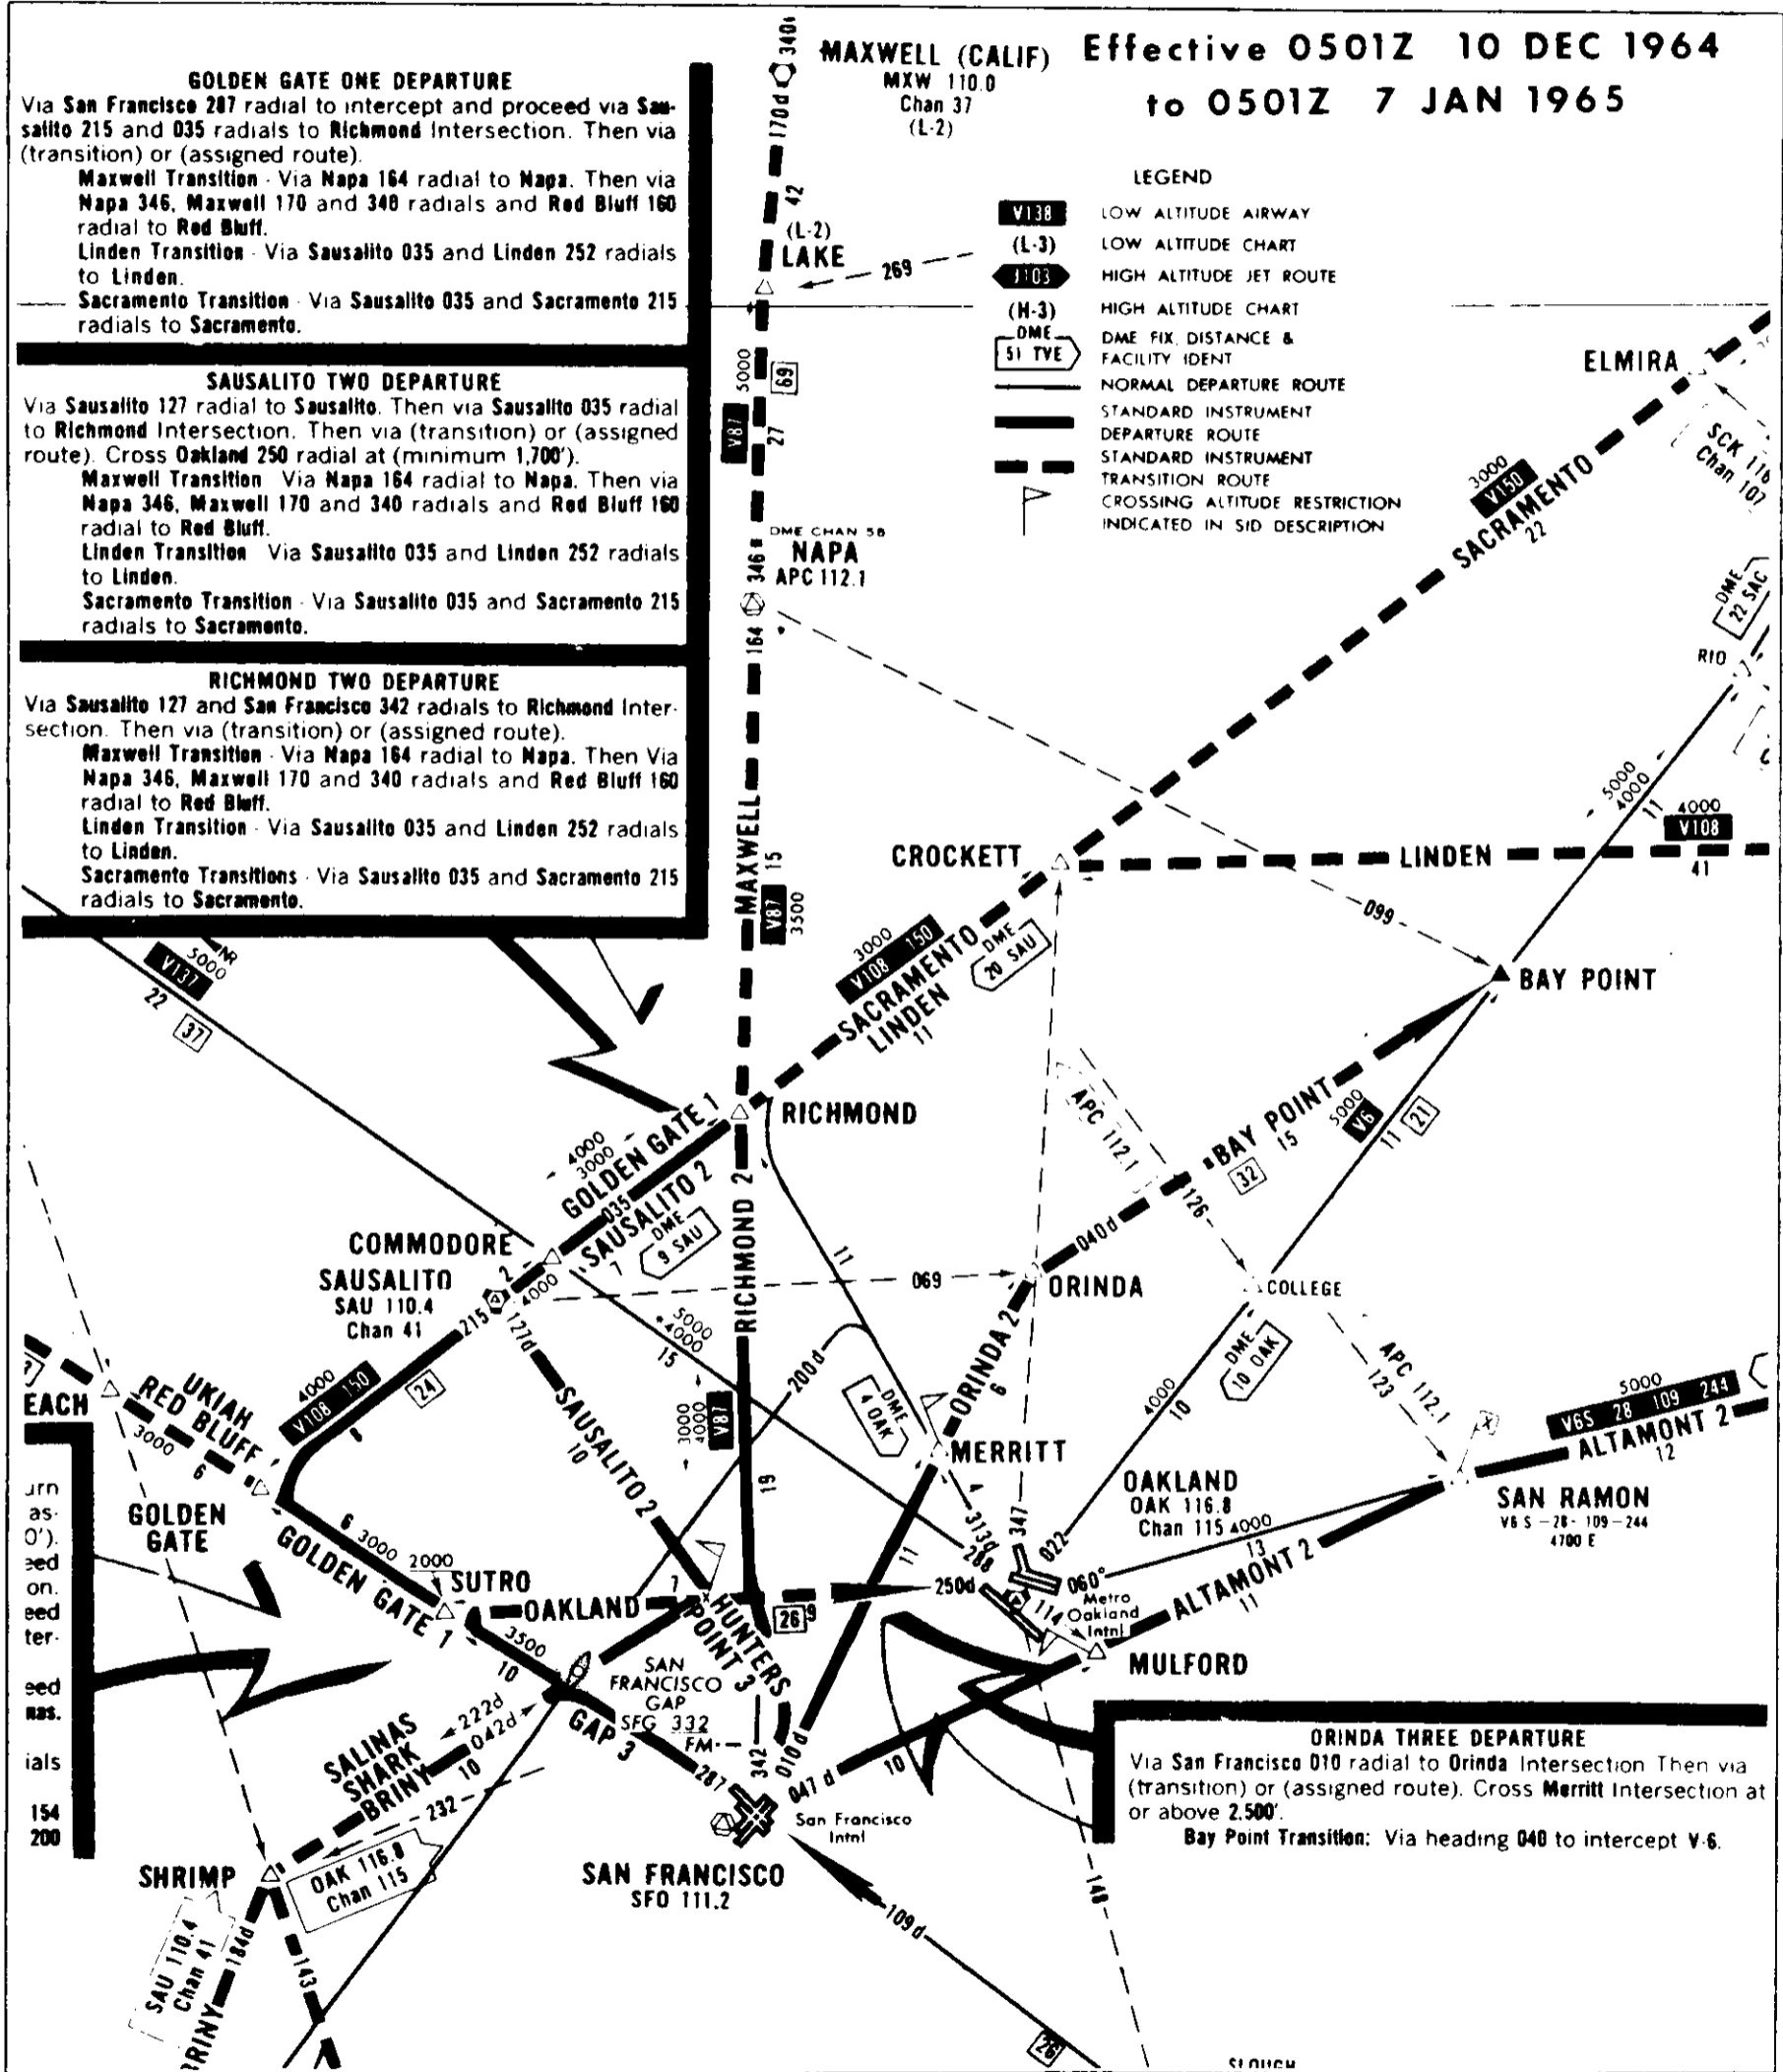
FIGURE 23-1

* Radar vectoring could not be provided an aircraft departing runway 28 via the Golden Gate Standard Instrument Departure until the aircraft reached an altitude of 1 500 ft. This was because standard obstruction clearance from the terrain, both vertical and lateral, could not be achieved in so far as criteria, as existing on 24 December 1964, were concerned. Lateral clearance from obstructing terrain is so critical that there is no space available in which to vector an aircraft safely below 1 500 ft. (See Figure 23-1).

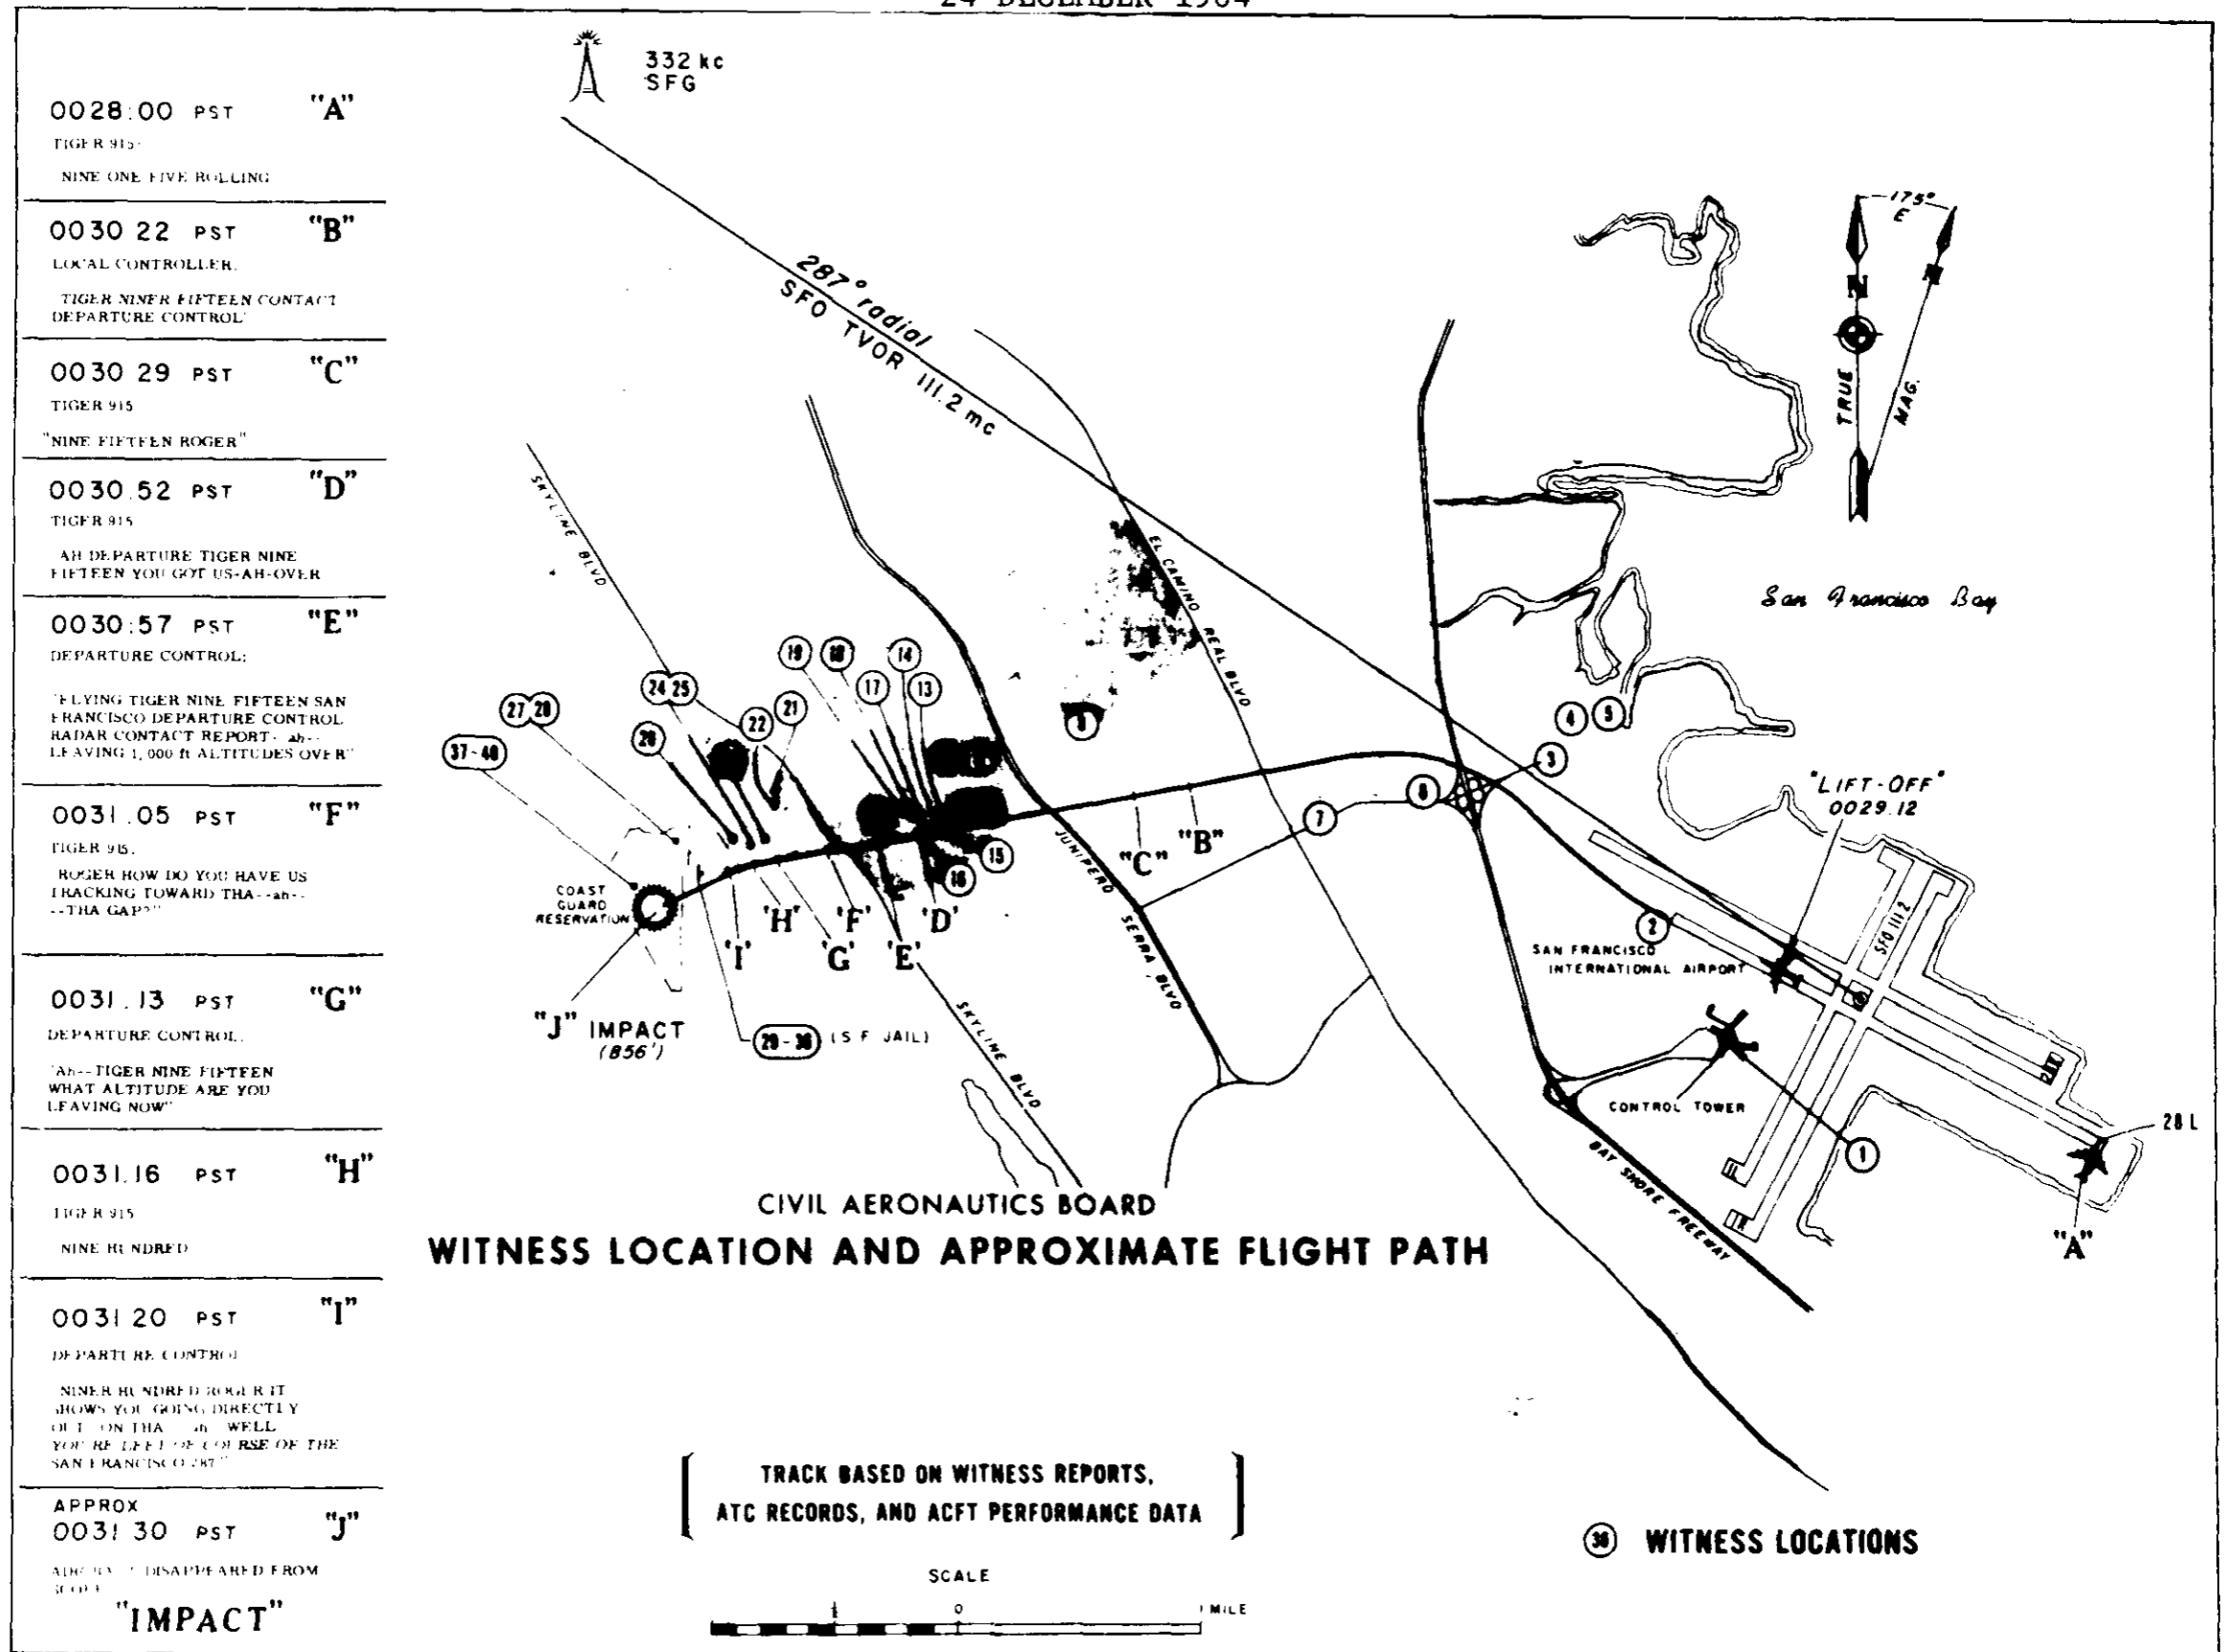
FIGURE 23-2

At 0031:20, the Departure Controller advised that they were left of the San Francisco 287° radial. As he received no acknowledgement he repeated his message. The Departure Controller stated that within seconds after the second transmission, the target stopped, bloomed, and disappeared from the radar scope. Repeated attempts to communicate with the flight after its disappearance from the scope were unsuccessful. At this time, 0032:30, the controller placed a time hack on the communications tape. Ground impact was computed to have occurred at approximately 0031:30. Main impact occurred 860 ft above sea level on Sweeney's Ridge, at approximately 4.3 miles on the 257° radial of the SFO TVOR. The co-ordinates of the impact area were 122°28'00" west longitude, 37°38'28" north latitude. (See Figure 23-2)
