ICAO CIRCULAR

CIRCULAR 82-AN/69
Volume III

AIRCRAFT ACCIDENT DIGEST No. 16

Volume III

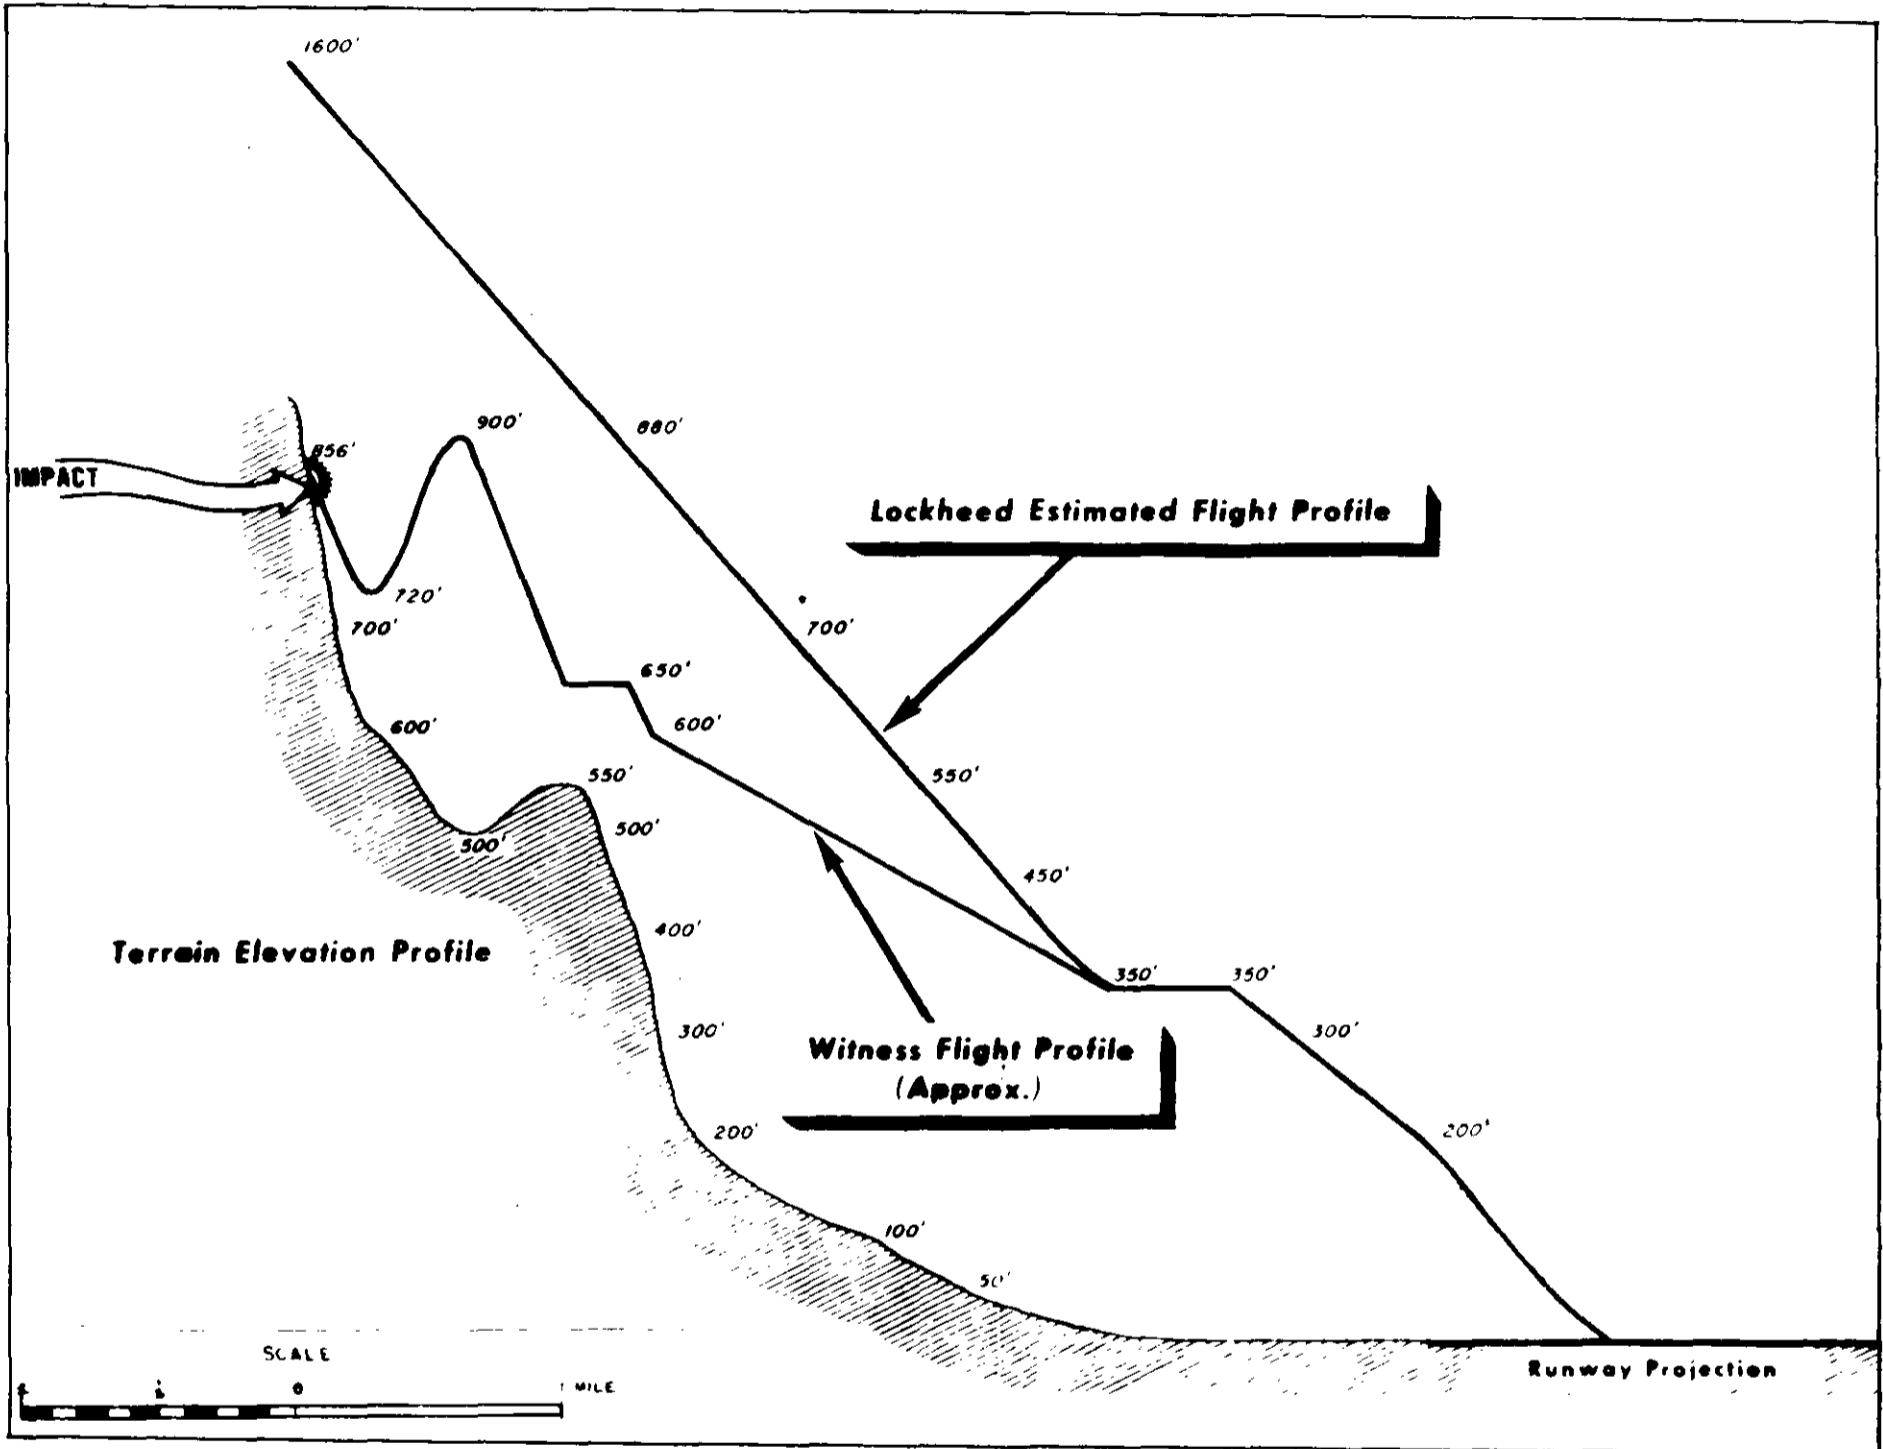
FIGURE 23-3

Performance figures of the manufacturer indicated that this aircraft's rate of climb should have been in excess of 800 ft/min from lift-off. The chief pilot of the airline at San Francisco stated that in his experience similarly loaded L-1049H aircraft will normally climb between 400-500 ft/min on departures from runway 28 at SFO. While no minimum rate of climb per mile was established for runway 28 departures at the time of the accident, the FAA has since specified that 250 ft/mile is the minimum acceptable. (See Figure 23-3)
